## Case Study 21. Capps Low-Water Bridge

North central California. El Dorado National Forest, Placerville Ranger District. North Fork Cosumnes River. Meiss Cabin Road, Primary Forest Route 52.

## Appendix A—Case Study **21**

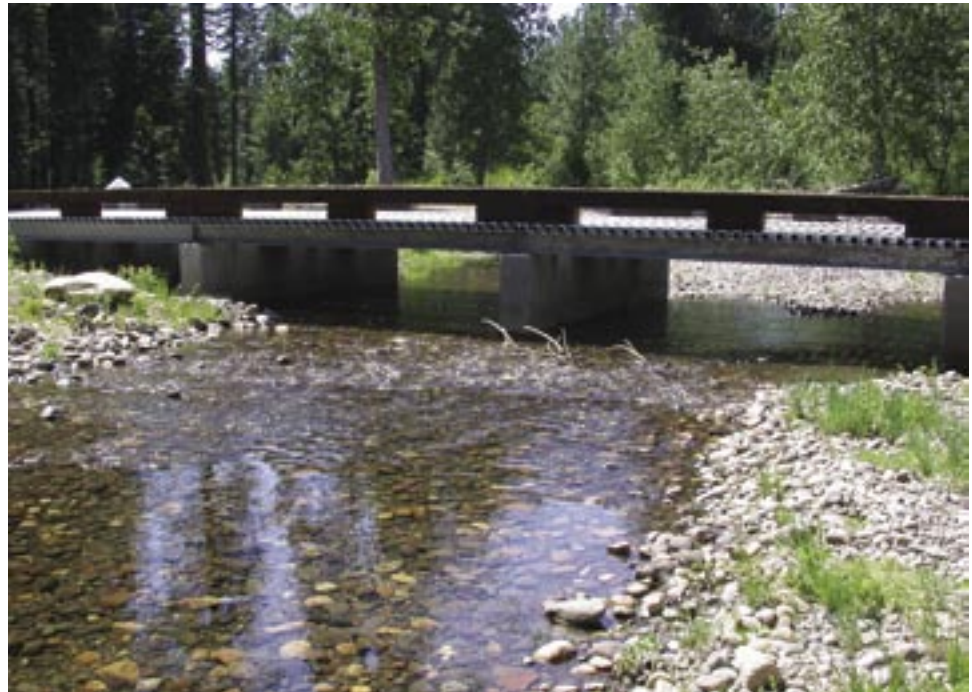
This low-water bridge was constructed in 1998 as an Emergency Relief for Federally Owned Roads (ERFO) project (figure A132). It replaced a vented concrete slab ford that plugged and caused substantial channel and flood plain damage during the 1997 flood. Because the old ford blocked sediment transport during high flows, it had caused dramatic channel aggradation and flood plain erosion. To reestablish channel stability at the site, the designers decided to bridge the entire flood plain, and to provide for overflow in case of debris jamming. The bridge has 13 concrete piers set on bedrock and the deck is square steel tubing with two smooth steel plate runways.

Figure A132. Looking downstream at the Capps low-water bridge. July 2002.

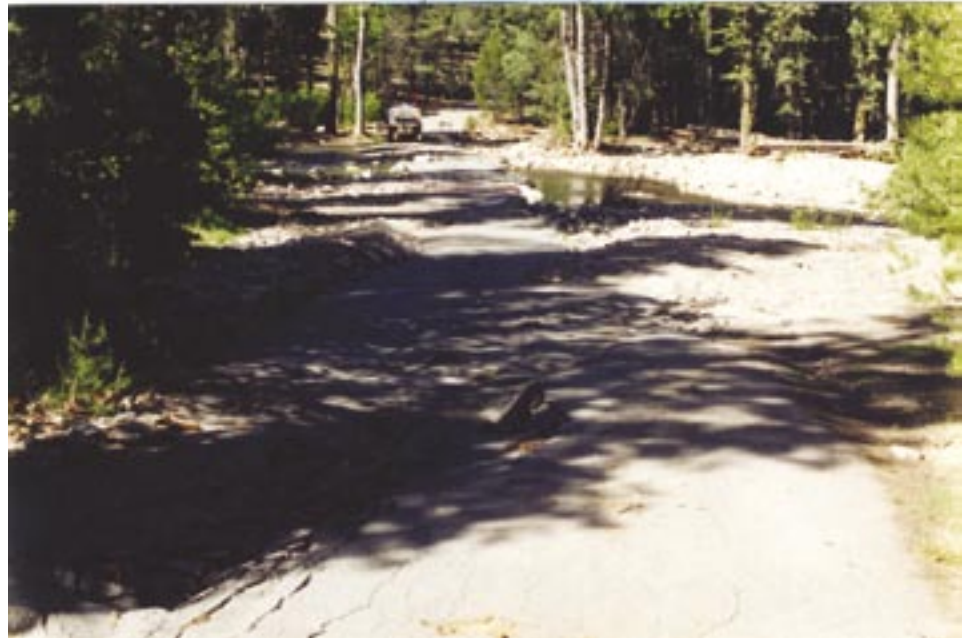
Subsequent ford improvements did not solve the problem. The structure that existed prior to the 1997 flood of record was a concrete slab with an 8-foot-wide concrete box culvert, which filled with bed material and needed annual cleaning even during normal years. During floods, the ford plugged and flow spread over the flood plain, eroding and changing channel location, and washing out the road approaches. To reopen the road after floods, onsite stream-deposited material was routinely heaped up into a turnpike across the eroded flood plain, topped with an aggregate base, and either paved or oiled. This practice, combined with erosion during floods, explains why the flood-plain surface at the crossing site is several feet lower than in adjacent sections upstream and downstream of the site. Because of the widened section, sediment deposition was a serious problem, and the channel became so embedded it seemed to be paved. The vented ford washed out in 1997, during the flood of record (figure A133).

Figure A133. Capps ford after the 1997 flood. Flood flows spread out across the entire valley and road is washed out on far side.

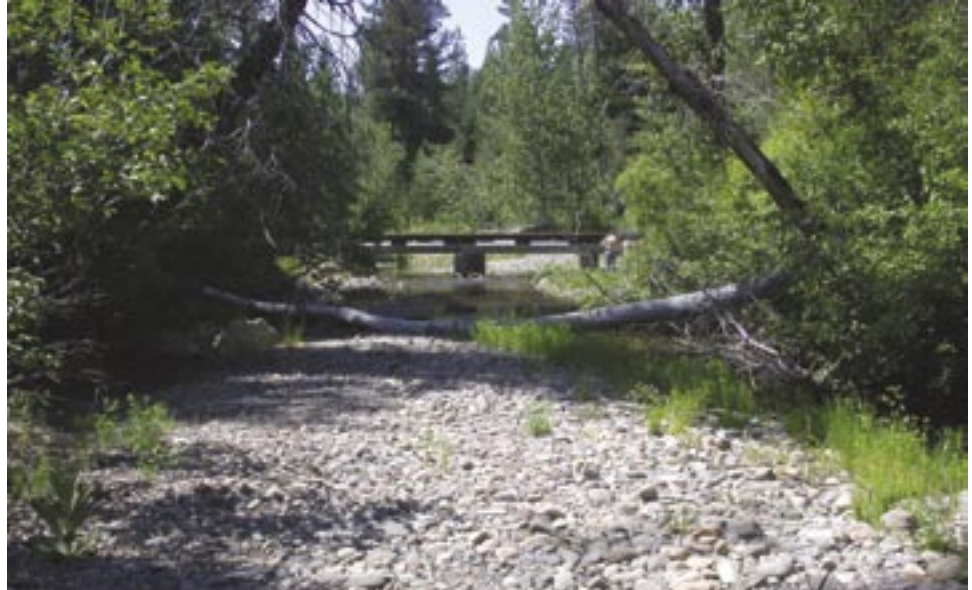
**Channel Description:** At the crossing site, the channel is best described as a Rosgen C3 because of channel widening and flood plain modifications due to the crossing. It is a B3 or B4 upstream and downstream (figure A134), with some bedrock-controlled sections. Bankfull width is between 20 and 30 feet. The low terrace adjacent to the natural sections of the river has been lost at the crossing site, and the bridge crosses a 300-foot flood

Figure A134. Downstream view of Capps bridge showing cobble bars and debris in channel.

Because the previous structure obstructed sediment transport, bed material at the site was much finer than in up- and downstream reaches. Cobble-embeddedness was very high. The new structure has allowed fines to migrate through, opening up the cobble bed again, and improving fish habitat.

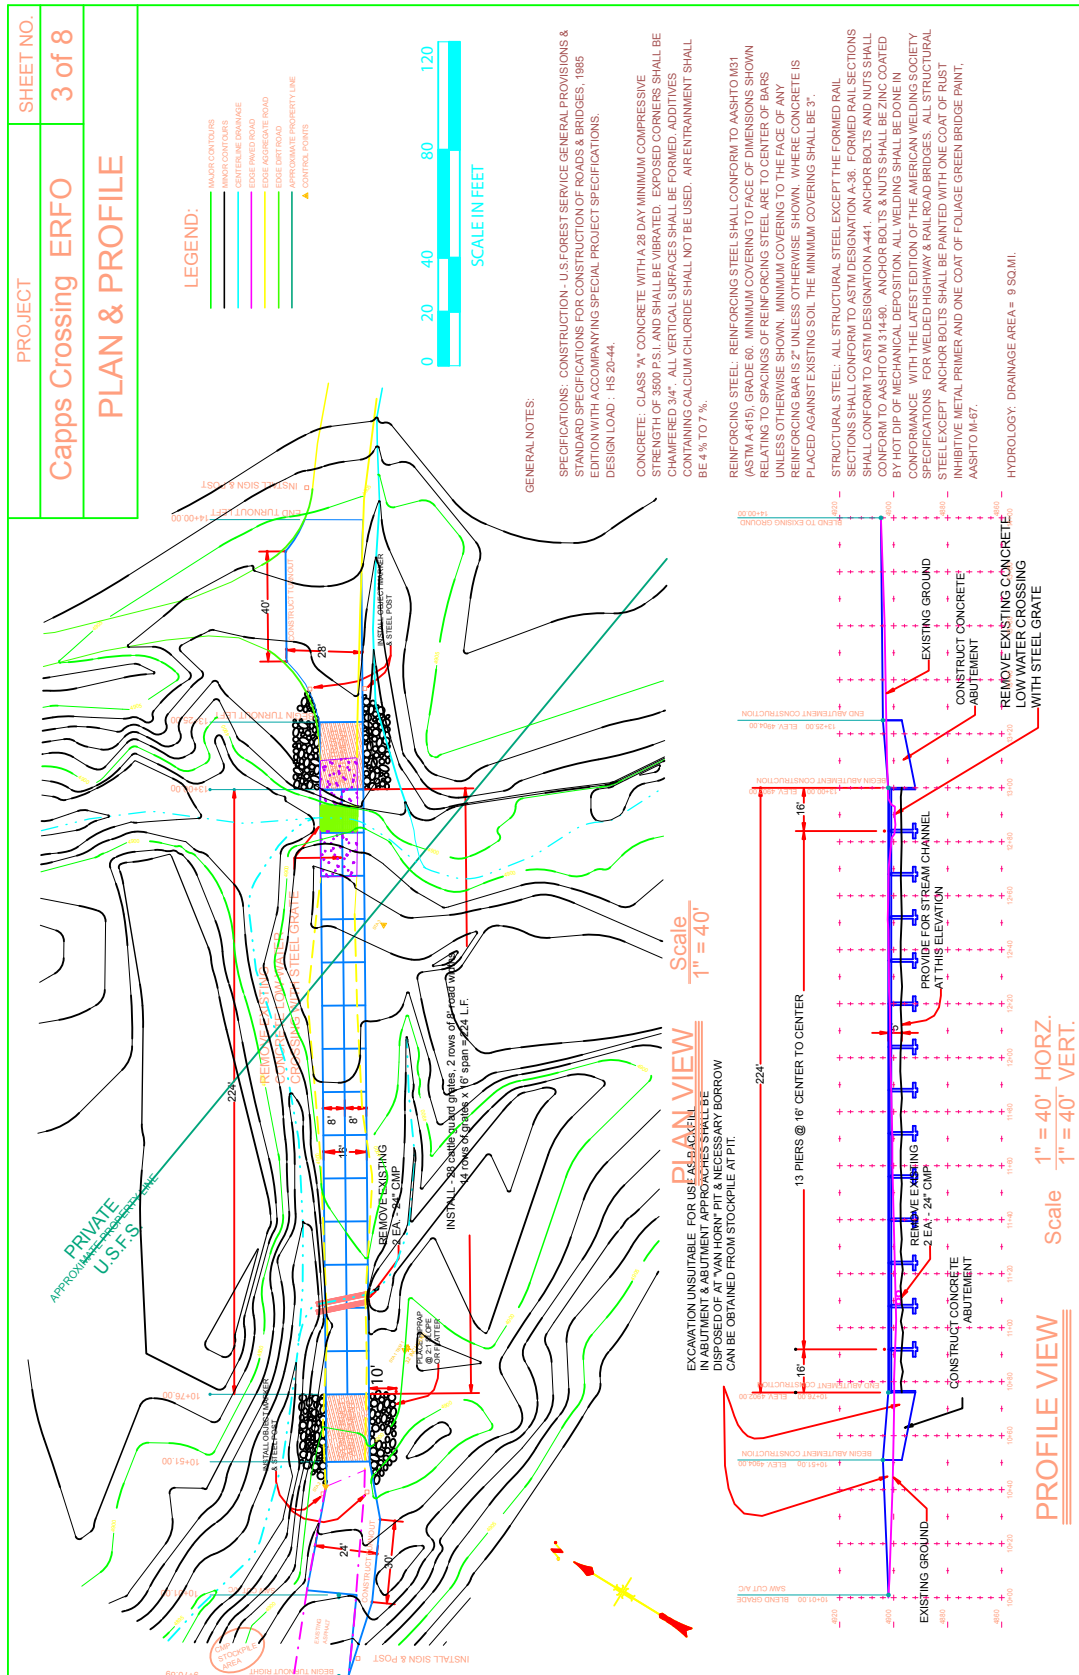
Figure A135—Site plan and cross section for Capps Crossing replacement project. A full size drawing may be found on the CD included in the back of this publication.

bedrock. The deck consists of 16-foot-long sections of box iron grating 16 feet wide. Steel beams support the rectangular steel tube decking. The 25-foot-long concrete abutments slope down to the deck at 8 percent (figure A135).

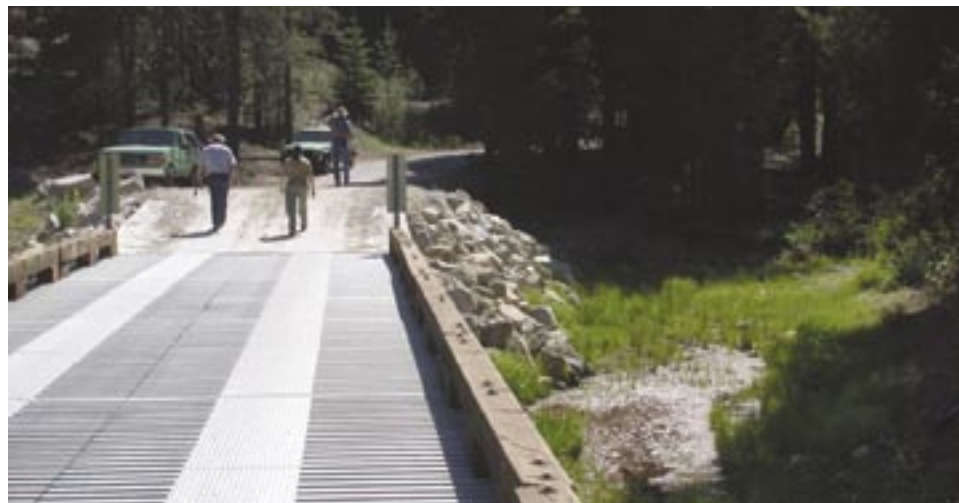
**Safety:** Early cold weather in this area makes icing a hazard while the road is still open. Wooden guard rails were added to keep vehicles from sliding off the roadway (figure A136). Safety signing is limited to type III object markers on the ends of the bridge.

Figure A136. Note concrete abutment with riprap, grating with tire runways, and wood curbs.

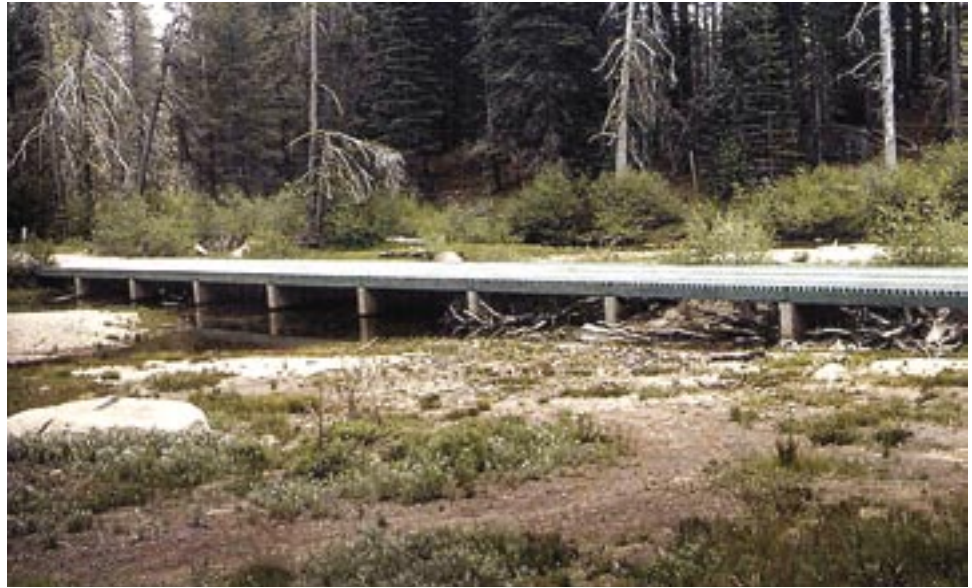
On January 1 2006, the bridge underwent a flood estimated to have an 85-year return interval. Large amounts of debris were caught under and on the bridge, and sediment accumulated around the structure as a result. Perhaps due to sediment accumulation upstream of the bridge during the flood, flow spread over the entire flood plain and has concentrated into two principal channels, one on either side of the flood plain. Maintenance work will include debris removal and in-channel work to confine low-flow to a single channel and remove some sediment deposits.

Figure A137. Looking downstream at Capps bridge with debris trapped under deck, 1988.

This low-water bridge is a solid heavy duty structure that is expected to sustain flooding well. In retrospect, forest personnel believe it would have been advisable to space the piers at a distance equivalent to the current active channel width to minimize the potential to block floating wood debris.

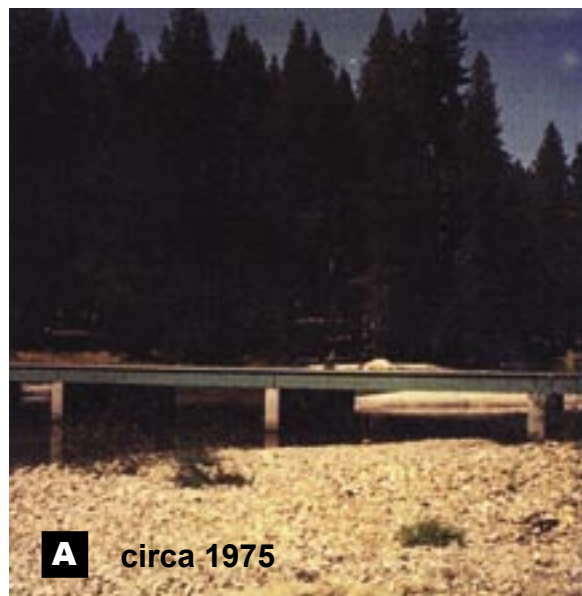
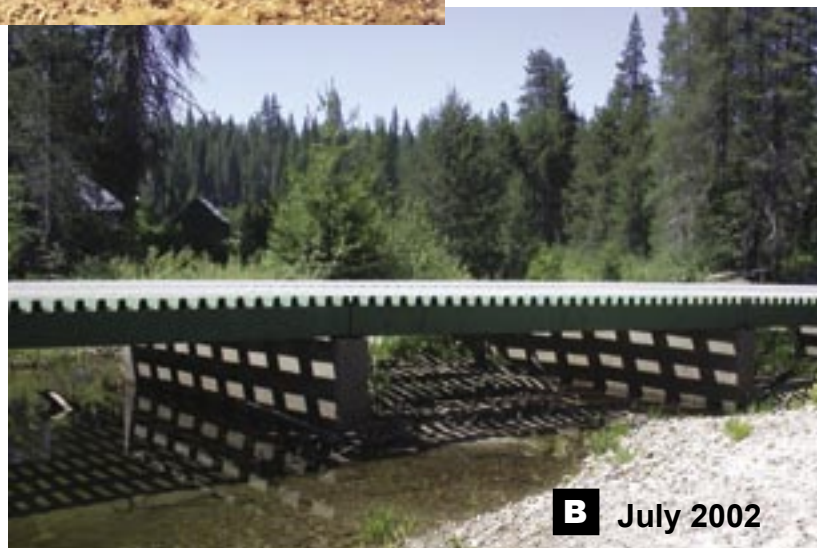
This reach is flatter than Capps, bed material is finer (coarse gravels about 1 to 1½ inch), and the channel appears to be more stable. The bridge is located just upstream of a right-angle bend in the river and crosses the point bar leaving enough space for natural adjustments in sediment storage. Woody debris trapped under the bridge on the point bar side has not been removed, and has contributed to sediment accumulation (figure A137). Both upstream and downstream bars have enlarged since the 1970s (figures A138a, A138b). Nonetheless, comparing current channel conditions to Brink's 1974 description, the channel does not seem to have changed much, indicating that the stream is functioning naturally and is stable. None of the pier footings are exposed.

Figures A138a and A138b. Looking downstream at the Jones Wreckum Bridge. A138a. Bridge inspection photo.
