**Case Study 9. Mesman Slotted Concrete Slab Ford****Location**

South-central Oregon. Fremont National Forest. Thomas Creek crossing on Forest Road 3724. 15 miles Northwest of Lakeview, Oregon.

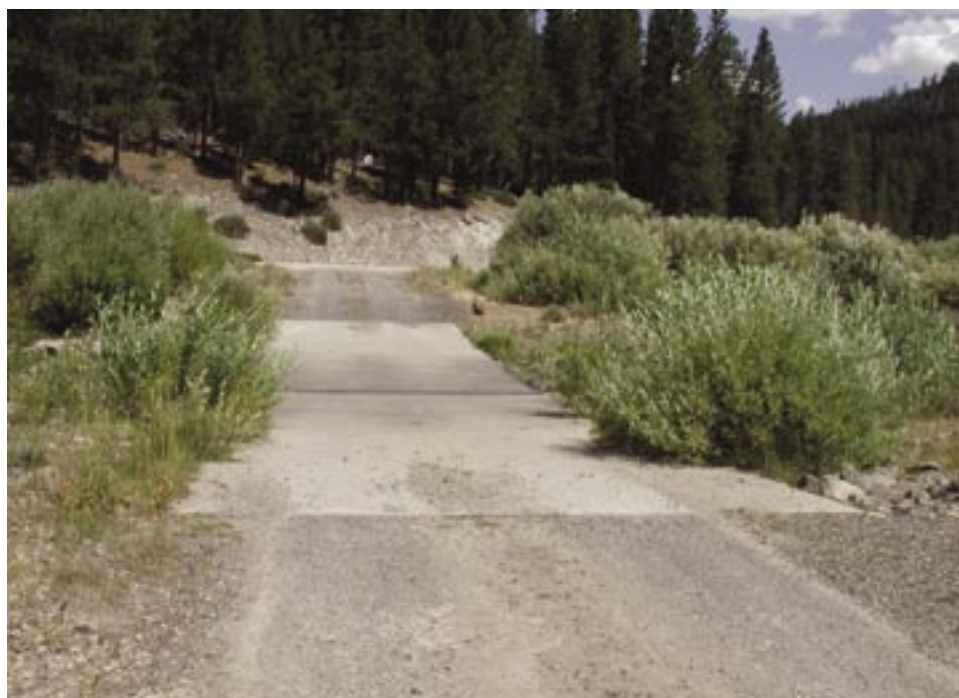
This slotted concrete slab ford was constructed in 1996 on a perennial stream with resident redband trout. Previously at this site, there had been a series of structures that either did not pass fish or were not stable. Fish passage is most important during spring high flows for the spawning migration, and the current structure is low enough that trout successfully swim over it during spring flows. To achieve low flow fish passage, there is a 9-inch box slot with a 4-inch opening at the top (similar to the gap in a cattleguard) crossing the middle of the ford (figure A52).

Figure A52. Looking north at the Mesman ford.

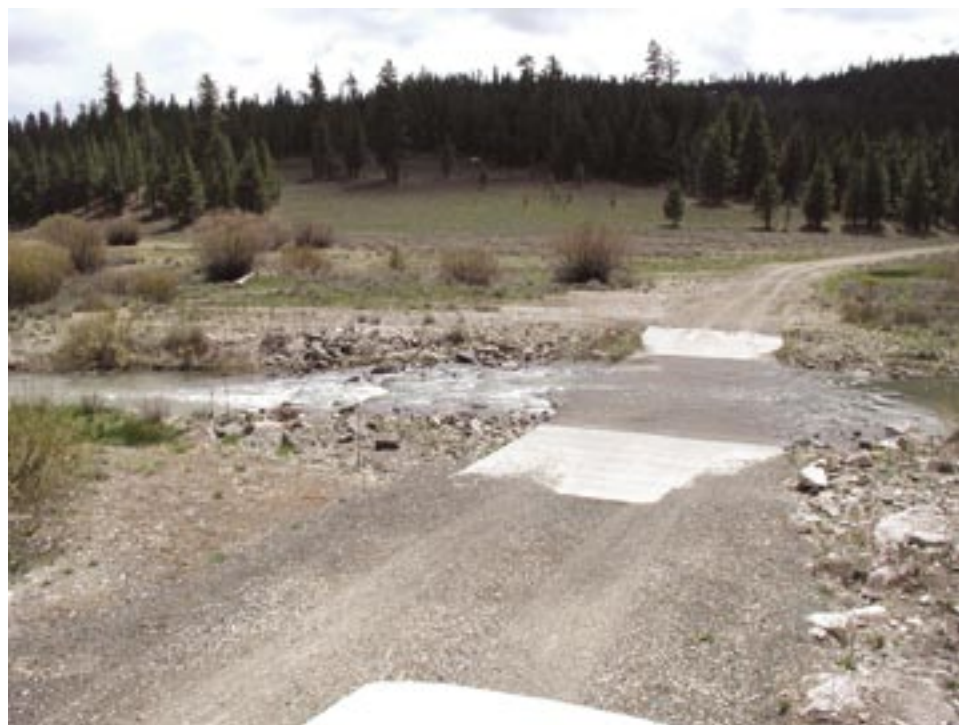
**Hydrology:** Thomas Creek is a near-perennial stream with peak flows during spring snowmelt runoff, and low summer flows (less than 1 cubic foot per second). Watershed area above the crossing is approximately 20 square miles. Most years, high flows submerge the structure at least 1-foot deep (figure A53).

Figure A53. Spring flow over the Mesman slotted ford.

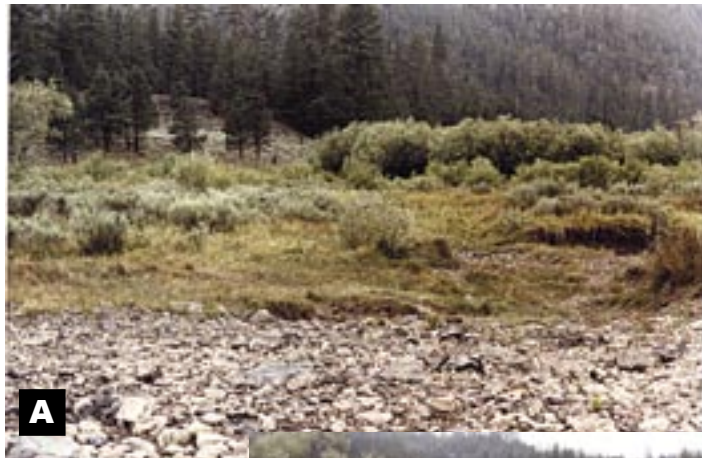
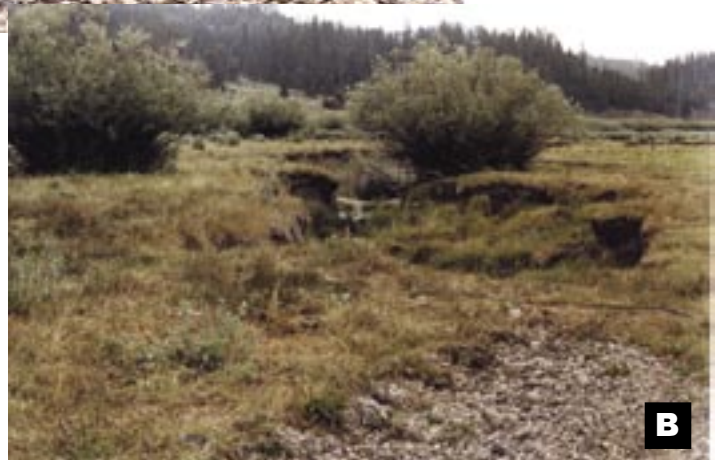
A large headcut had moved up through the valley to just downstream of the crossing by the mid-1980's (figure A54b). Channel incision was attributed principally to the old grazing system, which had reduced native bank-stabilizing vegetation. The crossing probably contributed to channel instability by blocking the flood plain and concentrating floodwaters through the single crossing structure. In 1988, the forest initiated an effort to restore the incised channel and reconnect it to its flood plain. The channel was reshaped and slope was controlled with rock check dams.

Figures A54a and A54b. Thomas Creek in 1988 as seen from the ford (a) looking upstream of the crossing (b) downstream of the crossing.

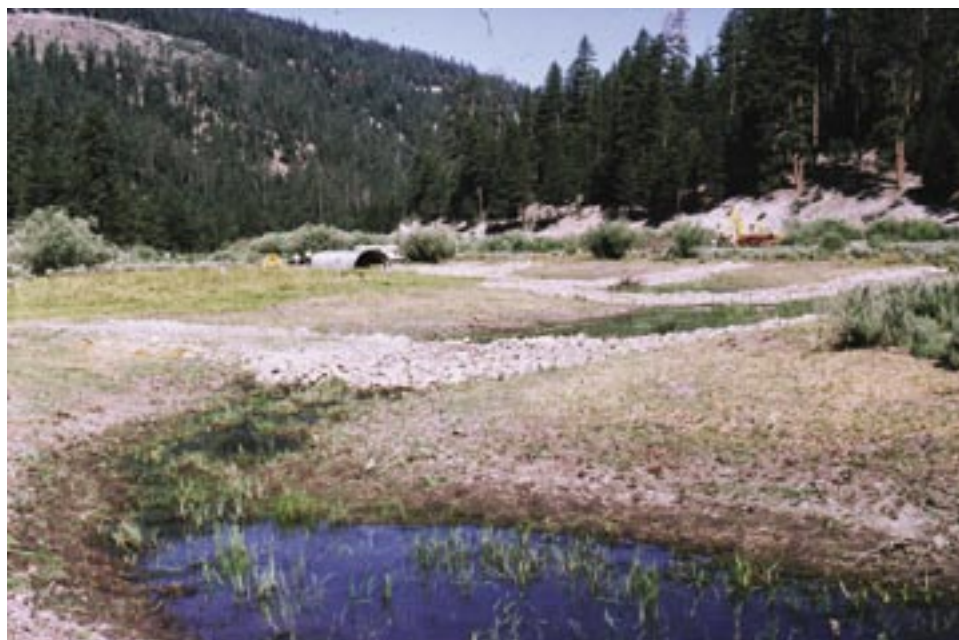
Restoration objectives were to reestablish the natural overbank flow regime, narrow the channel, restore natural vegetation, and improve trout habitat. Shortly thereafter the open-bottom arch culvert that later failed was installed (figure A55).

Figure A55. Looking upstream at the rehabilitated channel during placement of the culvert in 1988.

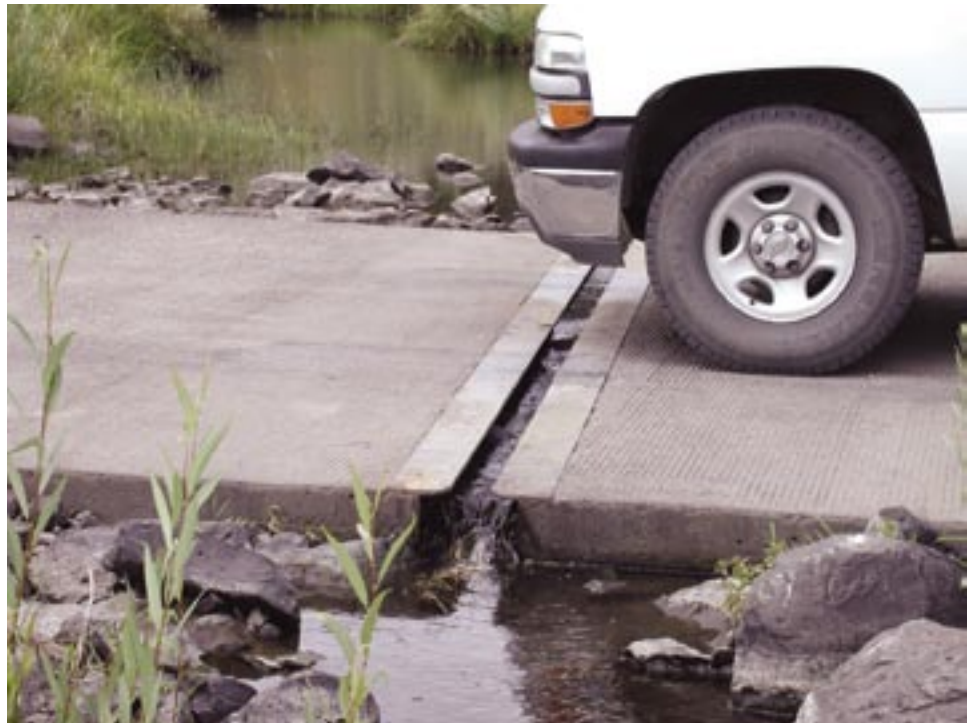
**Structure:** The driving surface of the ford is reinforced concrete. Two parallel W-flanges with tops set flush into the concrete run across the ford perpendicular to the roadway. These create an open slot box (9½ inches wide by 10½ inches high), with a 4-inch opening at the top to allow cleaning with hand tools. The slot passes low flows, fish, and possibly other aquatic species. It was designed for a velocity of less than 2 feet per second and a depth of at least 4 inches during normal summer flows to allow passage of both juvenile and adult fish. The ford and the slot slope downstream at 0.5 percent, which is flatter than the stream, and sand and gravel retained in the slot provide at least a partial natural bottom (figure A56).

Figure A56. View of the slot with gravel bottom, August 2006.

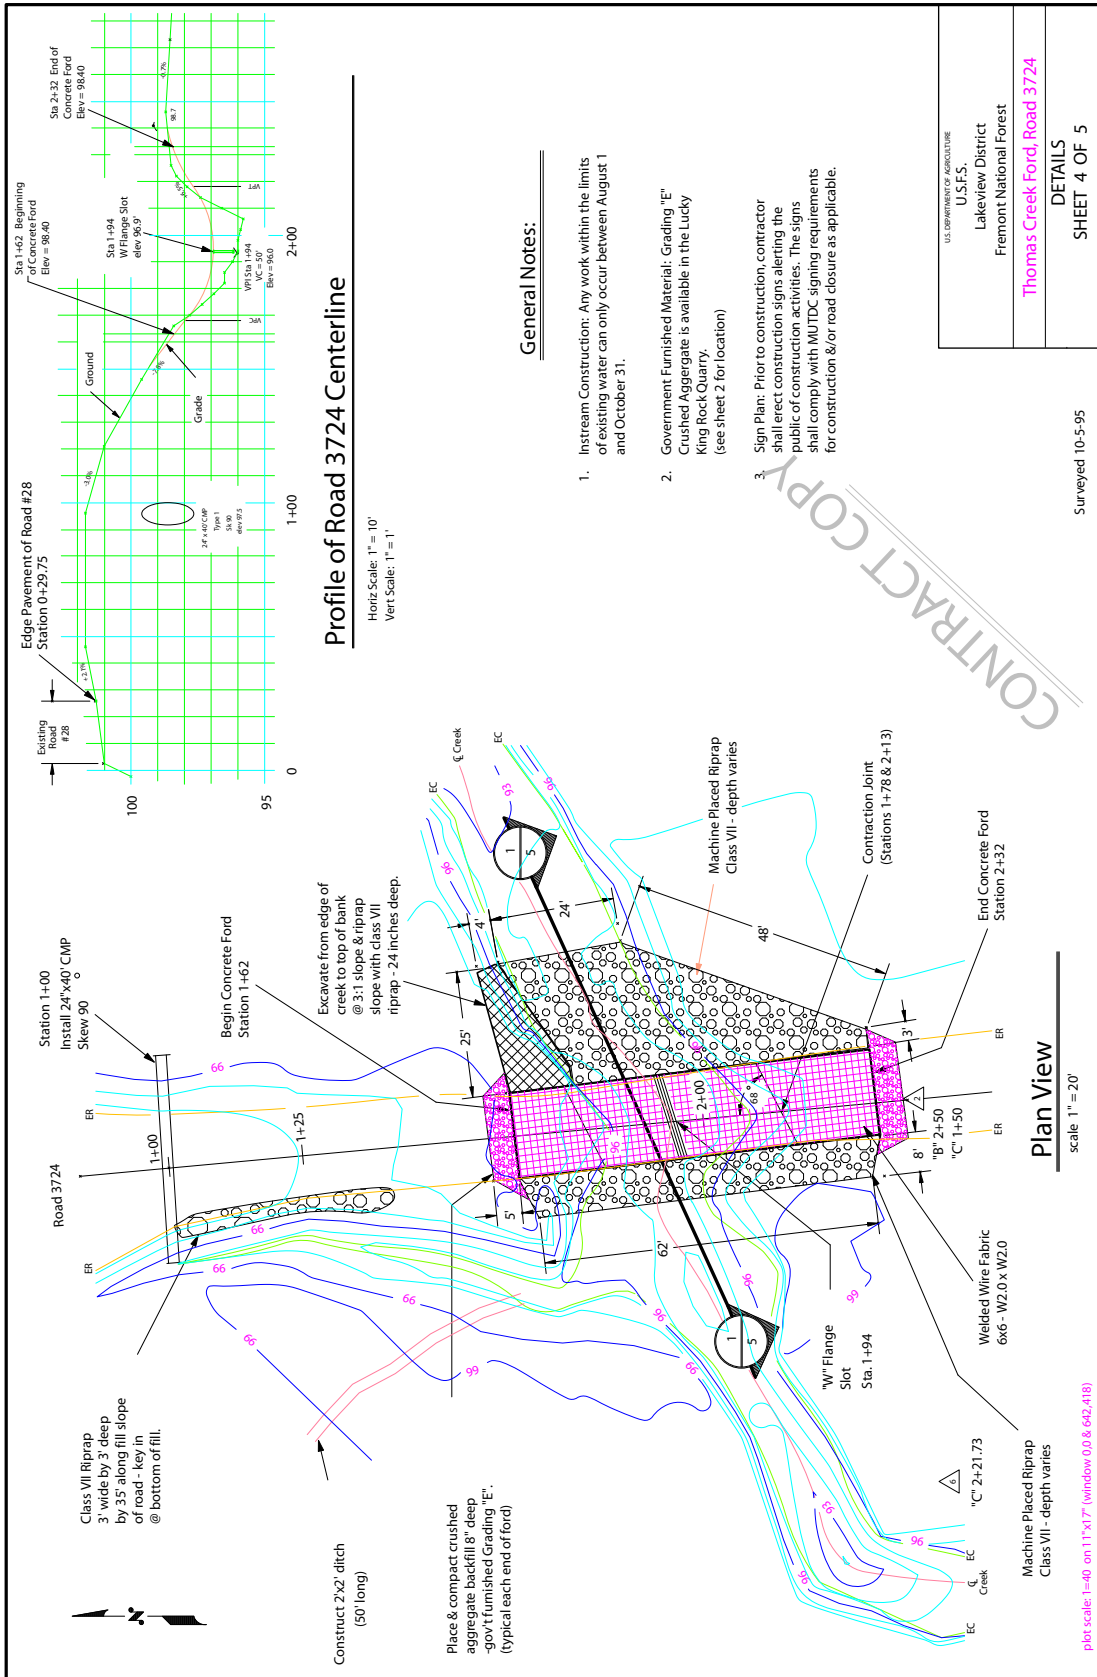
Figure A57a—Thomas Creek ford contract drawings sheet 4: site plan view. (Designed by Jerry Panter, 6/28/1996) A full size drawing may be found on the CD included in the back of this publication.

The designer incorporated several drainage features in the road as it crosses the flood plain approaching the ford (figure A57a). North of the

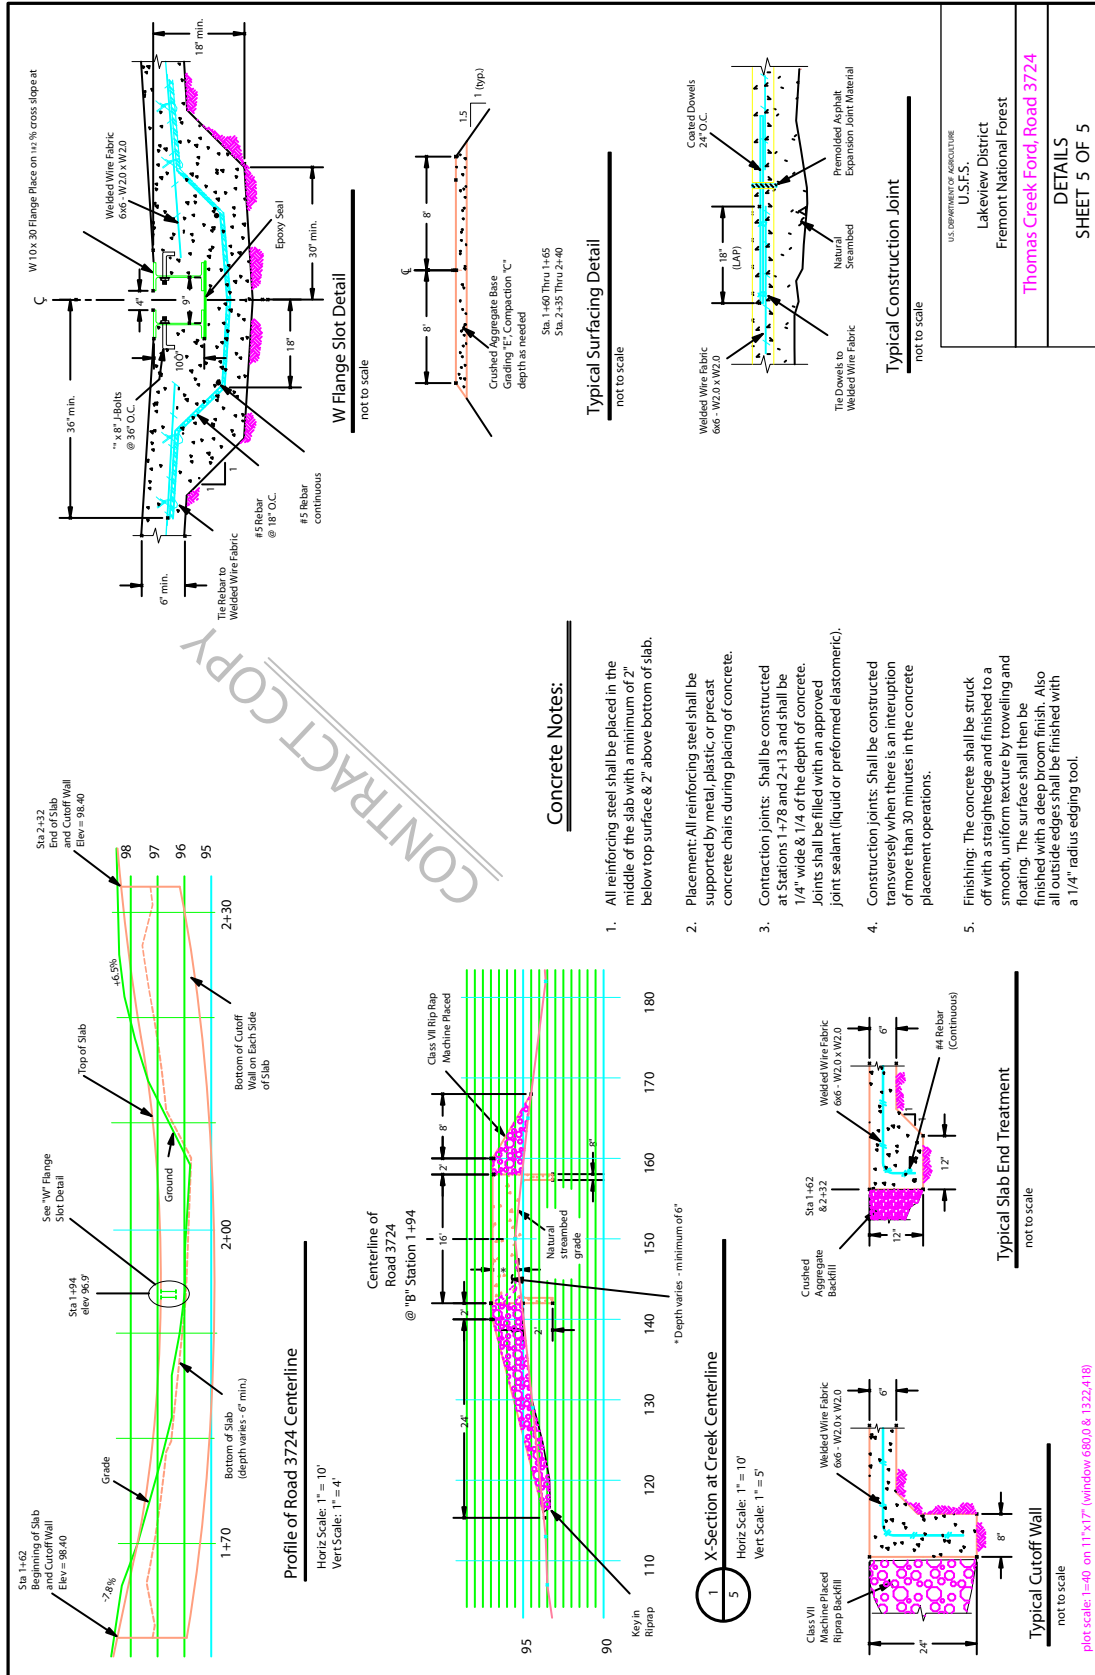
Figure A57b—Thomas Creek ford contract drawings sheet 5: road profile, slot detail, cross section along creek. (Designed by Jerry Panter, 6/28/1996) A full size drawing may be found on the CD included in the back of this publication.

Thomas Creek is susceptible to scour, so 24-inch-deep cutoff walls on the upstream and downstream sides were part of the design (figure A57b).

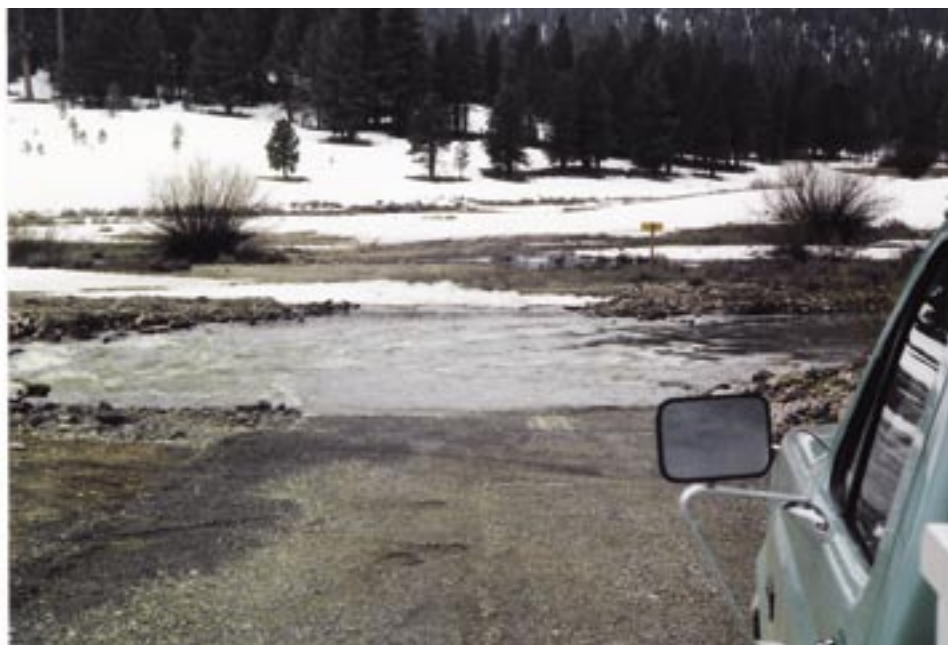
crossing, a flood plain overflow channel was rerouted toward the ford. There is a flood-plain culvert under the road in that vicinity in case ditch capacity is exceeded. About 150 feet south of the crossing, there is a grade sag in the road surface to permit flood plain flows to overtop the road (figure A58).

Figure A58. Looking south across the submerged ford in January 1999. The road dip beyond the ford is conveying flood plain overflow.

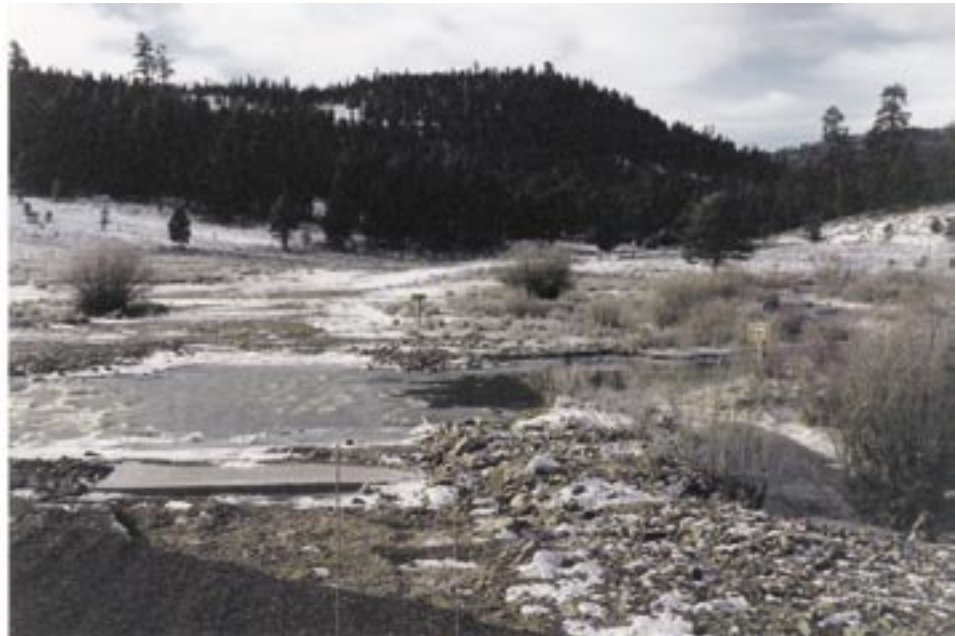
In 1997, a flood estimated to exceed a 100-year event sent 3,000 cubic feet per second over the ford and submerged the entire flood plain. Other than the loss of a few cubic yards of gravel surfacing from the approaches, no damage occurred (figure A59). In the 10 years the ford has existed, no other maintenance has been required.

Figure A59. Shortly after the 1997 New Year's Day flood. Some gravel washed from the approaches (in foreground) was the only damage from the largest flood on record.

The only change the forest would make in the design is to extend the concrete further up the approaches to cover the full wetted perimeter of a major flood event.
