Cispus River Engineered Logjam Restoration Project

Developing Monitoring Plans— Chapter 3

Project Methods, Design, and Monitoring

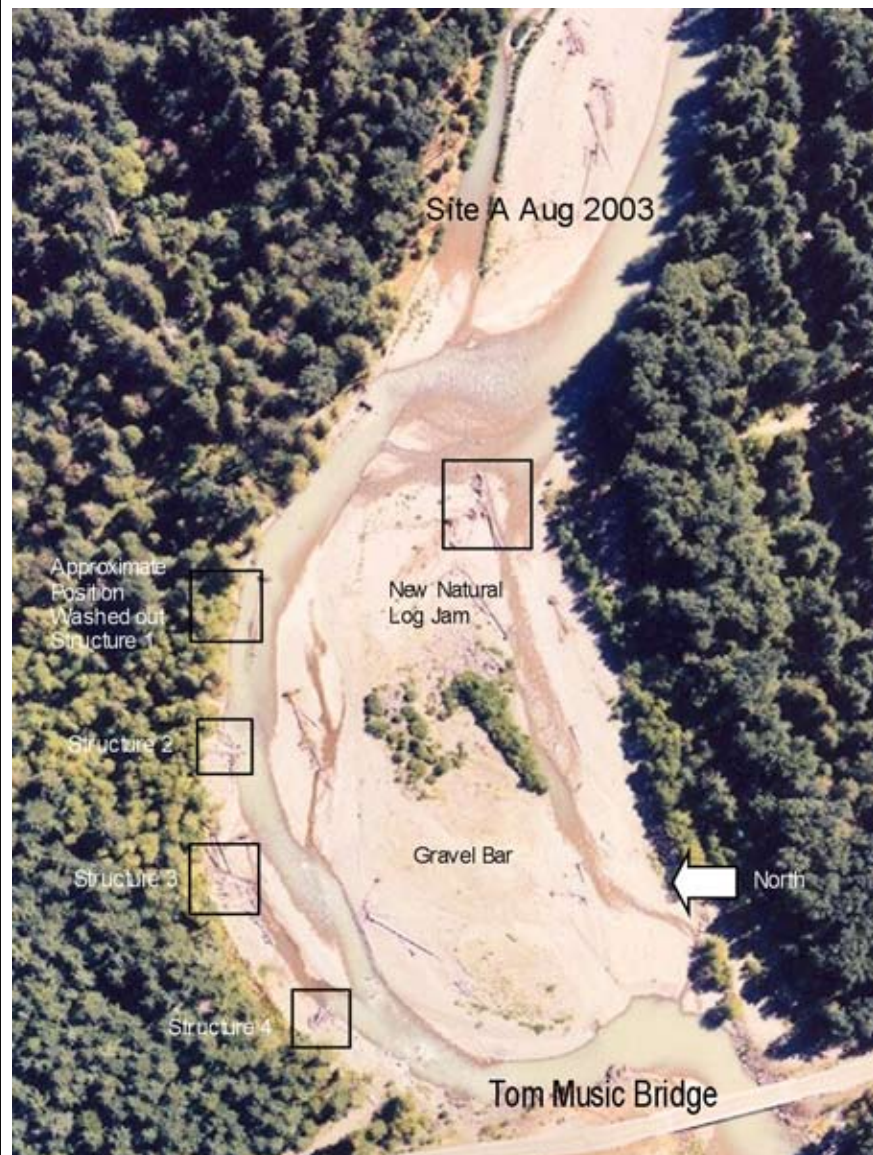
Figure 3 - Site A in 2003, with labels that show the locations of the structures; logjam formed in the flood of 2003.

The important points from these photographs are that (1) a greater portion of the river is flowing down the side channel in 2003 than in 1999, (2) new streambanks are building between the existing structures, and (3) the new streambanks provide greater protection for the approach to the bridge and the archeological sites behind the structures.

The furthest upstream engineered logjam (one of four, installed in 2001) washed out during the 2003 flood. Therefore, the risk for bank erosion at this logjam location is now the same as that of the preproject condition. The three remaining logjams are structurally sound and functioning as expected. The backwater areas downstream of structures two and three allowed sediment to deposit in these areas. As a result, new banks are building and protecting the area between the structures. In addition, a log

was recruited in the area between structures two and three and caused the formation of a gravel bar that deflects flows away from structures three and four. This gravel bar reduces the risk to the bridge approach and archeological sites.

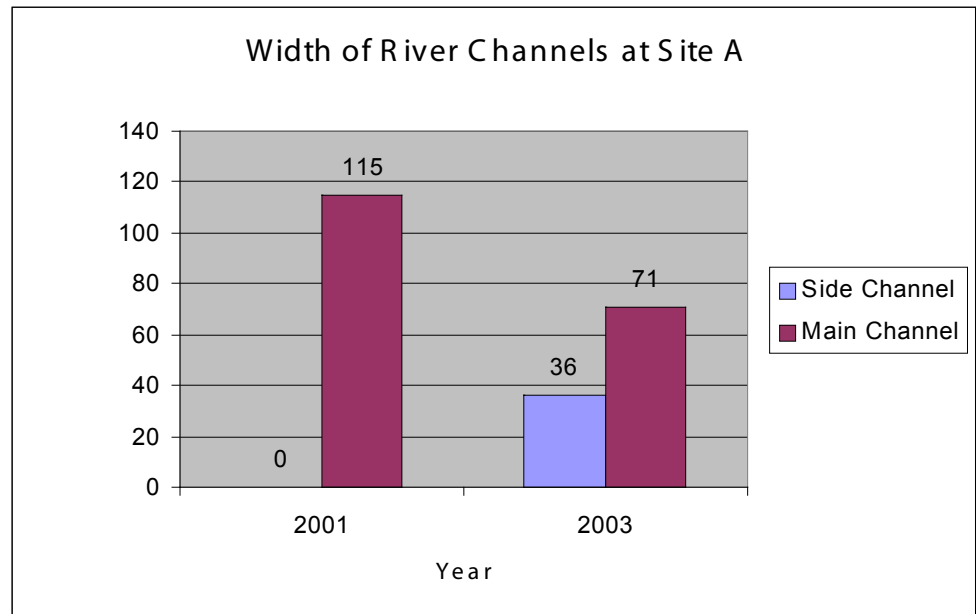
Figure 4. A comparison of the width of the main channel and side channel between years.

An overflow channel is now perennial, carrying approximately 10 percent of streamflow during low flow. This channel goes directly under the bridge, reducing the amount of water flowing in the main channel and reducing erosive forces on the archeological site and bridge approach.

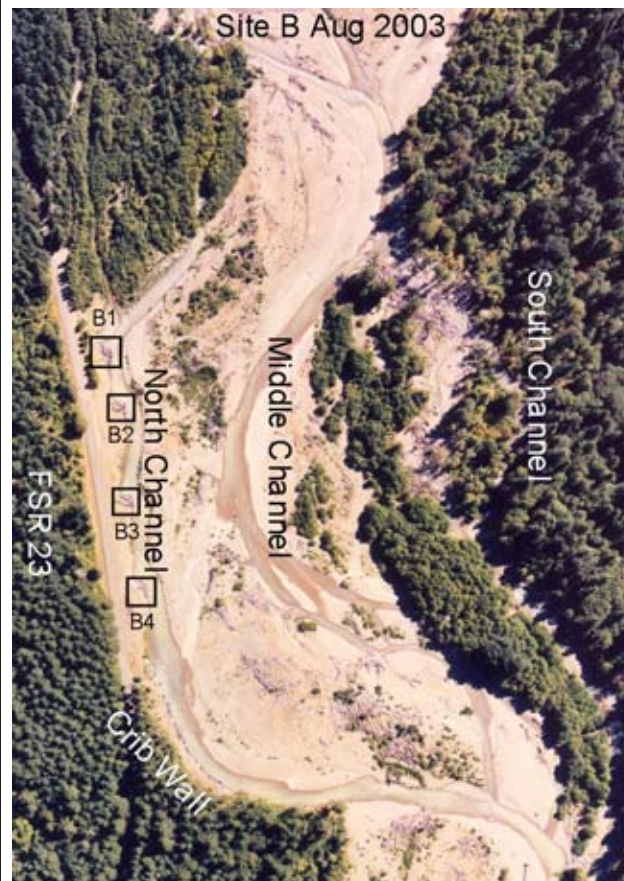
Figure 6 – The position of the river channels and the structures.

The large channel has switched sides of the valley, so that the largest channel is now on the north side of the valley next to FSR 23. The key points are these: (1) the North Channel is carrying a greater proportion of the rivers flow, and (2) the construction of the structures pushed the North Channel away from FSR 23, and (3) the North Channel increased in width while the South Channel is much smaller.

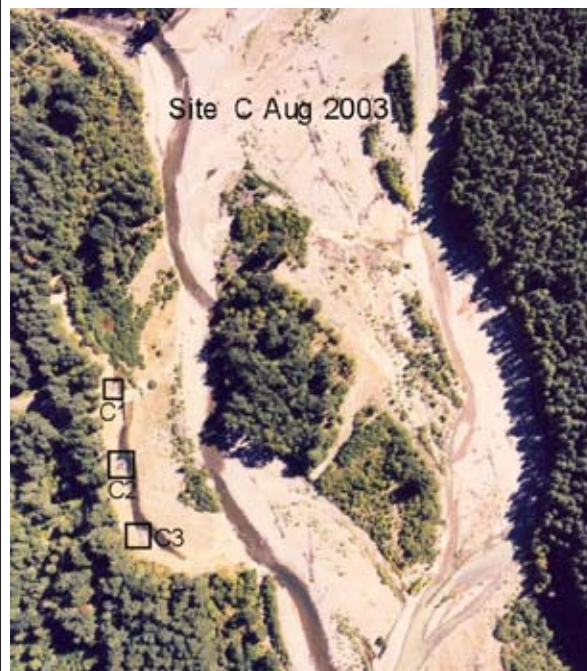
Figure 8 – Site C, 2003, with position of the structures.

The key points are as follows: (1) the channel next to the structures is wider and deeper in 2003 than in 1999, despite a decrease in streamflow, and (2) the main channel has shifted away from the channel across the intervening bar.
