Forest Service

SAFECOM Summary August 2007

Interagency Aviation Safety Alert

Subject: Retardant Dip Tanks

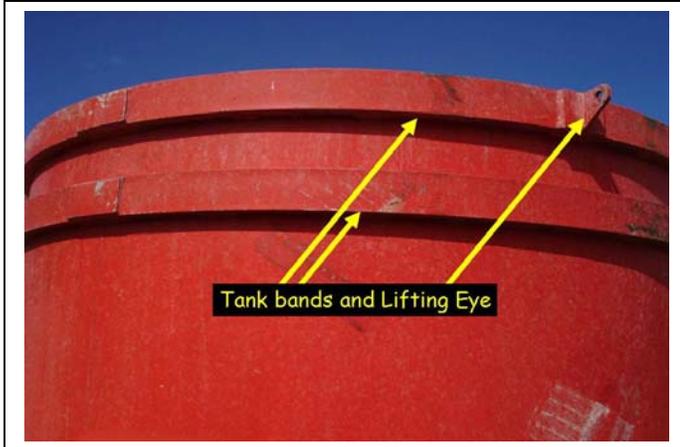
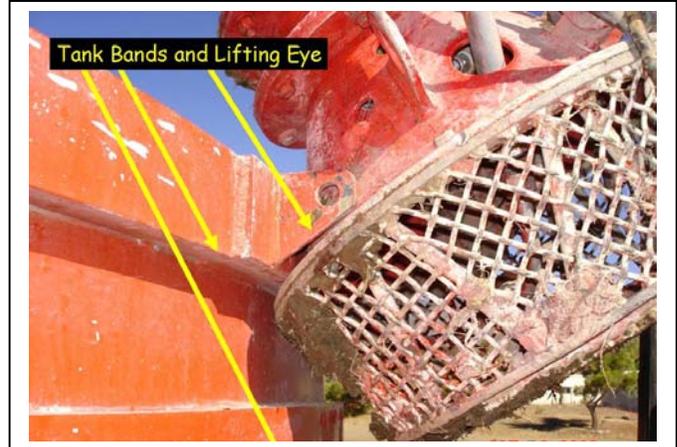
In May 2007 a Bell 206L-4 had the bucket snag on the lip of a tank, requiring the dip site manager to pry it off with a shovel. The bucket snagged on a clamp that was holding PVC around the top of the tank.

In October 2006 a Type-1 helitanker was severely damaged while attempting to hover-dip from a 5000-gallon portable retardant tank (PRT) when the snorkel inadvertently became lodged on the lip (ring) that surrounds the tank’s frame.

Portable Retardant Tanks. The frame of portable retardant tanks (PRT) may have lift rings, tank bands (aka collars), or other structural components that can “catch” snorkels and water buckets. All PRTs should be inspected, and any structural hazards mitigated, prior to use.

- 1) Inform all helicopter flight crews and Incident Command Teams of the snagging hazard presented by certain dip tank frames.
- 2) Inspect all portable retardant tanks prior to use for protrusions and snagging hazards.

- 3) Ensure that there are NO rings or protrusions around the perimeter of the tank that a snorkel or bucket can “catch”. Remove the hazard or shield it from the snorkel/bucket assembly.

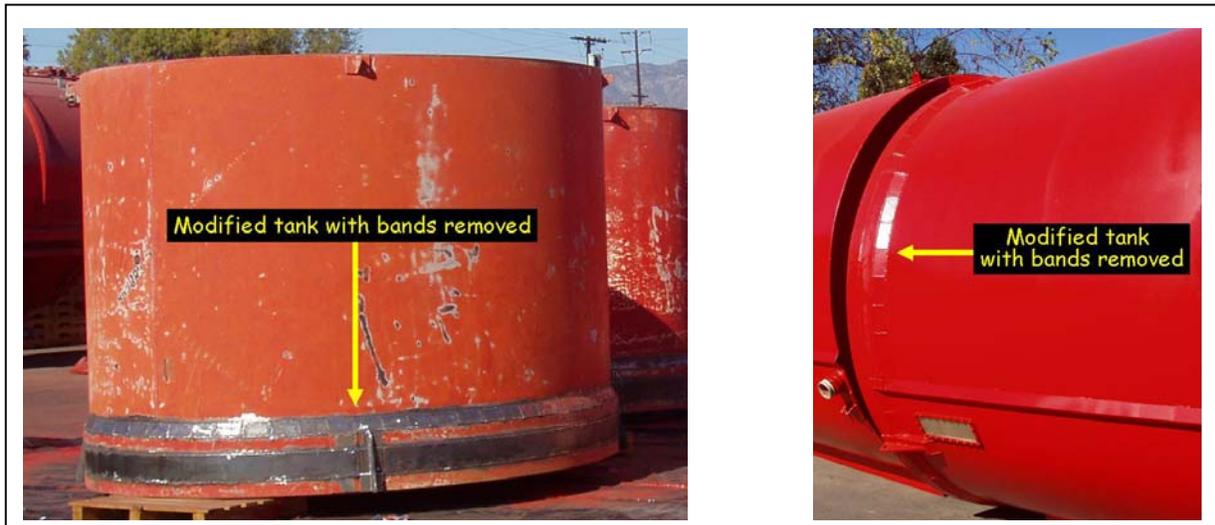
Flight Crews. Flight crews must understand, and be vigilant of, the potential hazards when snorkeling or dipping from PRTs. Modifying PRTs reduces, but does not eliminate, the risk of snagging something. Whenever possible, *before operations begin*, flight and ground crews should review what to do if a snorkel or bucket becomes snagged. This may involve landing the helicopter, **releasing the bucket, or calling for ground assistance.**

- 5) **If hazardous tank assemblies are found**, require the vendor or the appropriate authority (if government owned) to provide appropriate modifications before use.

- 6) If the parts can't be removed or the hazard can't be otherwise mitigated by shielding/wrapping, **remove the tank from service**.
- 7) If contracted, **ensure that the contracting officer is informed** of tanks that are removed from service.
