August SAFECOM Summary

FOREST SERVICE AVIATION RISK MANAGEMENT

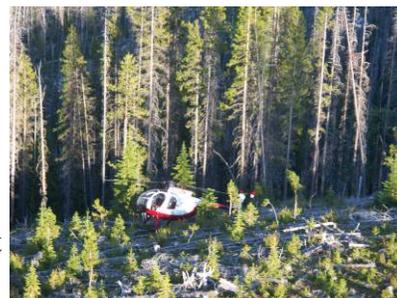
On August 18, 2008, at 1640 Pacific daylight time, a Hughes 369D, N622PB, collided with terrain near Bonners Ferry, Idaho. The United States Forest Service (USFS) was operating the helicopter as a public use flight. The helicopter sustained substantial damage; the commercial pilot and three passengers were not injured. Visual meteorological conditions prevailed and a visual flight rules (VFR) company flight plan and flight following were in effect. The pilot departed from Bonners Ferry Ranger Station about 1600.

According to the USFS safety officer, the pilot was picking up firefighters and had landed on a pinnacle. After loading the helicopter, the pilot began to depart and 10 to 15 feet above the horizon and approximately 30 to 40 feet above the trees, the pilot was having difficulty maintaining altitude in the helicopter. He then performed a 180-degree turn back to his departure point and the helicopter landed. During the landing, the tail rotor drive shaft sheared. This accident was upgraded from an incident on August 25, after verification of the helicopter damage.

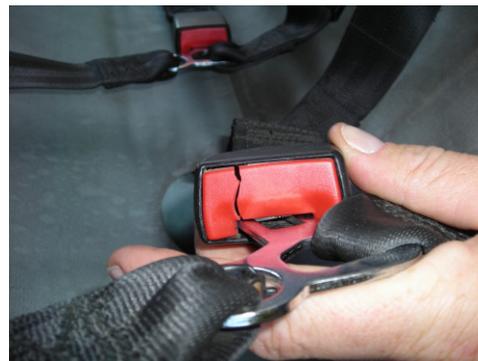
SAFECOM 08-0855 Aug. 27th the crew of a helicopter was engaged in rappel proficiency training while assigned to an incident. During this training a crew member was taking off his seatbelt, he was positioned to be the first rappel. During the loading process he noticed that the plastic release button on his seatbelt buckle was cracked. The Captain was seated adjacent to him and acknowledged the find. The flight proceeded as normal. At the completion of the training flight the problem was discussed with the Superintendent of the helicopter module. Further investigation took place by the Captain; he found two more seat belts where the plastic release buttons were cracked. Through consultation with the Regional and National Maintenance Inspectors, the following corrective action was taken. The defective seatbelt buckles were immediately removed from the aircraft by the mechanic and new buckles were installed. All of the remaining buckle assemblies were thoroughly checked for cracks and defects on the release buttons, none were found. The buckles were manufactured by DART for the following Bell model helicopters in use, 205/212/214/412.

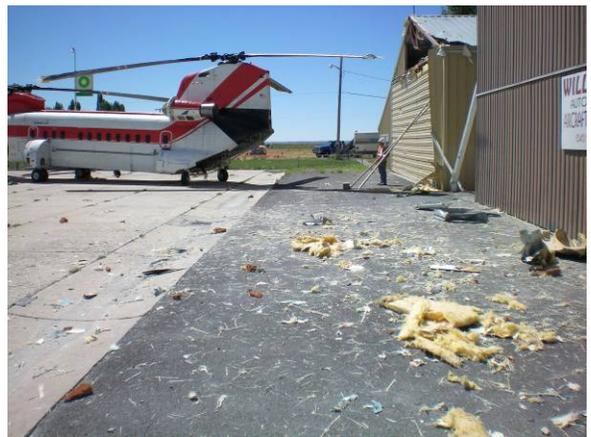
SAFECOM 08-0829 While on ferry flight the aircraft stopped to refuel. The aircraft was taxiing to the fuel site. There was a small plane in the pilot's usual pattern so he attempted to maneuver into the fuel site. He slowly brought the tail of the helicopter around to line up with the fuel site, while doing so his rear rotors caught the airplane hanger adjacent to the fuel site. There were no injuries; however the helicopter and adjacent buildings sustained damage. The metal framed hangar structure heavily damaged the three rear rotor blades resulting in a large debris field stretching out to 100 feet in all directions from the hangar. The hangar, in turn, was heavily damaged by the rotor blades. The aircraft was shut down in place and contacts were made. The FAA was contacted about the incident and a Notam was issued advising aviators that there was no fuel available at airport pending debris cleanup and the removal of the aircraft. Once the FAA had received all their required information they advised the airport management that the aircraft could be moved whenever possible. Pictures were taken by the local sheriff department and the aircraft was moved from the fueling area. Cleanup of the debris was assigned to the vendor. The aircraft will be repaired at the Burns airport. The vendor is planning to change all six rotor blades, the rear rotor head, and the main drive shaft to the rear transmission. During the repair process the aircraft will undergo additional inspections by the vendor to ensure that no other damage is present.

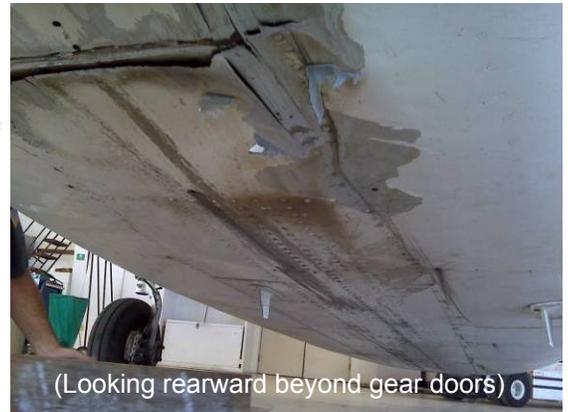
SAFECOM 08-0753 Takeoff from Airport for Air Attack mission, normal taxi, run-up, and takeoff. When the Pilot cycled the landing gear to the up position he noticed a red light near the control indicating a problem with the landing gear. He gained altitude and cycled the landing gear to the down position. The indicator showed two green lights for the main gear but no green light for the nose gear. The red light remained lit. The pilot cycled the landing gear again with the same results. Pilot made a request to the Tower to fly by the Tower at low level for them to observe our situation. We did and Tower said the nose wheel appeared to be only partially in the landing position. Pilot made a request to the tower to maneuver to the west of the airport and trouble shoot the problem. We moved to the west of the Redding Airport and reviewed the checklists to see if we could fix the problem. Pilot cycled the gear up and down two more times with the same results. After the last time, we noticed a noise coming from the nose wheel compartment. It sounded like something had come loose and was flapping against the fuselage. Pilot made a request to the Tower to make a low level fly-by. The tower said the nose gear was not fully extended, the nose wheel appeared to be cocked to one side, and he said it looked like a hose was loose in the nose wheel area. At this time, the Pilot decided to land the aircraft. He reviewed his checklist while I secured any loose items in the cockpit area. We were instructed to land on runway 30. As we flew over the end of runway 30, the Asst. Airport Manager, observed the nose wheel as we flew by. He said the nose wheel appeared to be only partially extended and slightly cocked to one side. Pilot did a great job landing the aircraft. Once the main landing gear was on the ground, he held the nose wheel off the ground for several seconds as he shut down the power and fuel. The nose wheel did not support the aircraft at all and we skidded approximately 100 yards to a full stop. At that time we exited the aircraft. This landing occurred at 1507. RASM comments: **The pilot demonstrated excellent airmanship throughout this incident. He put the aircraft on the ground safely and no one was injured. Communication was good, and notifications appropriate.** The aircraft is in the process of being repaired and the vendor will work with the Regional Aviation Maintenance Inspector on returning it to contract availability once that occurs. This incident is classified as an incident with potential.
