September SAFECOM Summary

USFS FOREST SERVICE AVIATION RISK MANAGEMENT

SAFECOM Statistics

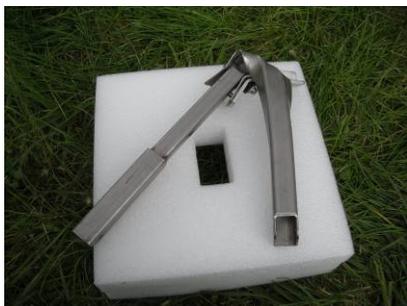
SAFECOM 08-0924 – Aircraft was ordered up with a bucket. The Helicopter is equipped with a fixed tank under the exclusive-use National Helicopter contract and within section B-12 is necessary to have a variable capacity collapsible bucket as an addition or back-up. The helicopter has a FAST {Fire Attack Storm Tank} Bucket, manufactured by Absolute Fire Solutions, INC and distributed by Simplex MFG. While making a dip at the dip site, one of the purse string wires hooked underneath the bolts rubber stopper and nut on the metal frame; this resulting in the frame bending under the added stress to the frame itself rather than the anchor points as intended. The frame was bent in a twisting manor and the purse string wire had grooves {ware} along it showing that it caught on "something" with an edge. The pilot brought the helicopter back to the helibase after noticing an issue with the bucket {2nd dip of 3rd fuel cycle}. The base was notified of the helicopters return and predicament. The mechanics removed the bent, twisted, partition of the frame to apply heat in order to straighten the partition back out. The corrected partition was replaced back on to the frame itself so the bucket would be operational. It was then noticed what caused the problem and a solution was made to flip the frame {each partition}, so that the bolt heads were underneath and the stopper and nuts were on top. This mitigation would then prevent the wires from catching on the frame causing the additional stress to the frame of the bucket when being picked out of the dip. This has been a reoccurrence for another helicopter at the same helibase and fire that also utilized a FAST Bucket as its primary bucket. It is believed that the same incident happened to theirs as well. RAMI comments: Mechanic notified FAST Bucket manufacture and applied approved repair to bent frame. The mechanic also notified manufacture that this is a common occurrence with these buckets. AMI recommends an Information Letter be generated for issues with FAST Buckets. All procedures were followed. RASM Comment: All this information plus pictures was sent to the National Aviation Safety Center with a recommendation to send out a Technical Bulletin on these buckets. NASC Comment: Simplex was notified of the problem and they will issue a technical bulletin with a recommended fix, which will be distributed by the NASC.

Bent Frame
