June SAFECOM Summary

FOREST SERVICE AVIATION RISK MANAGEMENT

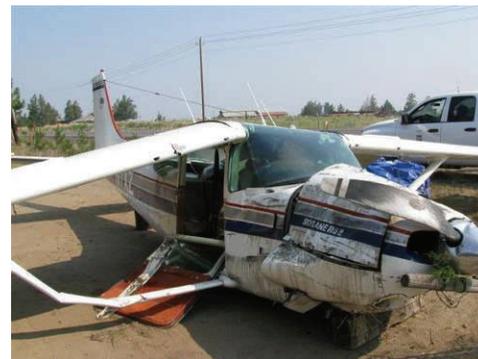
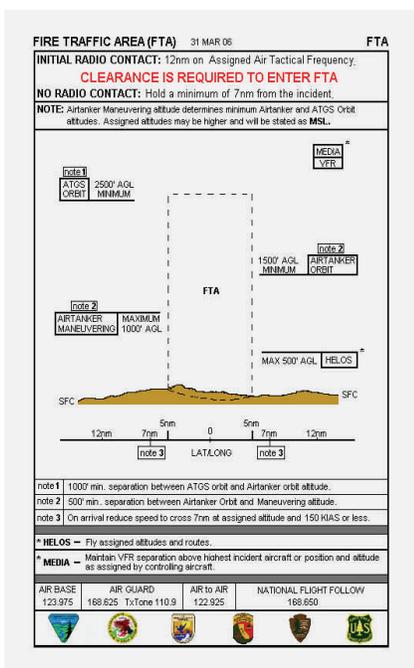
SAFECOM 08-0436 The Cessna TR182 RG was substantially damaged during a forced landing approximately 9 miles southeast of Bend Oregon. The pilot sustained serious injuries, the observer sustained minor injuries. The flight had departed Redmond, Oregon about 1530. The pilot reported detecting an unusual vibration as she descended from 7,500 feet while returning to base after conducting a local reconnaissance flight. The pilot reported that the vibration continued to become strong, accompanied by the propeller RPM "in the red" and rising engine oil temperature. Oil began to streak the windshield and the pilot shut down the engine and initiated a forced landing to a nearby grassy field. During the landing the aircraft struck a barbed wire fence and came to a stop on highway 20. A Forest Service investigation team has been assigned and will be party to the NTSB investigation.
