# **EVALUATION OF MIKE HORSE DAM**

January 2005

Stephen Romero, P.E.  
Regional Geotechnical and Dams Safety Engineer  
U.S. Forest Service

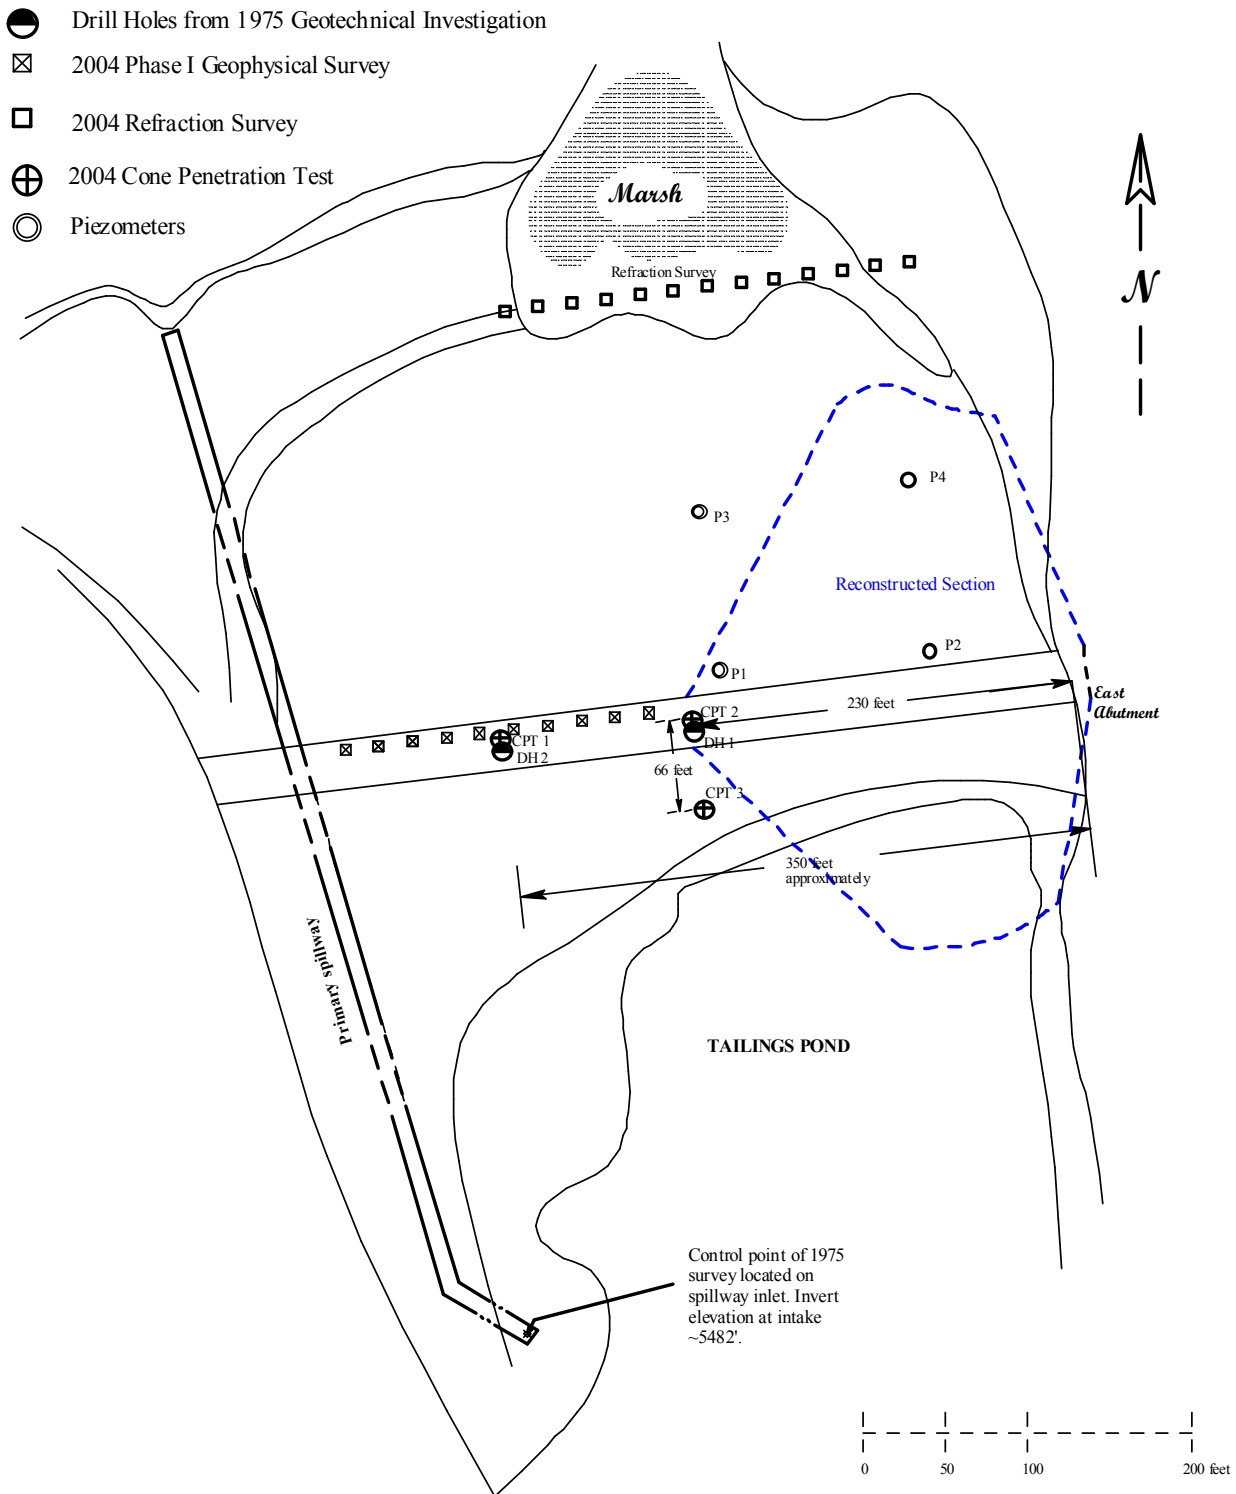
**Figure 1:** Cone Penetration and Geophysical Testing Layout

Voids were encountered in the upper loose sand layer in CPT 2. Voids were encountered in the lower loose sand layer in CPT 3.

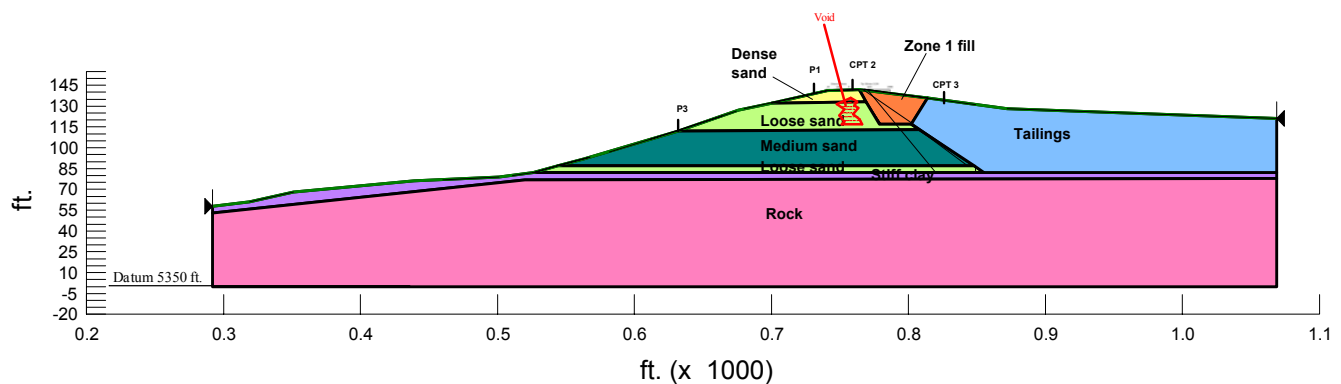
**Figure 2:** Soil Profile - section developed using CPT 1 and 2 results and available information

Figure 2 depicts the soil profile constructed using CPT data and information available from construction documents.

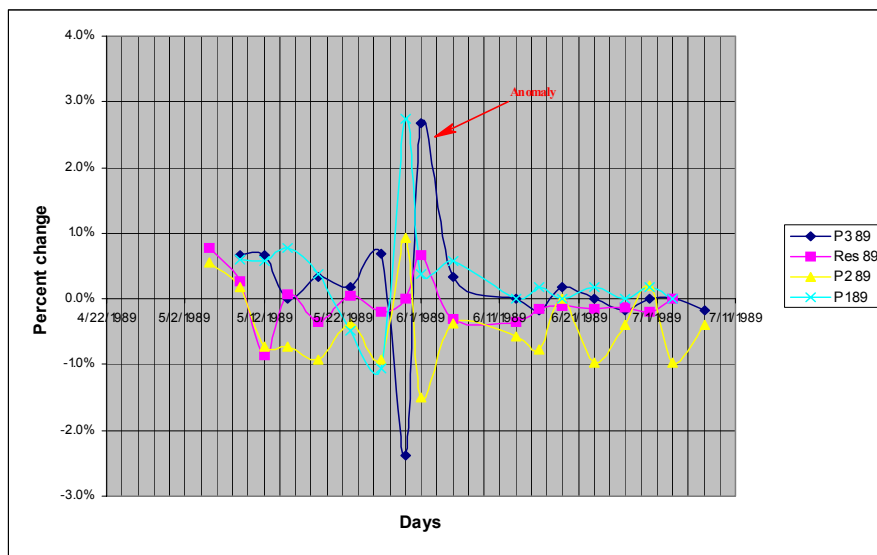
Figure 3 depicts a strong impulse in P1 and P3 readings. A damped version of the impulse appears in P2, which could indicate the response was consistent throughout the dam. The readings could depict a transient response to a non-hydraulic, possibly seismic, loading condition. Dams tend to amplify long waves which become prevalent as seismic waves move away from the point of origin.

**Figure 3:** First apparent anomaly occurred in 1989. Note substantial deviation in reading in P1 and P3 with respect to loading functions in the reservoir and in the rock at the foundation, which is represented by P2.

A search for recorded earthquakes within 100 km of the Mike Horse yielded a magnitude 2.7 earthquake near Boulder, Montana on the 28<sup>th</sup> of May, 1989 at about 6:30 pm. Piezometer recordings took place on the 27<sup>th</sup> and 30<sup>th</sup> of May, 1989. The distance from the Mike Horse dam to the epicenter was about 80 km which would have produced a rock acceleration of about .01 g at the Mike Horse using linear attenuation models. Refer to Table 1.

If the earthquake recorded in Boulder caused the transient observed it took about 7 days from initiation of excess pore pressures in the dam to dissipation. The average vertical permeability in the dam at P1 is about .33 ft/hr (using relative density computations made with cone penetration data). 7 days equals 168 hrs.

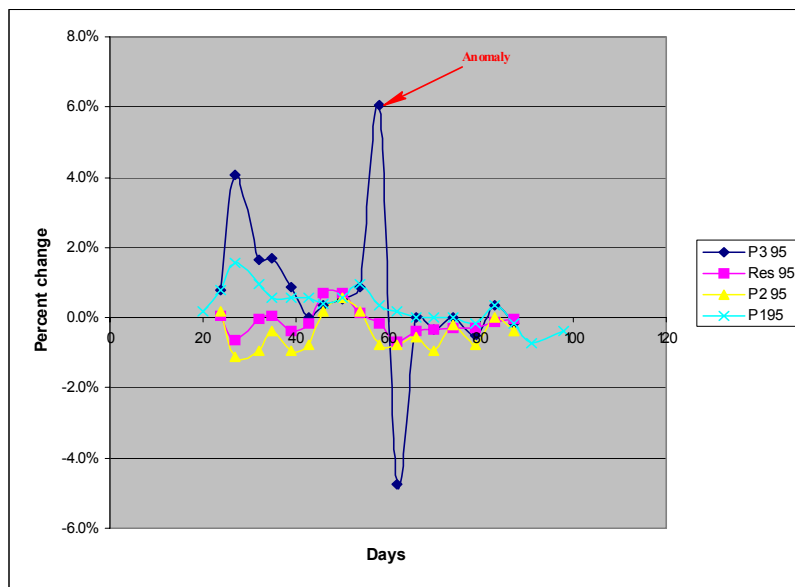
**Figure 4:** Anomaly occurs during relatively quiescent conditions on the loading surfaces at bedrock and the reservoir.

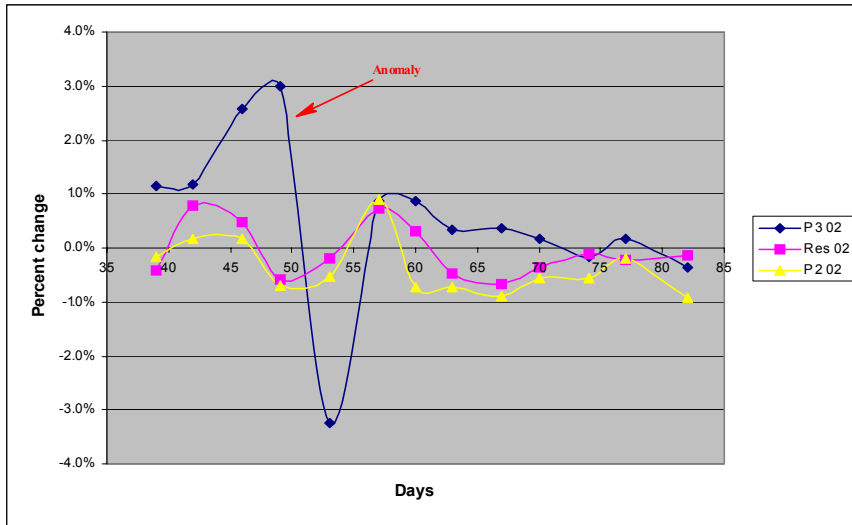
**Figure 5:** Last of the anomalies occurred in 2002. Similar but attenuated response seen in reservoir and P2.

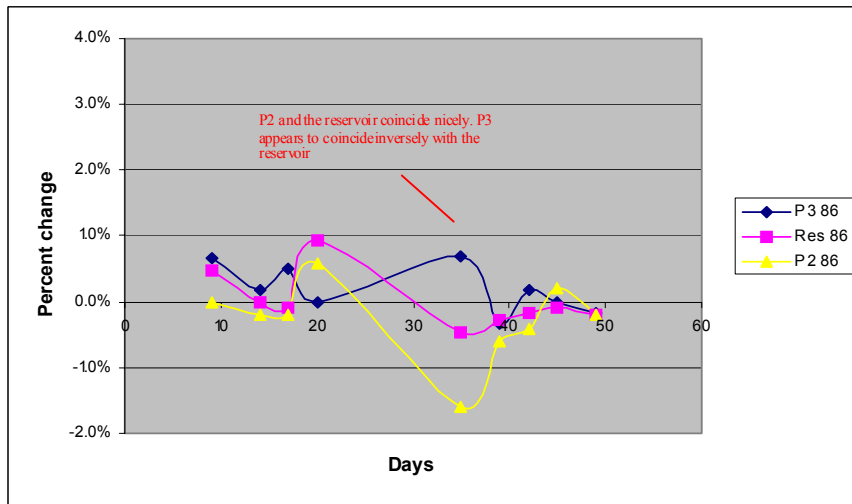
**Figure 6:** Representative piezometer sample from earlier readings. Note inverse relationship of P3 to changes in reservoir elevation. Also, note proportional relationship between P2 and the reservoir.

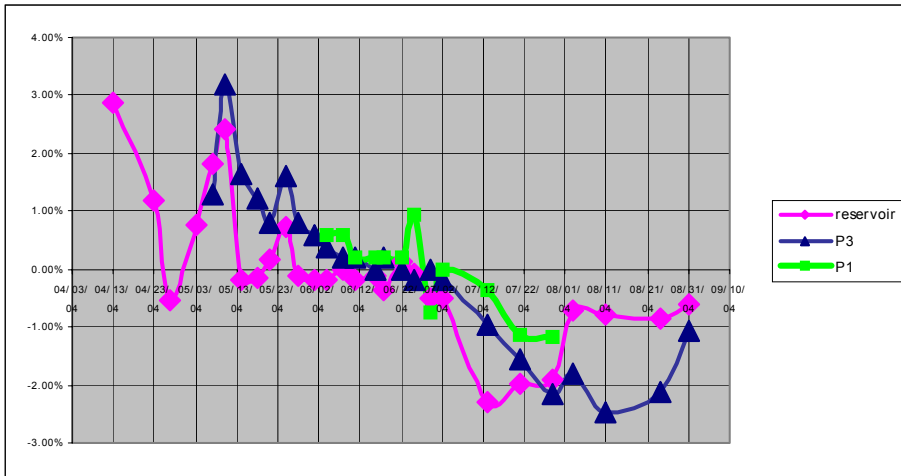
**Figure 7:** Log for piezometers 1 and 3 from most recent water year. Note substantial change in readings between water year 1986 in Figure 6.

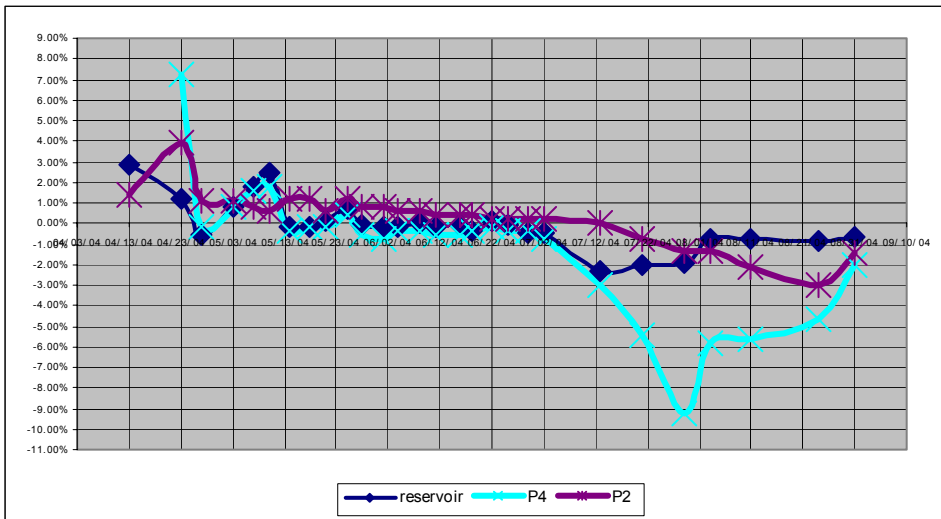
**Figure 8:** The response of P4 to reservoir changes suggest a hydraulic connection to the reservoir through east abutment.

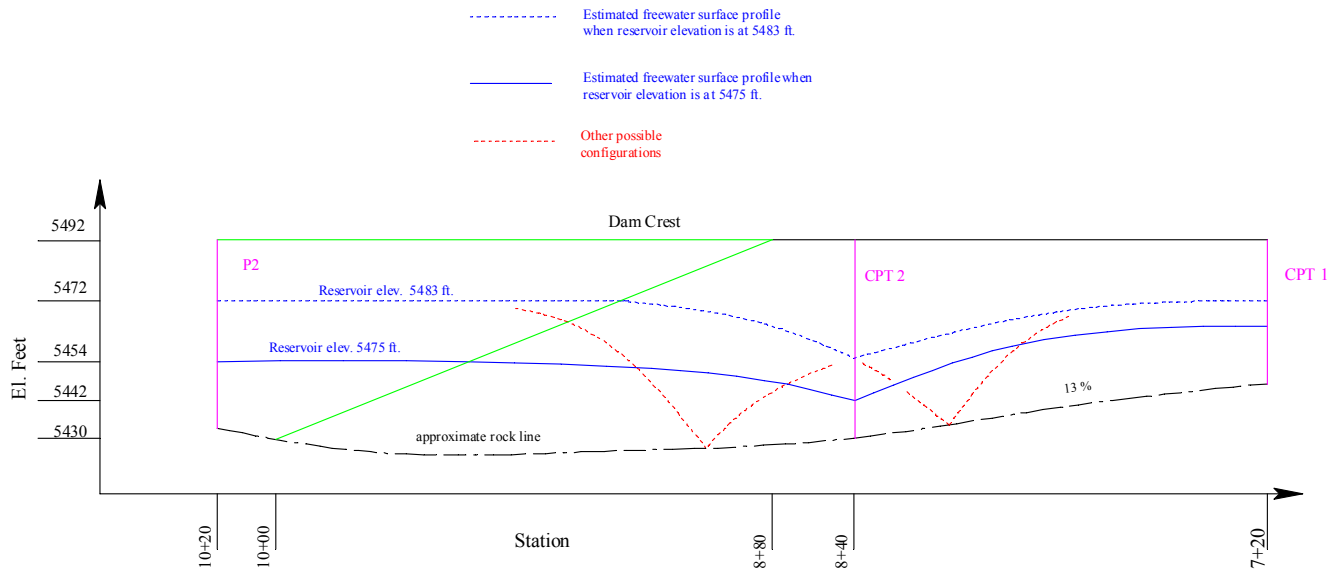
The net result can be approximated as a linear depression in the groundwater surface extending roughly from CPT 2 to the dam toe. The depression geometry suggest a localized zone is impacting the seepage regimen within the dam. If the depression is linear it is unlikely the piezometers or CPT's intercepted the vertex of the depression. Alternative configurations are displayed in Figure 9. Figure 10 displays the relative positions of the free water surface at CPT 1 (derived from two points) and CPT 2 (derived from 3 points) on the day of testing. Figure 11 displays a trimetric interpretation of the data. The accuracy of the free water surface can be improved with more testing.

**Figure 9:** Depiction of groundwater profile derived from piezometer and pore pressure measurements obtained from pressure transducer on cone penetrometer. Section taken through dam crest. Profile adjusted to reflect differences in permeability between reconstructed section and original embankment.

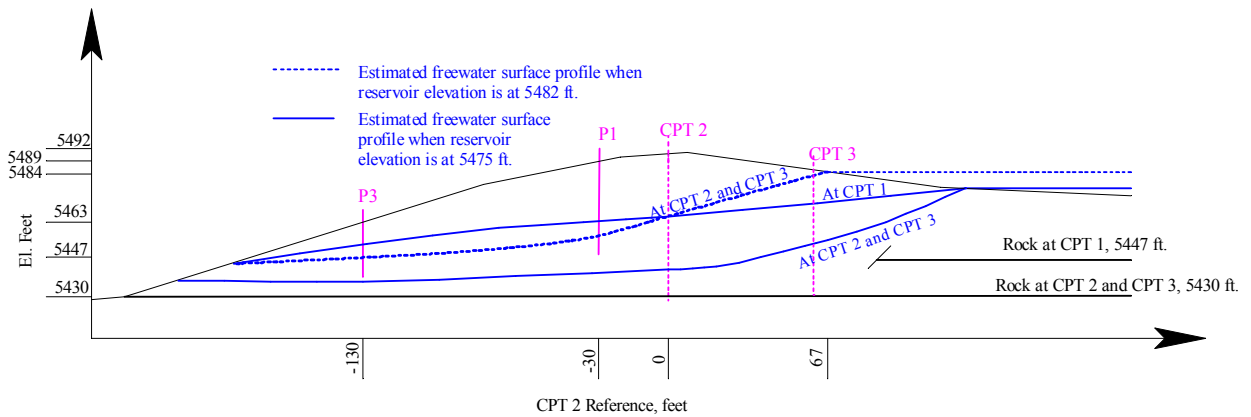
**Figure 10:** Depiction of groundwater profile derived from piezometer and pore pressure measurements obtained from pressure transducer on cone penetrometer. Section taken through dam at the location of CPT 2.

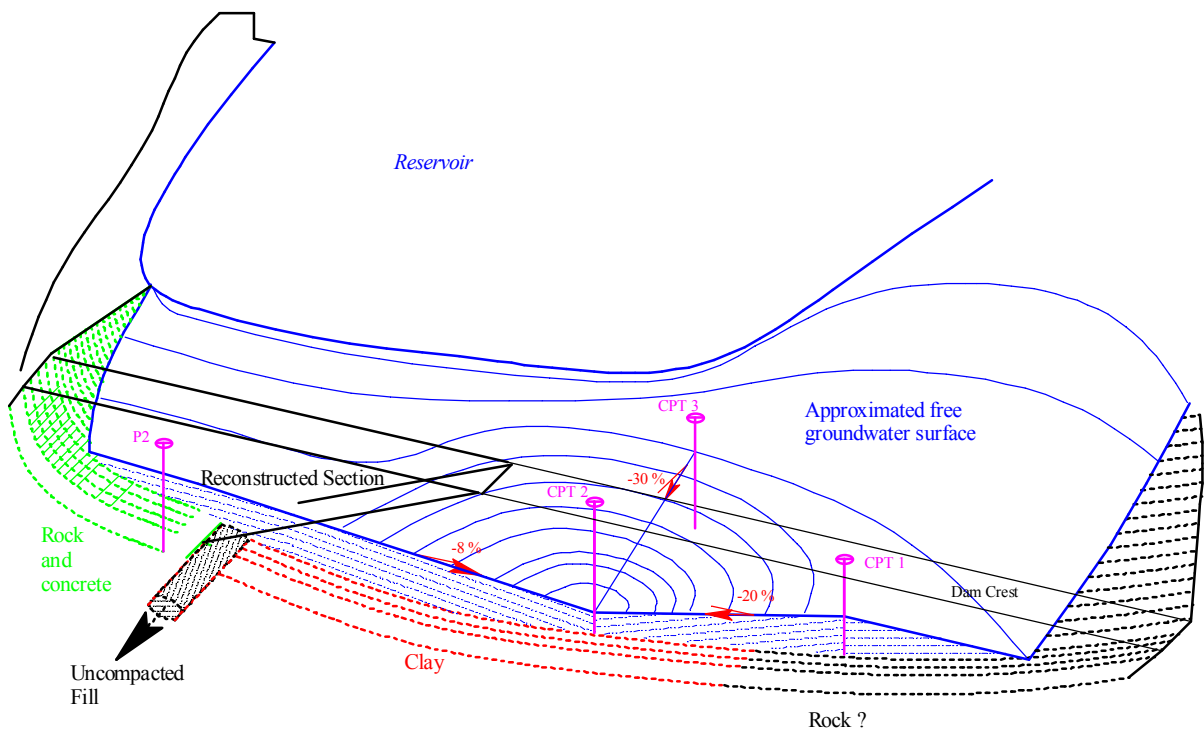
Gradients exist in three dimensions with all gradients apparently sloping toward a minima located along a line perpendicular to the dam crest running through P1 and P3. Gradients moving from East to West between P2 and CPT 2 vary between -8% and -17% over the year. Gradients moving from South to North between P5/CPT 3 and CPT 2 vary between -30% and -35%. The gradient between CPT 1 and CPT 2 moving from West to East was -20% on the day of testing. The gradient between P4 and P3 moving from East to West varies between -1% and -3%.

**Figure 11:** Trimetric representation of groundwater system based on piezometer, CPT, and reservoir measurements. Indicated gradients were computed from measurements taken during cone penetration testing. Representation will vary should more data become available.

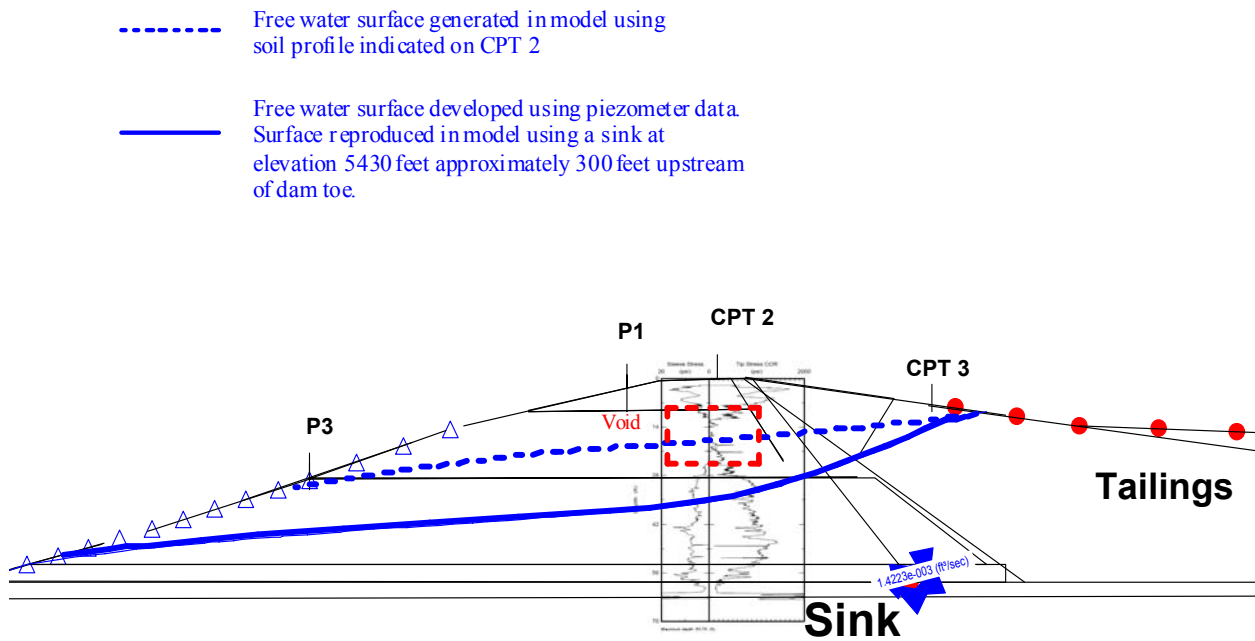
Low pressure zones were introduced into the SEEP/W model. A piezometric surface similar to that observed in piezometric records was achieved using a linear sink with no pressure head at the foundation/embankment interface at elevation 5430 feet on a line perpendicular to the dam crest extending 300 feet upstream through P1 and P3 from the dam toe. The flow rate into the sink required to draw the free water surface down to a configuration matching observed gradients was approximately 150 gpm. A similar result was obtained using a system of well equations. The results are depicted in Figures 15 and 16.

**Figure 15:** CPT 2 tip resistance plot overlain on seepage model result. Upper blue dashed line is piezometric surface that would normally develop in soil profile developed using CPT data. Lower blue solid line represents piezometric surface as measured by piezometers 1 and 3 and developed in the model using a linear sink extending 300 feet upstream from the dam toe at foundation/embankment interface.

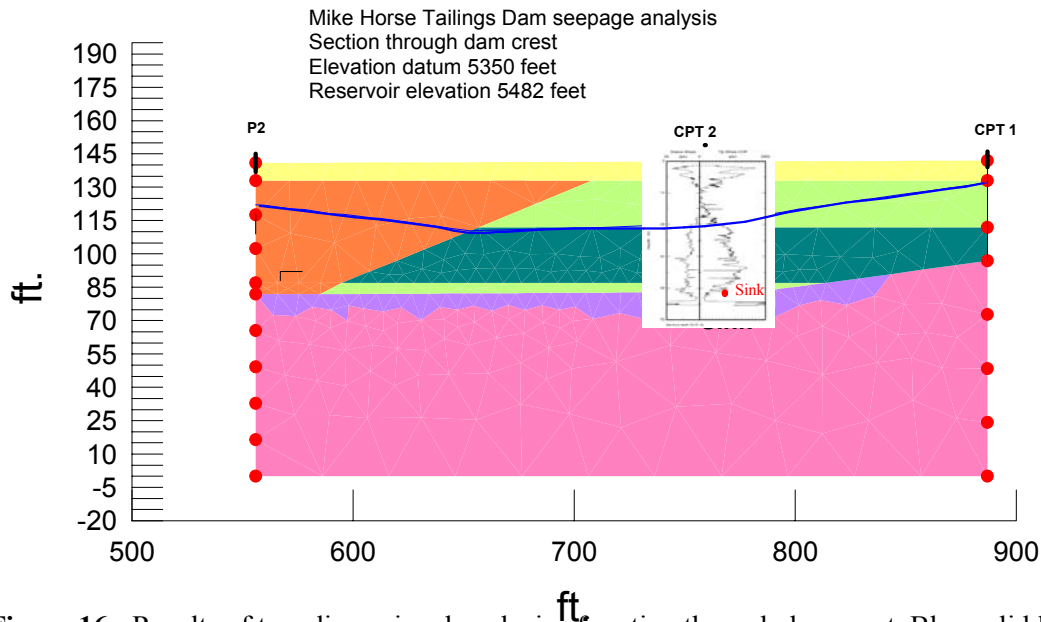
**Figure 16:** Results of two dimensional analysis of section through dam crest. Blue solid line represents piezometric surface as measured by piezometer 2 and CPT's 1 and 2. Piezometric surface developed in model using a linear sink extending 300 feet upstream from the dam toe at foundation/embankment interface.

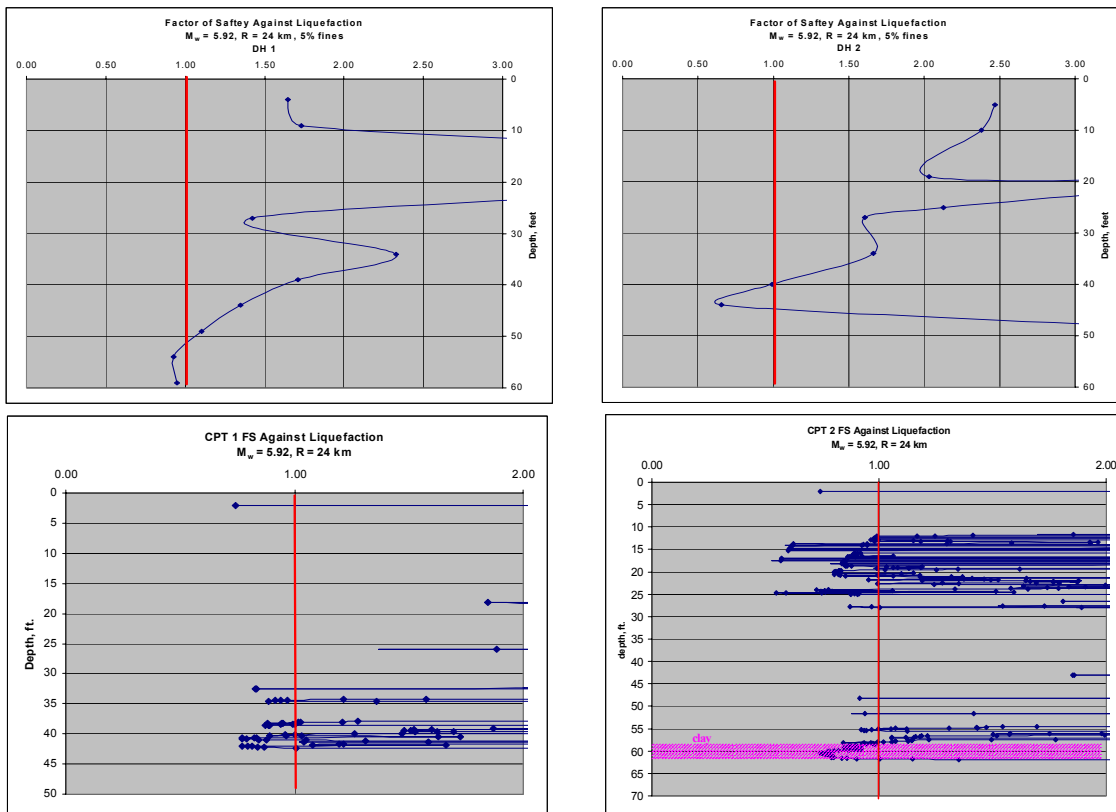
**Figure 17:** Liquefaction evaluation using SPT and CPT results – 500 year return interval

The CPT and SPT liquefaction evaluation was conducted using peak accelerations for a 500 year event or 10% probability of occurrence every 50 years (per guidelines proposed by Montana Dam Safety Division for existing dams). The peak acceleration was estimated at .11g on rock. The results of the evaluation are displayed in Figure 17.

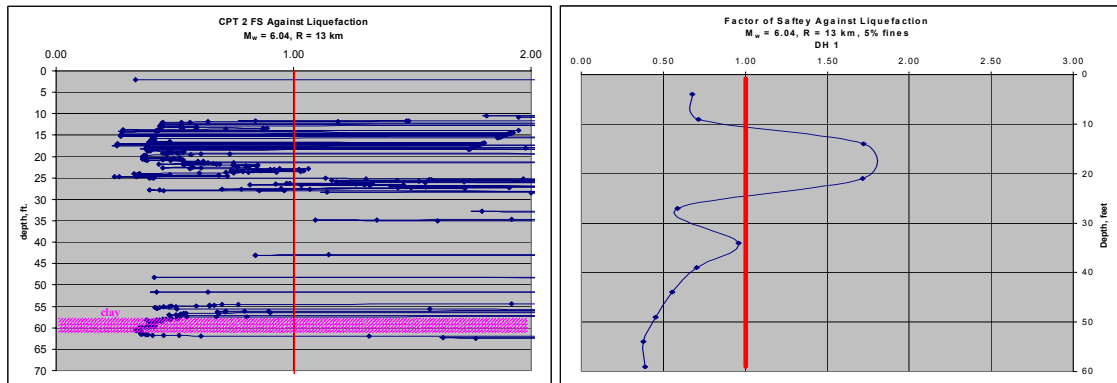
**Figure 18:** Liquefaction evaluation using SPT and CPT results - 2500 year return interval

The SPT evaluation indicates all soils below elevation 5468 feet will liquefy during a 2500 year seismic event assuming the crest peak acceleration equals the PGA (a non-conservative estimate). The results are depicted in Figure 18.

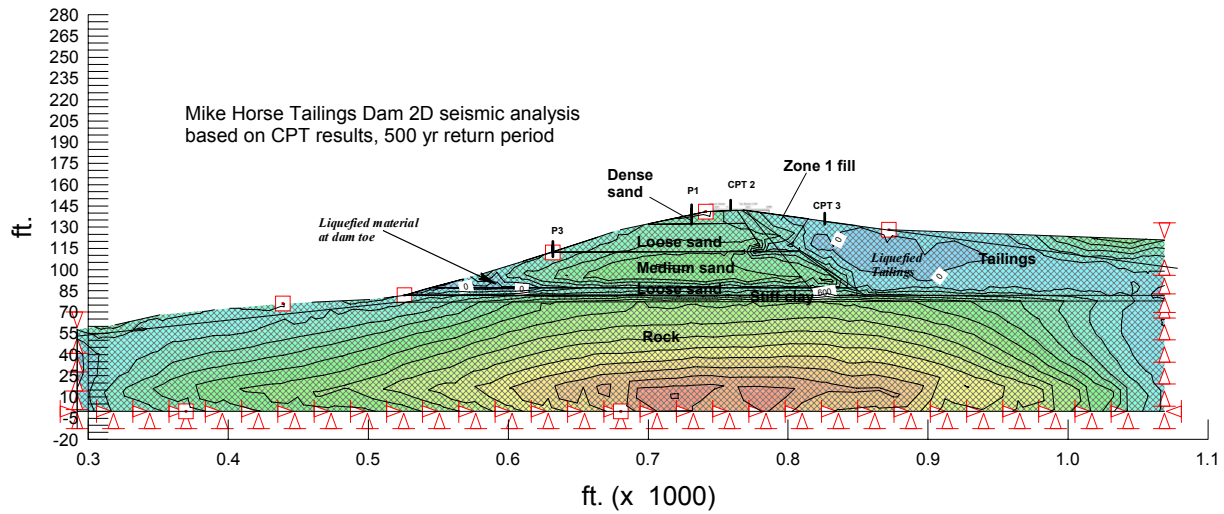
The results indicate that the dam liquefies under both 500 year and 2500 year loading scenarios. However, the liquefied zone is primarily confined to the lower loose sand layer. The liquefied zone extends from the dam toe upstream approximately 100 feet in the loose sand layer at the foundation/ embankment interface. Tailings retained behind the dam liquefy. Figure 19 is representative of the extent of liquefaction under both loading scenarios.

**Figure 19:** Depicts lateral effective stresses immediately after 500 year seismic event. Note liquefied zones in dam toe and tailings.

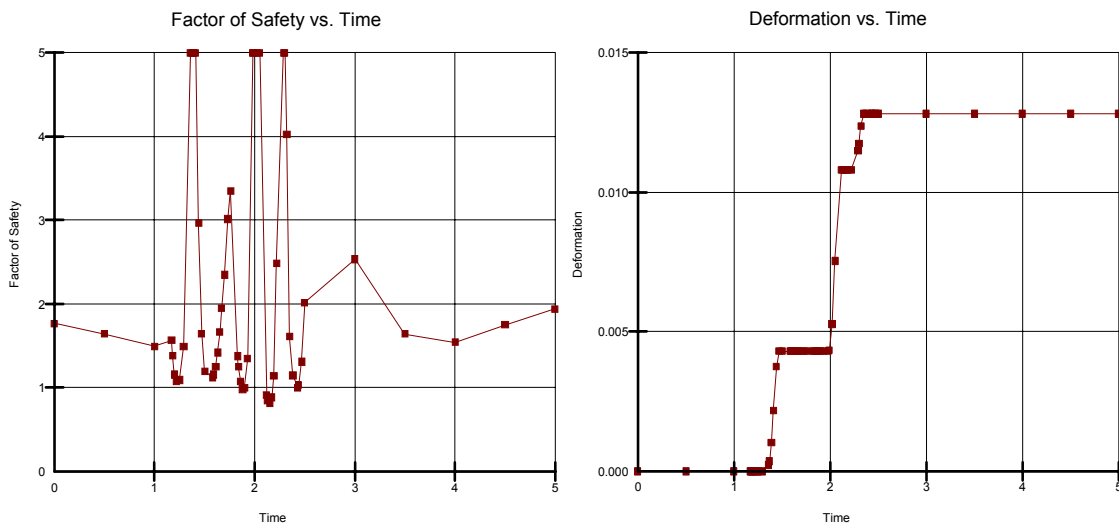
The factor of safety against a circular arc and irregular circular-wedge slope failure on the downstream dam face temporarily drops below 1 for both the 500 year and 2500 year events. Total deformation is less than .015 feet during the 500 year event and .1 feet for the 2500 year event indicating the dam should not fail catastrophically during the earthquake. Refer to Figures 20, 21, and 22.

**Figure 20:** Factor of Safety and Deformation versus time – 500 year event. Time is in seconds and displacement in feet.

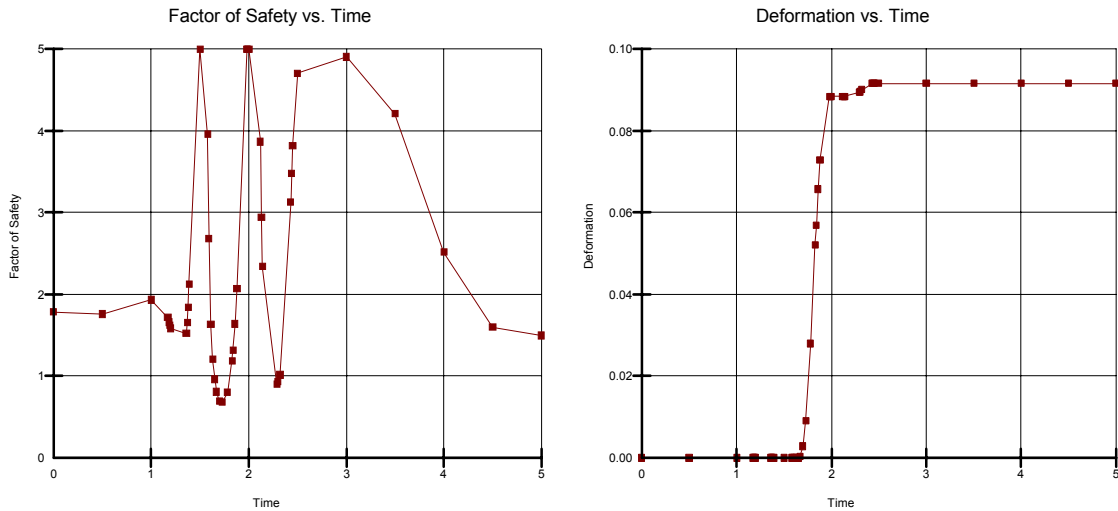
**Figure 21:** Factor of Safety and Deformation versus time – 2500 year event. Time is in seconds and displacement in feet.

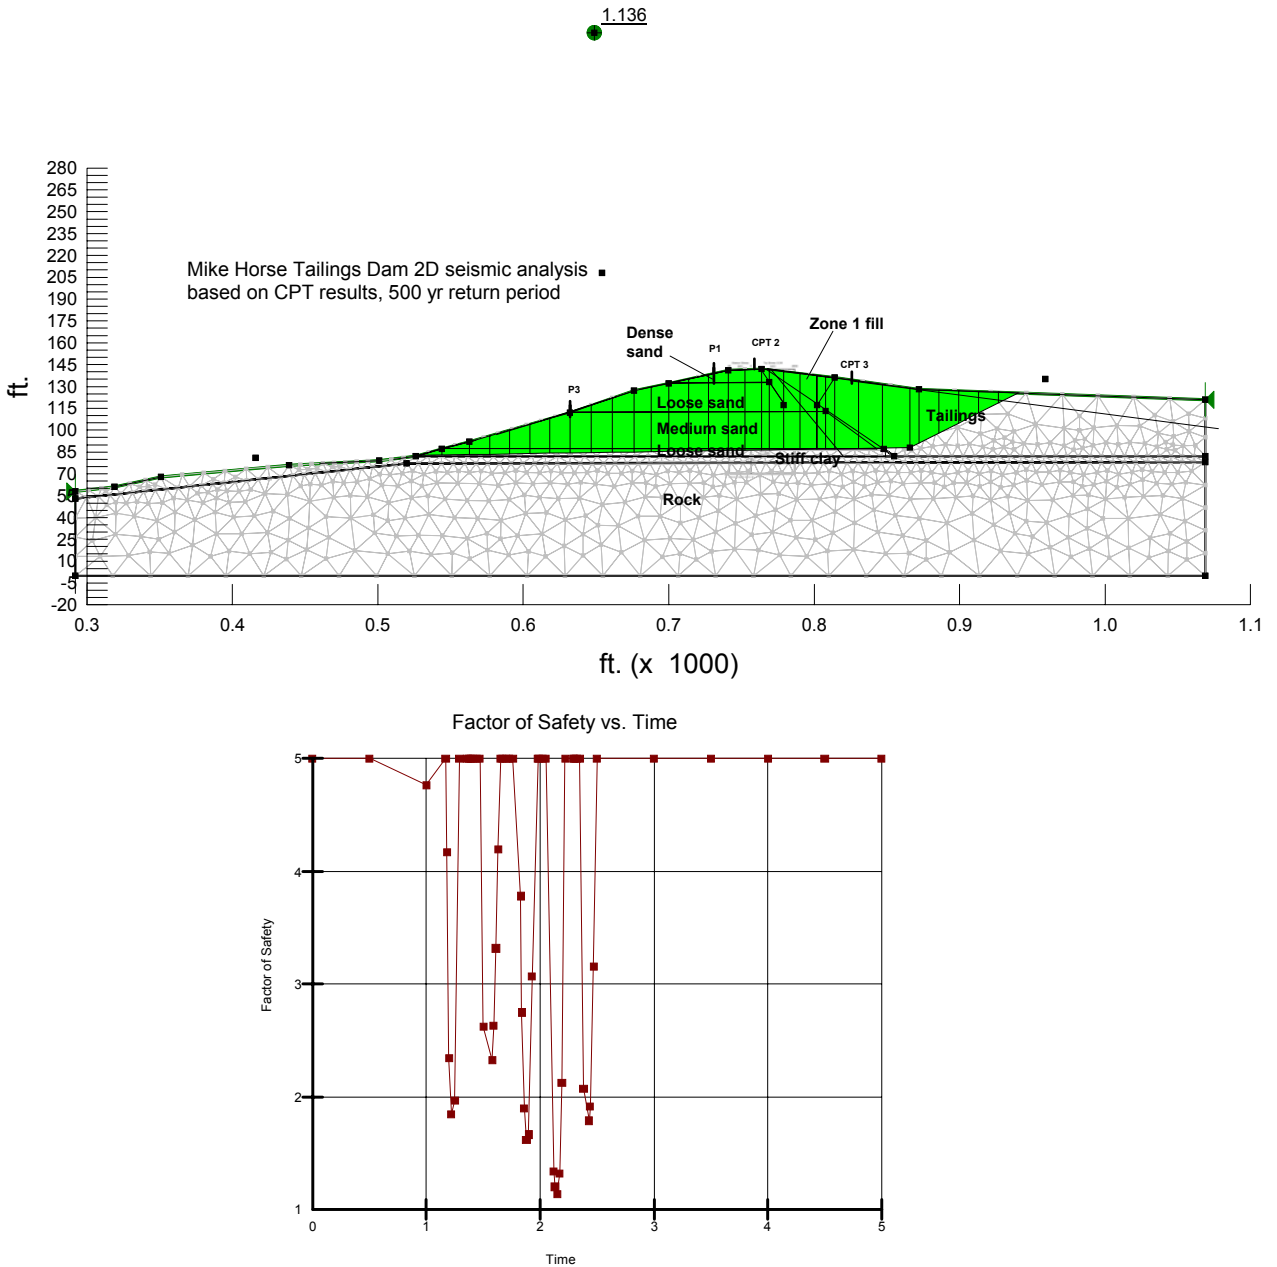
A block stability analysis was also conducted in an attempt to determine the global factor of safety against sliding for the dam. To do this a failure plane was forced through the loose sandy layer at the base of the dam. The exact slope of the loose sand layer is unknown. The forced failure plane was angled from the top of the loose sand layer on the upstream side to the bottom of the layer at the toe on the downstream side. A factor of safety of 1.14 was achieved for the 500 year event but drops below 1 during the 2500 year event indicating translation. The results are displayed in Figures 23 and 24.

**Figure 23:** Block failure analysis for factor of safety against sliding - 500 year event. Time is in seconds.

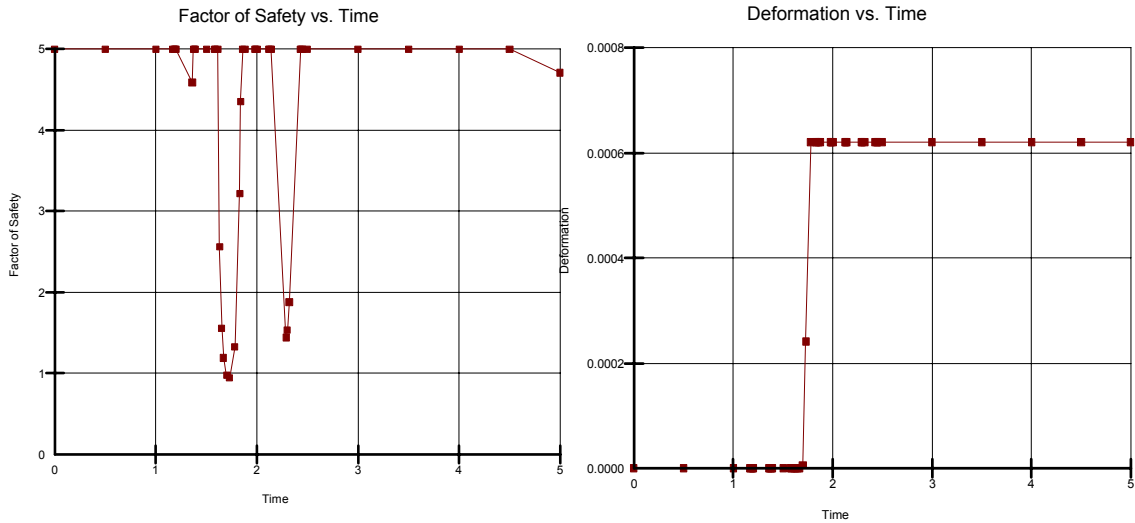
**Figure 24:** Block failure analysis for factor of safety against sliding and deformation - 2500 year event. Time is in seconds.

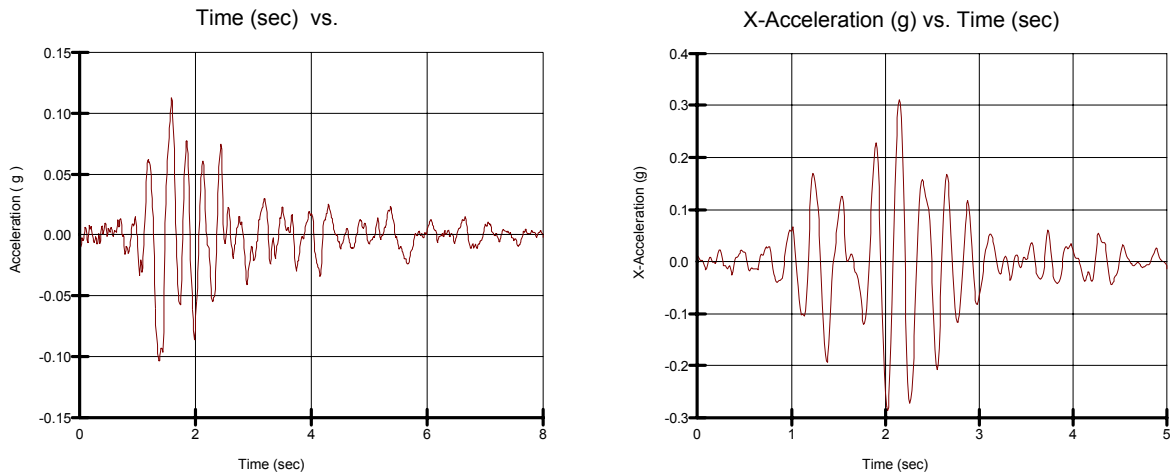
**Figure 25:** Input rock acceleration record (left) dam crest acceleration record (right).

The dam crest peak acceleration achieves about 3 times the peak acceleration for the time history used. This result is displayed in Figure 25.
