DRAFT CONCEPT ALTERNATIVES TECHNICAL MEMORANDUM  
FOR THE MIKE HORSE DAM AND TAILINGS IMPOUNDMENT  
AT THE UPPER BLACKFOOT MINING COMPLEX

LEWIS AND CLARK COUNTY, MT

February 21, 2006

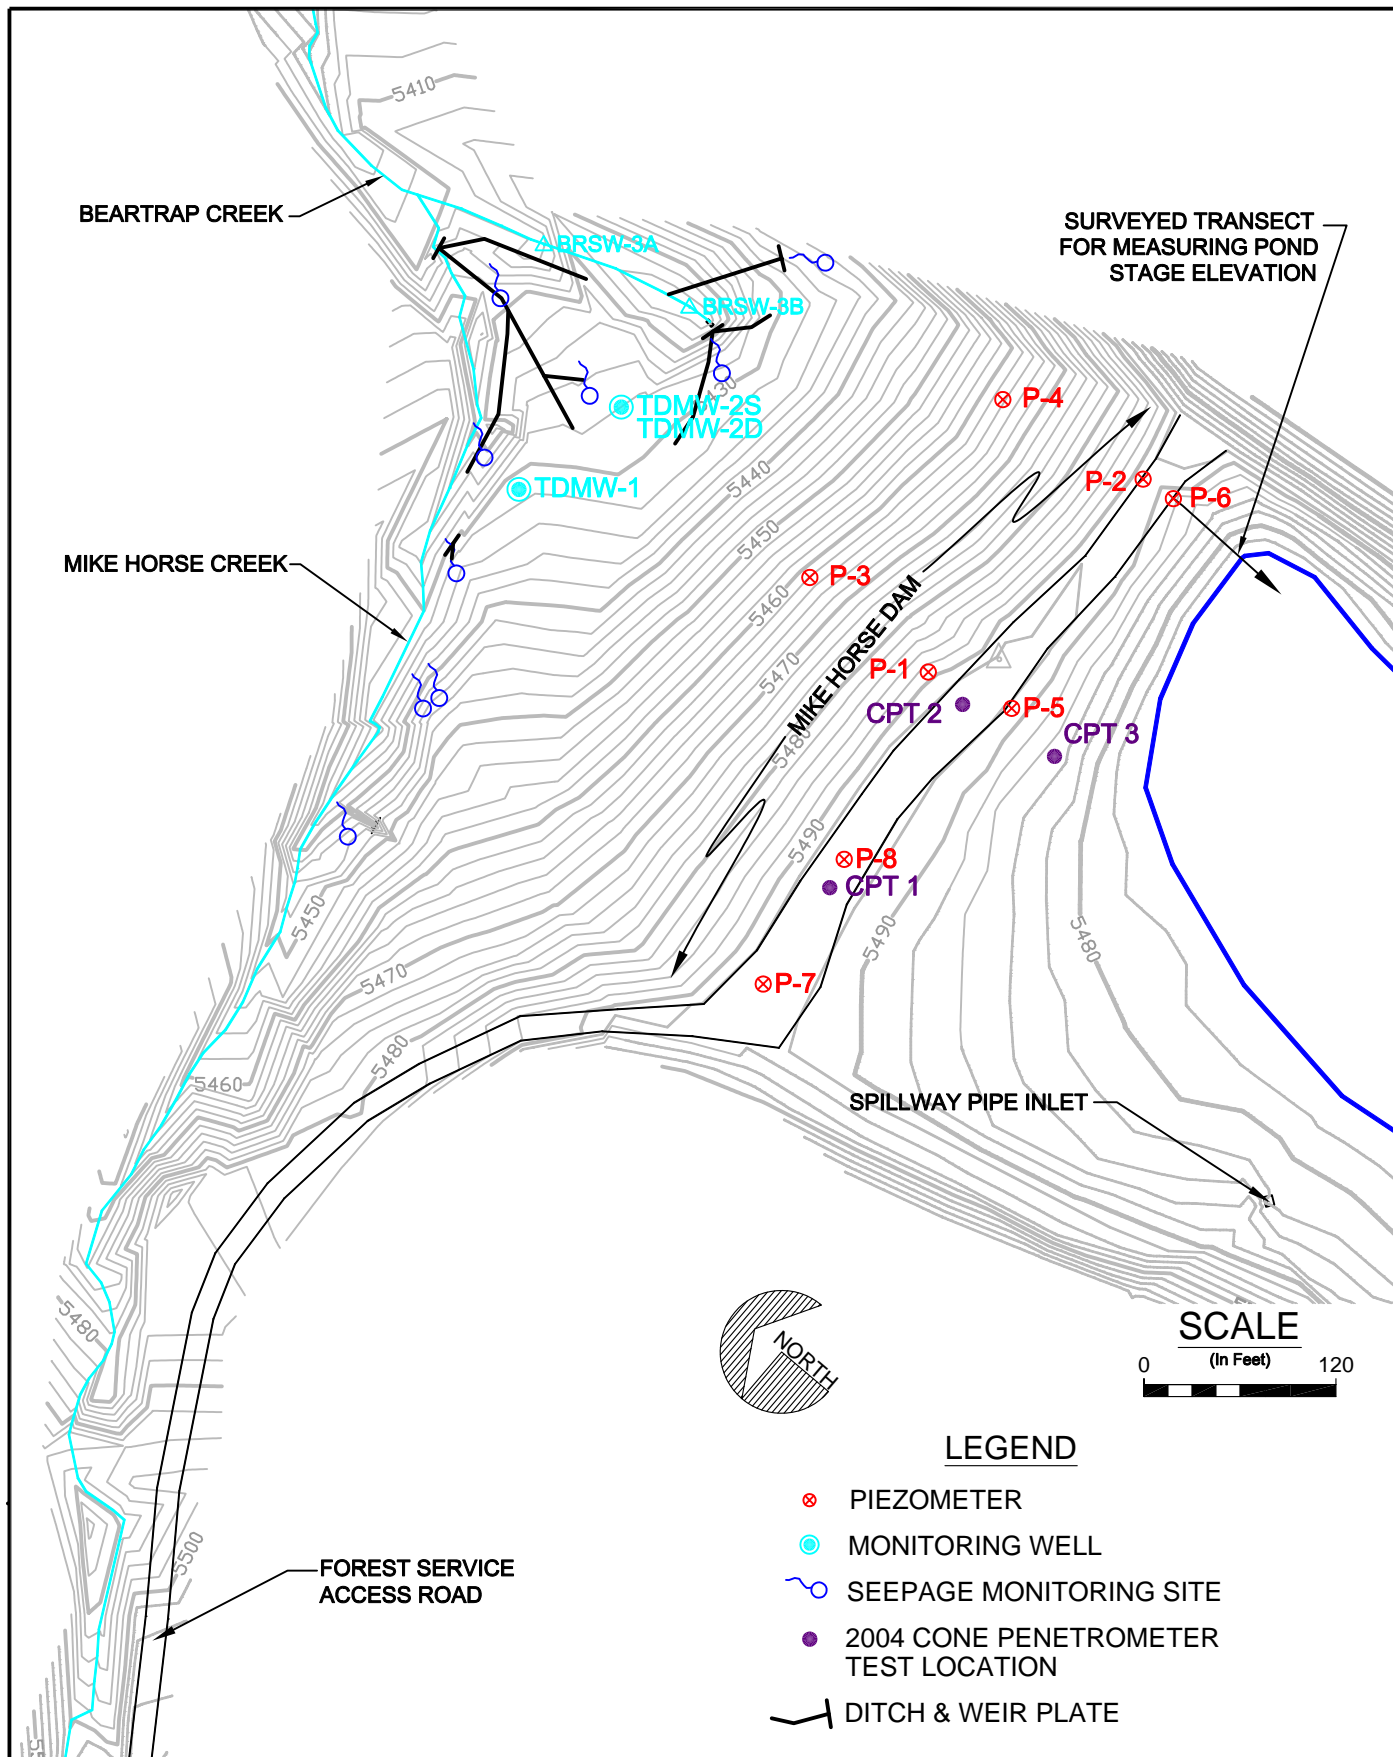
**MONITORING SITES  
MIKE HORSE TAILINGS IMPOUNDMENT**

During the 1980 construction effort, four piezometers (P1-P4, Figure 2-1) were installed on the eastern portion of the dam to collect data on the hydraulic gradients and seepage velocities within the dam, which in part determine the potential for sediment piping to occur. ASARCO has annually collected piezometer data since 1980 on a weekly to monthly basis between April and October. These measurements were intended to be compared against reservoir levels. However, the piezometers were not installed deep enough and the associated staff gauge which measures reservoir levels to correlate with the piezometers was usually perched above the reservoir surface by mid-summer.

In 2003, ASARCO installed two additional piezometers (P5, P6) and a new reservoir staff gauge that provides the ability to measure reservoir levels through a complete water year. In 2005, two additional piezometers were installed (P7-P8) to greater depths on the central and western portions of the dam. Water levels have been collected weekly from April through July and every other week from August through October since 2004.
