**RESURRECTION CREEK RESTORATION  
2006-2007 Channel Morphology and  
Vegetation Monitoring Report**

**Bill MacFarlane, Hydrologist  
Chugach National Forest  
Anchorage, Alaska**

**October 2007**

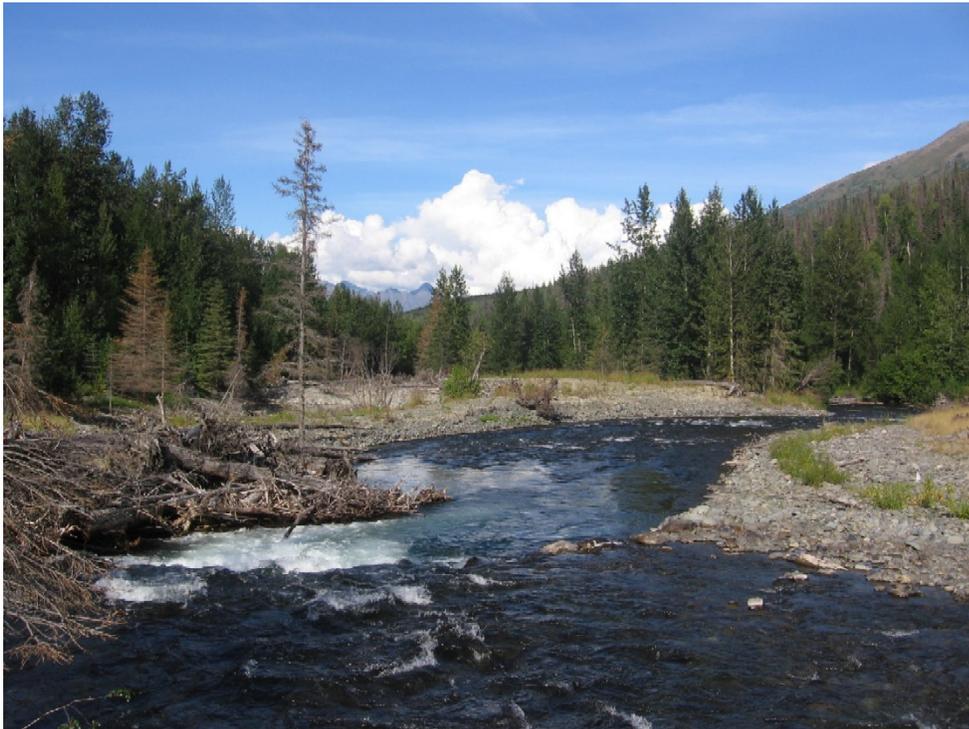
Channel changes have been observed in Meander 2. As shown in **figure 20**, the left (outer) bank along the riffle on the lower portion of Meander 2 has been eroding. The left bank is on a berm separating the main channel from the pond on the western side channel. This erosion is the result of deep flows along the bank and the 4-foot high, gravel and cobble bank with little protection from existing vegetation. Cross section 8+90 showed some notable changes between initial survey on 8/10/05 and re-survey on 8/31/07 (**figure 21**). As a result of high flows, this bank has eroded up to 3.5 feet in 2 years. The top of the berm is only sparsely vegetated, and the vegetation currently provides little bank stabilization. With the thalweg against the bank and a slight channel bend to the right, this bank may continue to erode during high flows, although the presence of large boulders in the berm will likely prevent erosion at some point. Up to a foot of bed erosion also occurred along the channel bed on the right side of the channel between 2005 and 2007.

**Figure 20:** View downstream at Meander 2, from Photo Point 15a. Erosion is occurring along the left bank downstream of the logjam.

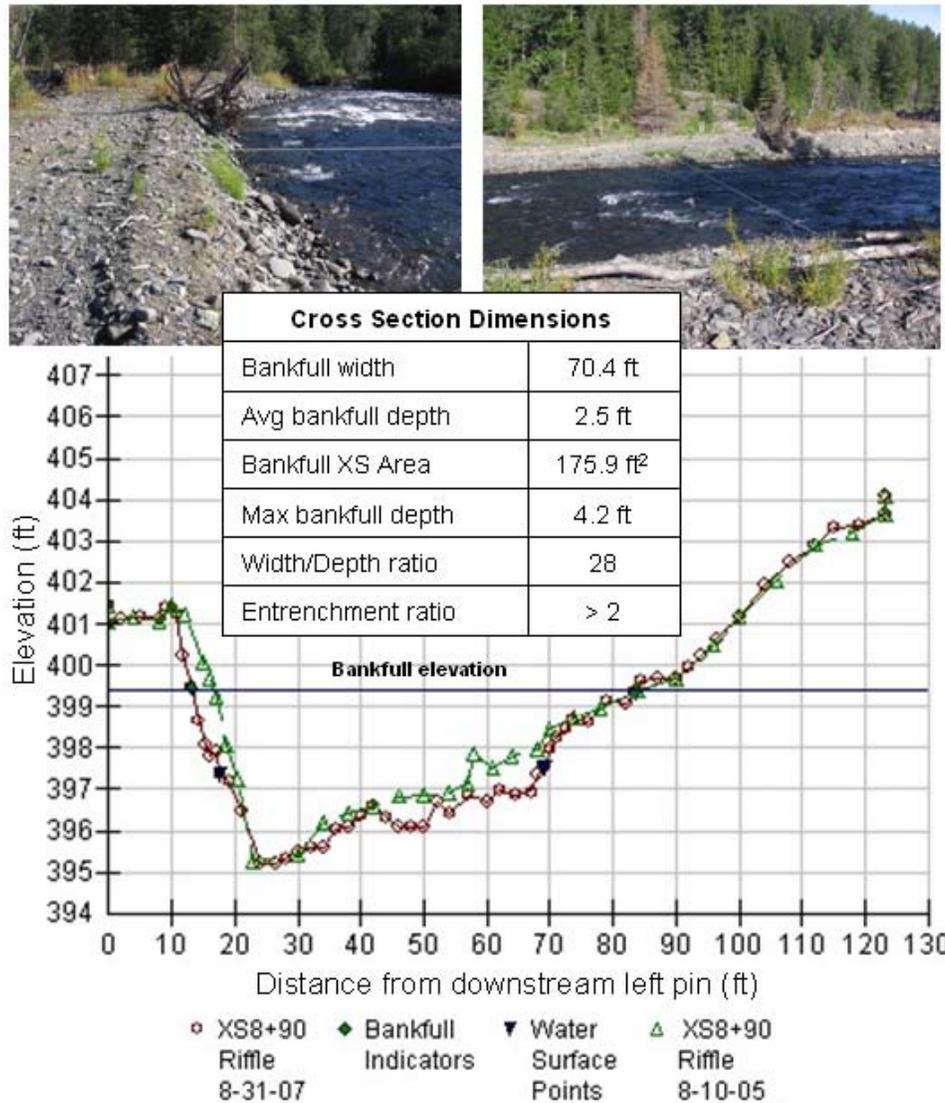
**Resurrection Creek Cross Section 8+90 – Riffle**  
**Surveyed 8/10/05 and 8/31/07**

**Figure 21:** Changes in Resurrection Creek Cross Section 8+90 from 2005 to 2007. Erosion is occurring along the left bank, and deposition is occurring along the right side of the channel bed.

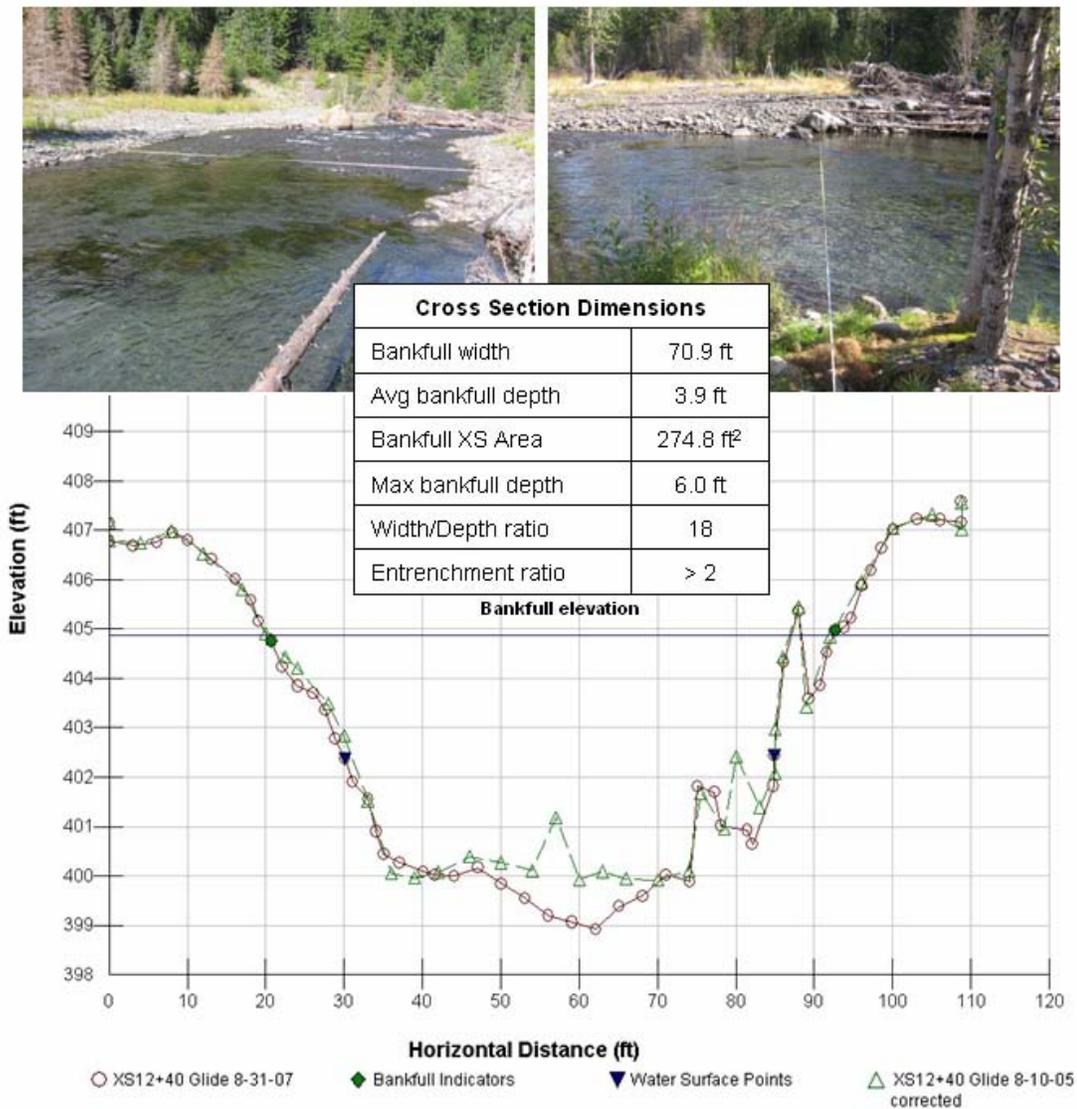
**Resurrection Creek Cross Section 12+40 - Glide**  
**Surveyed 8/10/05 and 8/31/07**

**Figure 22:** Changes in Resurrection Creek Cross Section 12+40 from 2005 to 2007. Downcutting has occurred in the center of the channel.

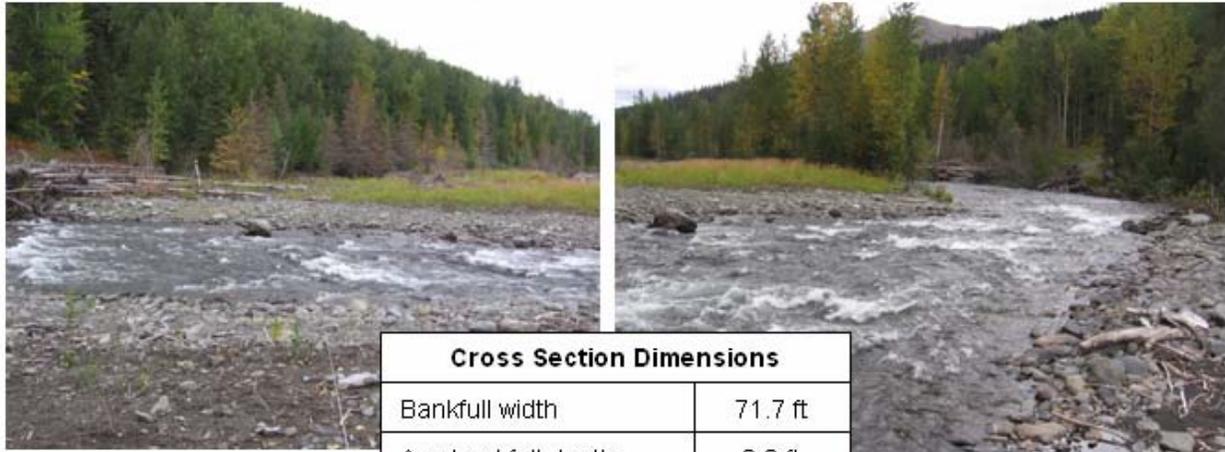
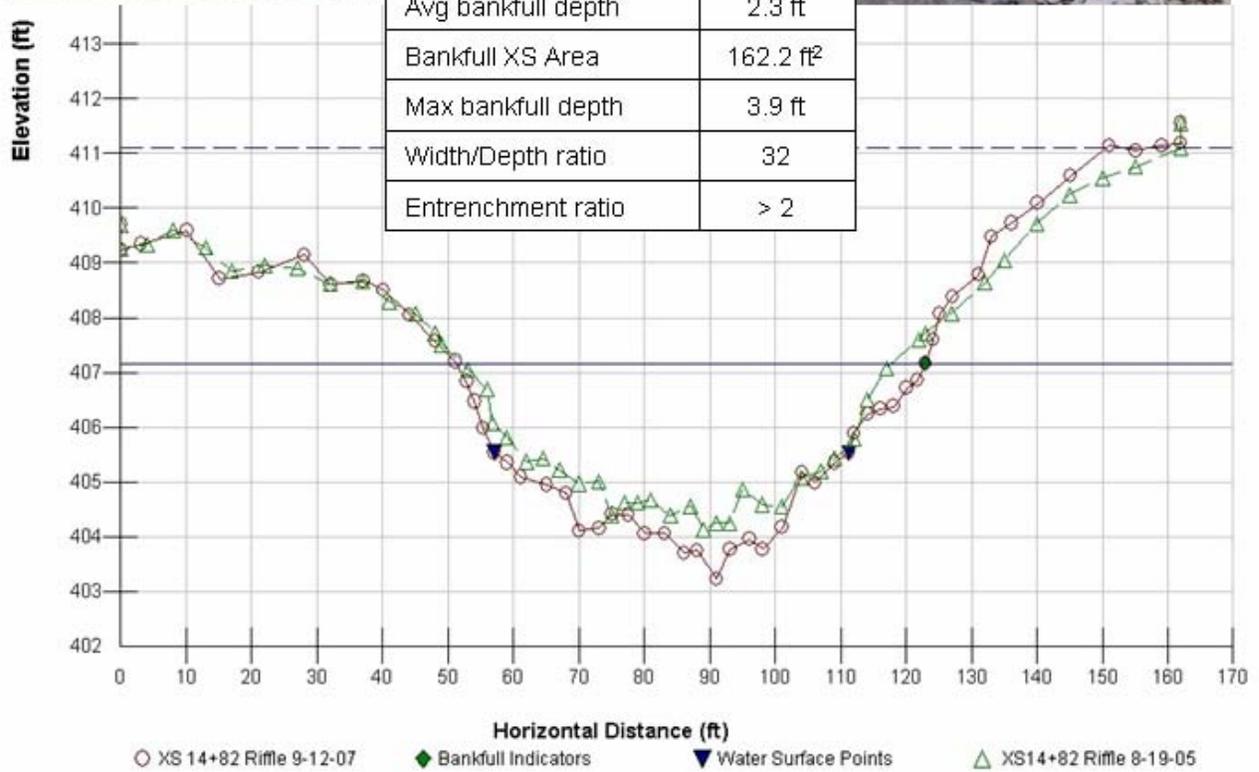
**Resurrection Creek Cross Section 14+82 - Riffle**  
**Surveyed 8/19/05 and 9/12/07**

Some channel changes have also occurred in the Meander 3 area. The riffle on the downstream end of Meander 3 has changed little. Cross Section 14+82 has shown up to about 1 foot of degradation on the riffle bed surface, with no major changes occurring along the banks (**figure 23**). The glide at Cross Section 15+38 showed very little change between its initial survey on 8/19/05 and re-survey on 9/12/07 (**figure 24**). This is a glide with a logjam on the left bank. Observed changes on the right floodplain in both of these cross sections are the result of construction work to build the Meander 3 eastern side channel in 2006.

**Figure 23:** Changes in Resurrection Creek Cross Section 14+82 from 2005 to 2007.

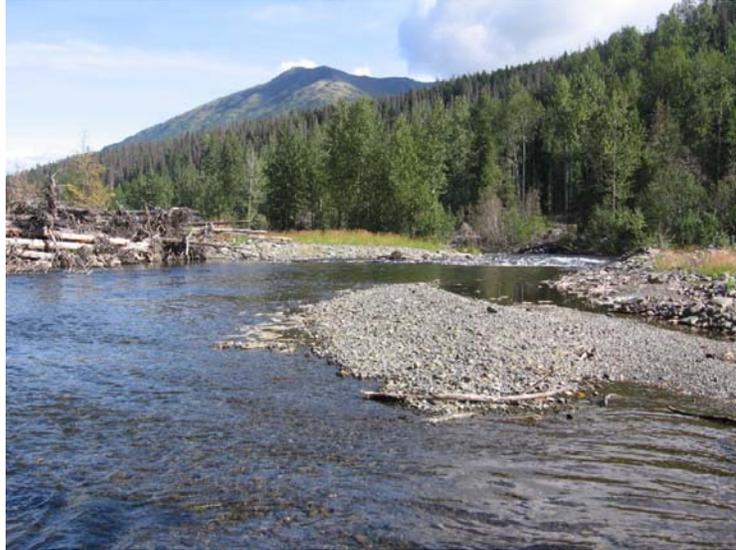
Observed changes that have occurred at Meander 3 include the development of a point bar on the inside of the bend (**figure 25**). Small gravel is accumulating in this low-energy area. This is also an area where numerous fish carcasses accumulate late in the summer. The point bar extends into the pool. The 103-foot bankfull width of the pool was constructed greater than the 70-foot design width, and the channel appears to be

adjusting accordingly by extending its point bar on the right bank. The main flow of the channel stays against the logjam on the outside of the bend and continues to scour out the pool while depositing material on the point bar. The channel will likely deposit material until it achieves its natural channel width of about 70 feet. Some evidence of beaver activity was seen in this area, but no beaver dams were observed on the main channel or side channels.

**Figure 25:** New point bar deposition at Meander 3.

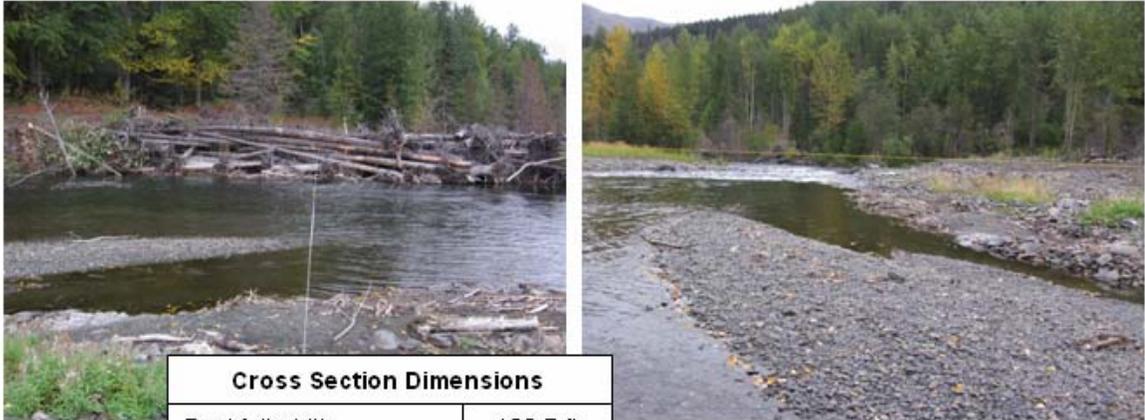
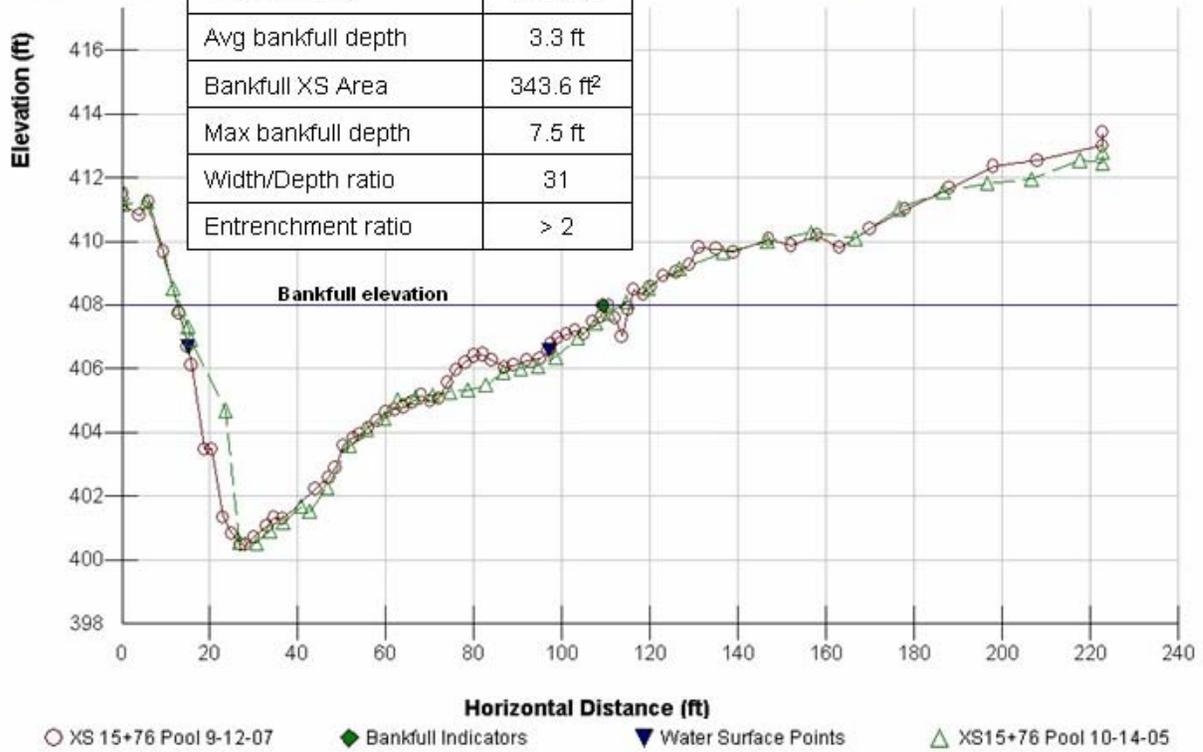
**Resurrection Creek Cross Section 15+76 - Pool**  
**Surveyed 10/14/05 and 9/12/07**

**Figure 26:** Changes in Resurrection Creek Cross Section 15+76 from 2005 to 2007. Gravel bar deposition has occurred along the right bank.

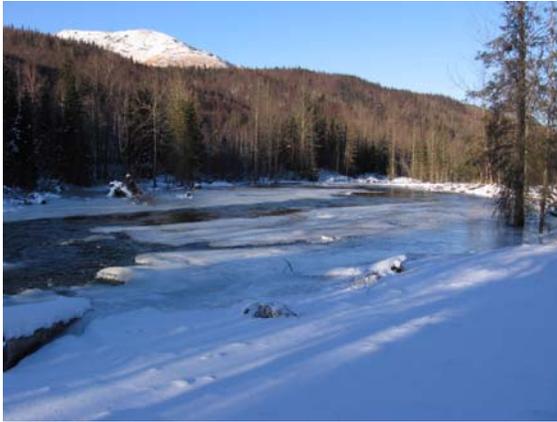
**Figure 29:** Overflow on anchor ice, near Meander 5, November 14, 2006.  
←

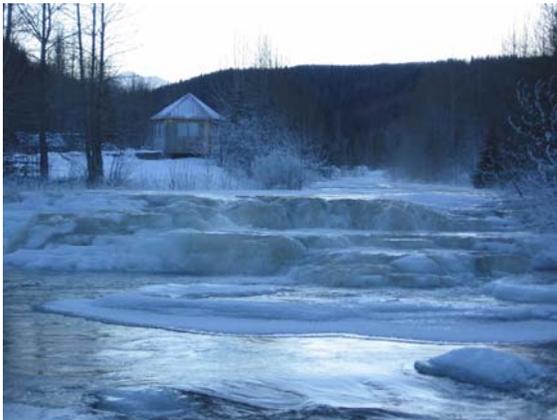
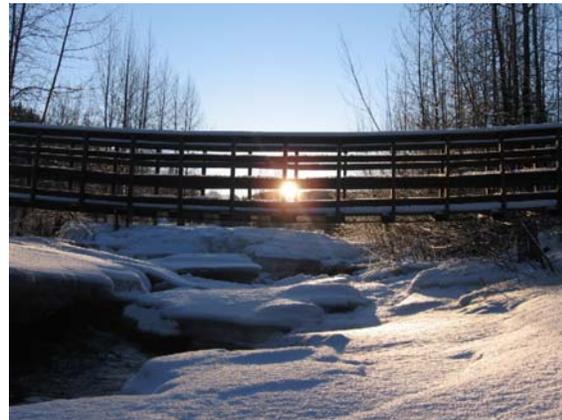
**Figure 31:** Ice dam at the Paystreke property, about 800 feet downstream of the end of the project reach, November 22 (left), and December 15, 2006 (right).

The channel in the Paystreke area is similar to the pre-restoration conditions of the Resurrection Creek channel, with a narrow, constricted channel, steep banks, and no floodplain. Under these conditions, ice will generally build up vertically, with nowhere to spread out. The restoration work restored the floodplain in the project reach, allowing ice and overflow to spread out over the floodplain and side channels, likely decreasing the risk of ice dams and ice dam breakout floods.

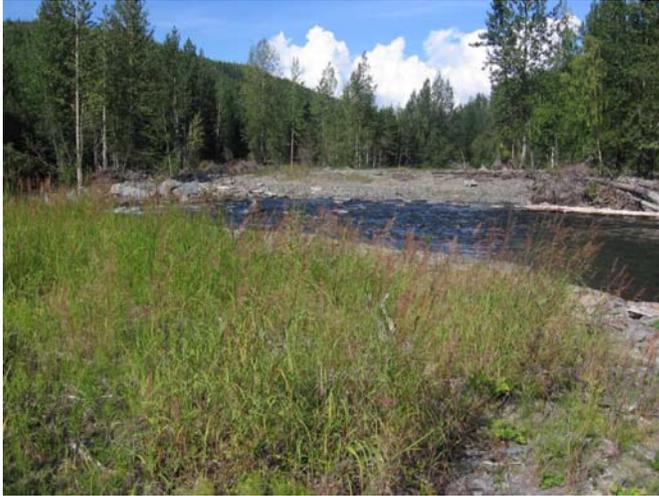
Observations in 2007 and photo point monitoring show that overall, revegetation on the newly created floodplains is occurring relatively quickly throughout the project area. **Figures 38, 39, and 42** show photo point monitoring of floodplain revegetation in areas that were restored in 2005. Areas that were spread with natural soils included a natural seed source and showed strong natural regeneration in 2006 and 2007 (**figure 36**). Areas that were spread with the mixture of clay and gravel showed little natural regeneration by 2007 (**figure 37**). Seedlings planted by the YRC in these floodplains will help greatly to promote future revegetation. Little or no natural revegetation has been observed on areas that were left as bare gravel and cobble. In many cases, the soil that was spread on the floodplains was not spread all the way to the bankfull elevation, leaving an area of bare cobbles and gravel on the lower floodplain. The YRC planted willow plantings in some of these areas.

**Figure 36:** Revegetated floodplain on natural transplanted soils at Meander 5, with slower revegetation rates occurring on clay soils on the far side of the river (August 31, 2007).

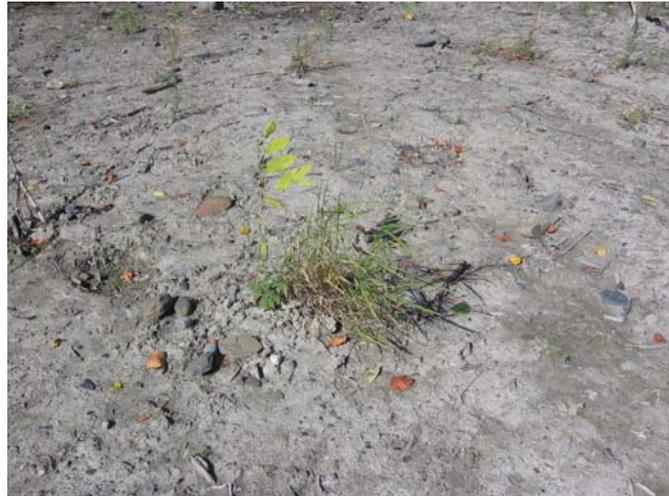
**Figure 37:** Sod transplant in clay soils on Resurrection Creek floodplain. Little natural regeneration is occurring in the clay soils (August 31, 2007).
