**RESURRECTION CREEK RESTORATION
2005 Channel Morphology Monitoring Report**

**Bill MacFarlane, Hydrologist
Chugach National Forest
Anchorage, Alaska**

March 2006

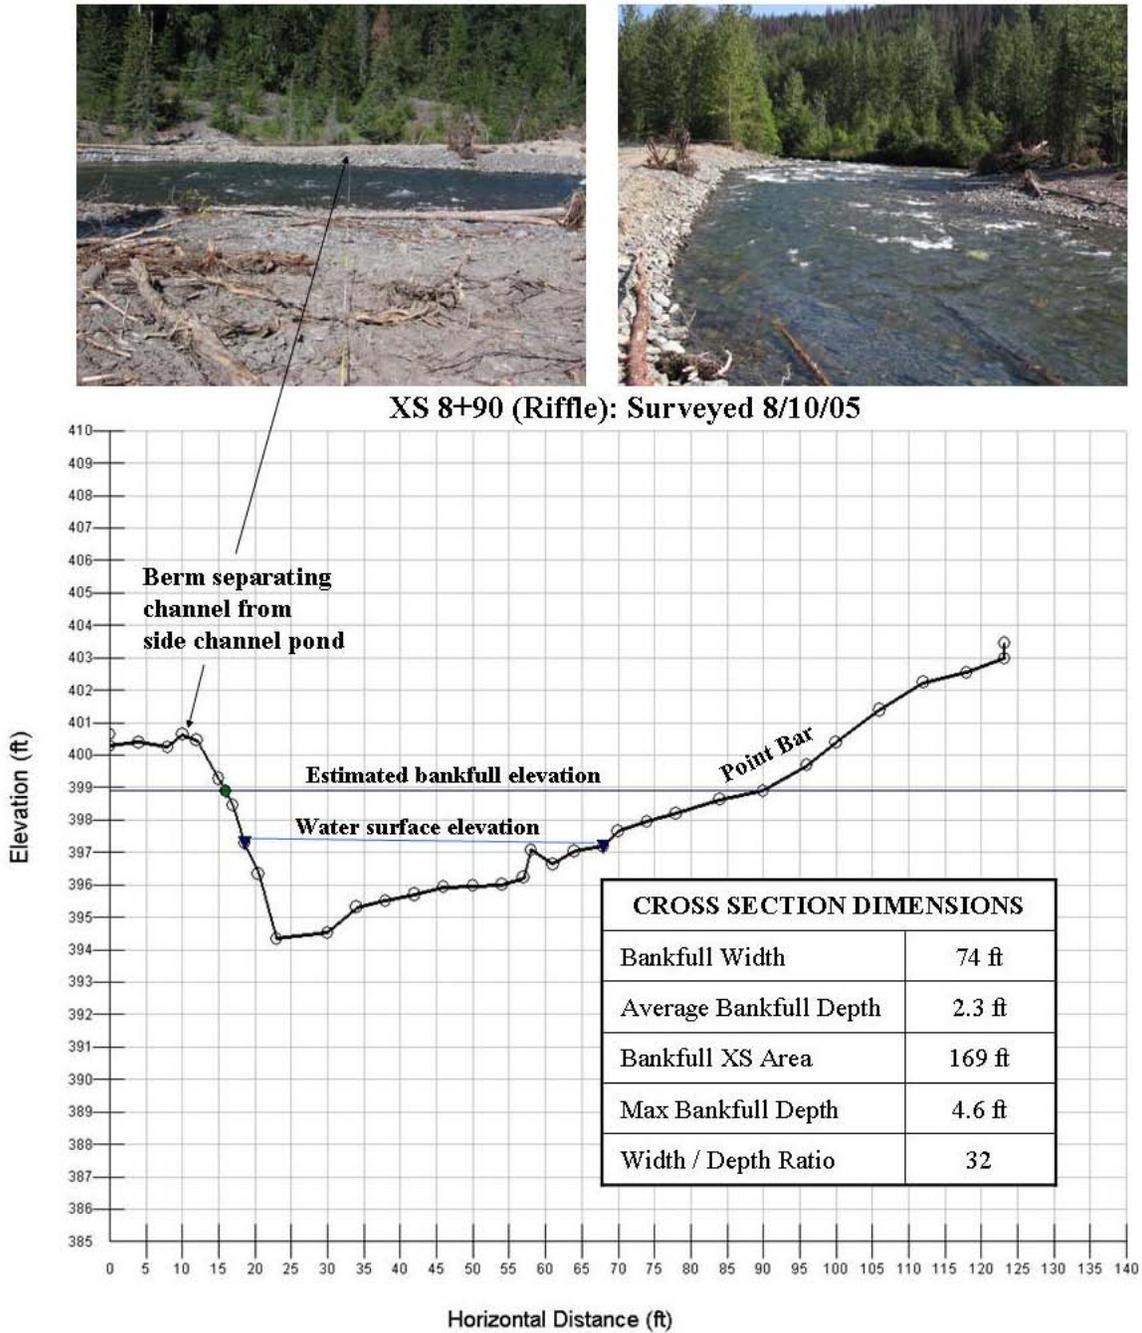
Figure 7: Cross Section 8+90 photos and details.

Cross Section 8+90 is located in the upper portion of the riffle at the downstream end of Meander 2 (**figure 7**). At this location, side channel ponds were constructed on both sides of the main channel. A narrow, 12-foot wide berm separates the main channel from the west side channel pond. This is a representative cross section and also serves to monitor bank erosion along the berm.

At this location, the thalweg is against the left bank, or the outside of the bend. This bank is the narrow berm that separates the main channel from the west side channel pond, as shown in the valley cross section (**figure 8**). During low flows initially following restoration, the water elevation of the pond was lower than the water elevation of the main channel. Although the pond outlet elevation is higher than the main channel, water seeps through the material and low flows do not maintain the pond at the elevation of the pond outlet. Pond and channel elevations will equilibrate during high flows when more water flows through the side channel, or when fine sediment fills and seals the pore space in the material comprising the berm at the pond outlet. The elevation of the berm between the channel and pond is higher than the bankfull elevation. This bank is composed of cobbles and gravel, and bank erosion is a concern, as high flows may create high shear stress against the bank. It is likely that the west side channel pond will gradually fill in with fine sediment in the future, and beaver activity is likely to occur in this area.

The bankfull channel width at cross section 8+90 is 74 feet. This is slightly greater than the design width of 60 feet, but some sediment deposition is expected to occur along the right bank. The channel slope at this riffle is 1 to 2%, steepening downstream of the cross section.

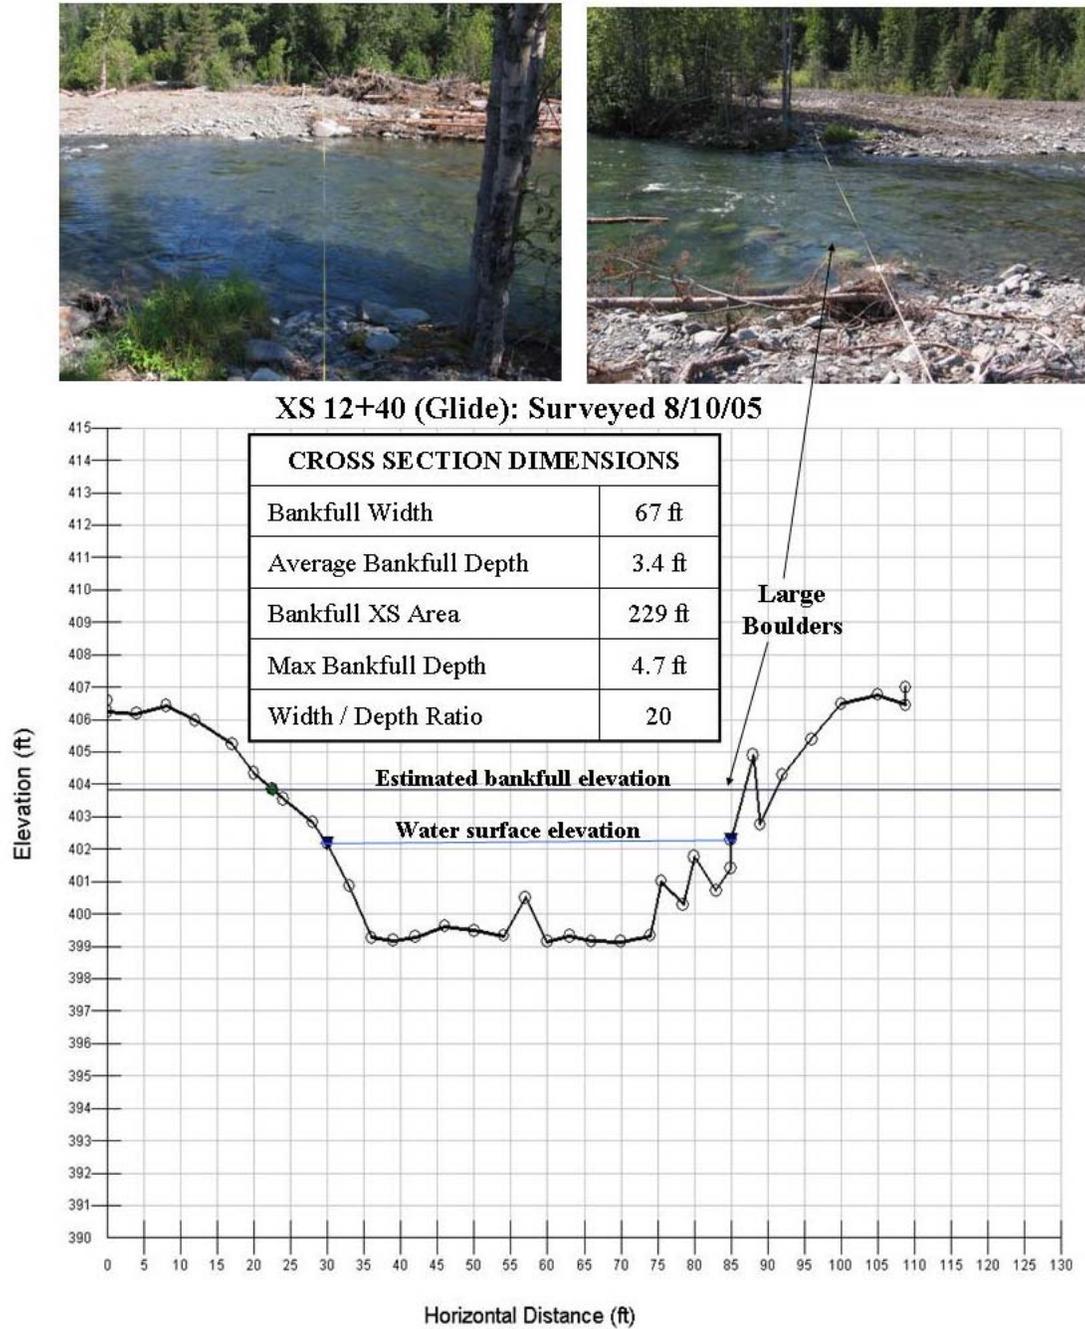
Figure 10: Cross Section 12+40 photos and details.

Cross Section 12+40 is located in a glide at the upstream end of Meander #2, at the point where Resurrection Creek was diverted out of its original channel into Meander #2 (figure 10). About 5 large boulders lie along the right bank, and a deep pool lies upstream of these boulders. This is a representative glide cross section.

The bankfull width of 67 feet is similar to the design bankfull width of 66 feet. Because of the greater water depths in this glide, the cross sectional area is larger than that measured in the riffle cross sections. The D_{50} at this cross section is 66mm (**figure 11**). This is considerably finer than the D_{50} of the pre-restoration project reach (122mm) and the D_{50} of the reference reach (99mm). Finer gravel was placed in this glide during restoration, and this material was naturally sorted by the river.

This glide provides good fish habitat, with spawning gravel as well as cover provided by the logjam and large boulders along the right bank. However, this glide is not well developed in terms of gravel sorting and fish habitat as compared to other glides upstream. Further development of the glide is expected to occur in the future. As more sediment is transported from upstream, gravel will sort itself in the glide. Deposition of gravel in a point bar will likely occur on the left bank.

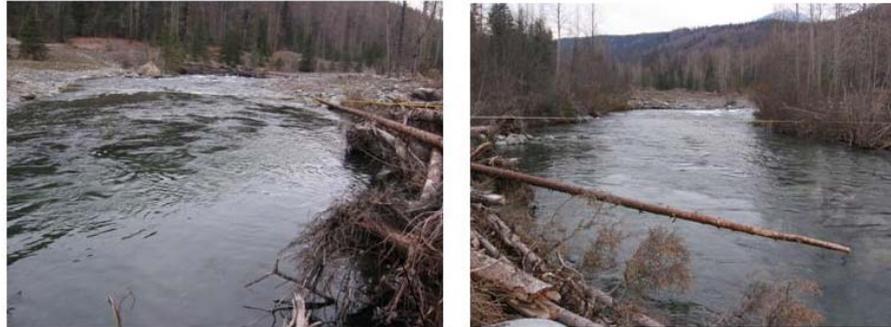
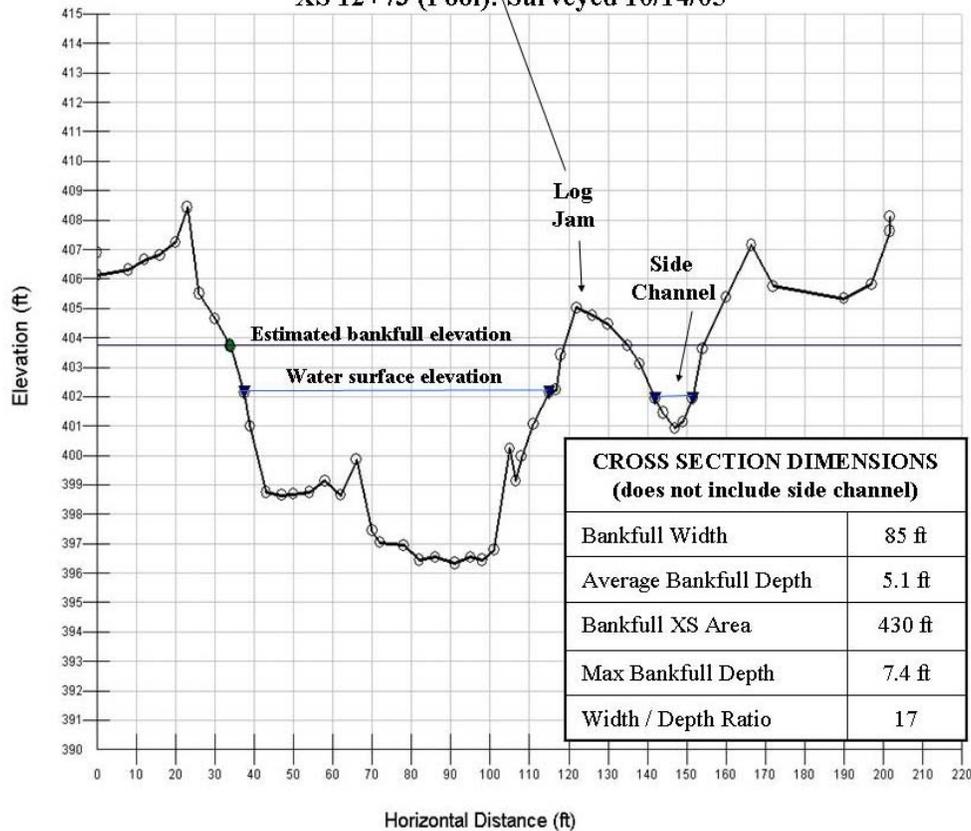
Figure 12: Cross Section 12+73 photos and details.

Cross Section 12+73 is located in the pool at the upstream end of Meander #2 (**figure 12**). A large logjam was constructed on the right side of this pool, and a side channel diverges from the east (right) side of the main channel at this logjam. The cross section crosses the side channel. The pool is deep, with a substrate of mostly large boulders.

Considerable sediment deposition is expected in this pool in the future. Surprisingly little sediment was deposited in the pool in the first few months following restoration, and the substrate remains very coarse. It is likely that much of the future sediment deposition will come from larger flood events.

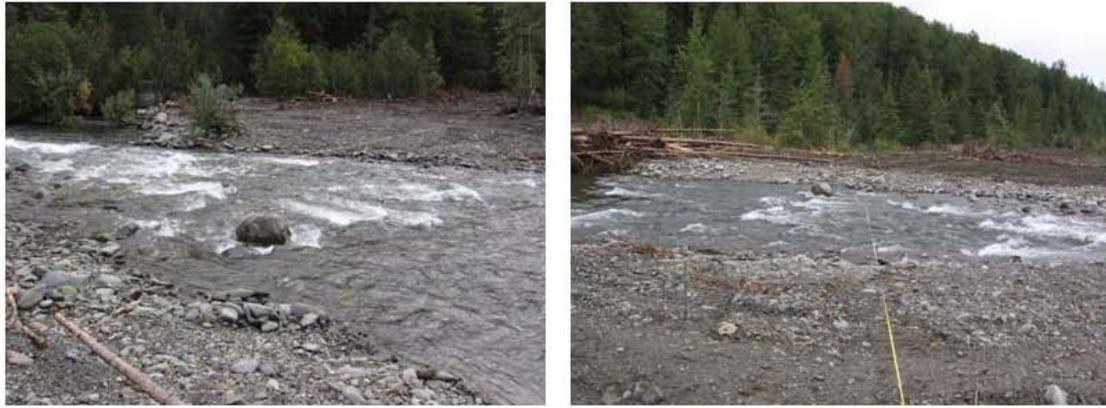
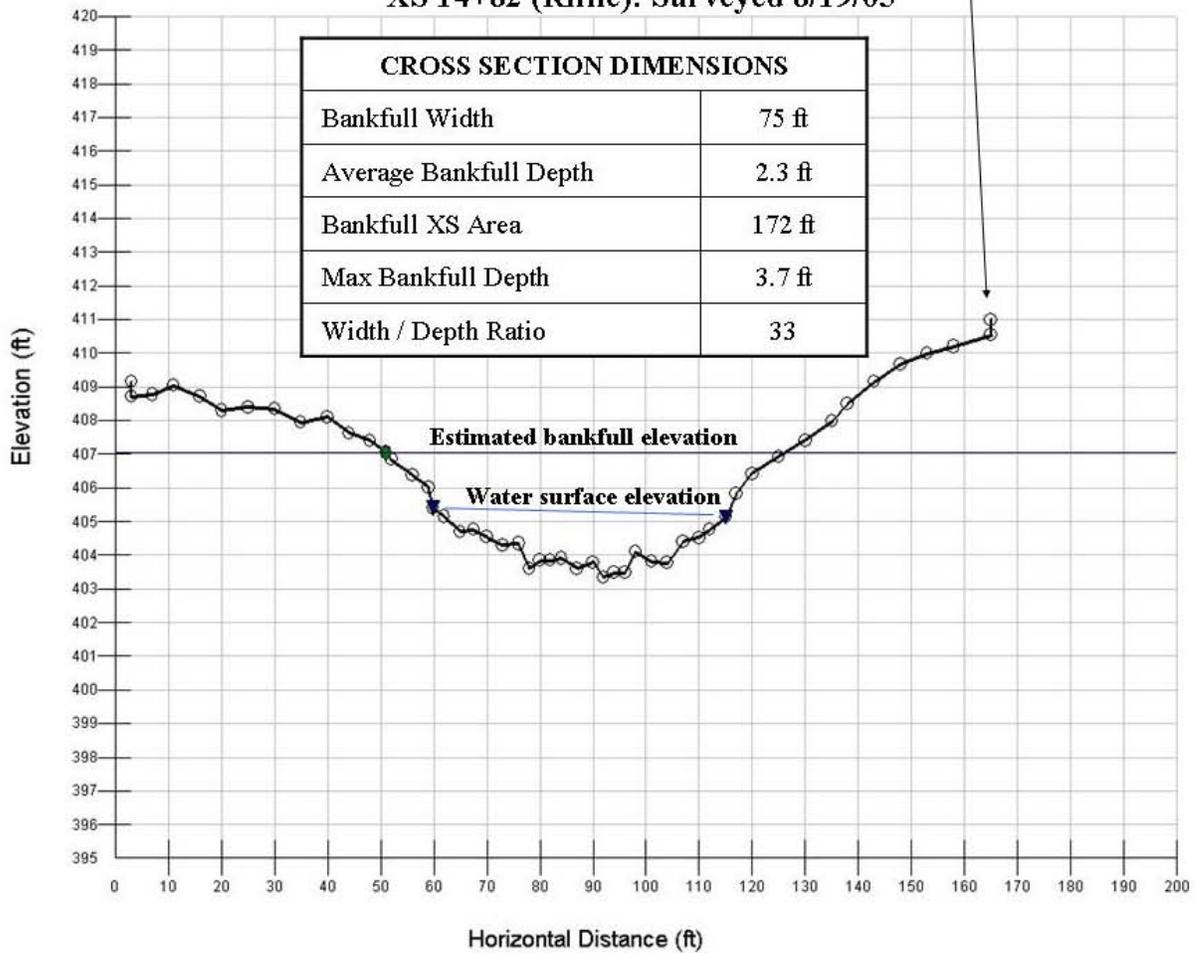
Figure 13: Cross Section 14+82 photos and details.

Cross Section 14+82 is located in a riffle in the downstream half of Meander #3, about 35 feet downstream of the start of the riffle (**figure 13**). Low gradient floodplain surfaces exist on both banks. This is a representative riffle cross section.

This cross section is not expected to change drastically in the future. The substrate is coarser than most other cross sections, shear stress along the banks is relatively low, and the low-angle banks are unlikely to sustain substantial erosion. The D_{50} in this riffle is 118mm (**figure 14**). This is similar to the D_{50} that was measured for the entire pre-project reach (122mm) and coarser than the D_{50} measured in the entire reference reach (99mm). However, this represents some of the coarsest bed material in the 2005 post-restoration reach.

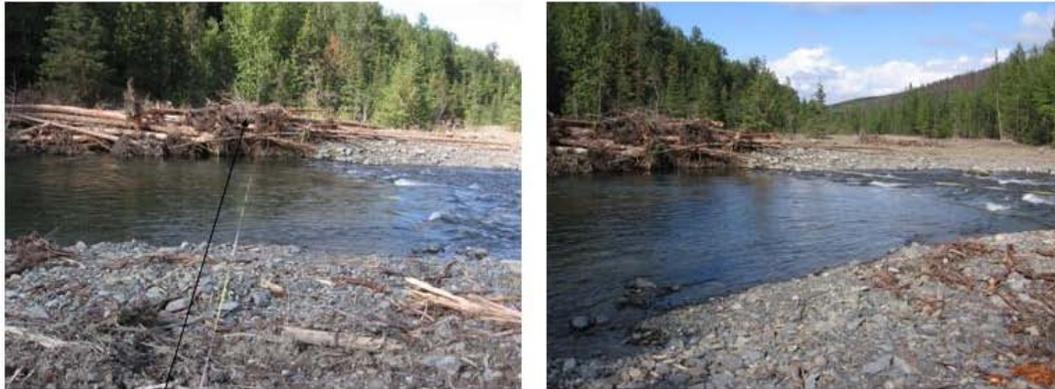
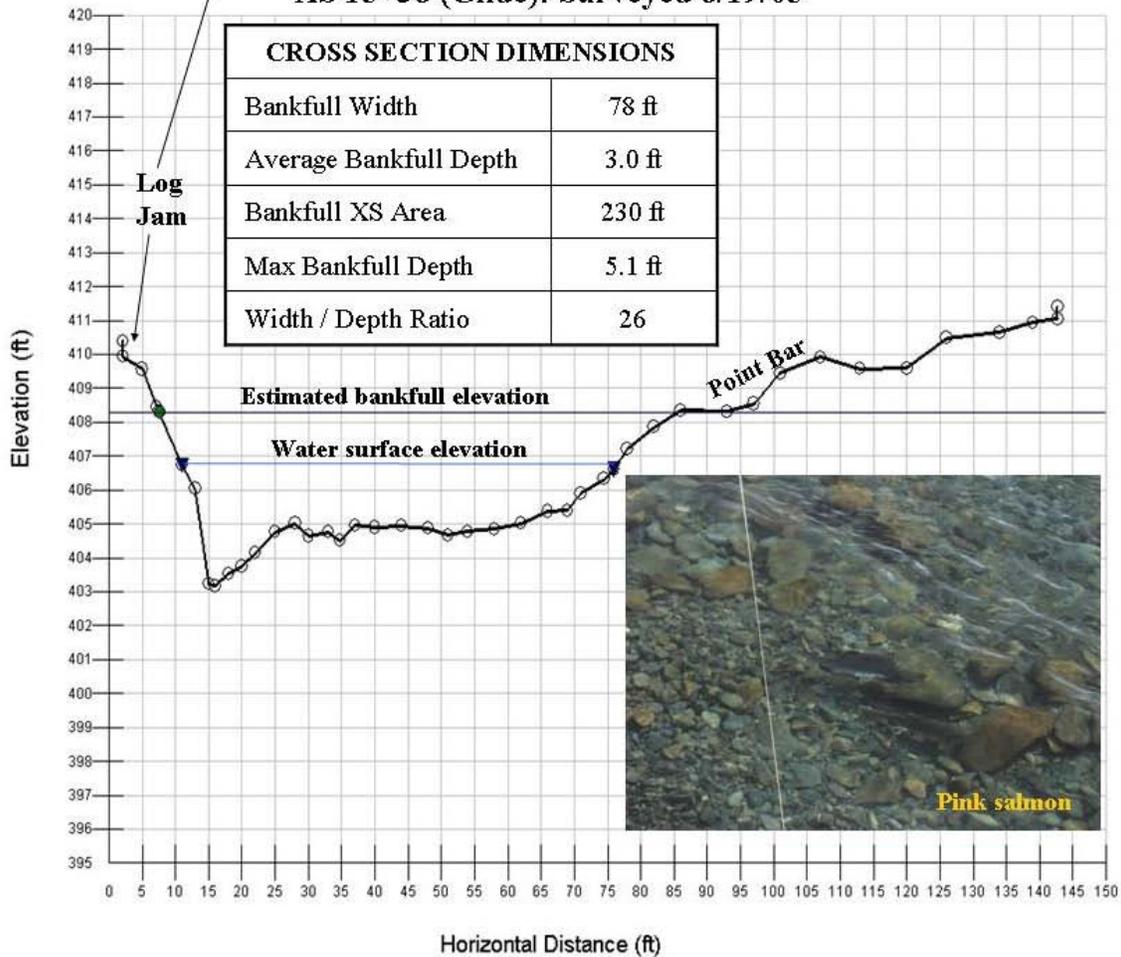
Figure 15: Cross Section 15+38 photos and details.

Cross Section 15+38 is located in a glide in the downstream half of Meander #3, about 10 feet upstream of the start of the riffle (**figure 15**). A logjam was constructed on the left bank along this glide and the pool just upstream. This glide includes a deep area against the logjam and has excellent fish habitat. This is a representative glide.

This well-defined glide has excellent fish habitat. The gravel is well sorted, the glide is relatively uniform across the channel, and the adjacent logjam and upstream pool provide very good fish habitat and cover. The D_{50} at this cross section is 46mm (**figure 16**), which is considerably finer than the D_{50} of the pre-project reach (122mm) and the D_{50} of the reference reach (99mm). The substrate in this glide is finer than that of the other glides. Although gravel was placed in this glide during construction, much of the sorting occurred very quickly after the water was put into the channel. It is likely that sediment deposition will occur on this glide, leading to further sorting of gravel and some infilling on the left side against the logjam.

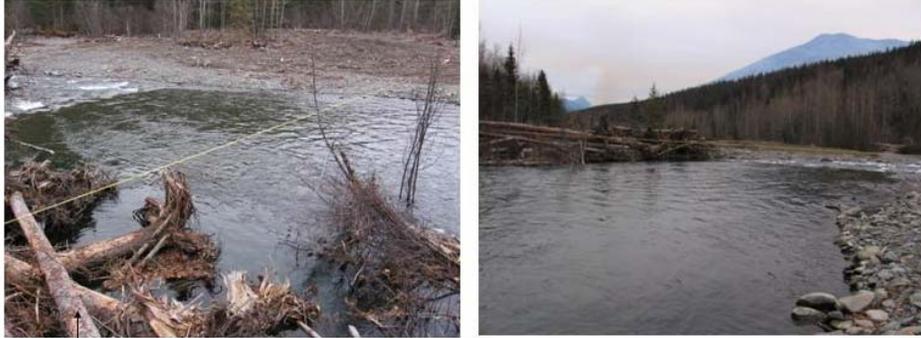
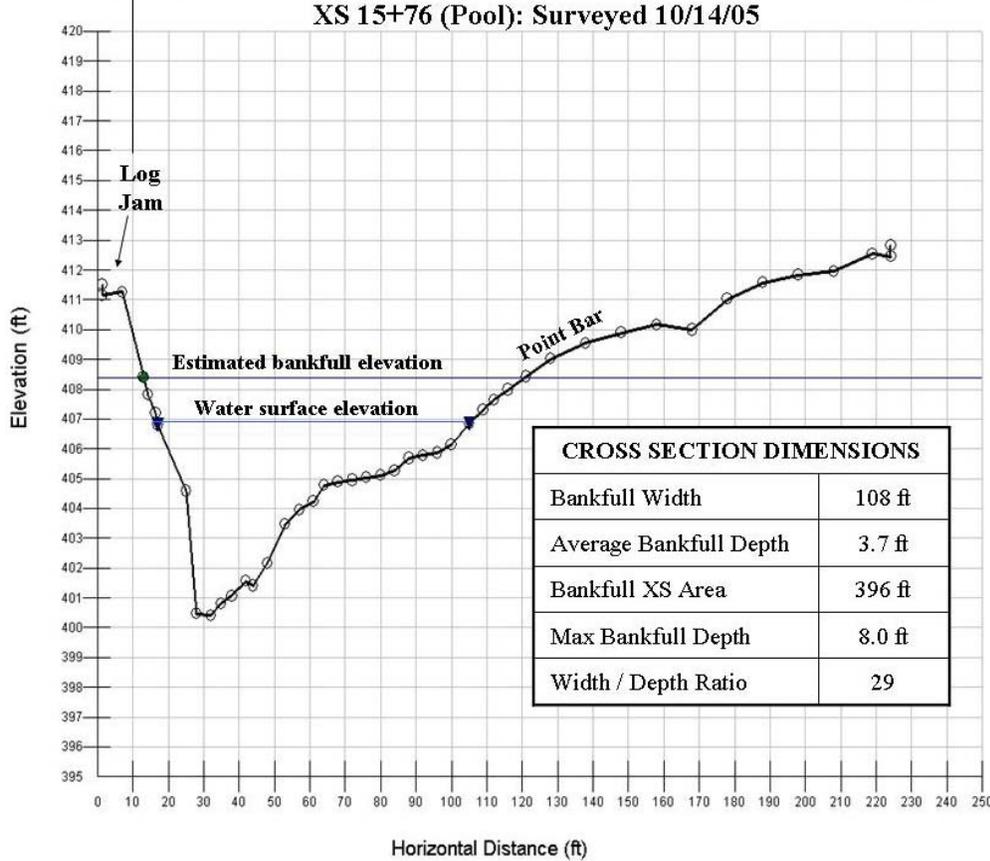
Figure 17: Cross Section 15+76 photos and details.

Cross Section 15+76 is located in a pool in the downstream half of Meander #3 (figure 17). A logjam was constructed on the left bank. The pool is deep against the logjam, and abundant fish habitat and cover are available. The right bank is a low-angle floodplain, and the left bank acts as a terrace. This is a representative pool cross section.

Sediment deposition is expected to occur in this pool. A point bar will likely develop on the right bank, with some infilling of the deep pool against the left bank. Sediment deposition will provide additional gravel to be sorted in the glide just downstream (Cross Section 15+38). Because of the well-sorted substrate, the pool depth, and the abundant cover, this area is expected to continue to provide high quality fish habitat.

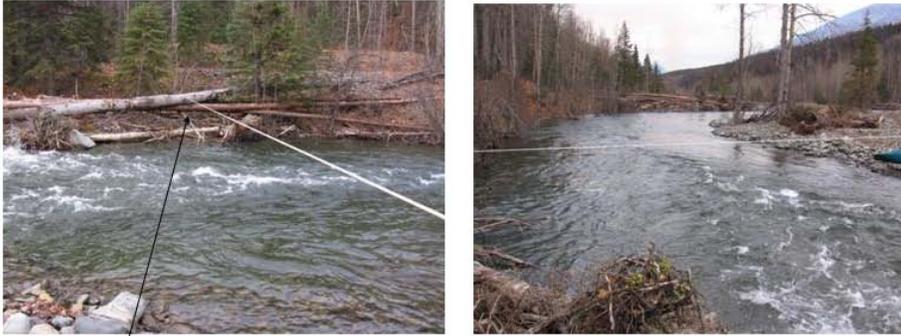
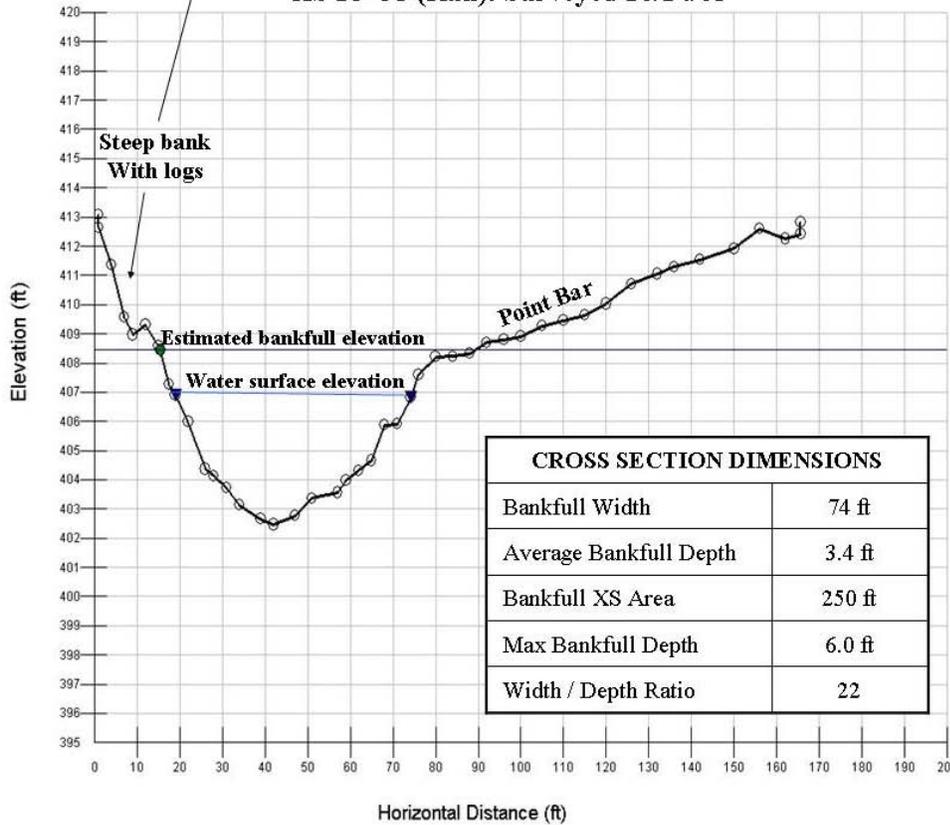
Figure 18: Cross Section 18+35 photos and details.

Cross Section 18+35 is located in a run on the outside bend of Meander #3 (**figure 18**). A small logjam, consisting of about 5 large logs, lies on the left bank. Fast current flows along the thalweg in the center of the channel, and eddies exist along both banks, with a low-angle floodplain on the right bank. A high terrace and the Resurrection Pass Trail are on the left bank.

Few changes to this cross section are expected to occur in the long term (>10 years). The thalweg is in the center of the river, and extensive bank erosion is not likely to occur. Some localized erosion from eddy scour downstream of the logs on the left bank may occur as a result of flow deflected by the logs into the bank.

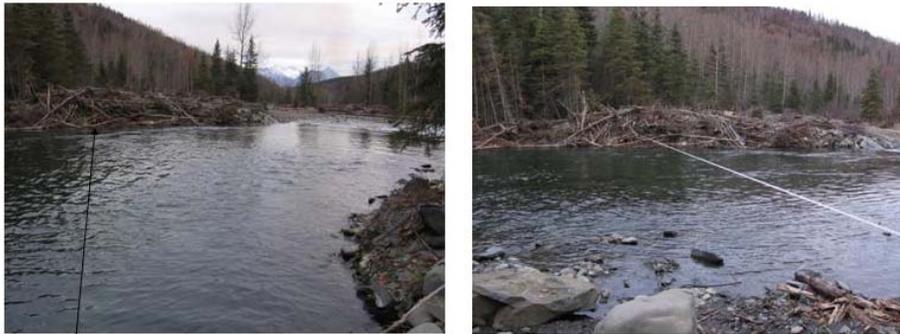
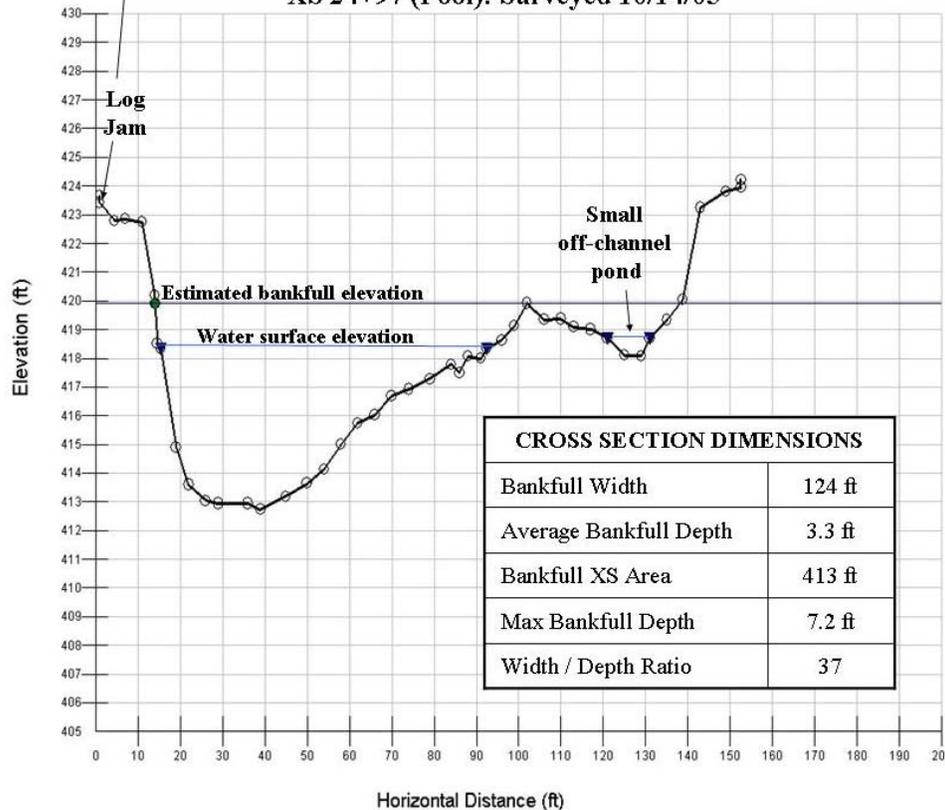
Figure 19:
Cross Section 24+97 photos and details.

Cross Section 24+97 is located in a pool on the outside bend of Meander #4 (**figure 19**). A logjam was constructed on the left bank. The right side of the channel is mostly slack water, and a low floodplain with a small off-channel pond exists on the right bank. This small pond is groundwater-fed.

It is likely that the off-channel pond area on the right bank will develop into a floodplain over time. This is a low-energy environment with considerable roughness from the surrounding trees. The terrace surface to the right of the pond was preserved during construction in order to preserve the spruce forest. New floodplain deposits on the right bank are expected to build up against this terrace.

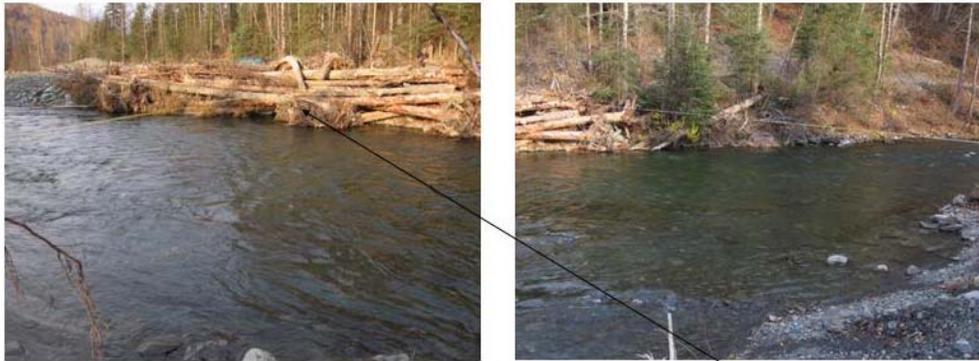
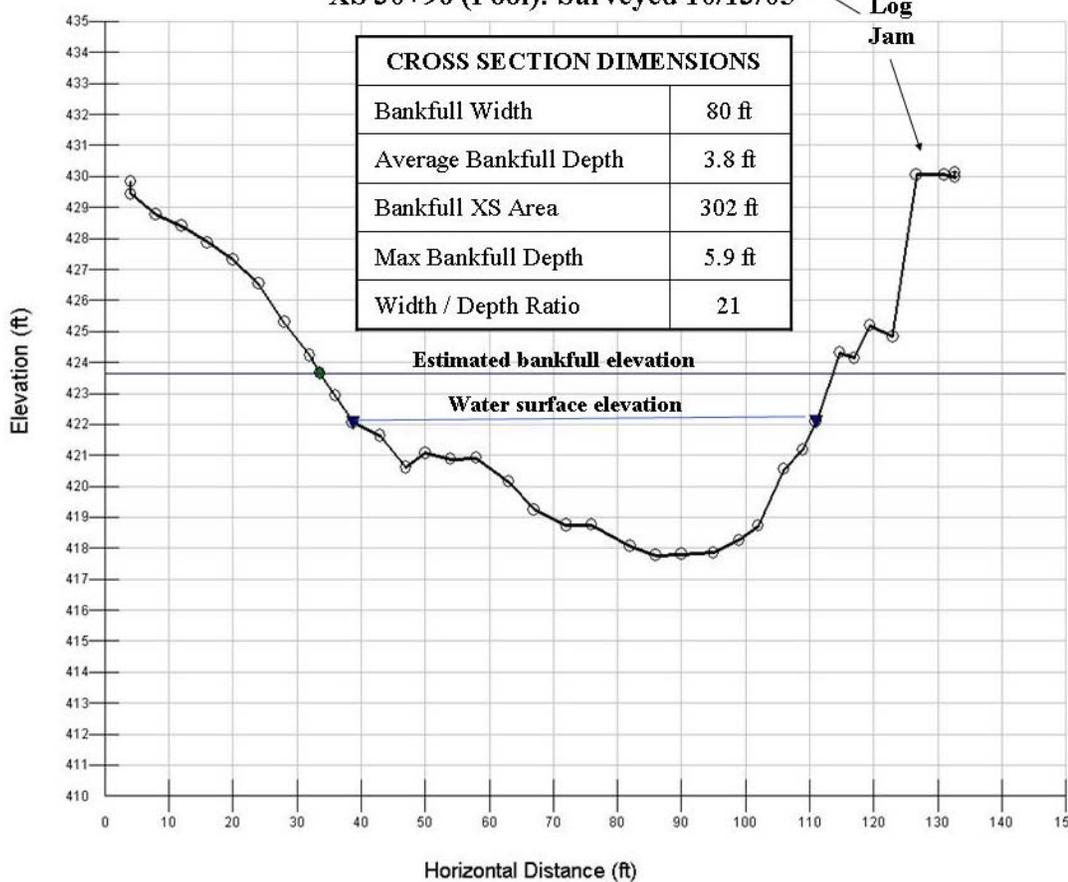
Figure 20:
Cross
Section
30+96
photos and
details.

Cross Section 30+96 is located in a pool at the upstream end of Meander #4, at the point where the main channel was diverted into Meander #4 (**figure 20**). A logjam was constructed on the right bank terrace, and the left side of the channel is mostly shallow slack water. This cross section may be affected by channel restoration activities in 2006.

Pool volume is expected to decrease as a result of sediment deposition and infilling. The glide downstream of this pool is not well developed. A point bar is likely to develop on the left bank.

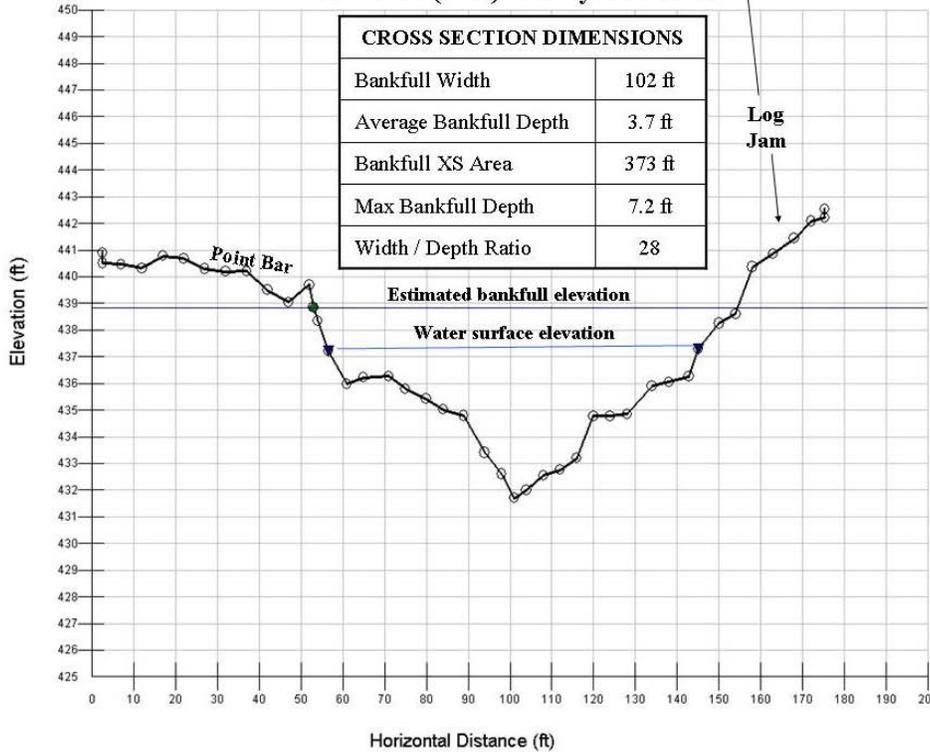
Figure 21: Cross Section 40+30 photos and details.

Cross Section 40+30 is located in a pool in the downstream half of Meander #5 and includes the main channel as well as the east (right) side channel where it diverges from the main channel (**figure 21**). A logjam was constructed on the right bank, on the outside of the bend, at the side channel inlet. High velocity flows and strong eddy currents exist against this logjam, and slack water exists on the left side of the channel.

of the bend. High velocity flows and strong eddy currents exist against this logjam, and slack water exists on the left side of the channel.

Sediment deposition is expected to alter the shape of this cross section in the short term (<5 years). This is a tight bend to the left. A point bar will develop on the left side of the channel, as most of the current flows against the right bank and the logjam. This short pool is followed by a short, steep riffle, which has the potential to be undermined, causing a headcut to advance upstream. If this happened, the pool elevation at Cross Section 40+30 would be lowered, and the amount of water that flows into the east side channel would decrease. Other factors can affect the dynamics of the side channel inlet, including sediment deposition and large woody debris. The flow that currently goes into the side channel is controlled by the existing logjam.

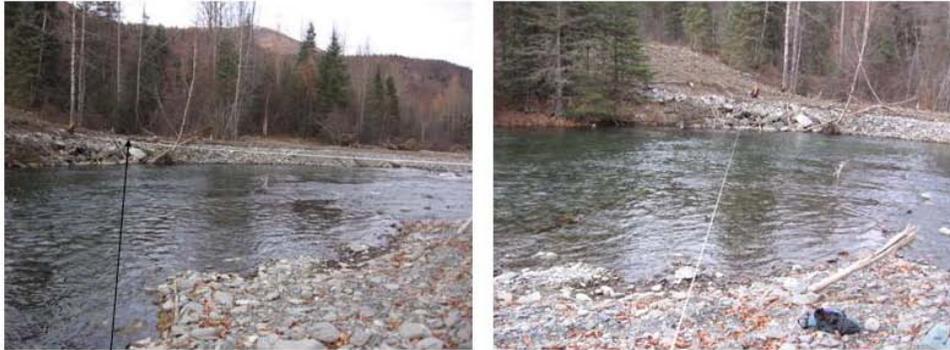
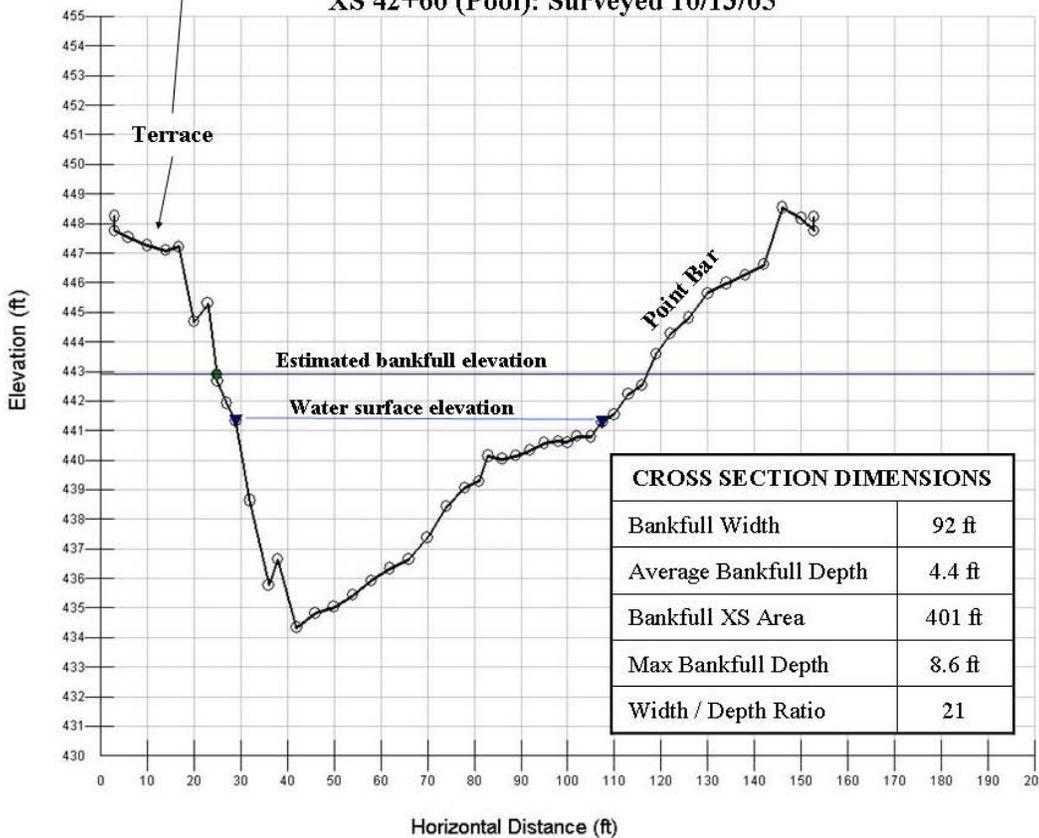
Figure 22: Cross Section 42+60 photos and details.

Cross Section 42+60 is located in a pool upstream of Meander #5, just downstream of the “new” Palmer Creek confluence (figure 22). The left bank is a terrace that grades into a floodplain further downstream.

The left bank is a terrace that grades into a floodplain further downstream. Many large boulders exist on the left side of the channel. The right bank is a moderately steep floodplain.

This pool is located just upstream of the diversion point where the main channel was diverted into Meander #5. It is likely that this pool will experience considerable infilling with sediment. This is a very low-energy environment, and the pool extends about 150 feet upstream. The substrate is currently very coarse. A point bar is likely to develop on the right bank. Channel changes may occur as a result of further channel restoration activities in 2006.

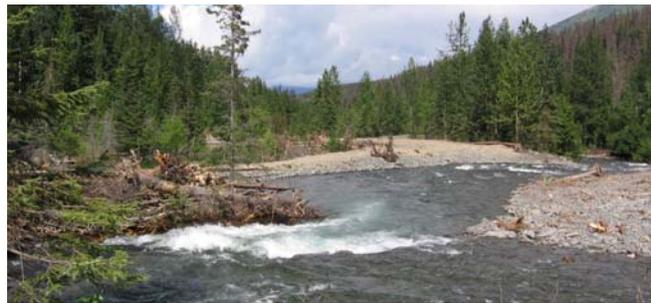
Figure 35: Berm on outside bend of Meander 2.

- The berm on the outside of the bend at Meander 2, separating the main channel from the west side channel pond, is relatively narrow (**figure 35**). Although it is reinforced by boulders, high shear stresses along this berm during high flows can cause bank erosion. High flows would not pour over this berm because the water surface elevation of the pond would be equal to that of the channel. However, any erosion of the berm may damage the integrity of the berm until it becomes stabilized by vegetation.

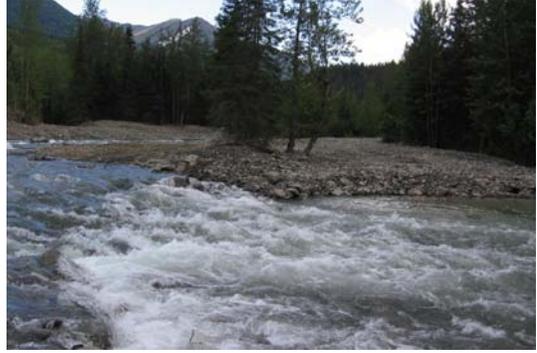
Figure 36: Lower end of riffle at Meander 5 (top), and lower end of riffle at Meander 2 (left).

- The lower ends of the riffles at Meander 2 and Meander 5 are very steep (**figure 36**). High energy flows in these locations have the potential to move enough sediment so that headcutting may occur in these locations. Headcutting and downcutting of the channel at each of these riffles would potentially alter the inlets of the side channels just upstream. These areas should be closely monitored in 2006 and possibly reinforced.
