**USDA Forest Service**  
**Southwestern Region**  
**Apache-Sitgreaves National Forests**

**Hannagan Meadow Motor Vehicle Accident  
Facilitated Learning Analysis**

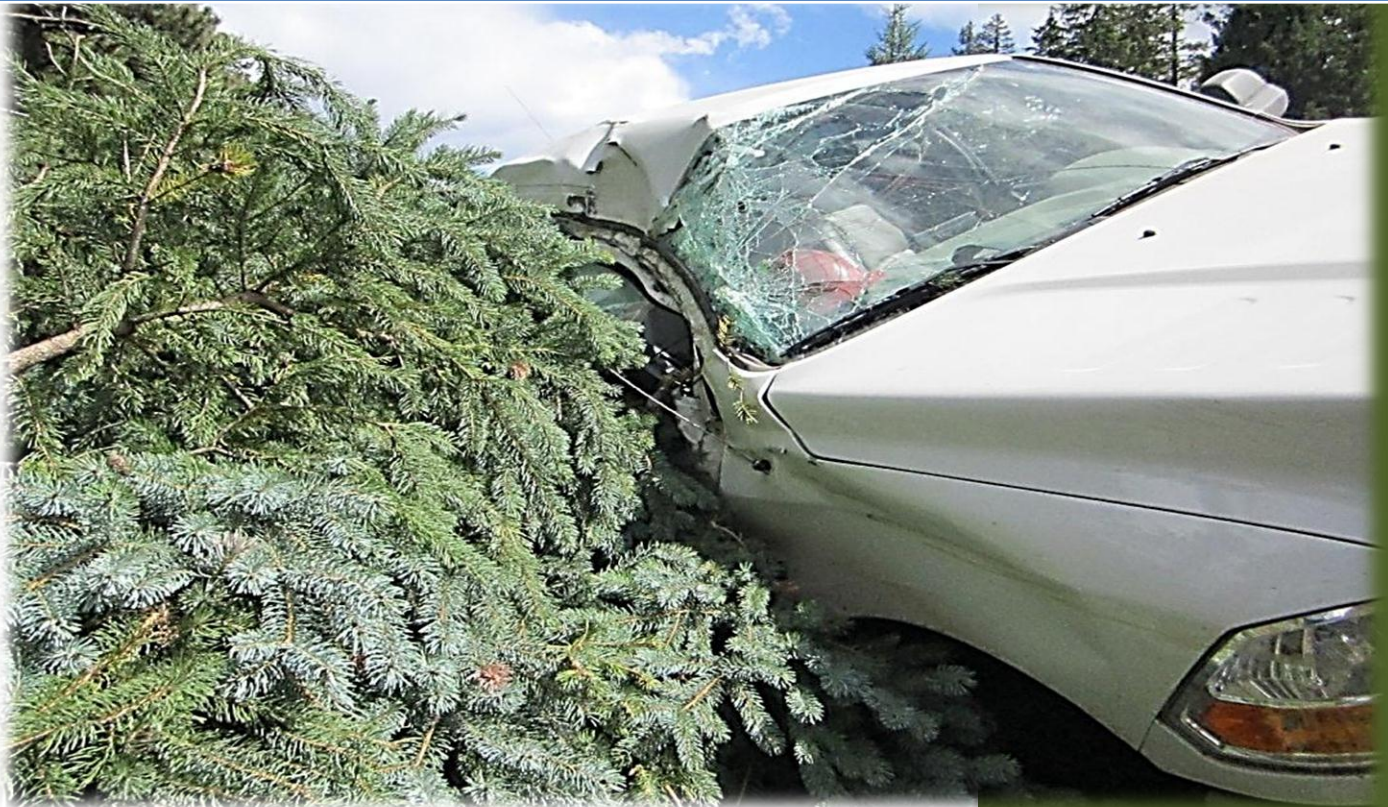
“It’s a good thing that I didn’t  
remove my hardhat before  
getting into the truck”

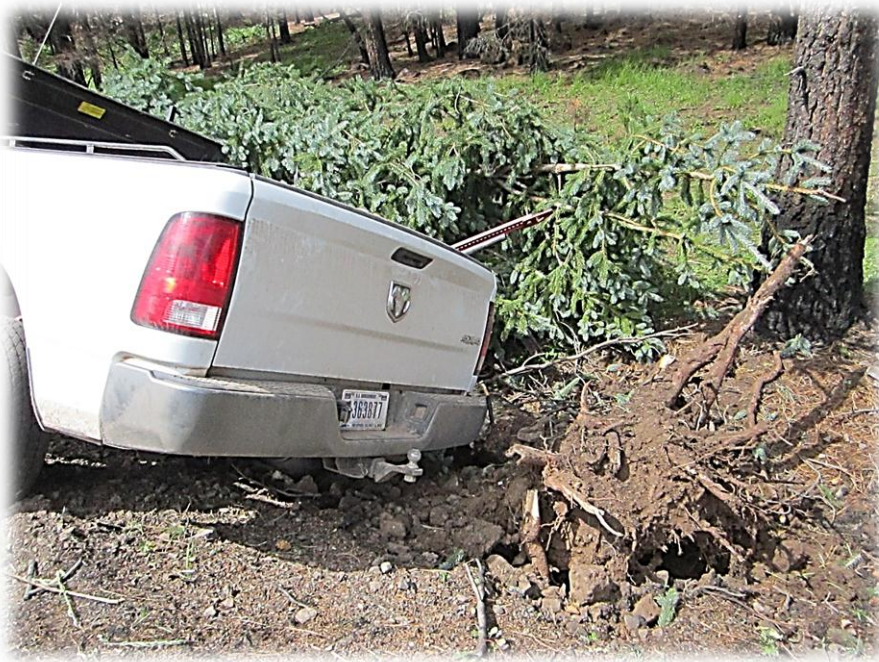
“A serious head injury to the passenger because of impact with the crushed interior door frame was avoided because he was still wearing his hard hat”

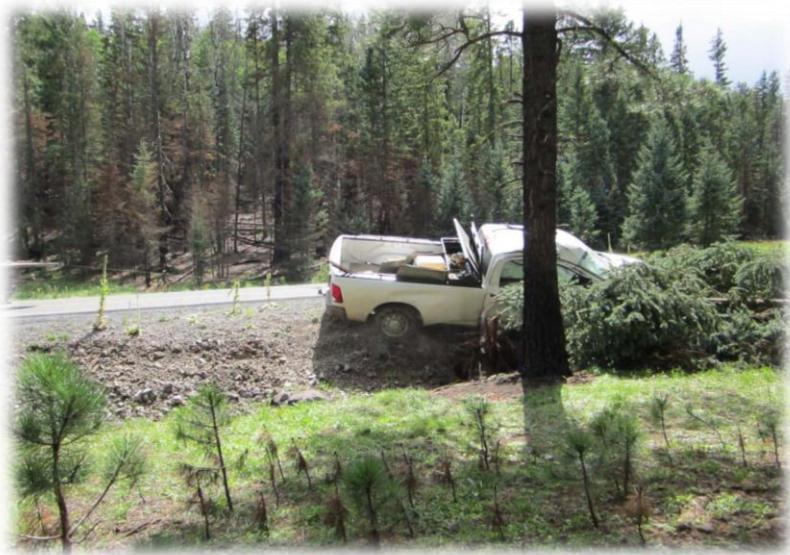
“The side-curtain airbag, seatbelt, sunglasses, and hardhat prevented life changing injuries to the passenger”

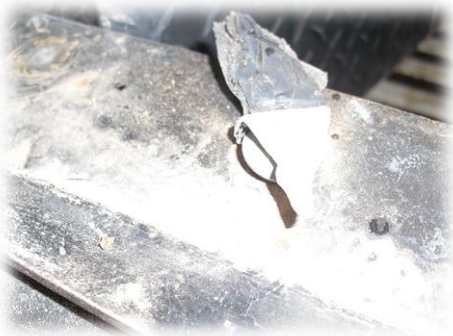
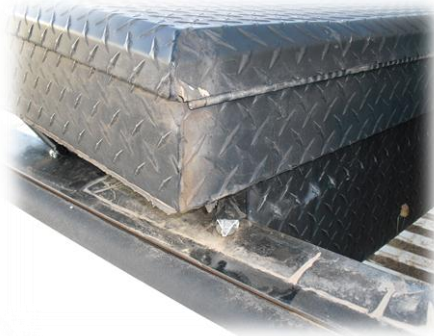
- 7) Ensure that all employees who conduct field work have CPR and 1<sup>st</sup> Aid training.
- 8) All FS vehicles that have mounted utility boxes need to be inspected to ensure that they are mounted per manufactures specifications. The utility box of the vehicle was only mounted using one bolt per side. As a result of the impact the box separated from the truck bed.
