The Effects of Fire

On Cultural Resources

THE HAMMOND FIRE

THE HAMMOND FIRE BAER PROJECT

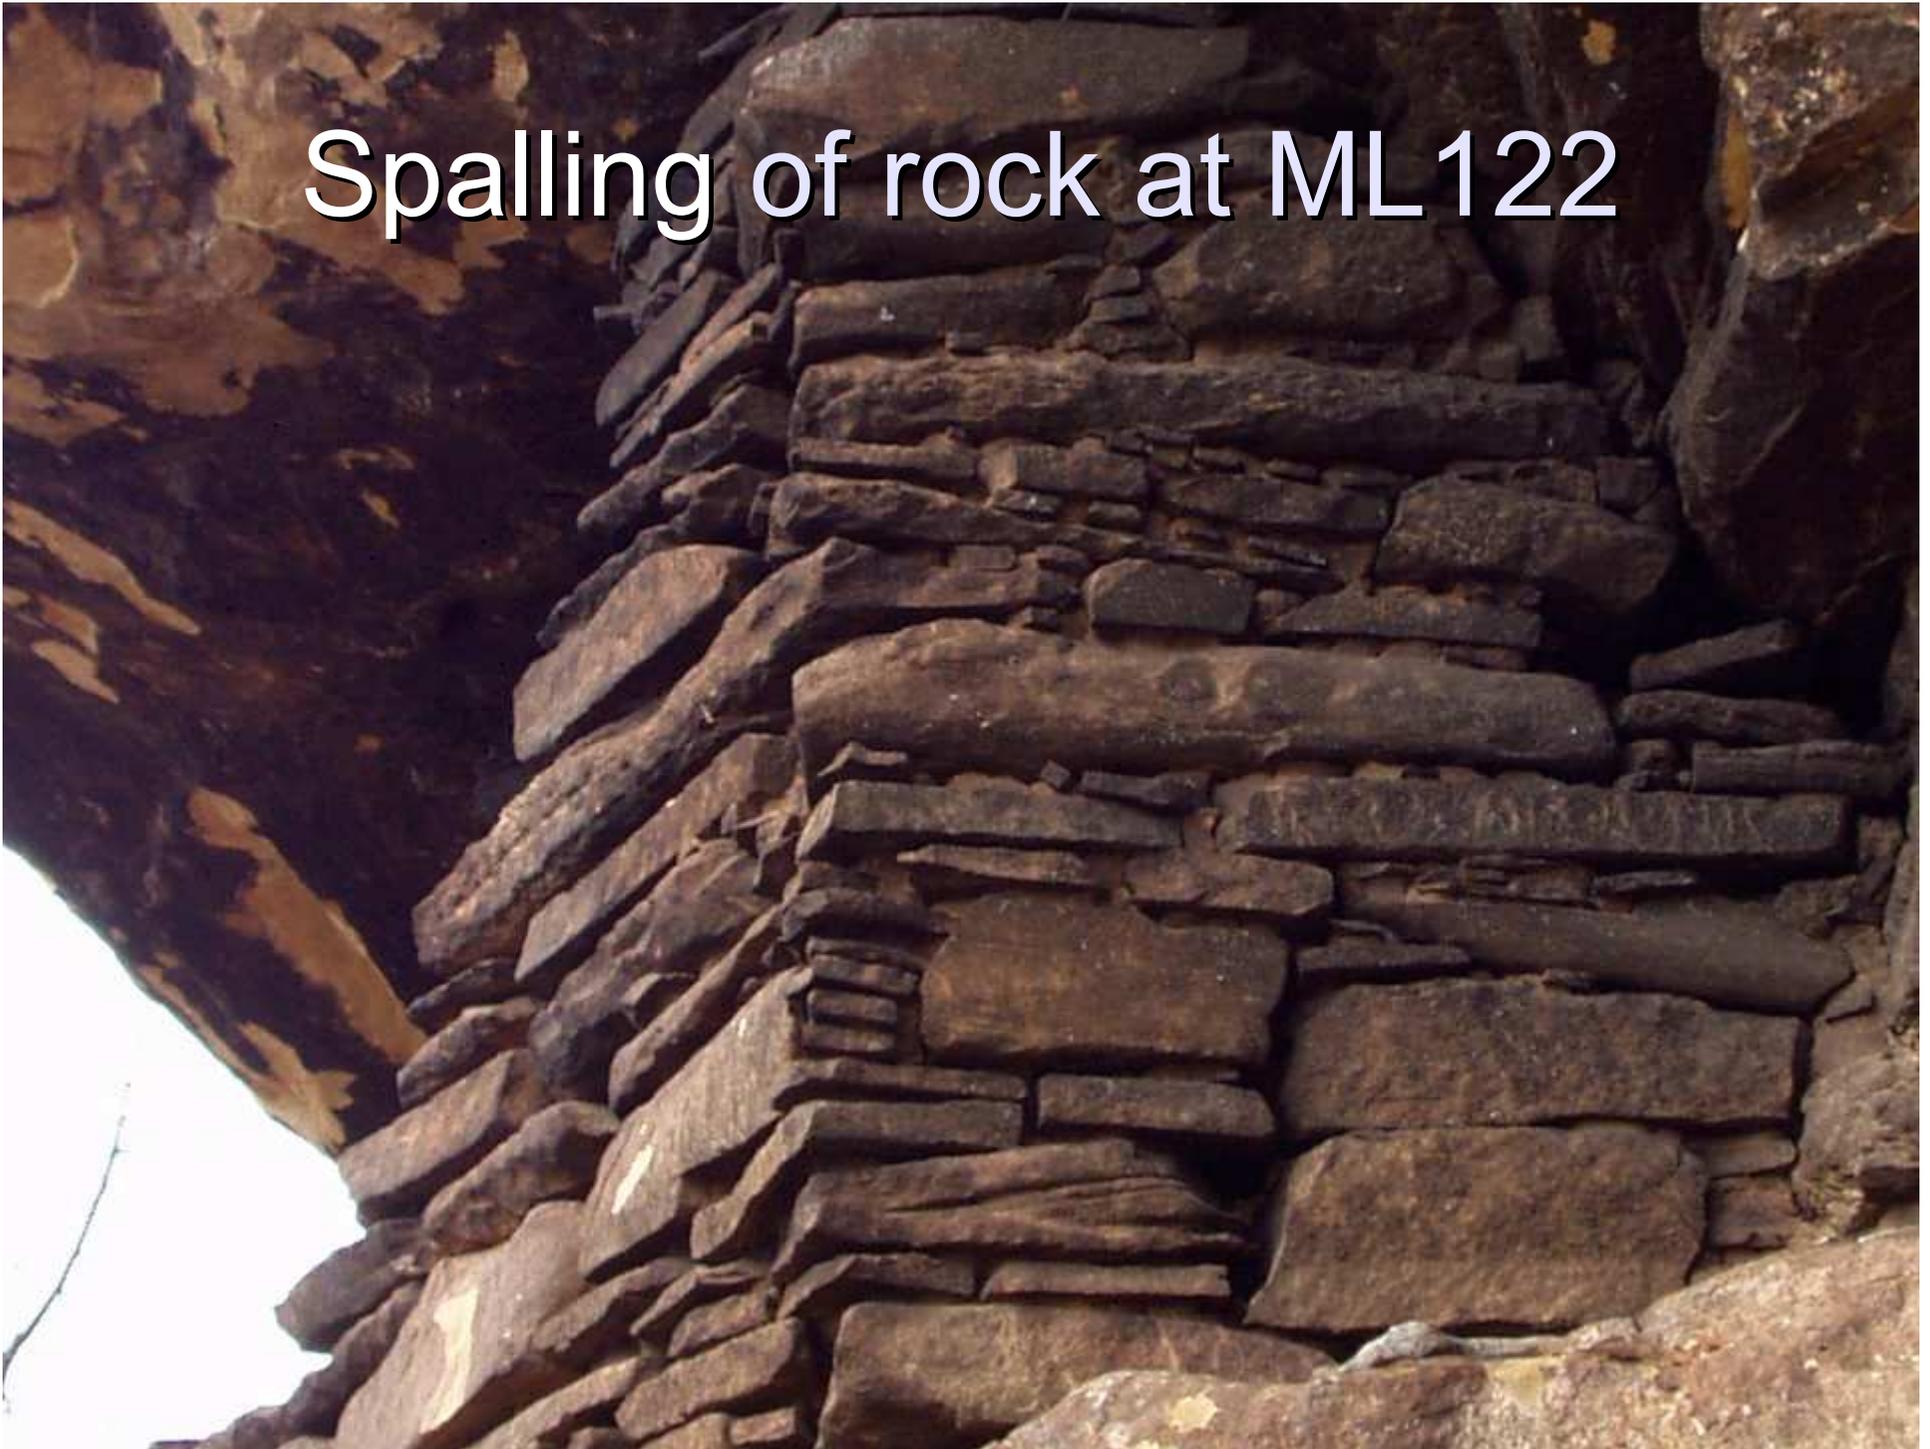
Spalling of rock at ML122

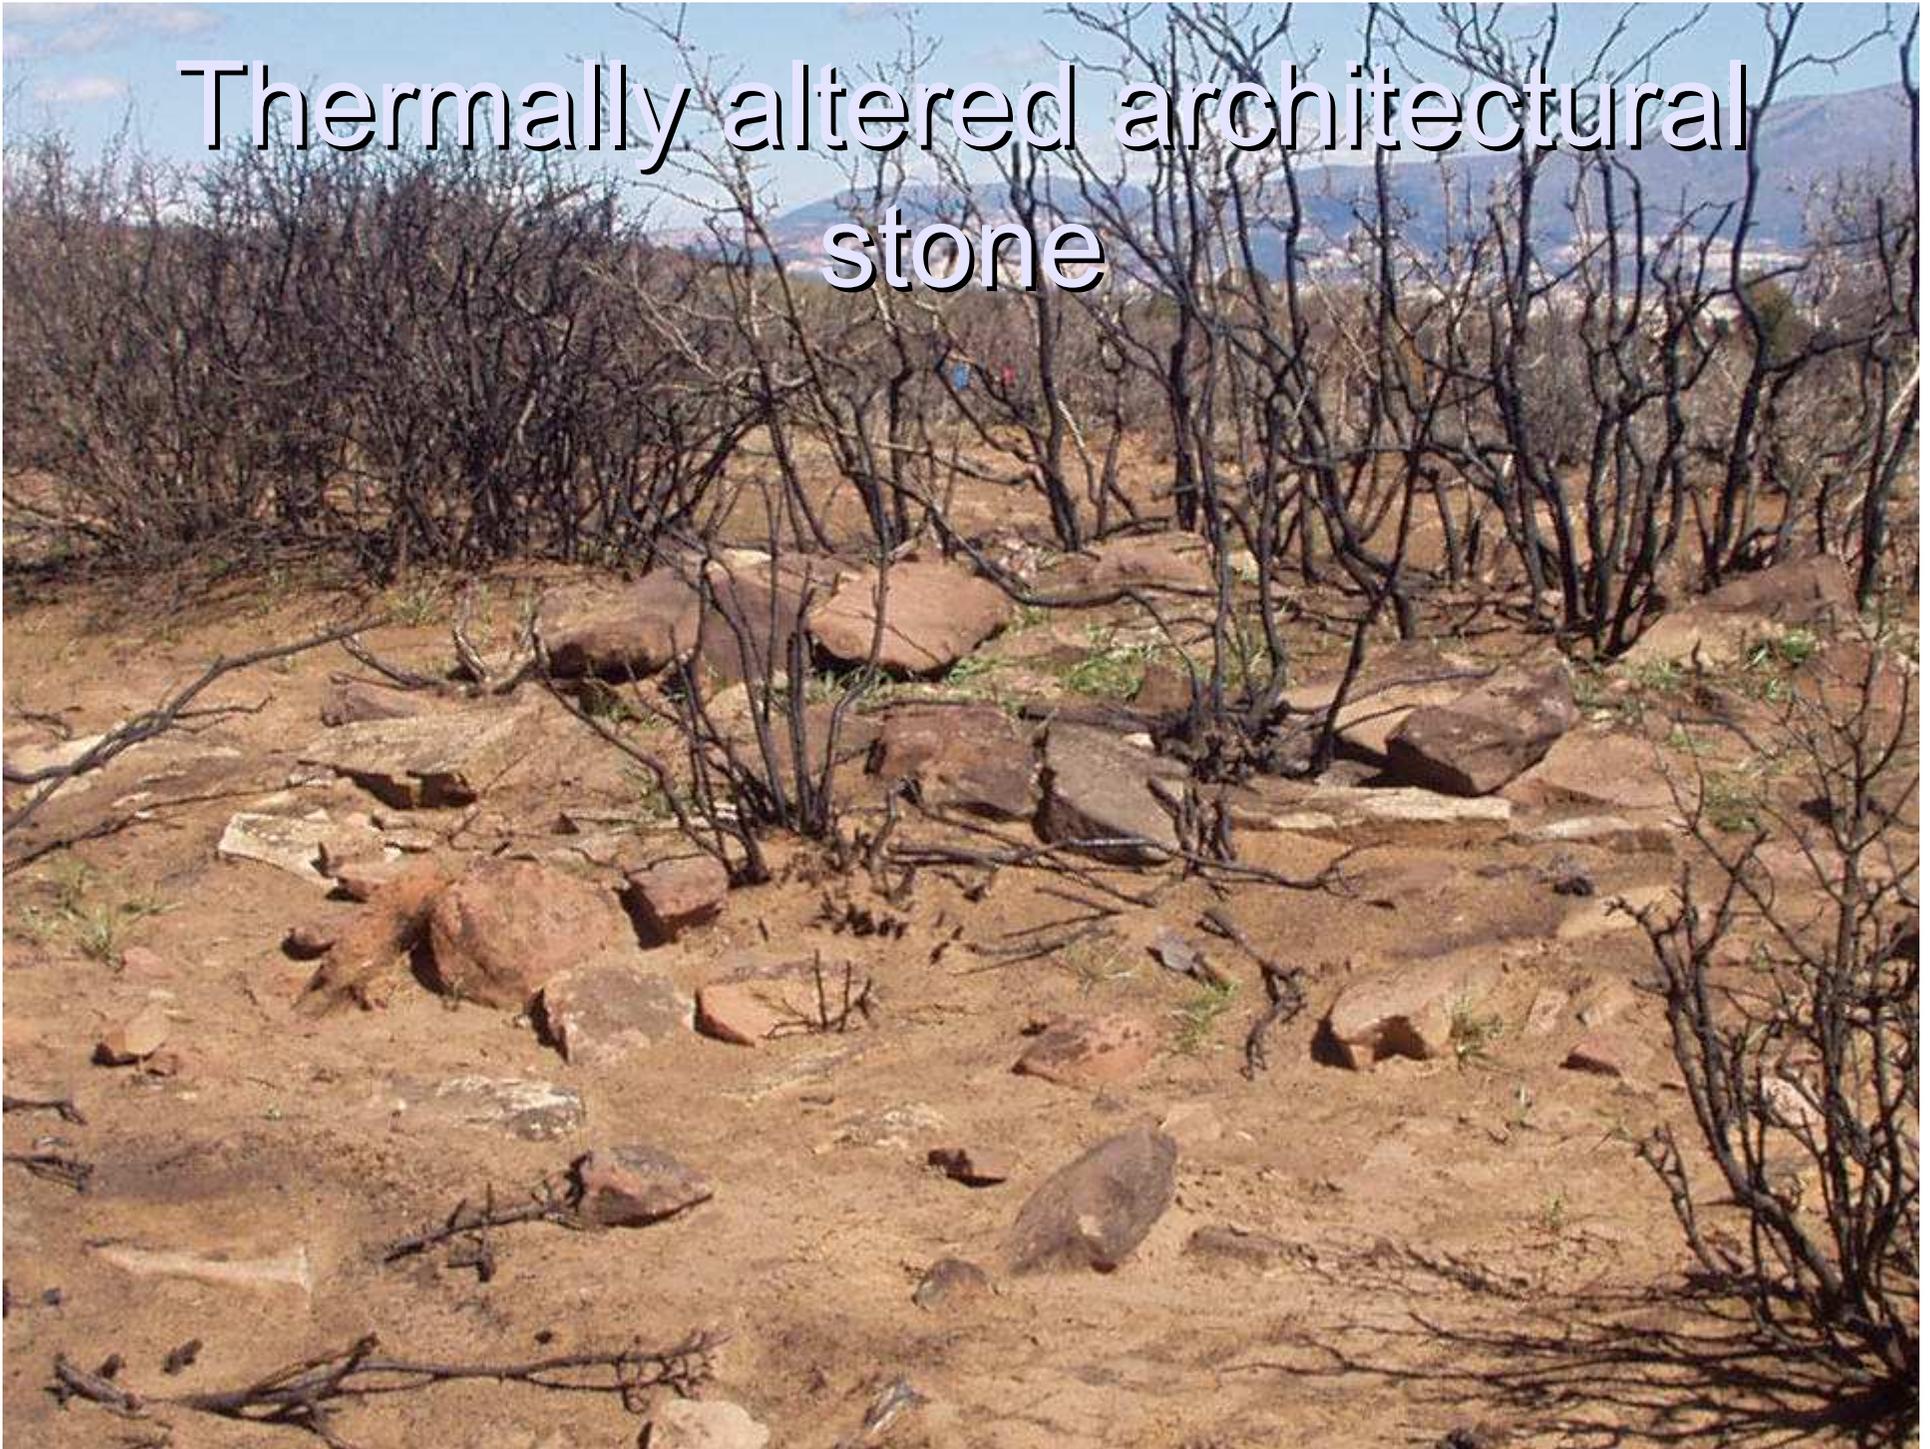
Thermally altered architectural stone

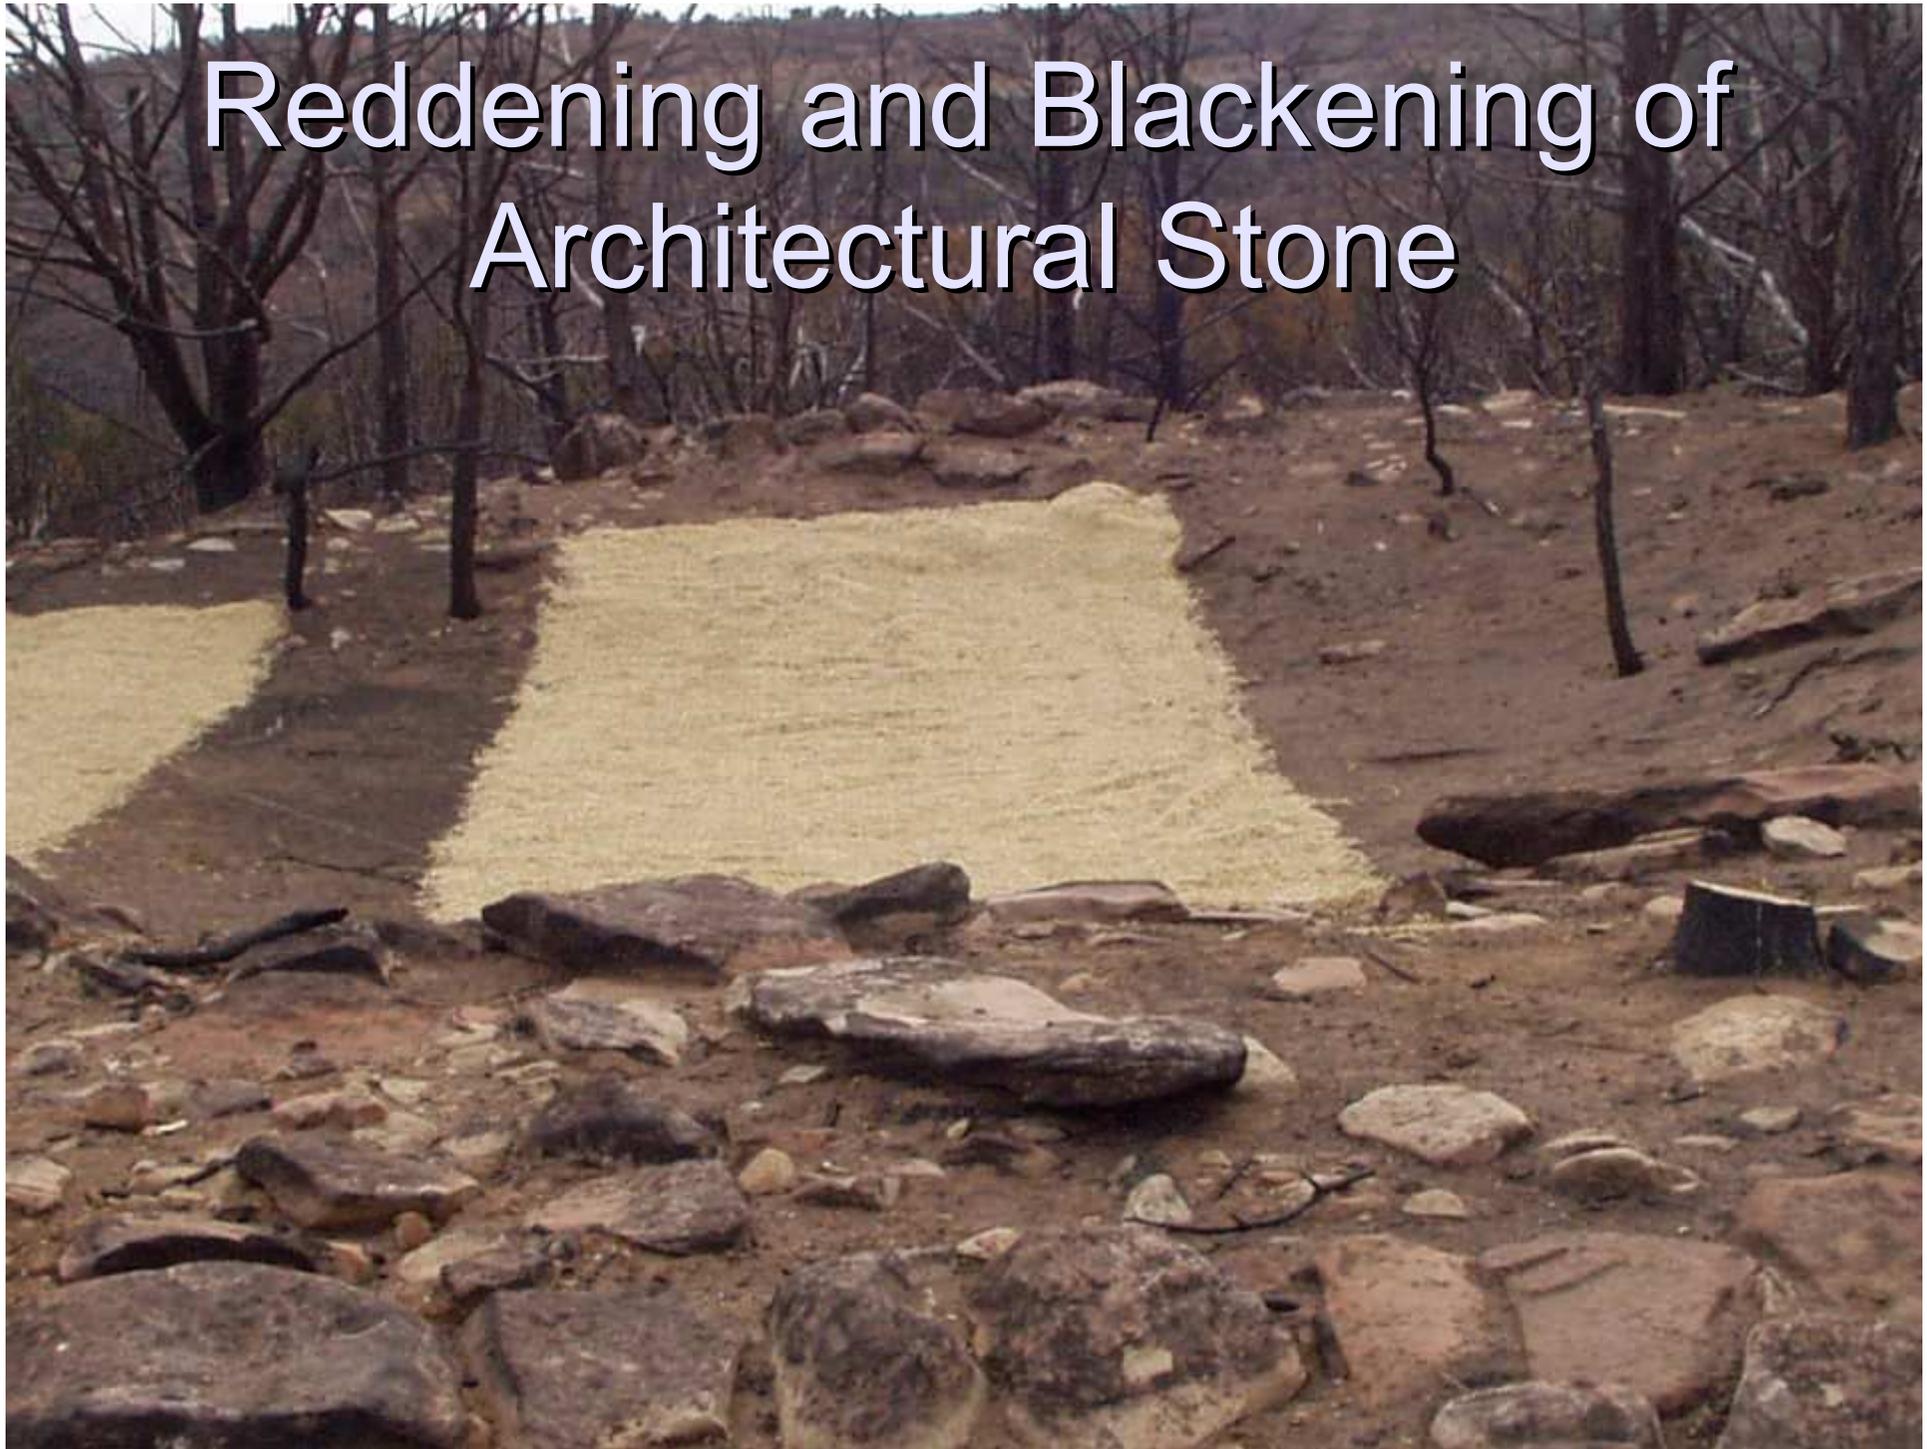
Reddening and Blackening of Architectural Stone

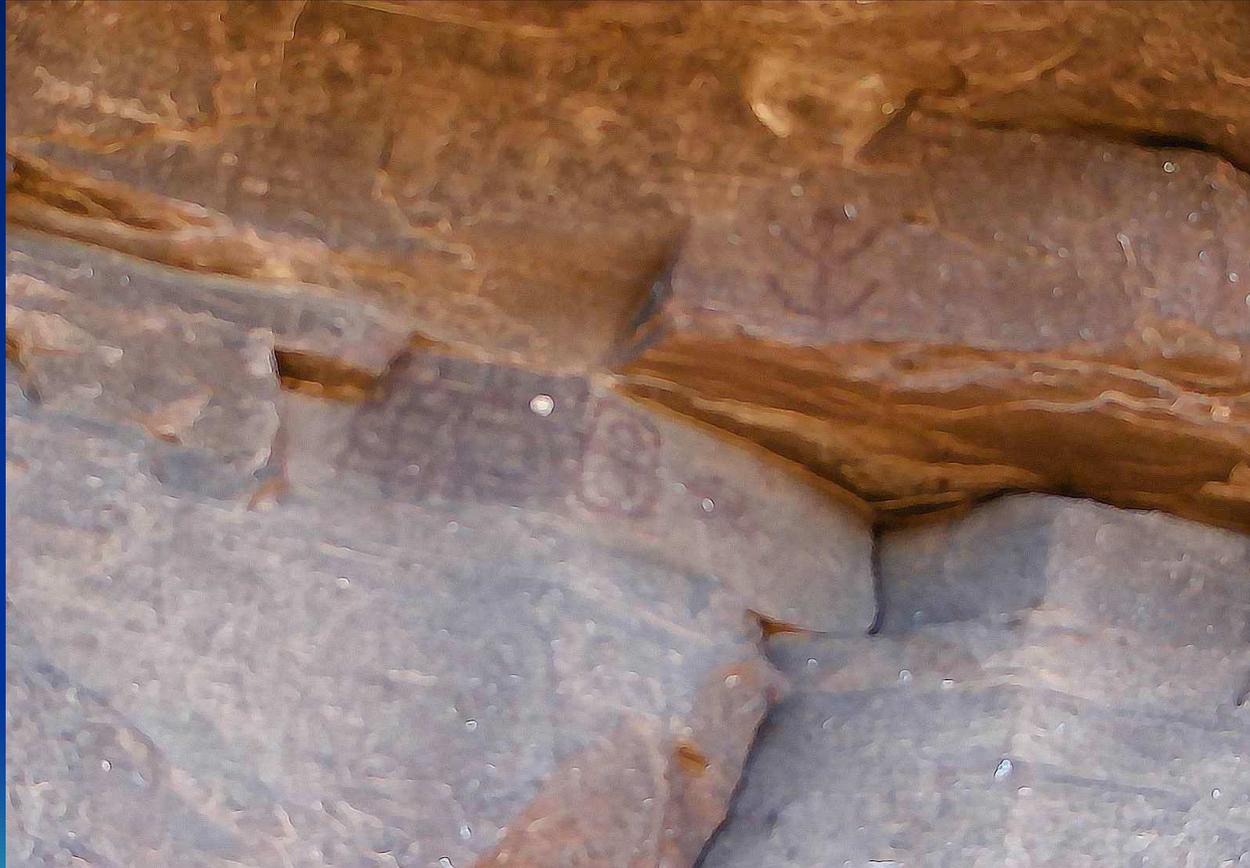
Burned Pictograph

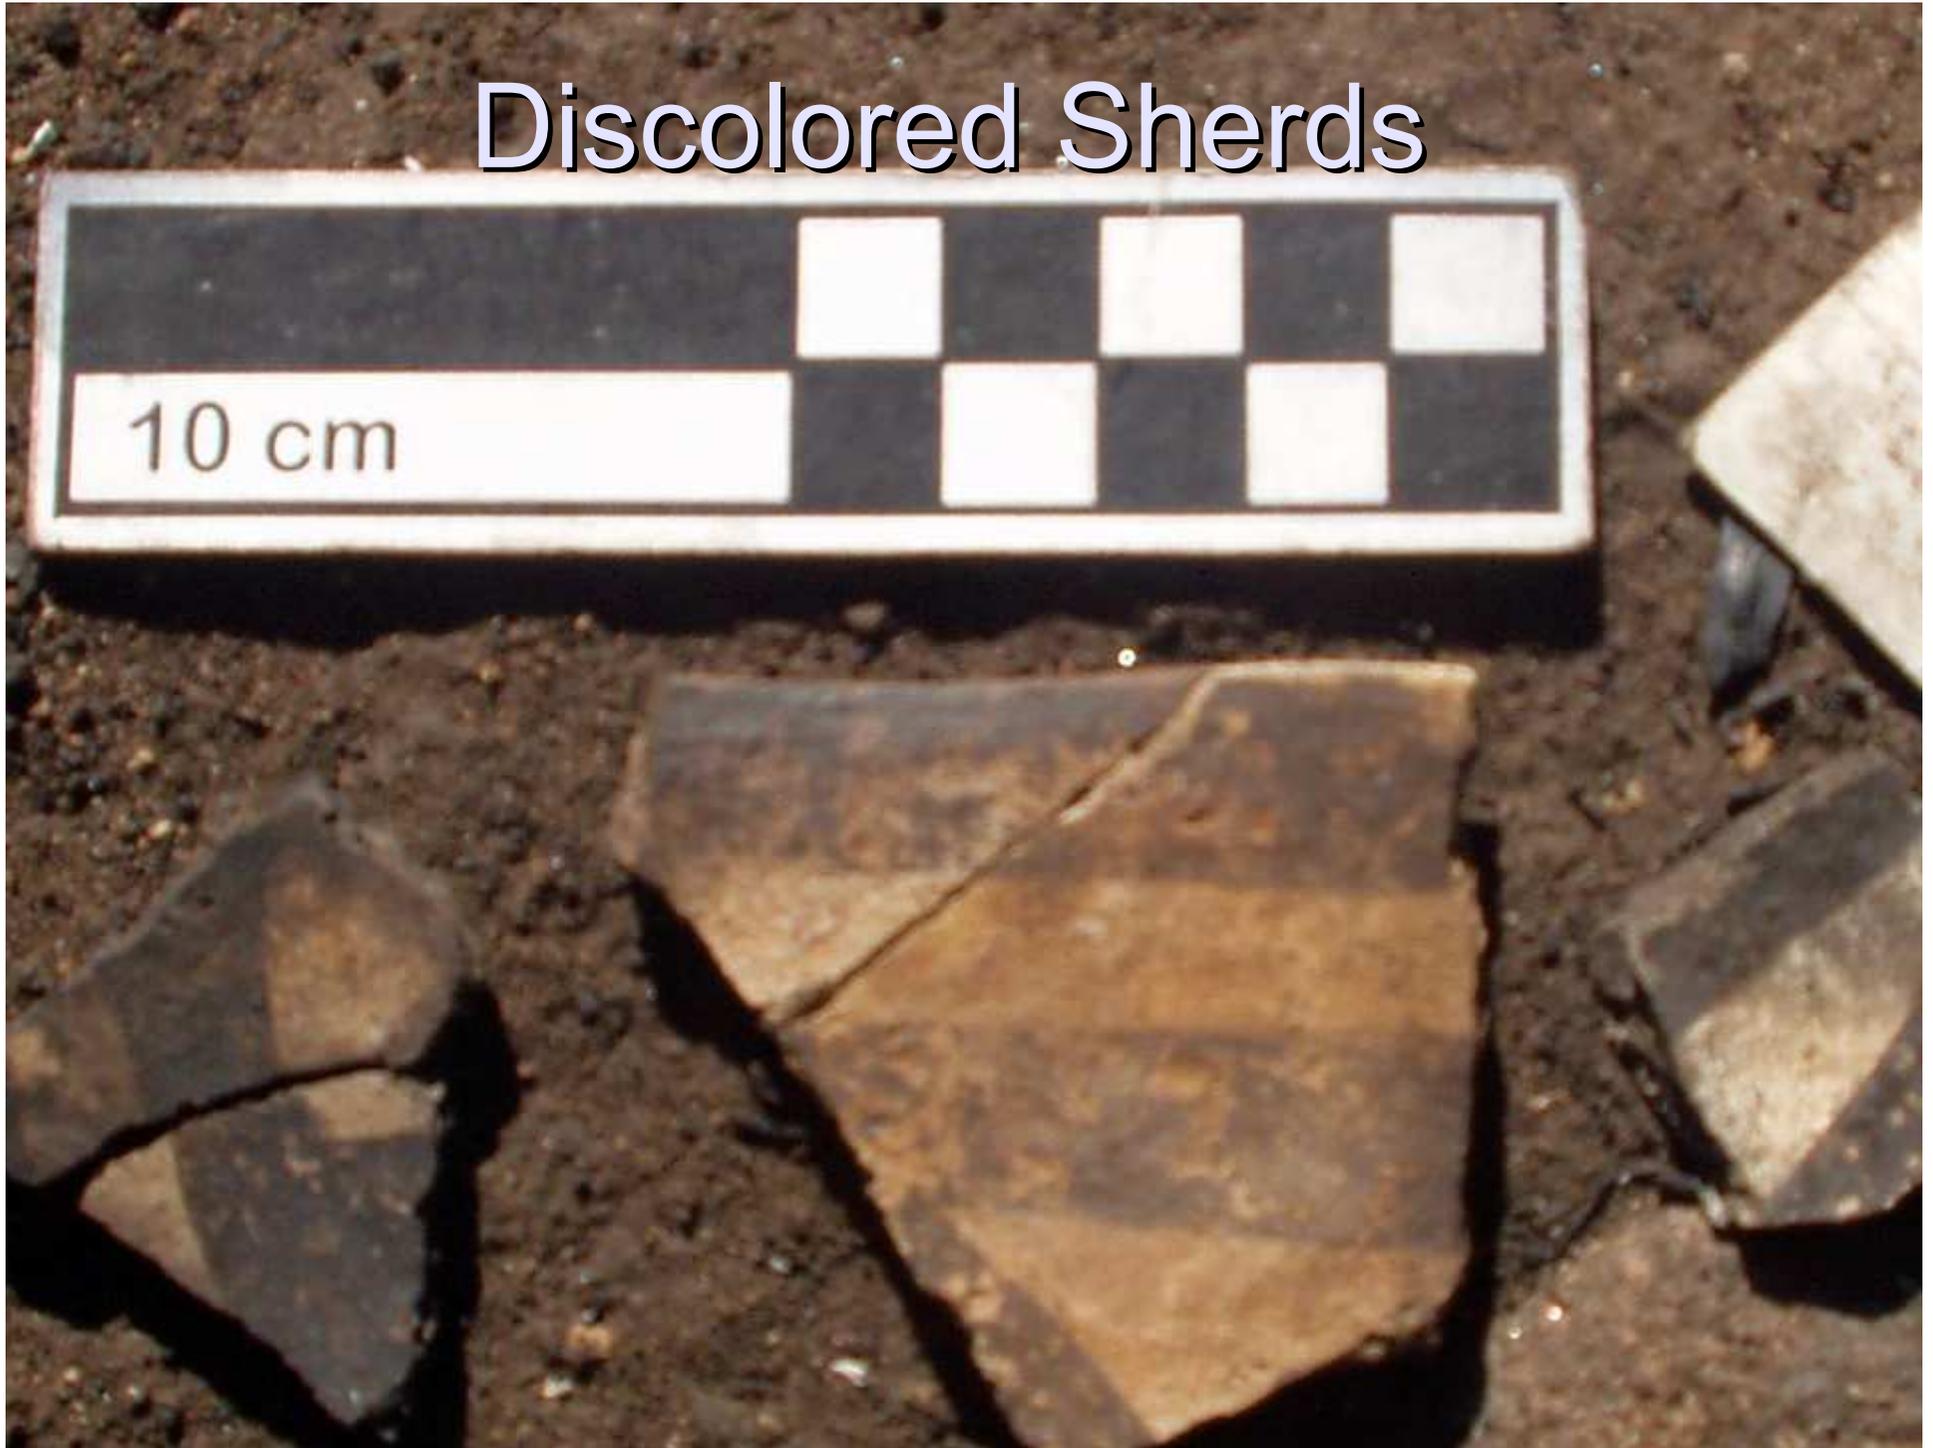
Discolored Sherds

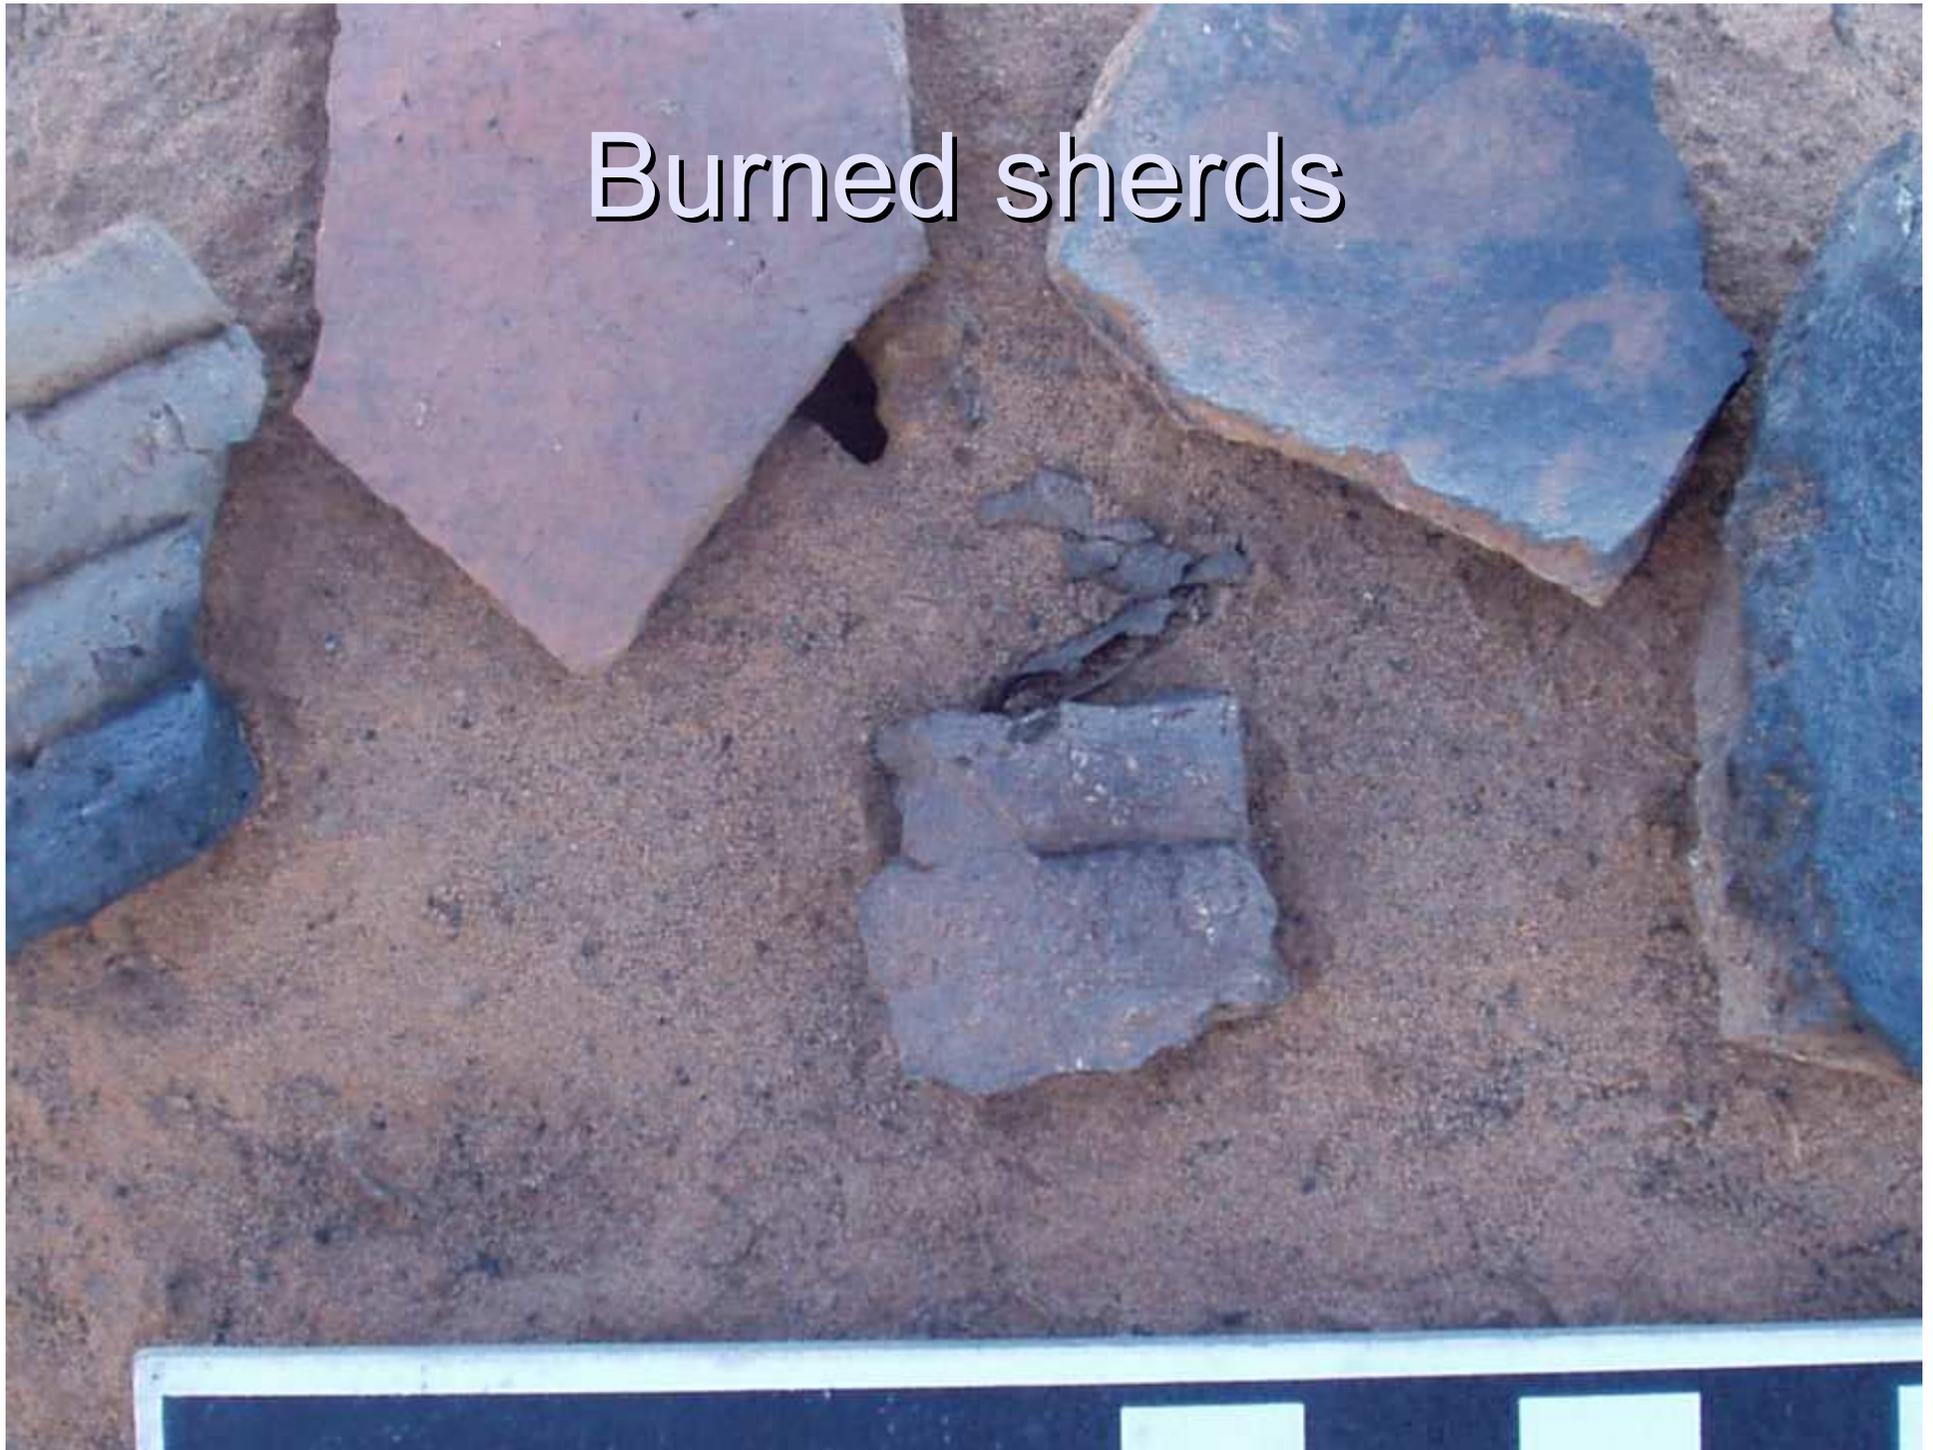
Burned sherds

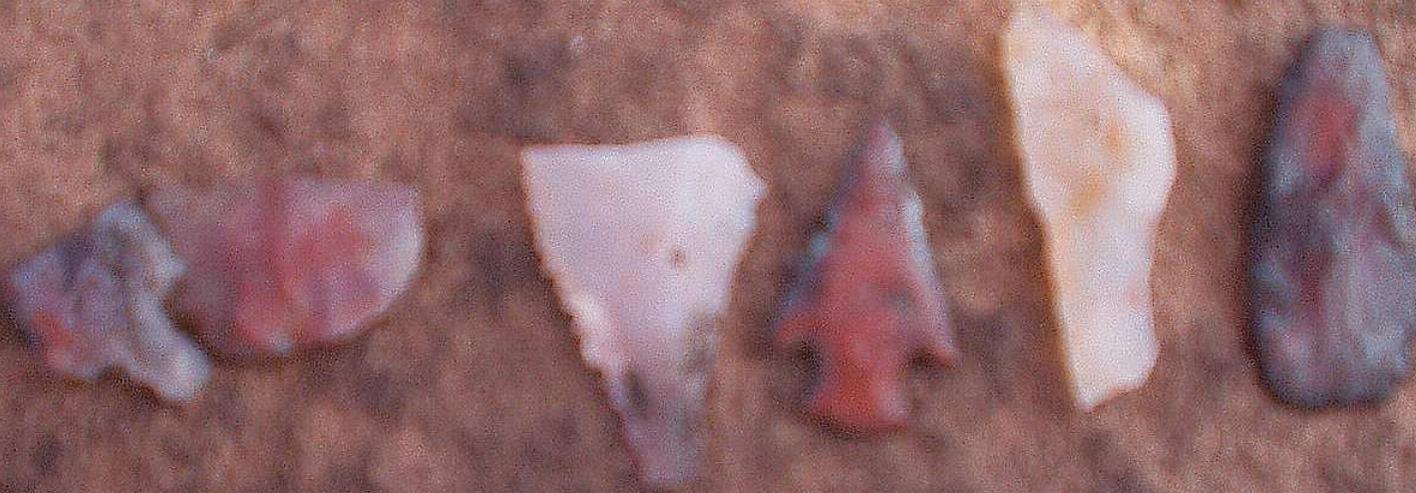
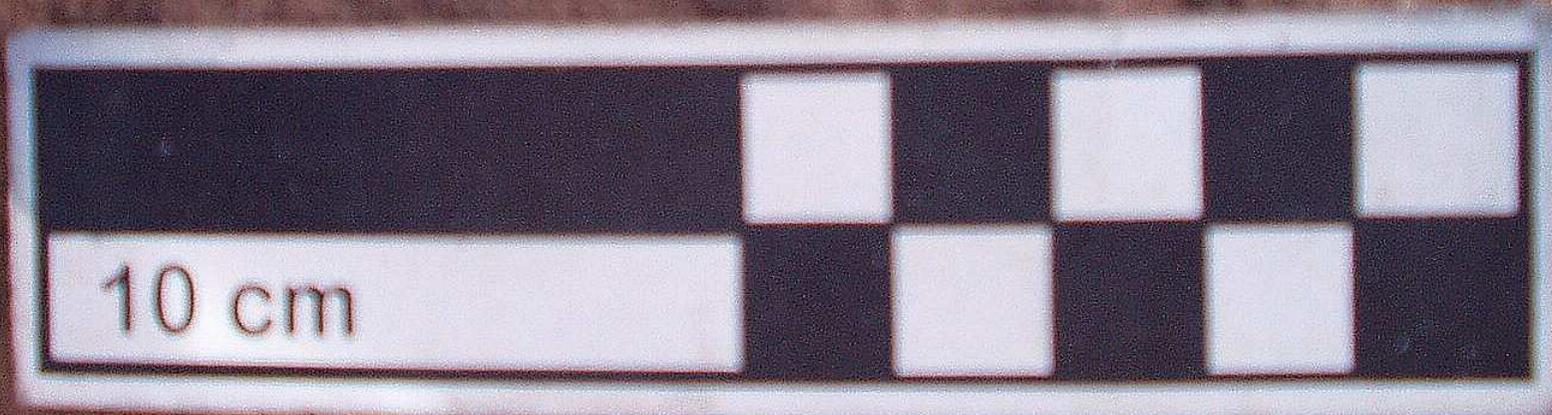
Altered Lithic Artifacts

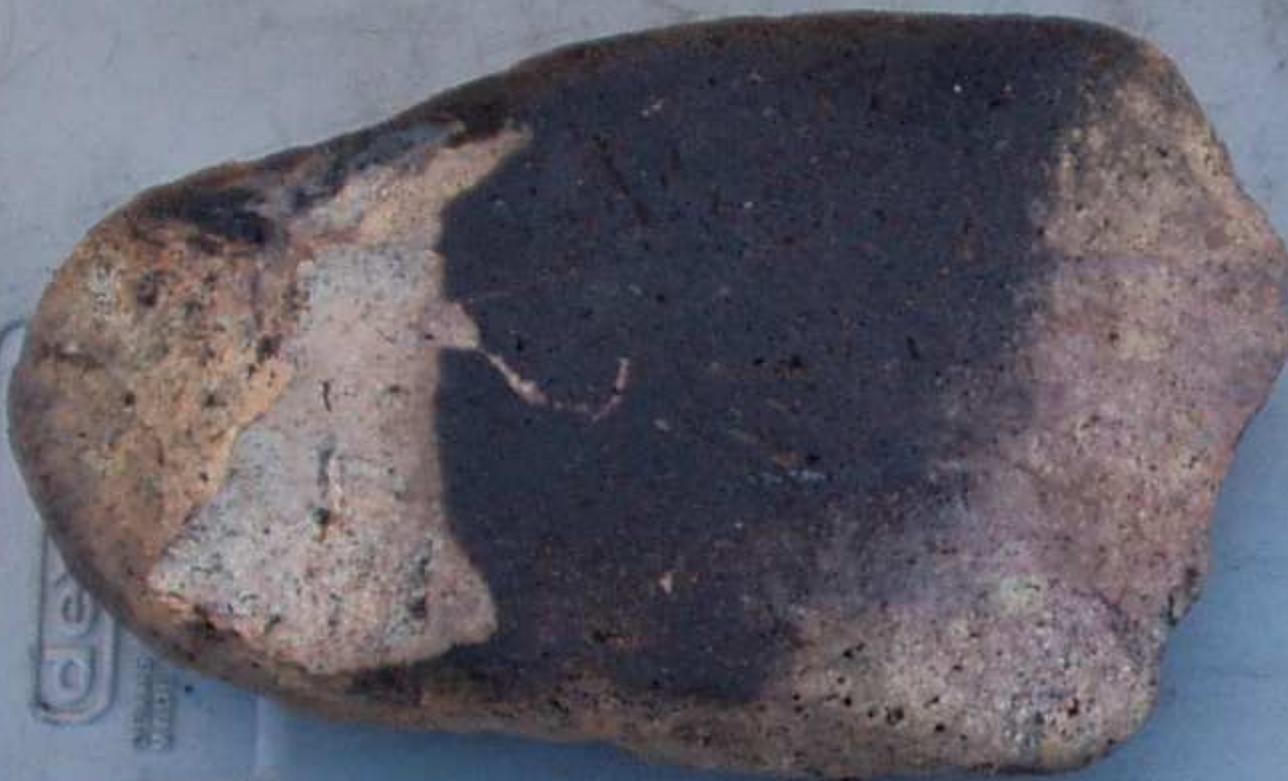
Blackened and spalled lithic

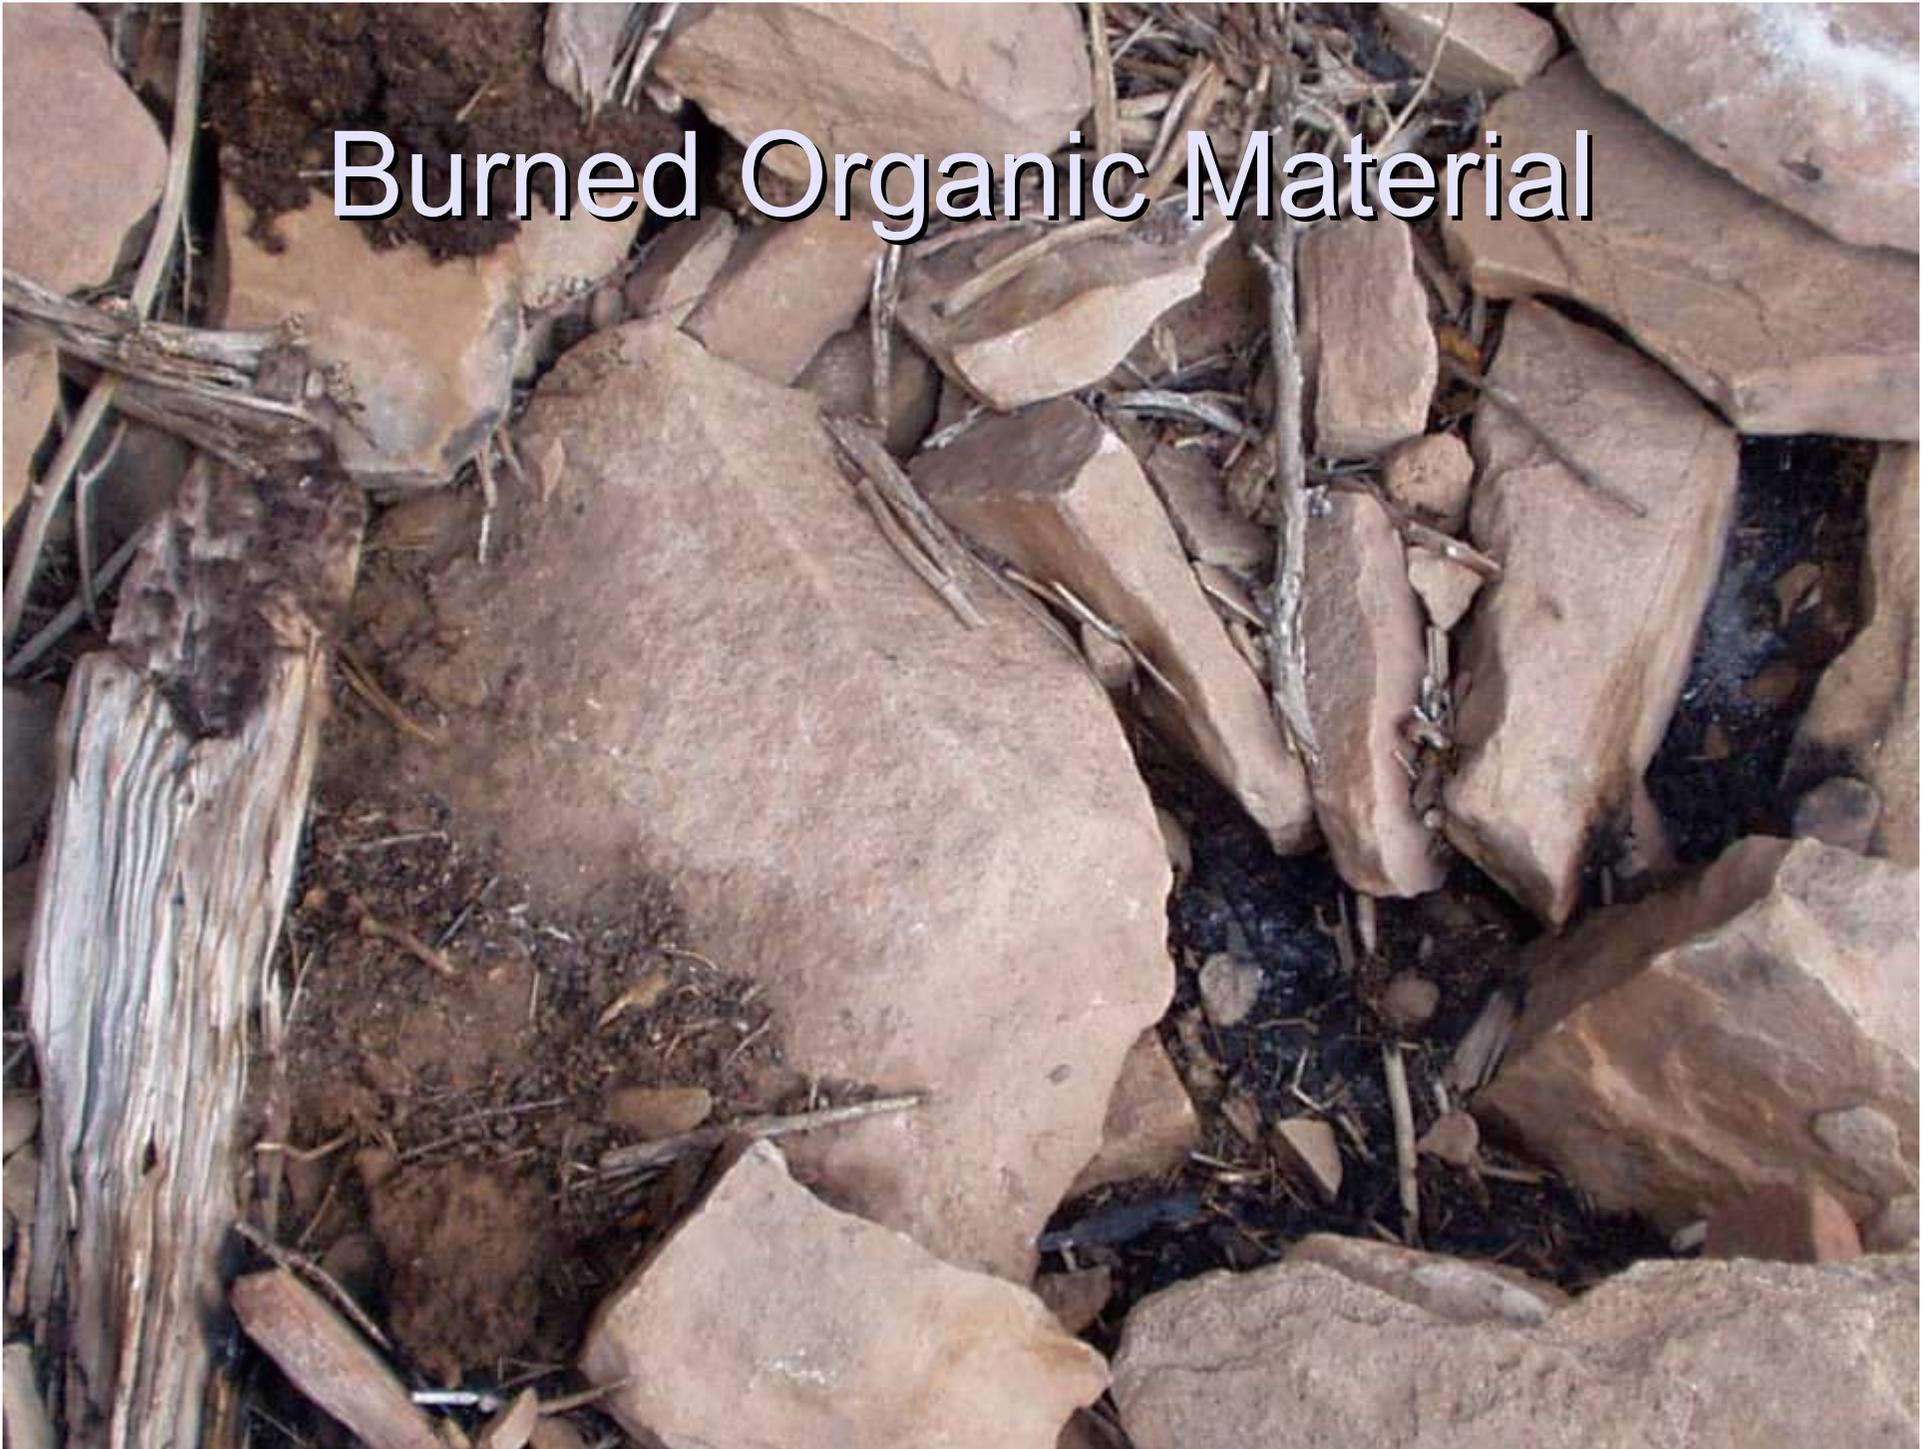
Burned Organic Material

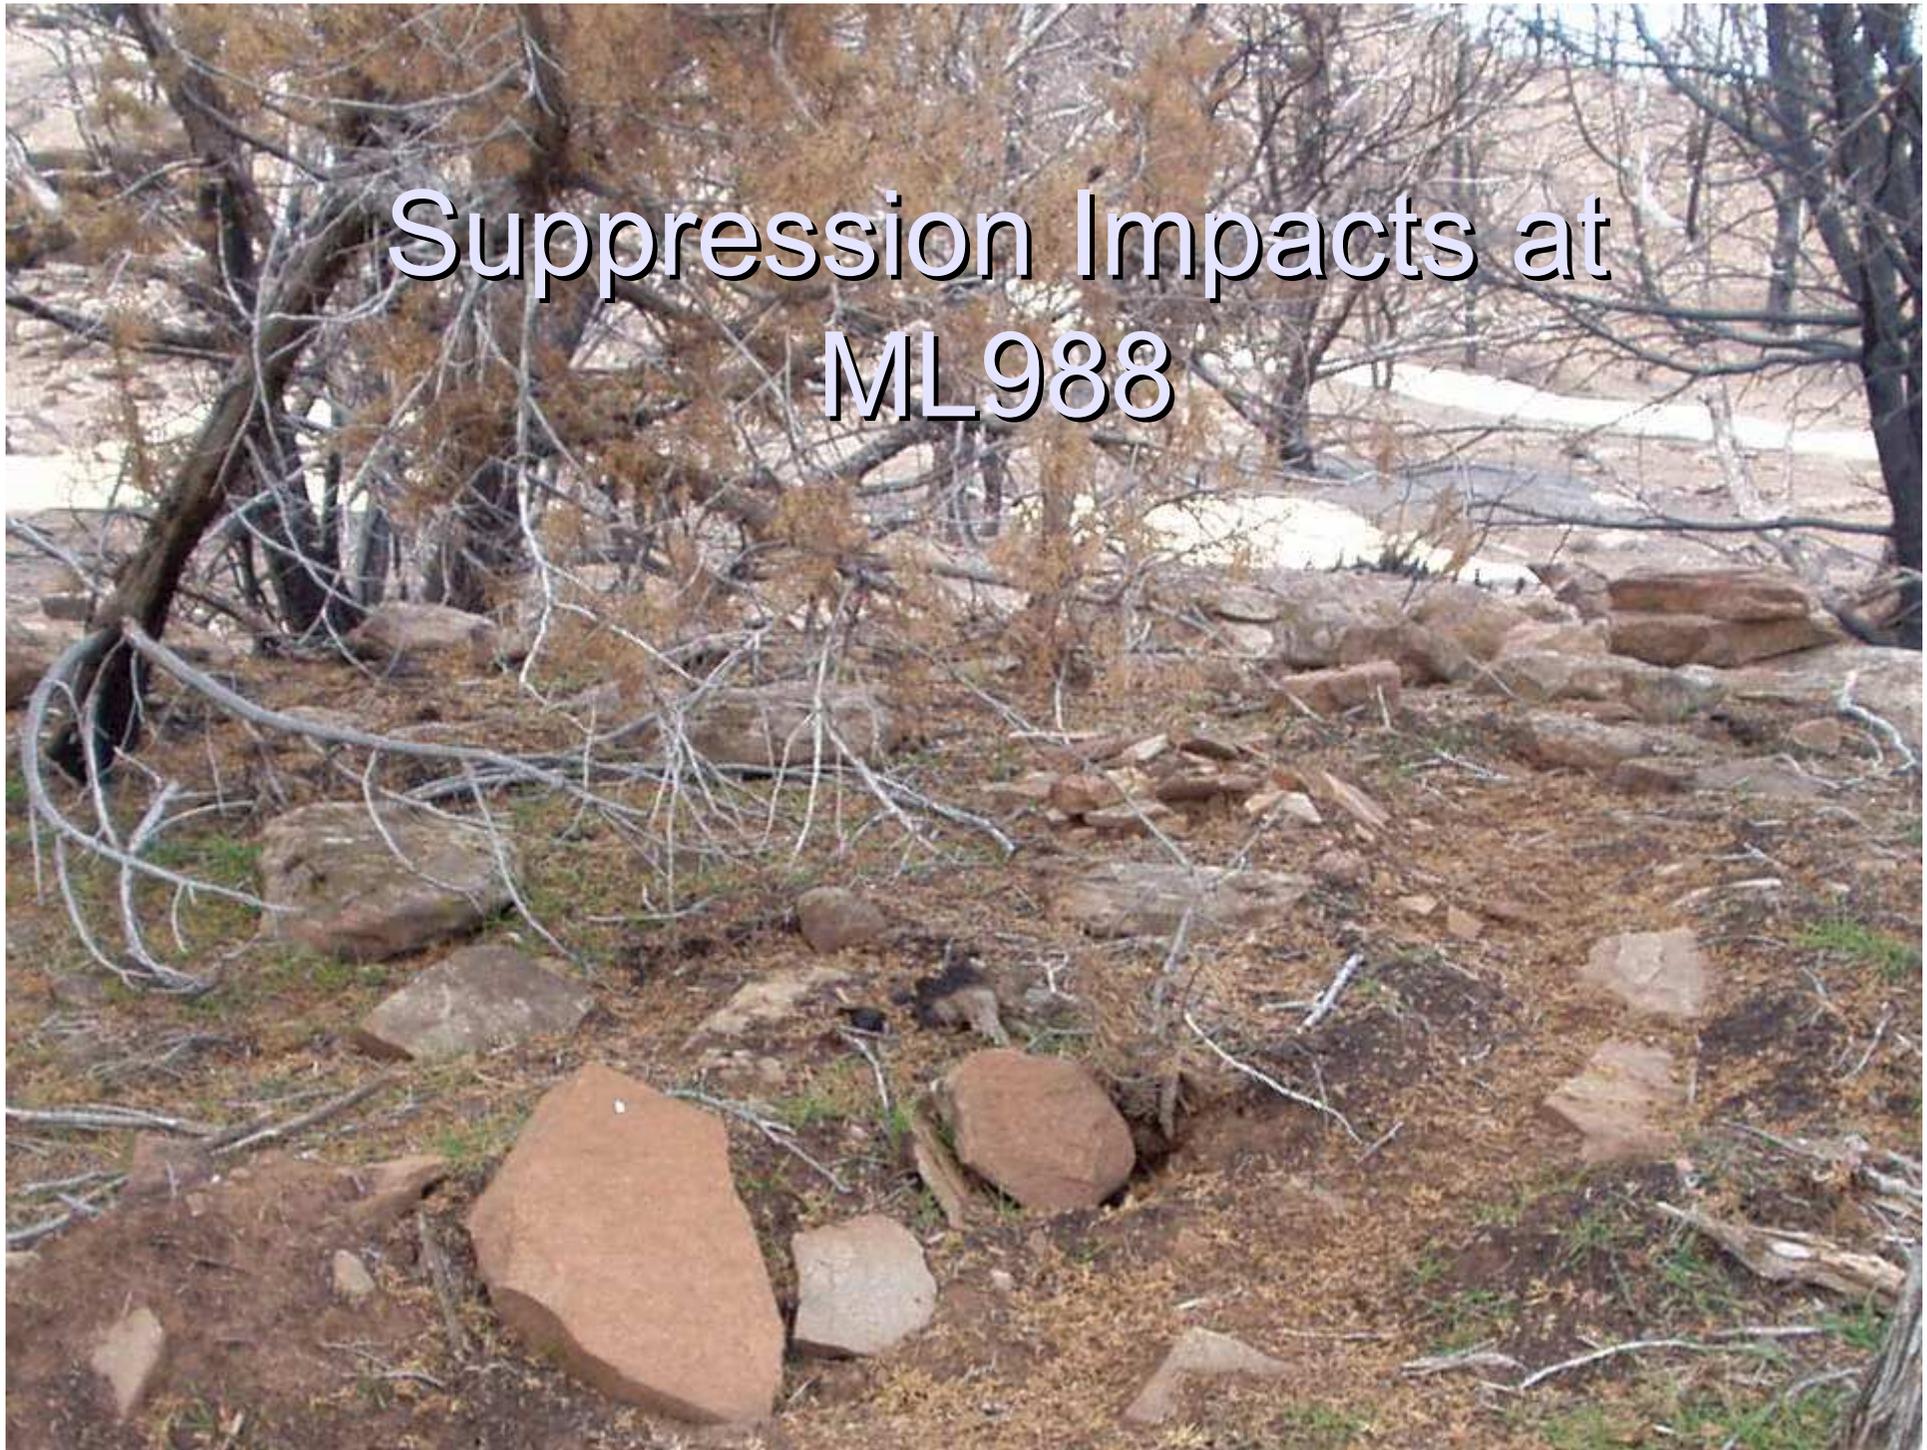
- Only one impact from mop-up
 - Small segment of hand line in upper portion of feature at ML988

Suppression Impacts at ML988
