The Effects of Fire

On Cultural Resources

THE HAMMOND FIRE

THE HAMMOND FIRE BAER PROJECT

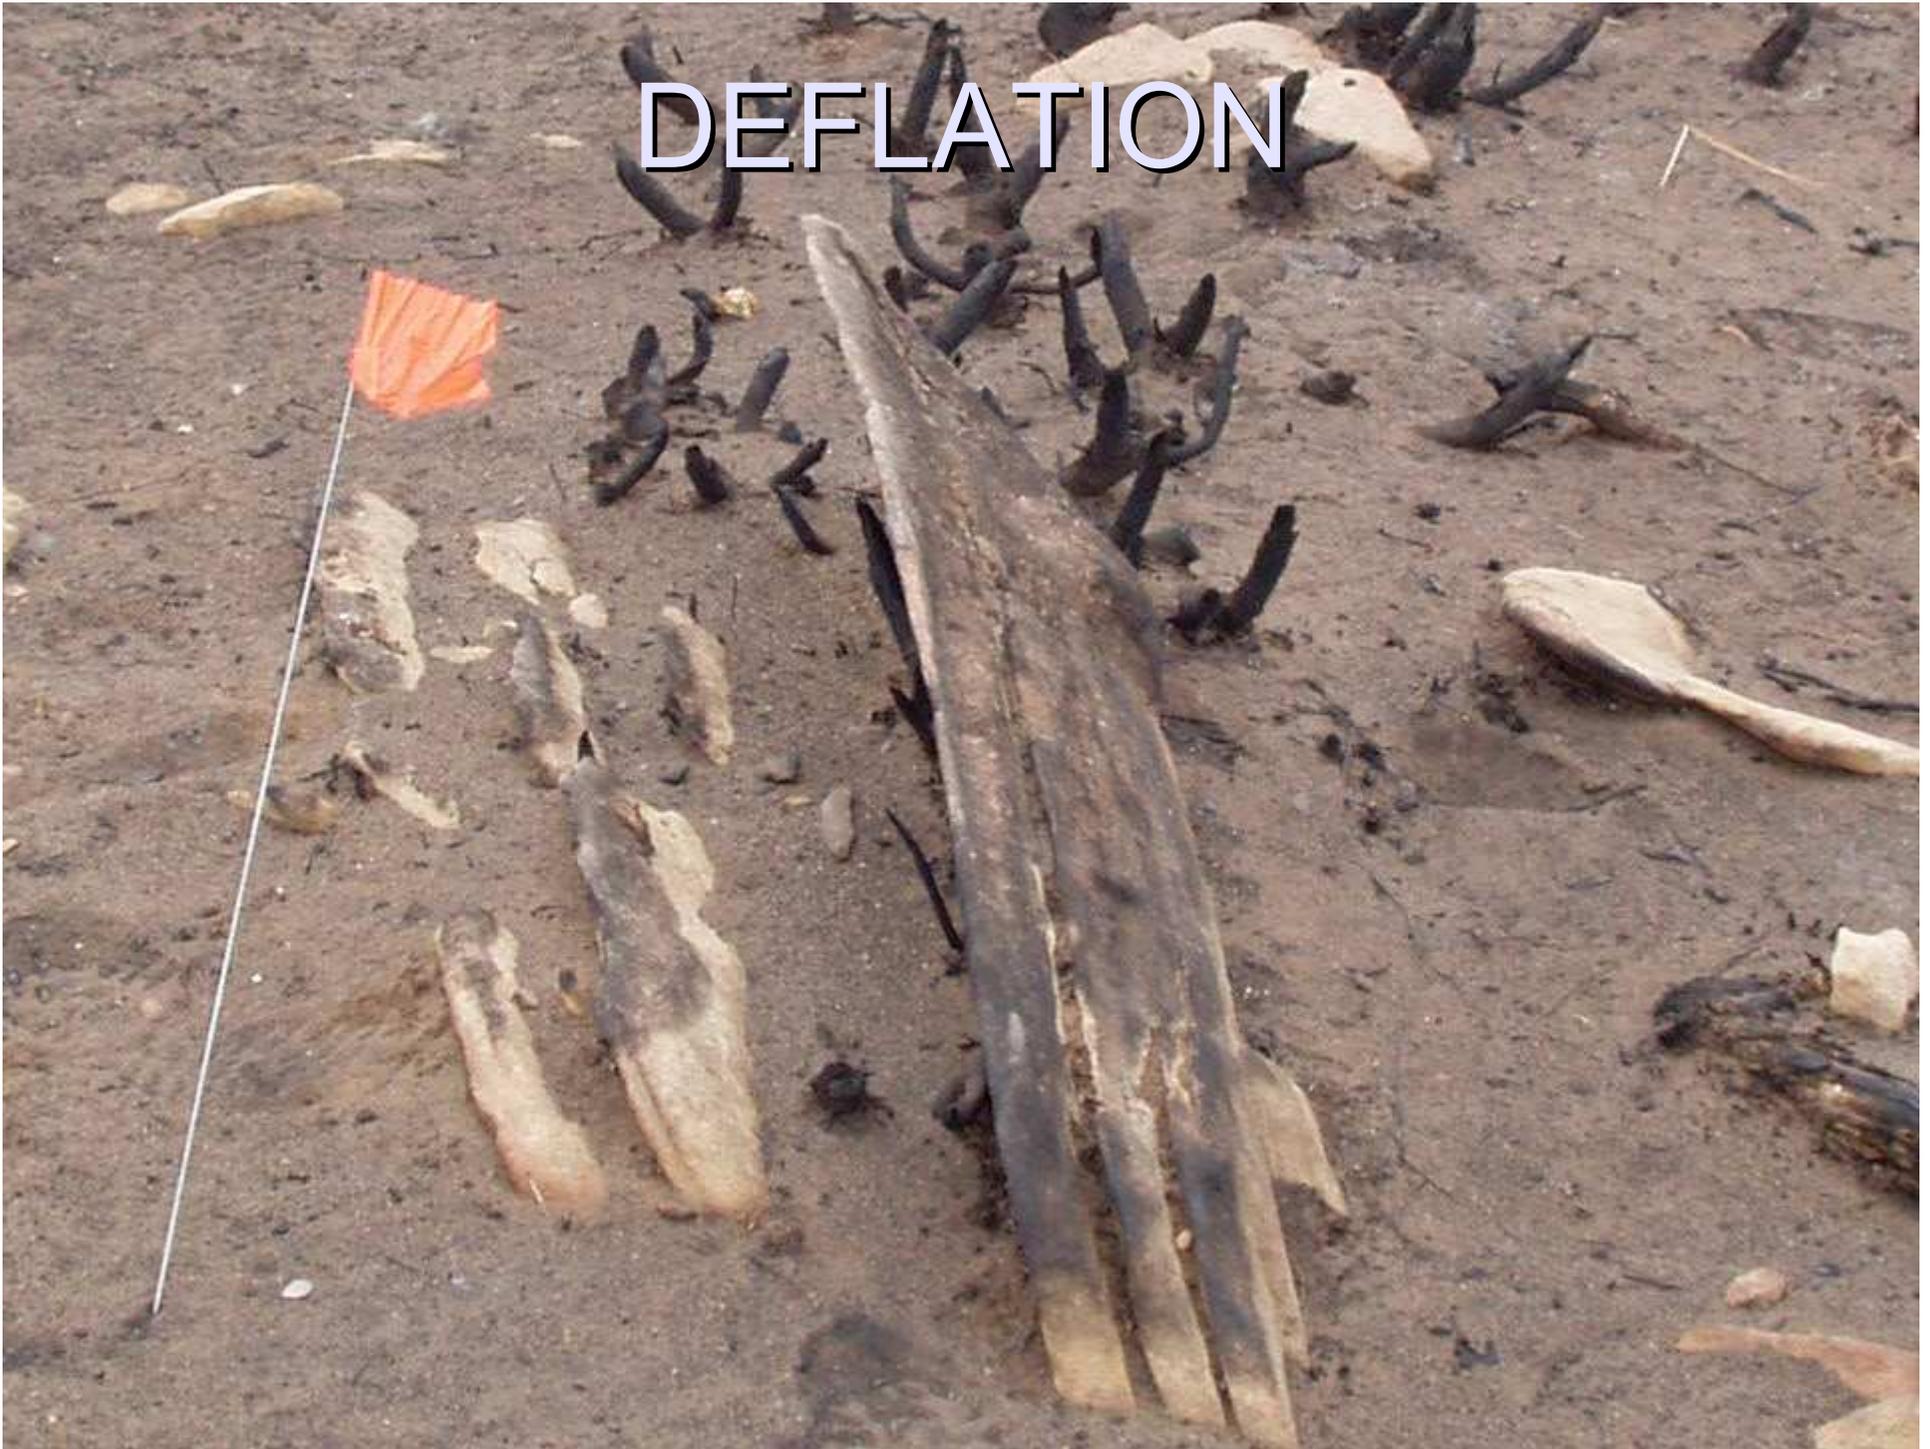
DEFLATION

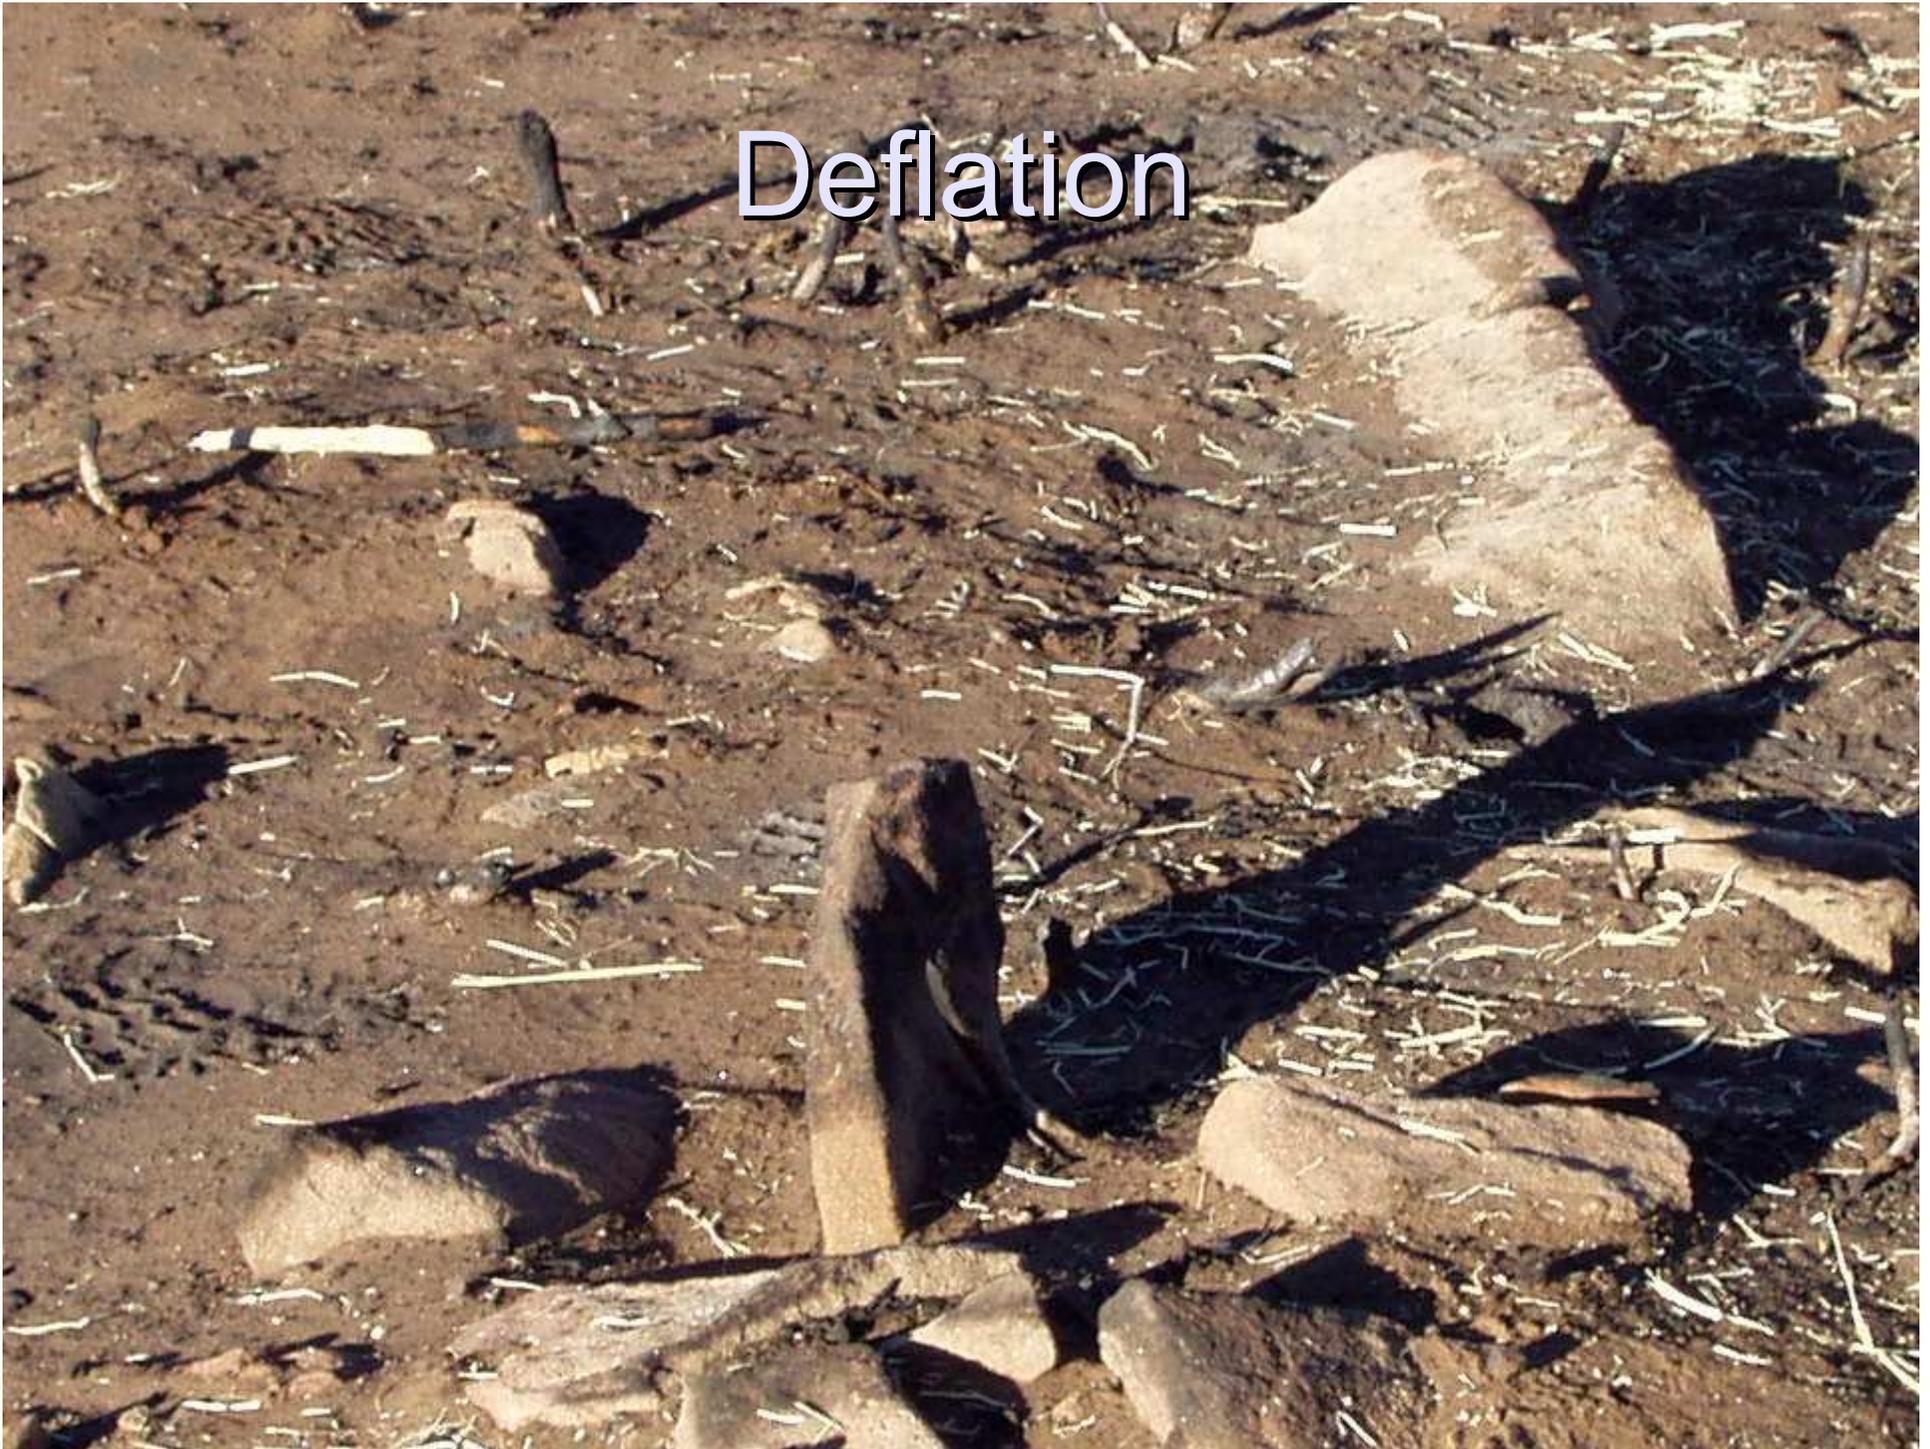
Deflation

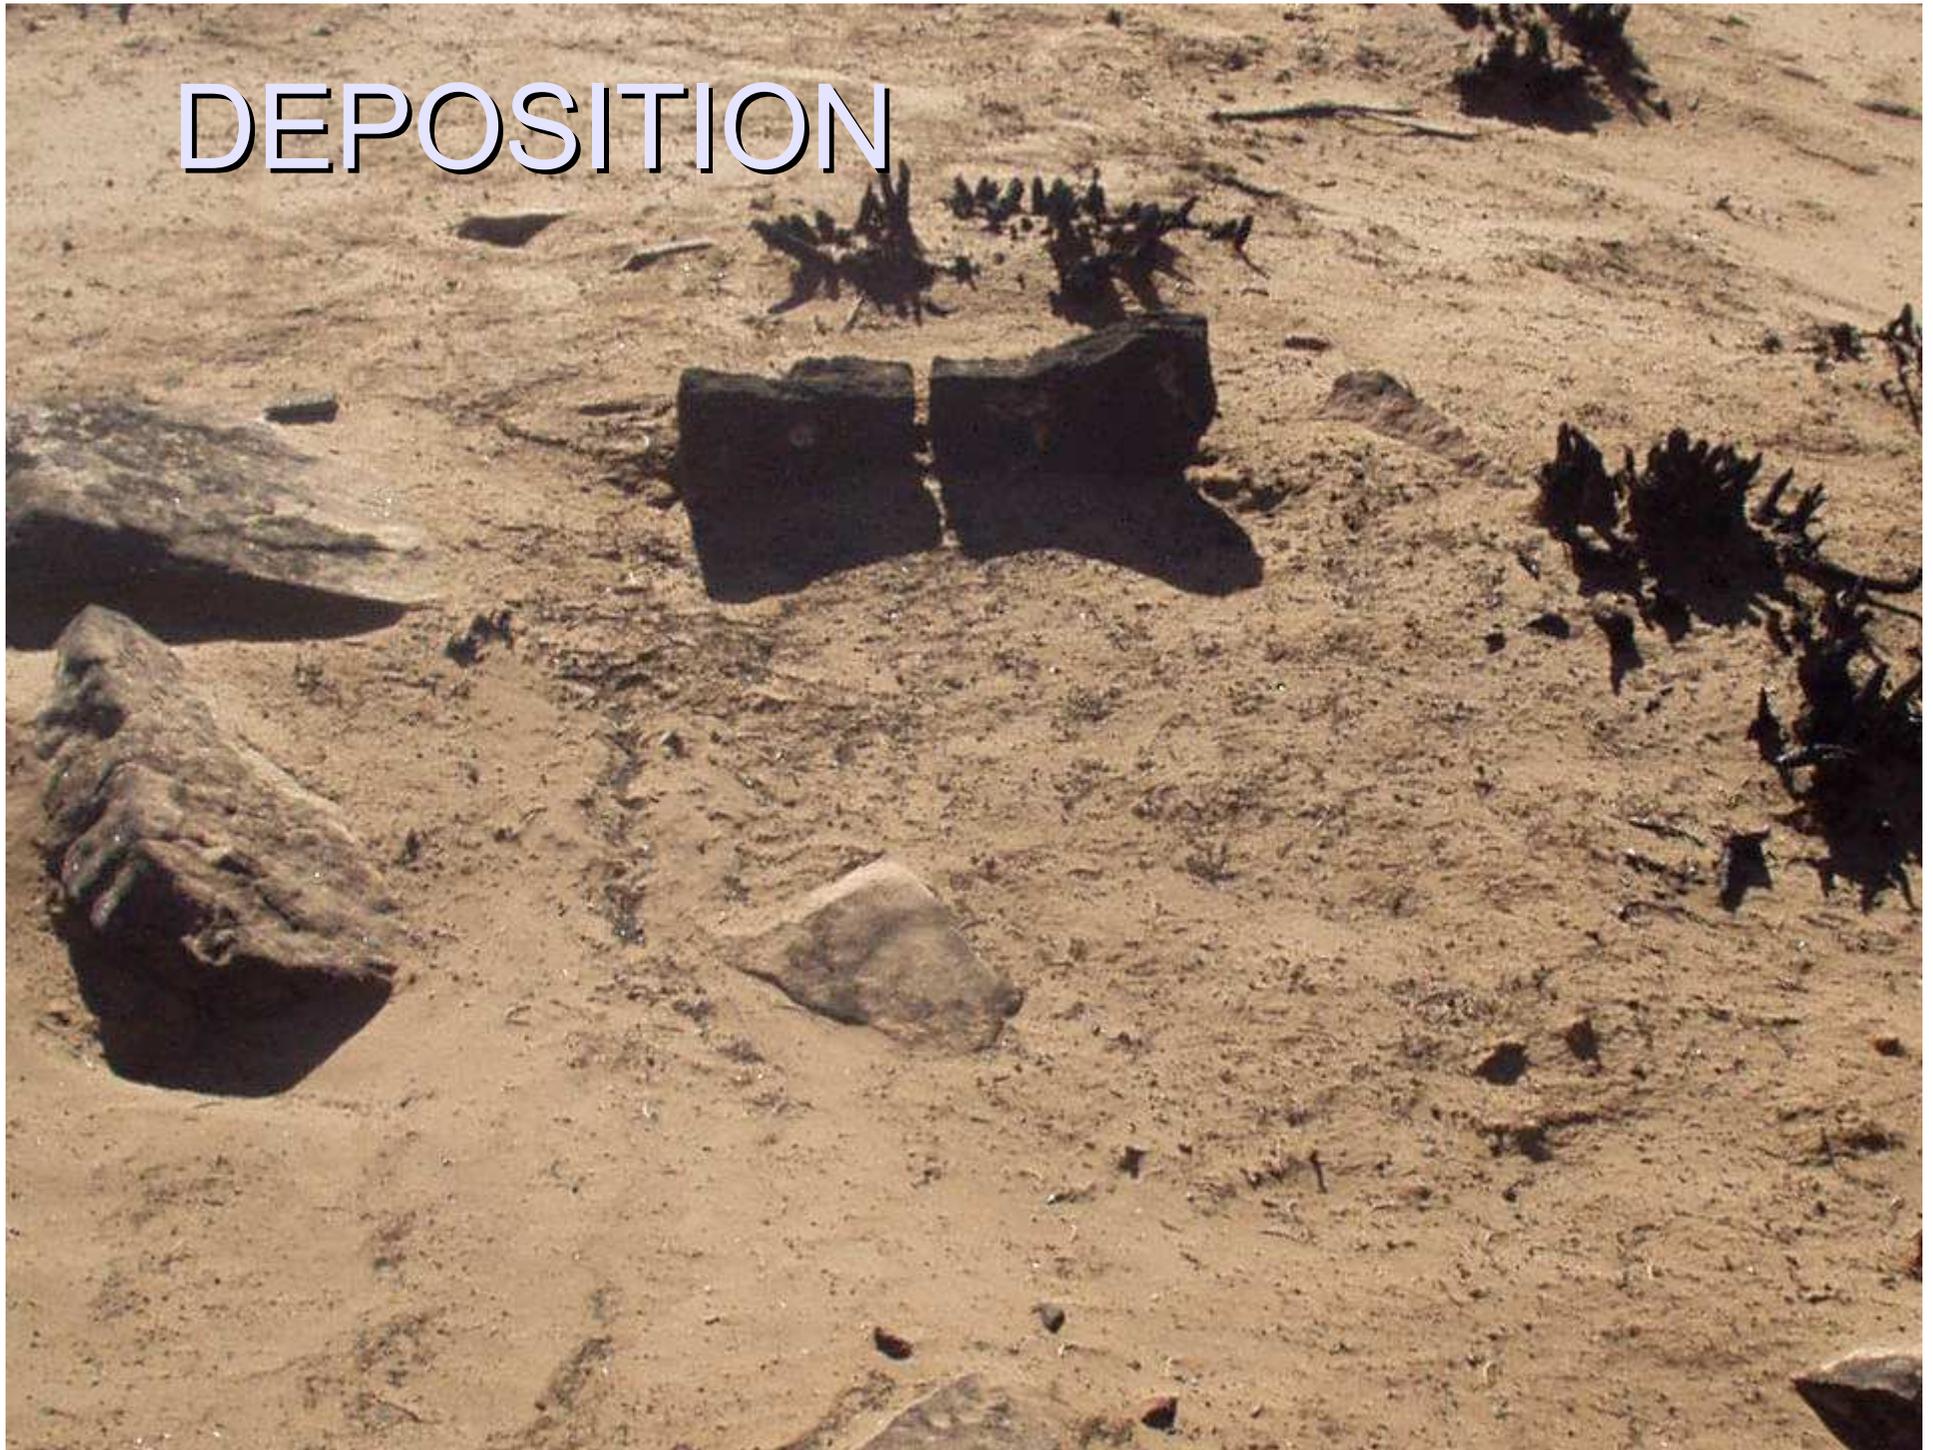
DEPOSITION

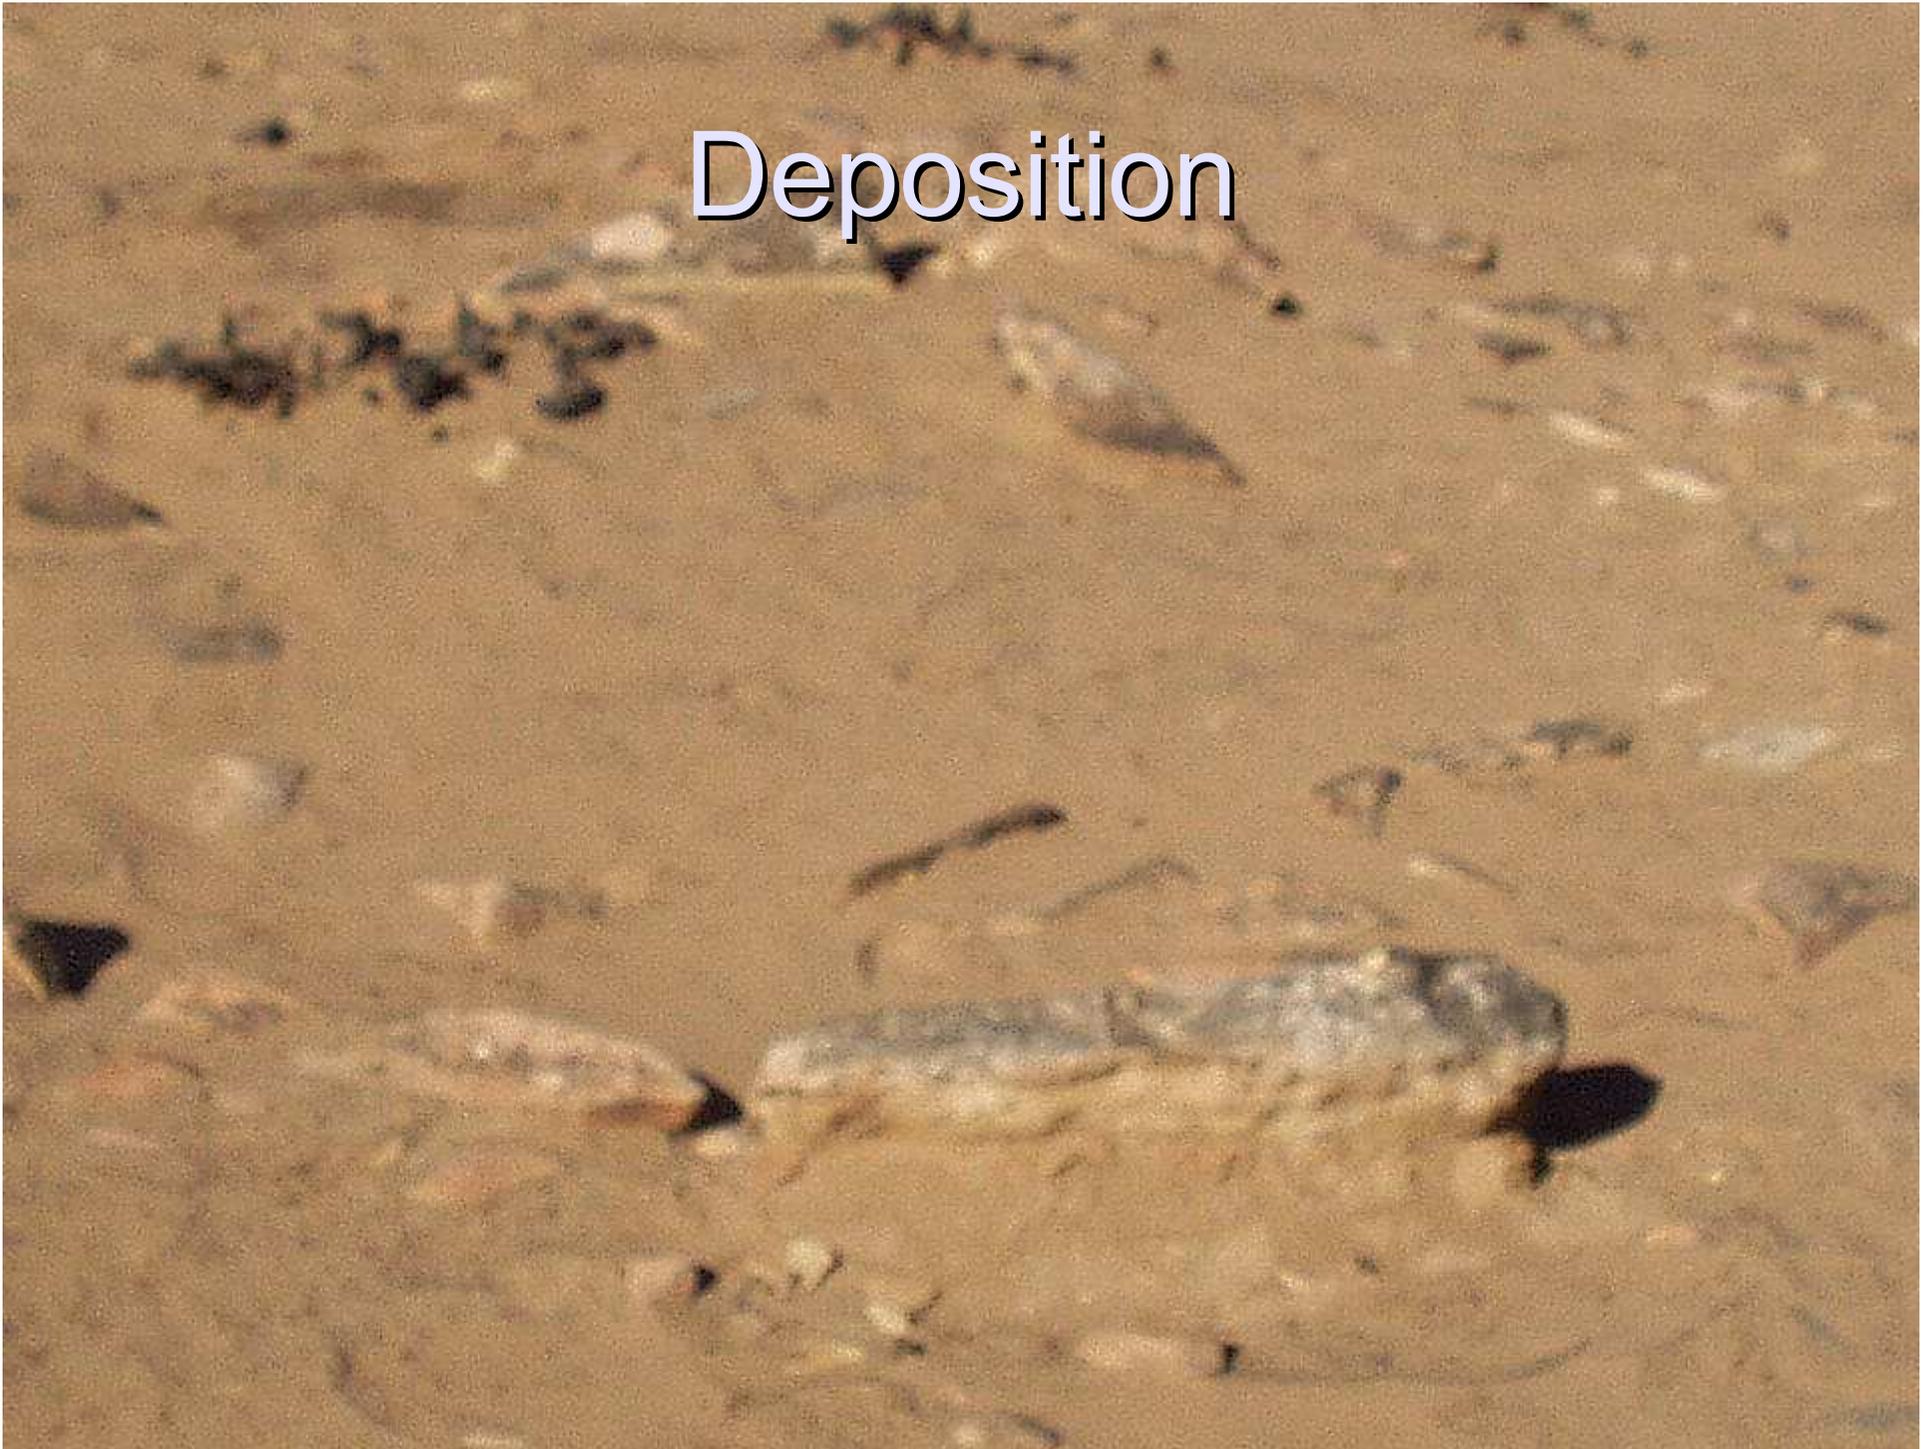
Deposition

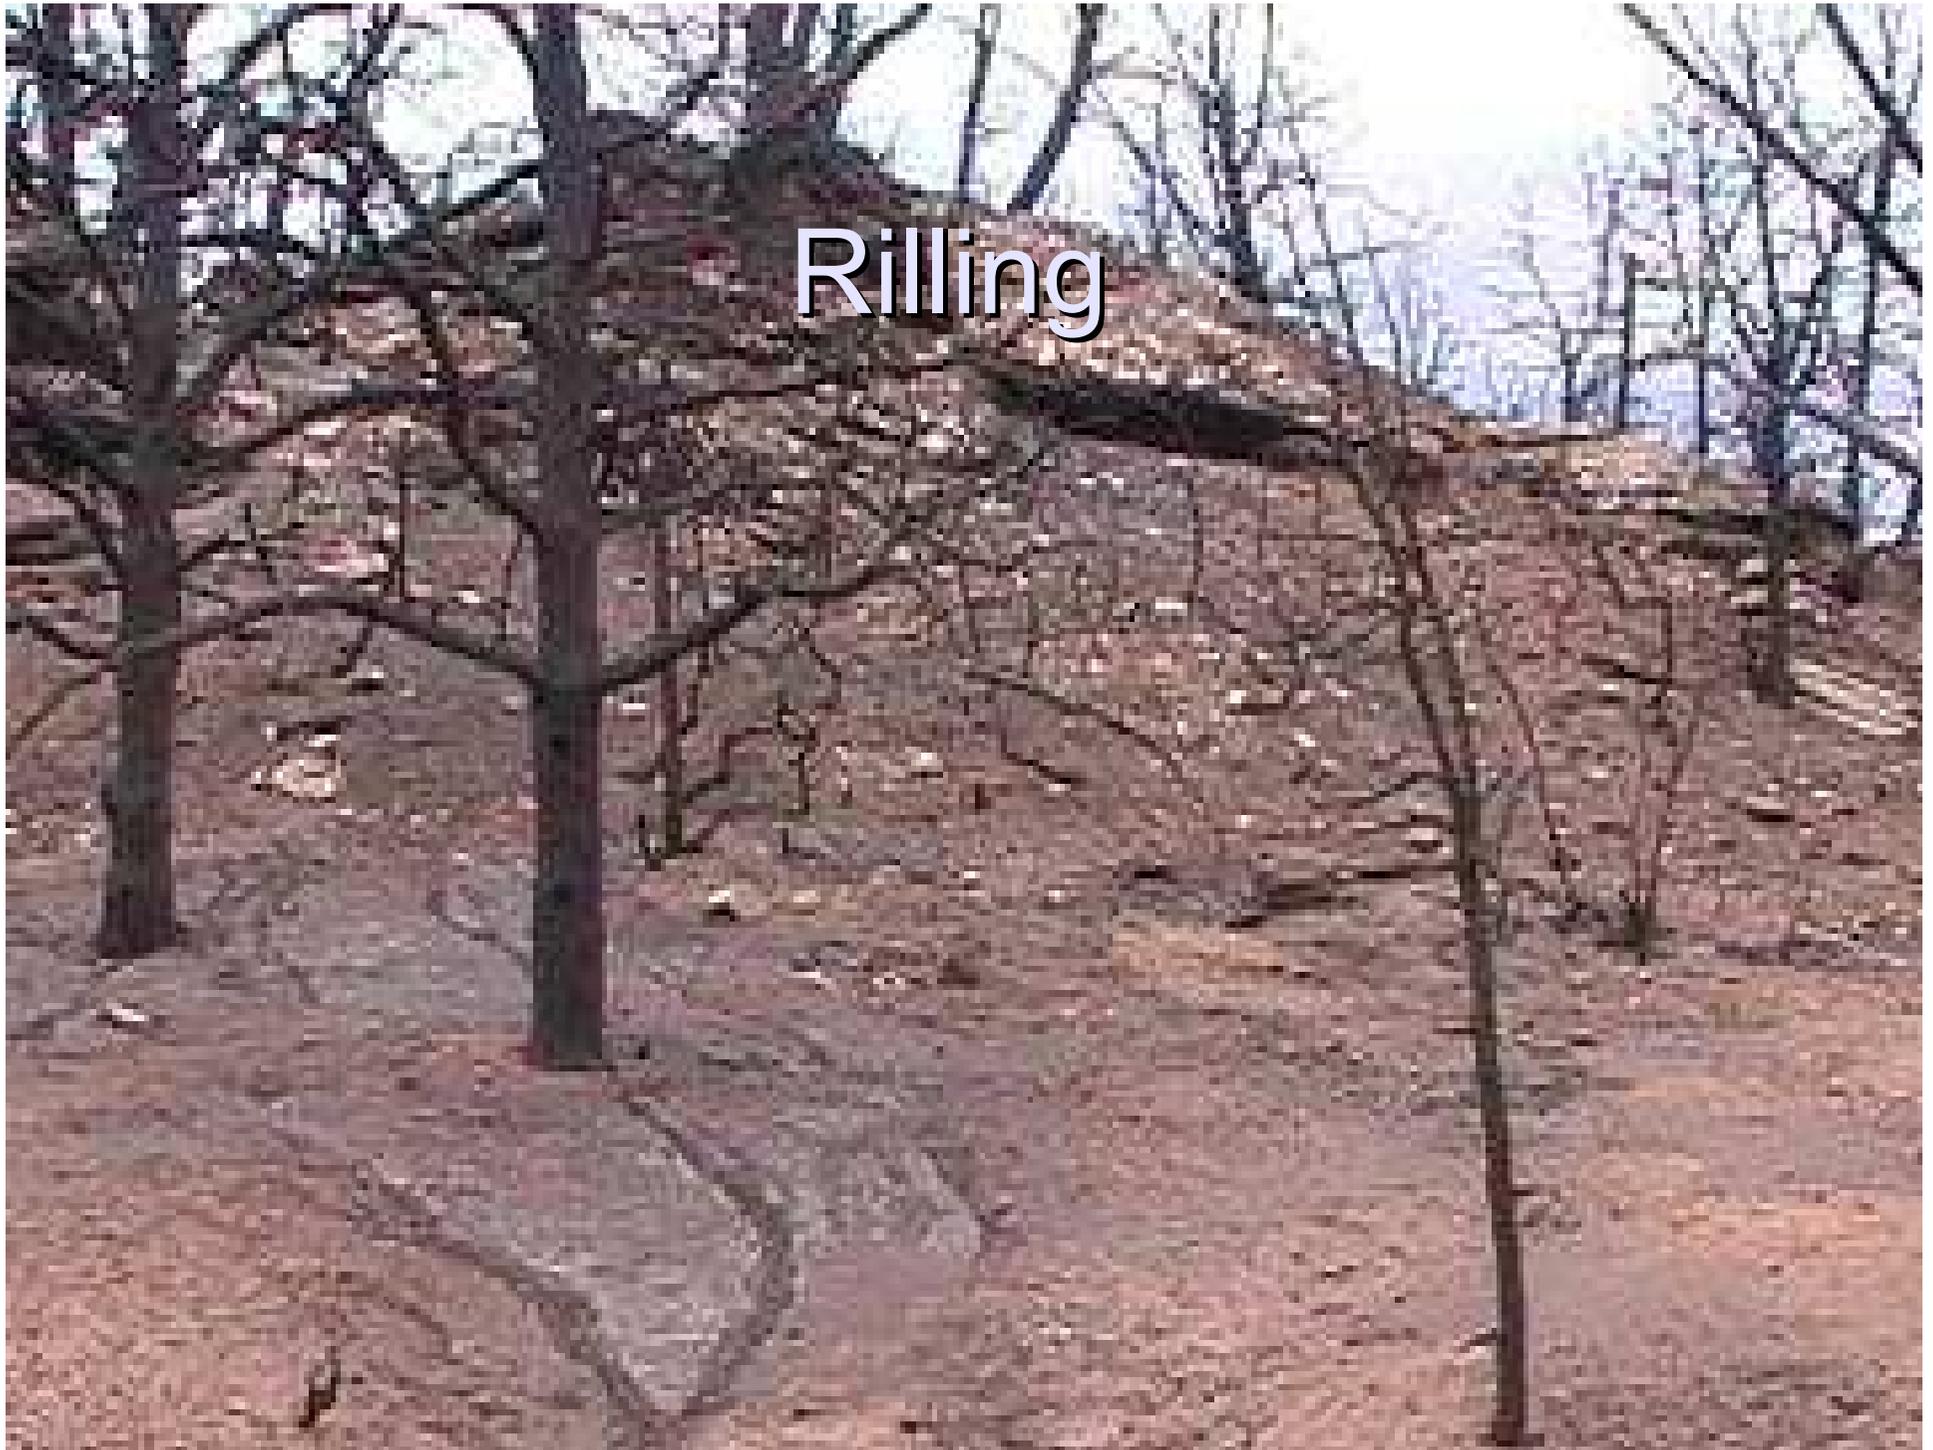
Rilling

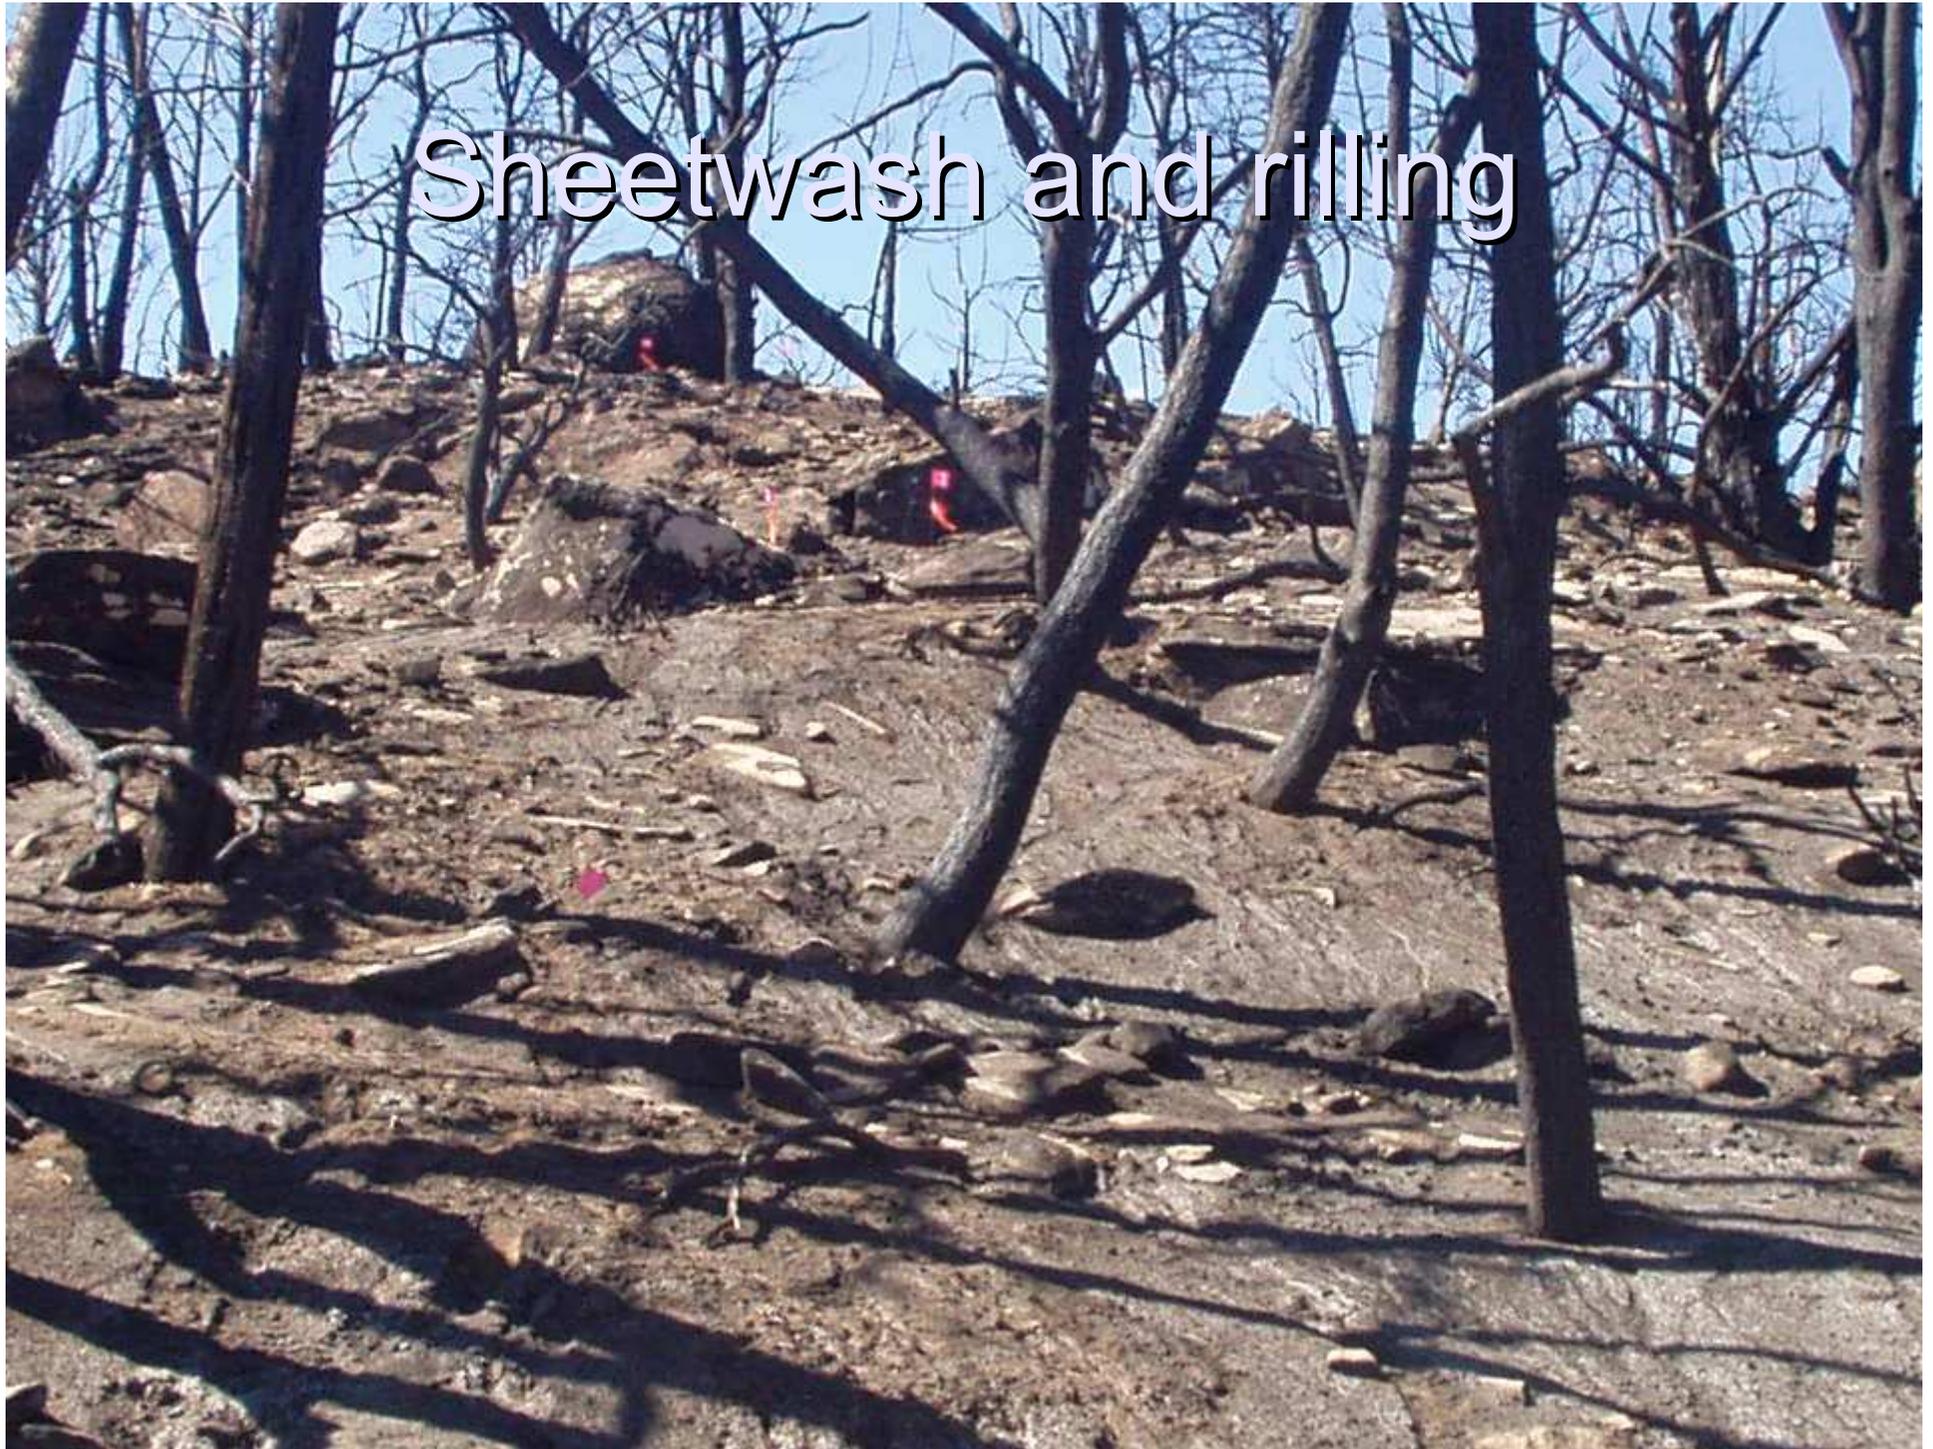
Sheetwash and rilling

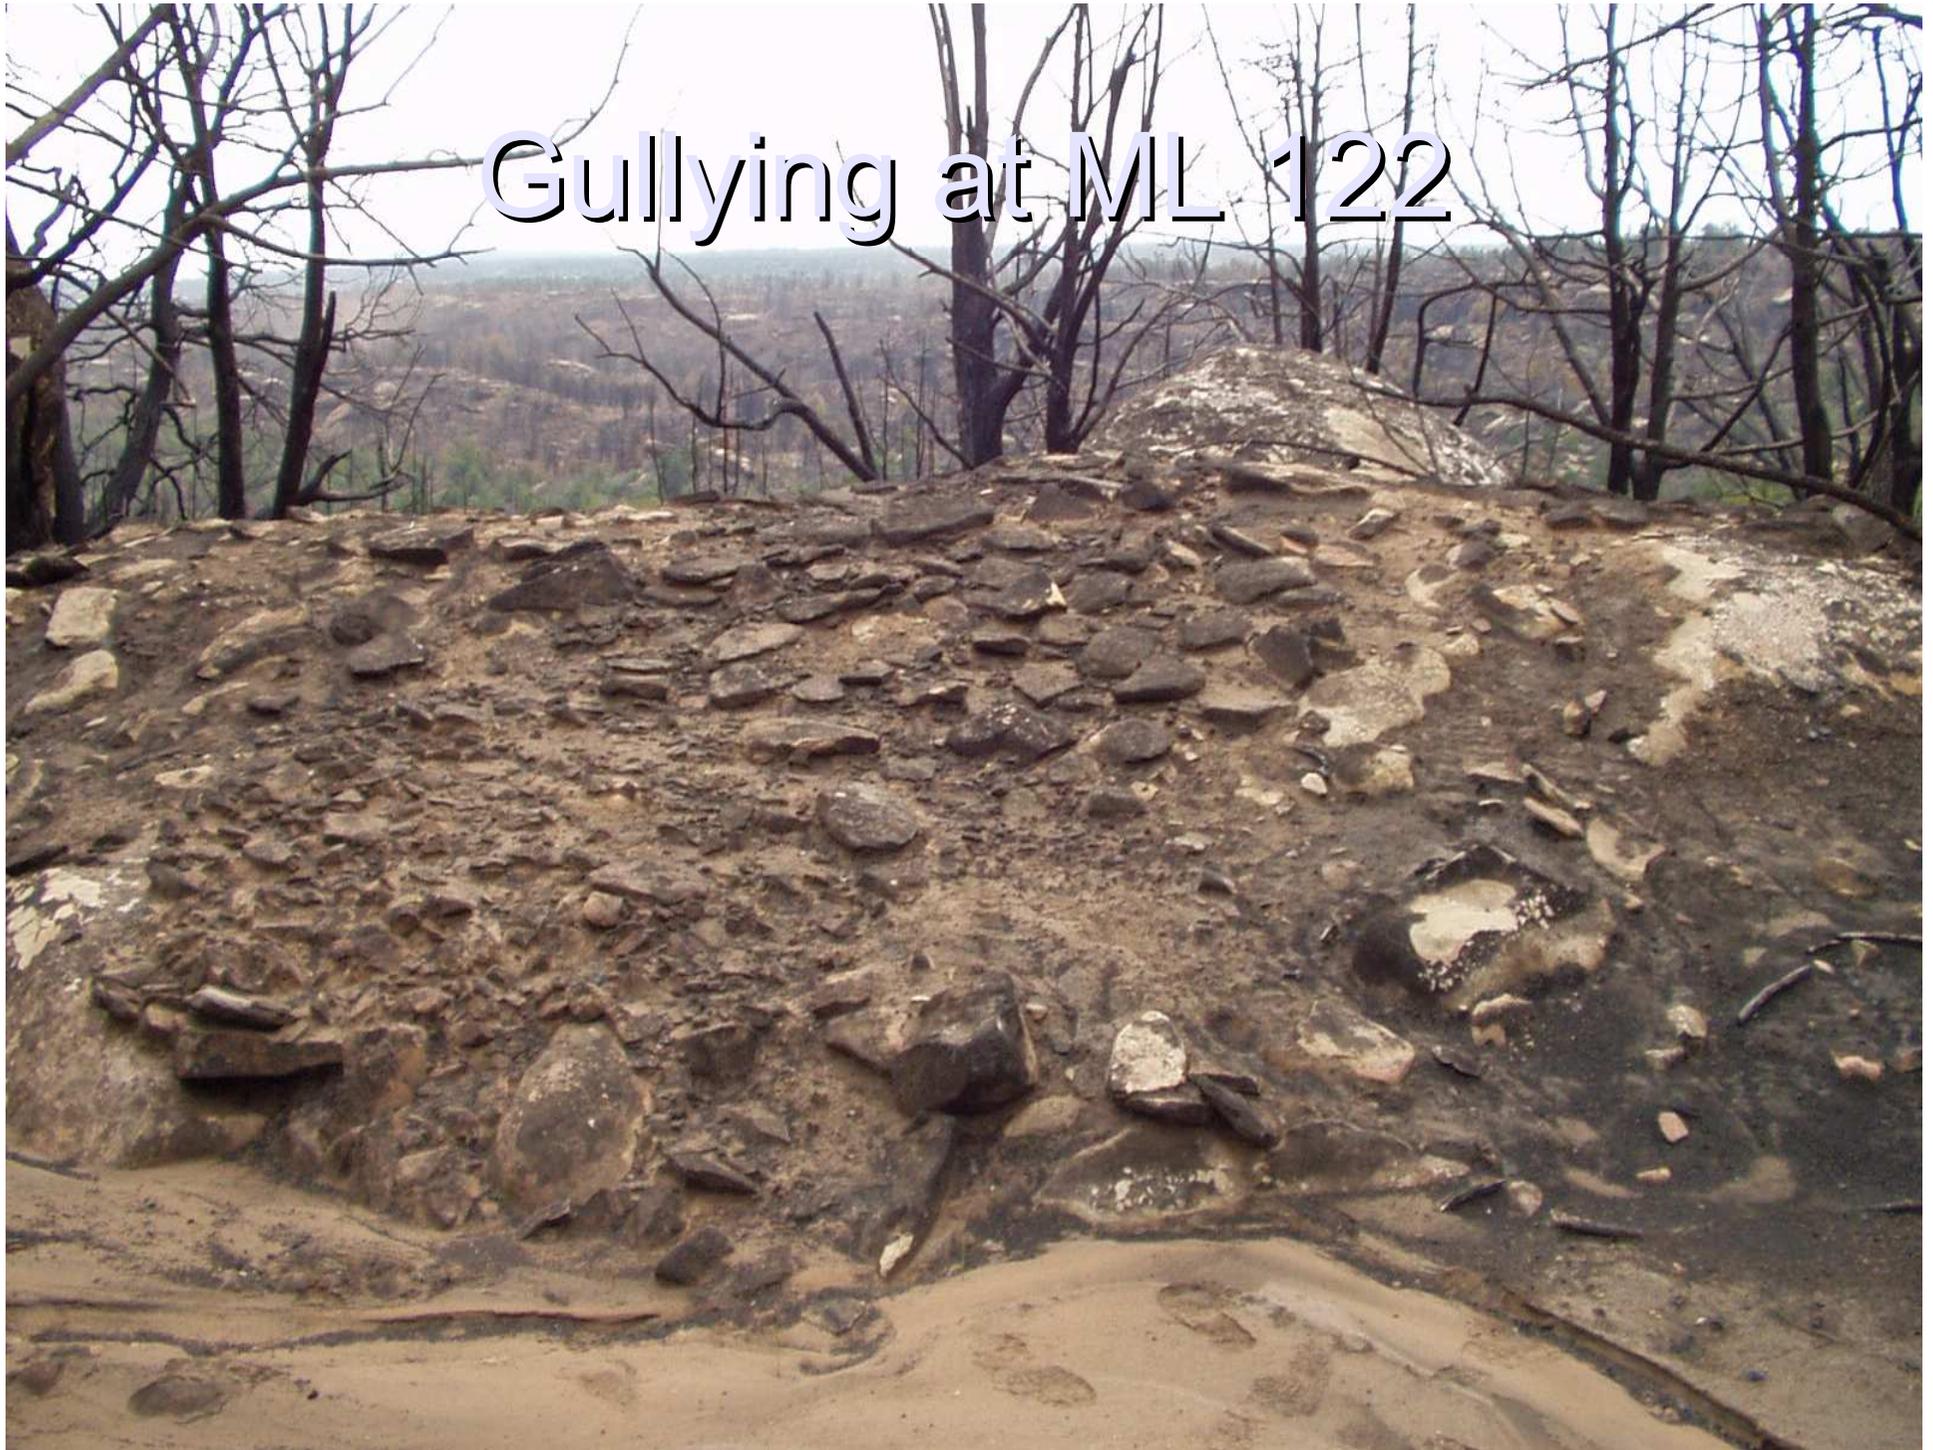
Gullying at ML 122

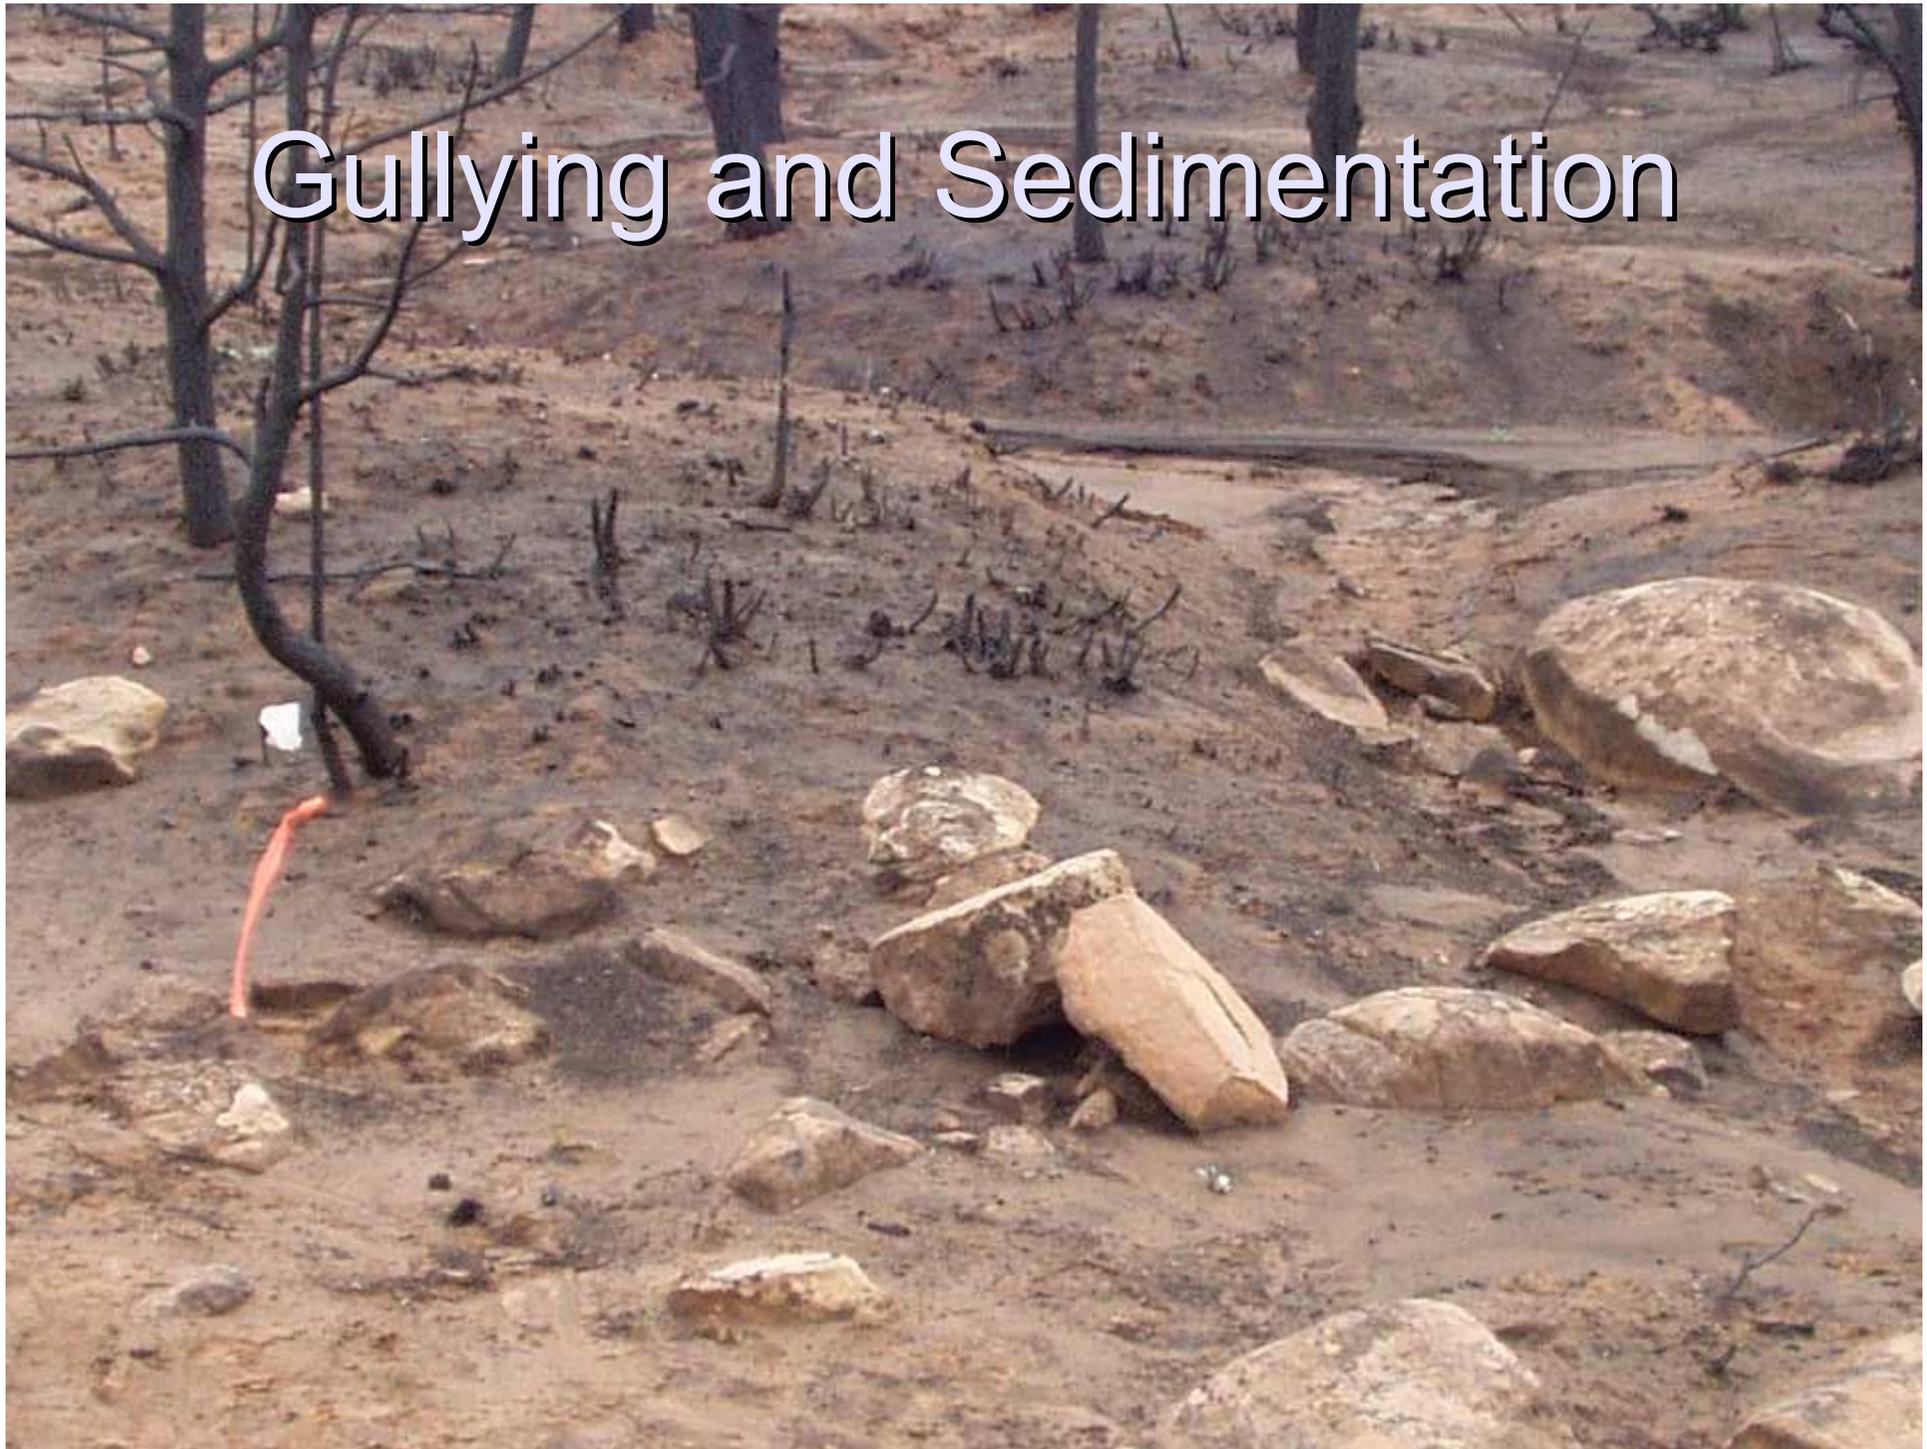
Gullying and Sedimentation
