The Effects of Fire

On Cultural Resources

THE HAMMOND FIRE

THE HAMMOND FIRE BAER PROJECT

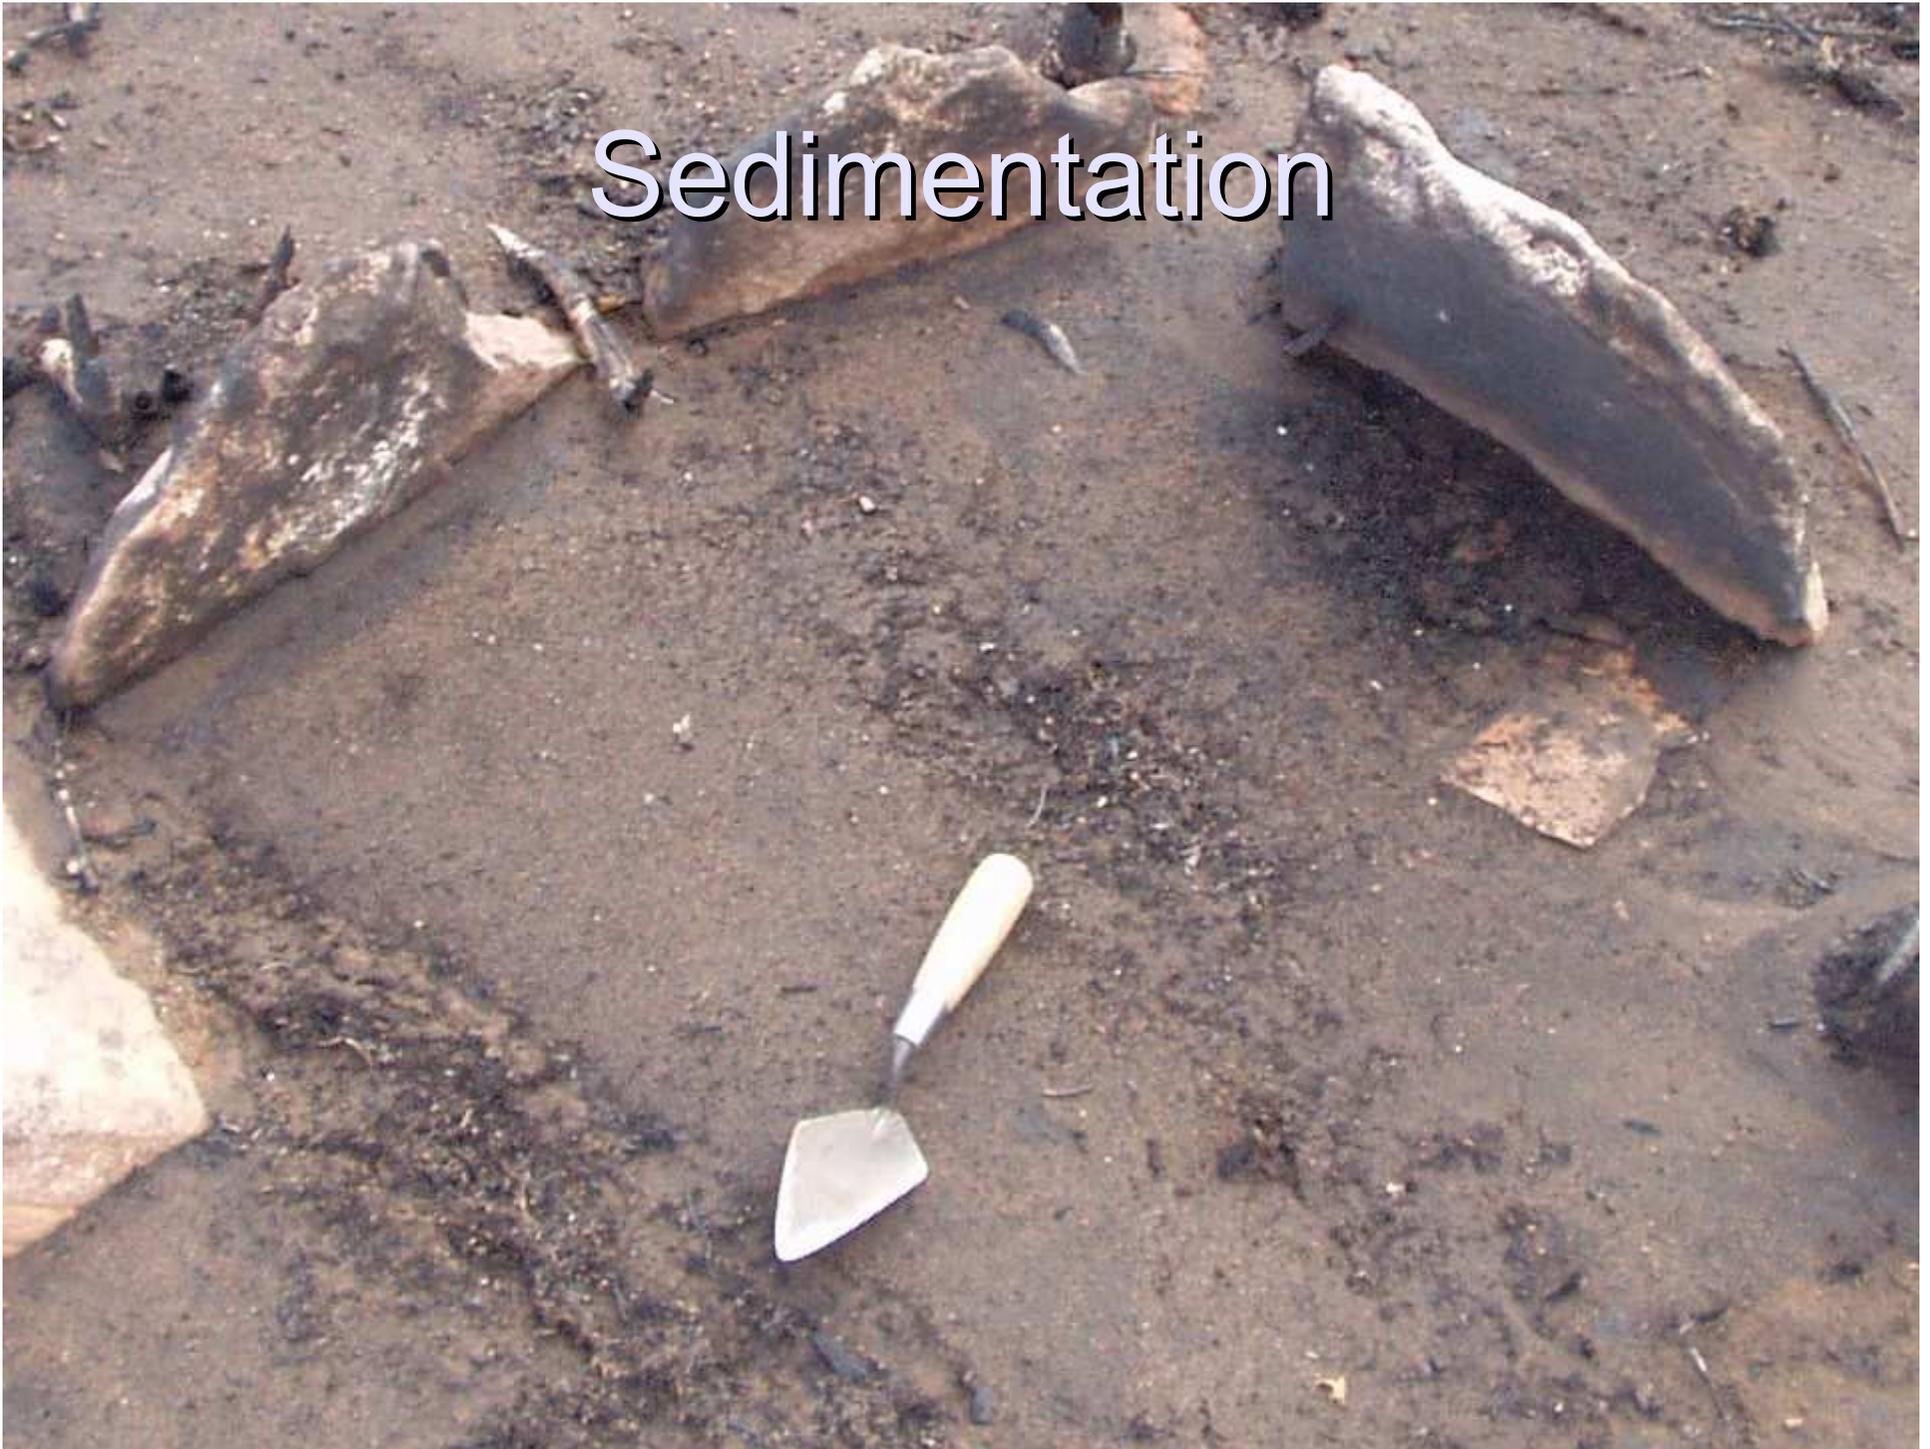
Sedimentation

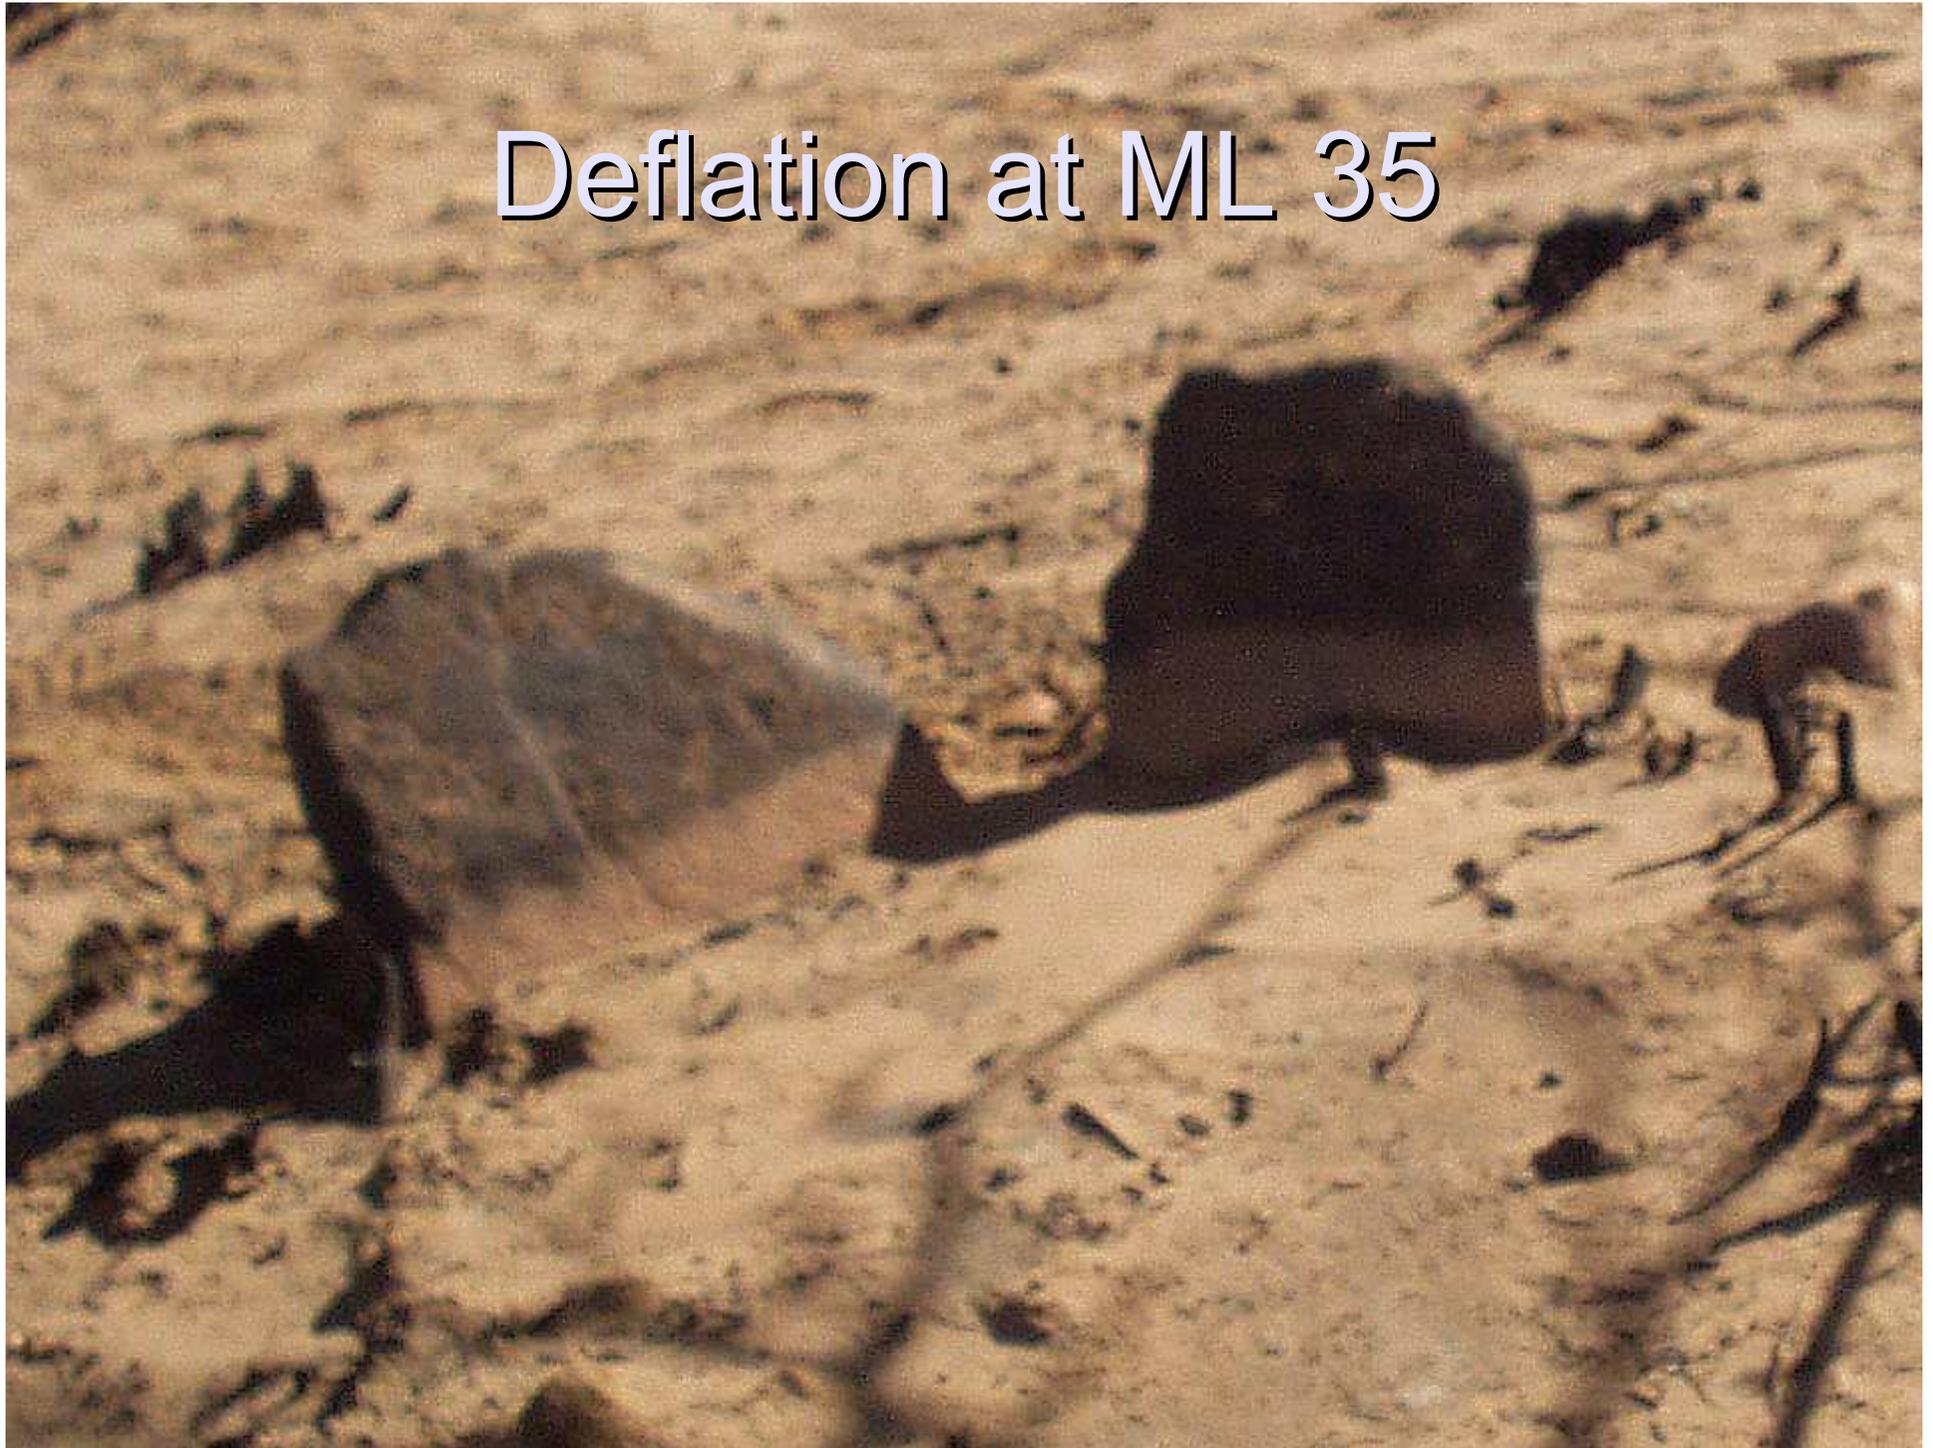
Deflation at ML 35

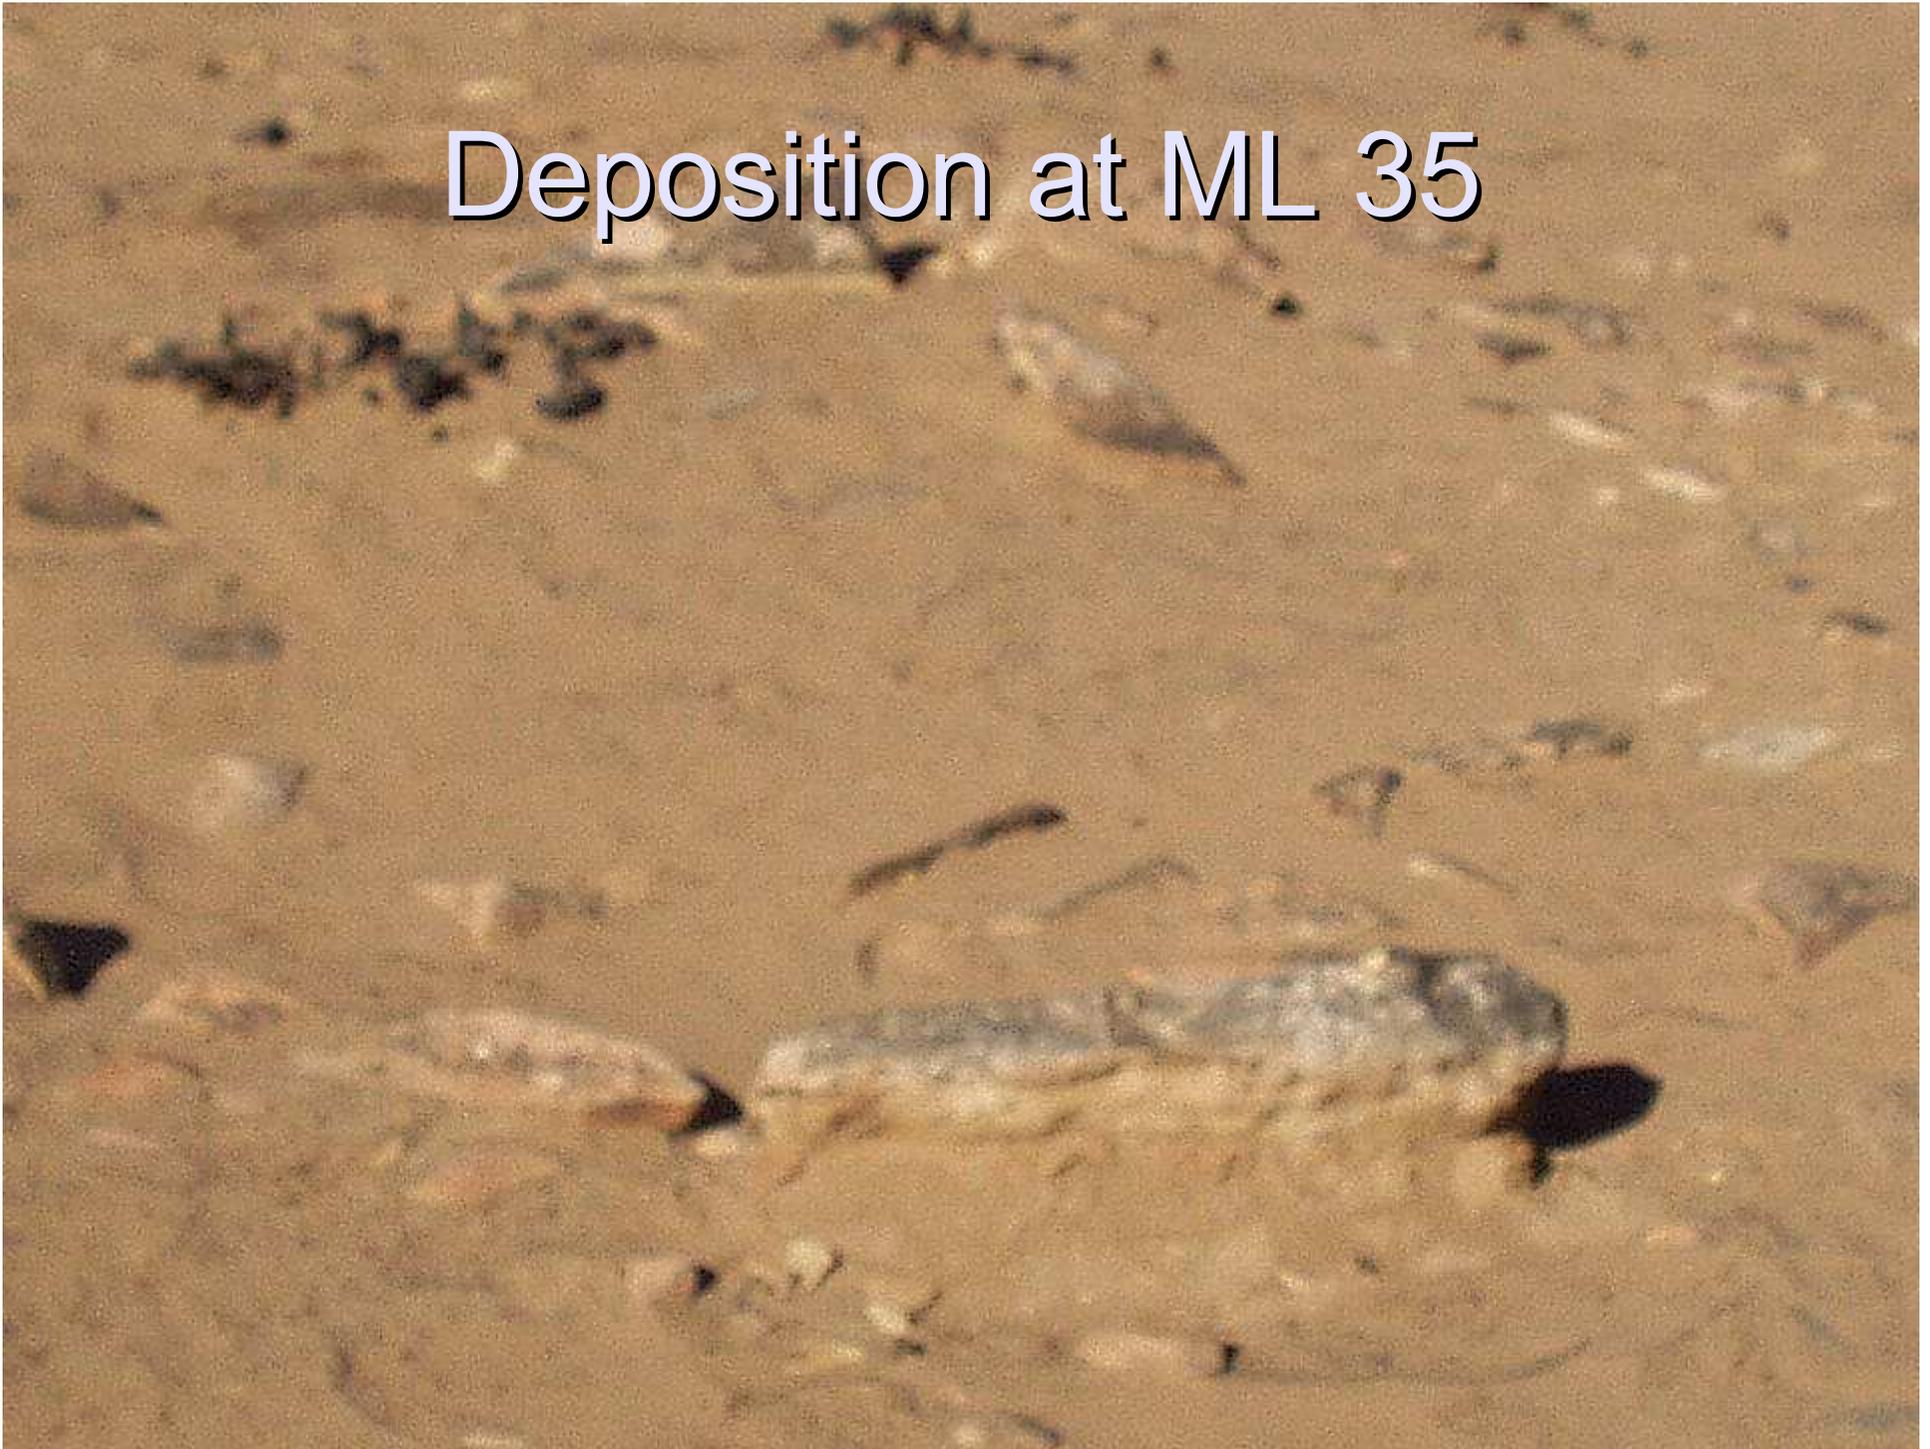
Deposition at ML 35

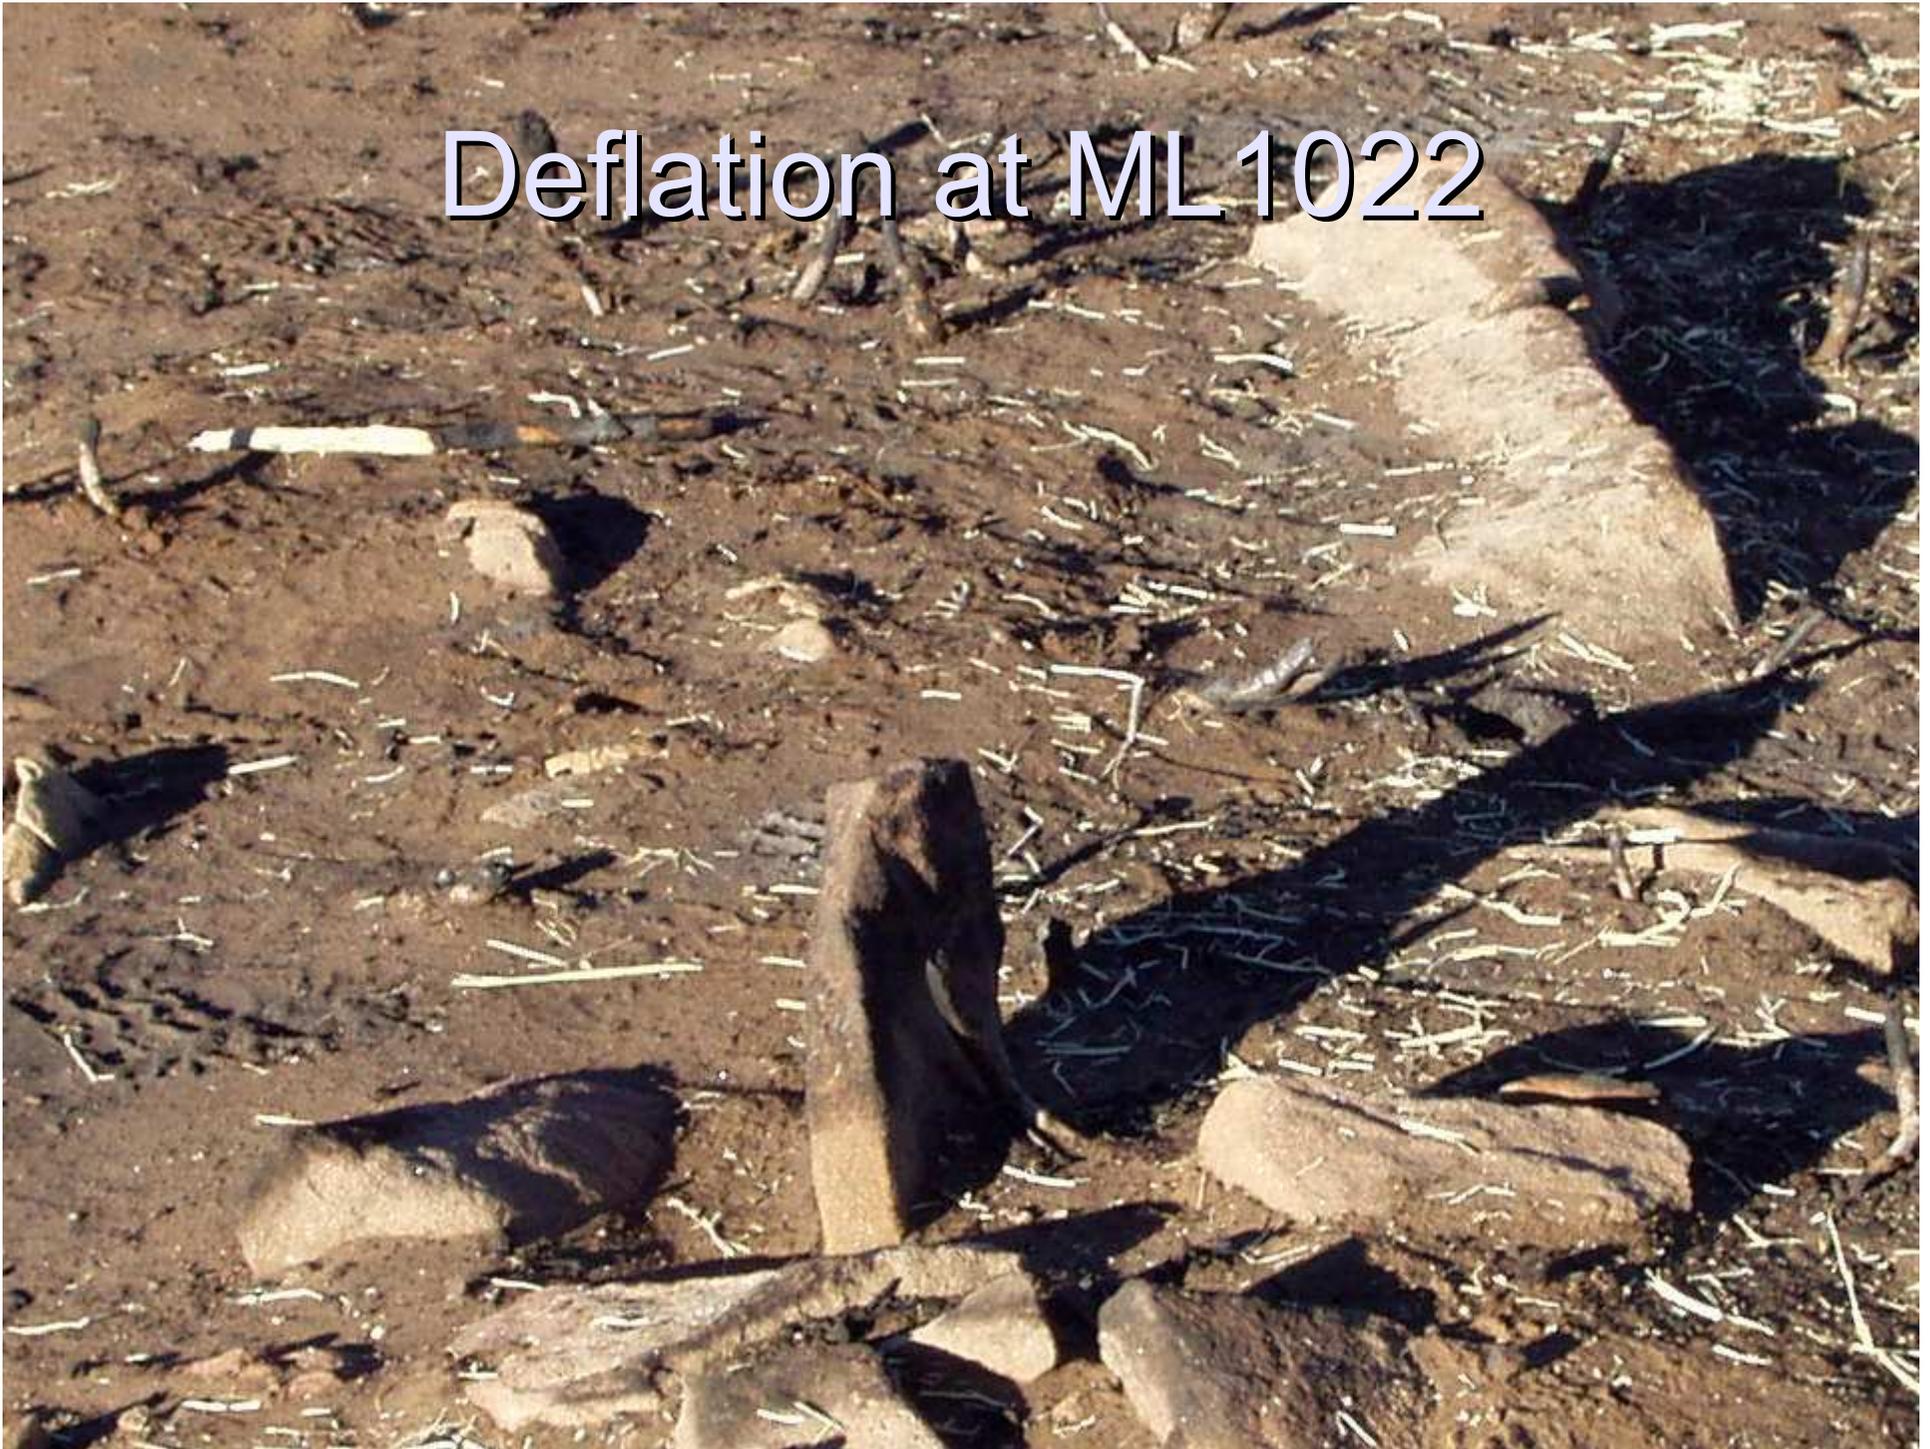
Deflation at ML1022

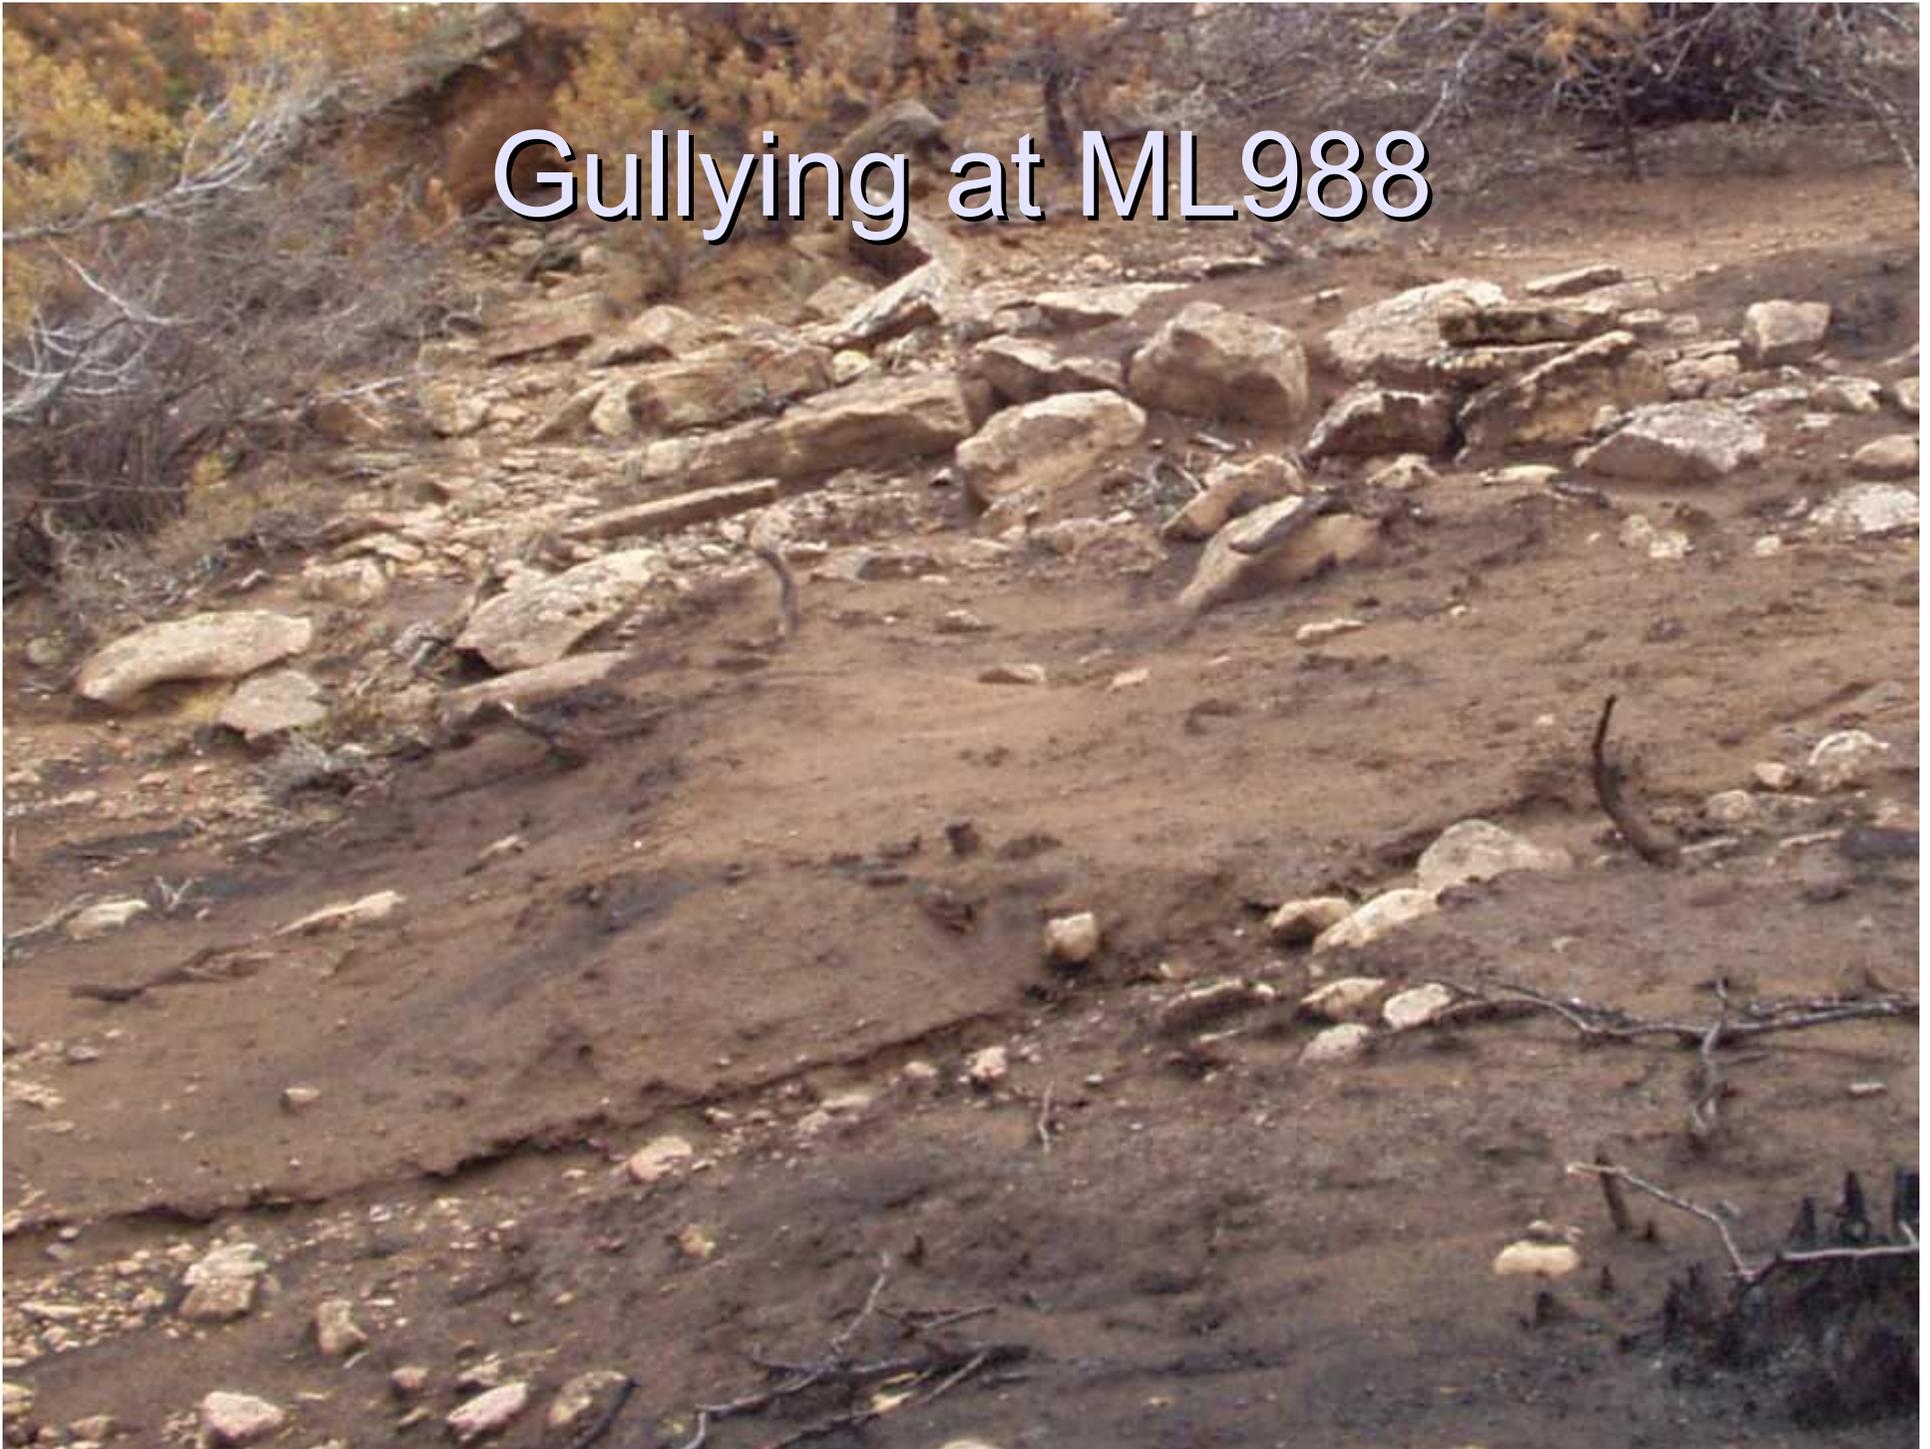
Gullying at ML988

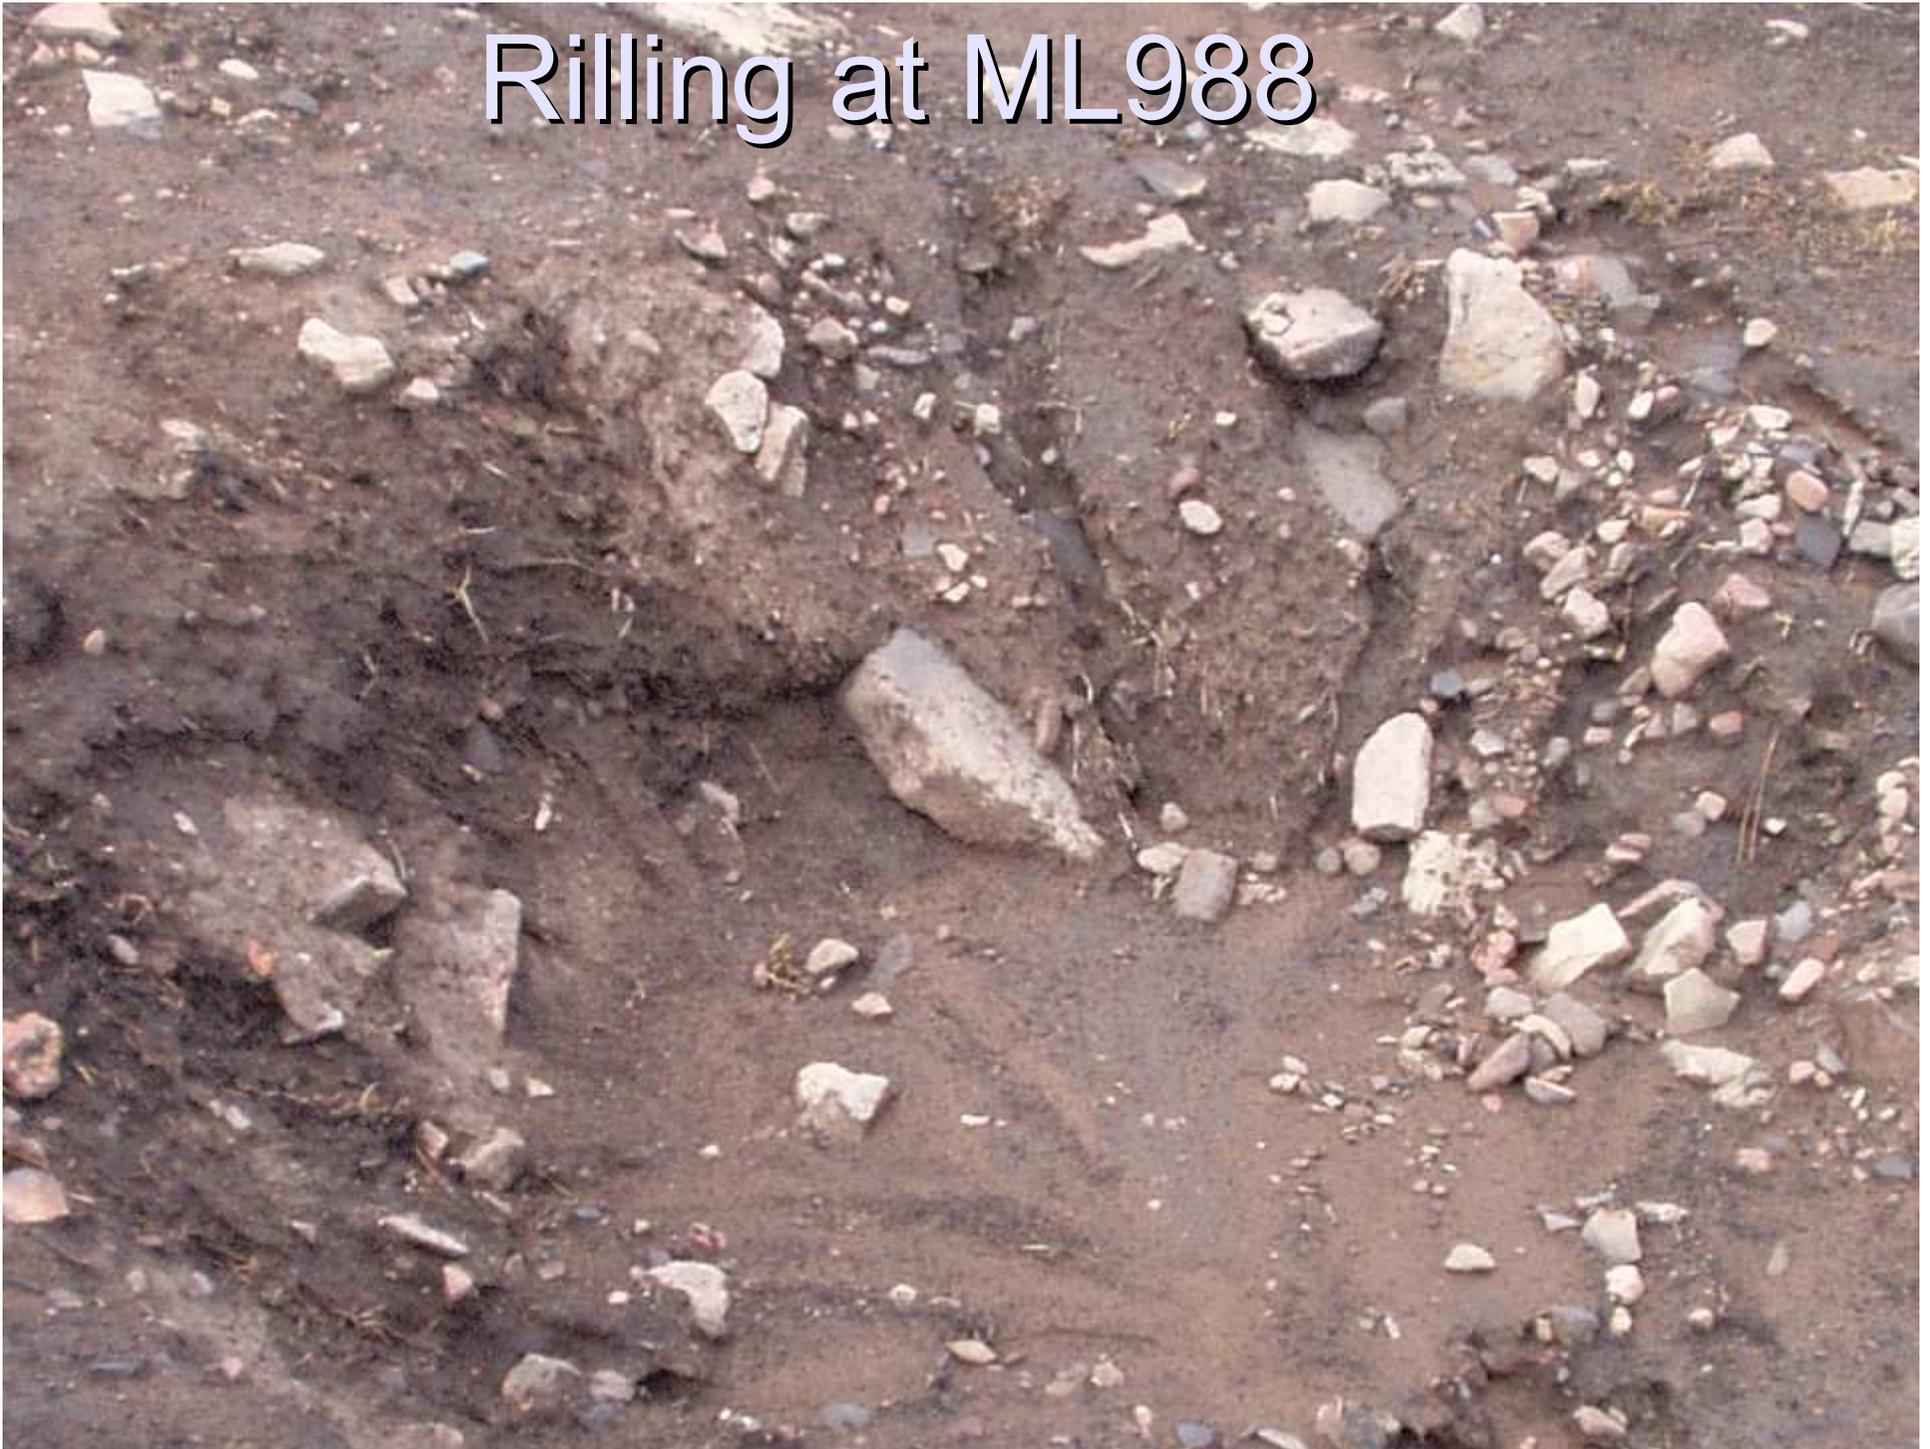
Rilling at ML988

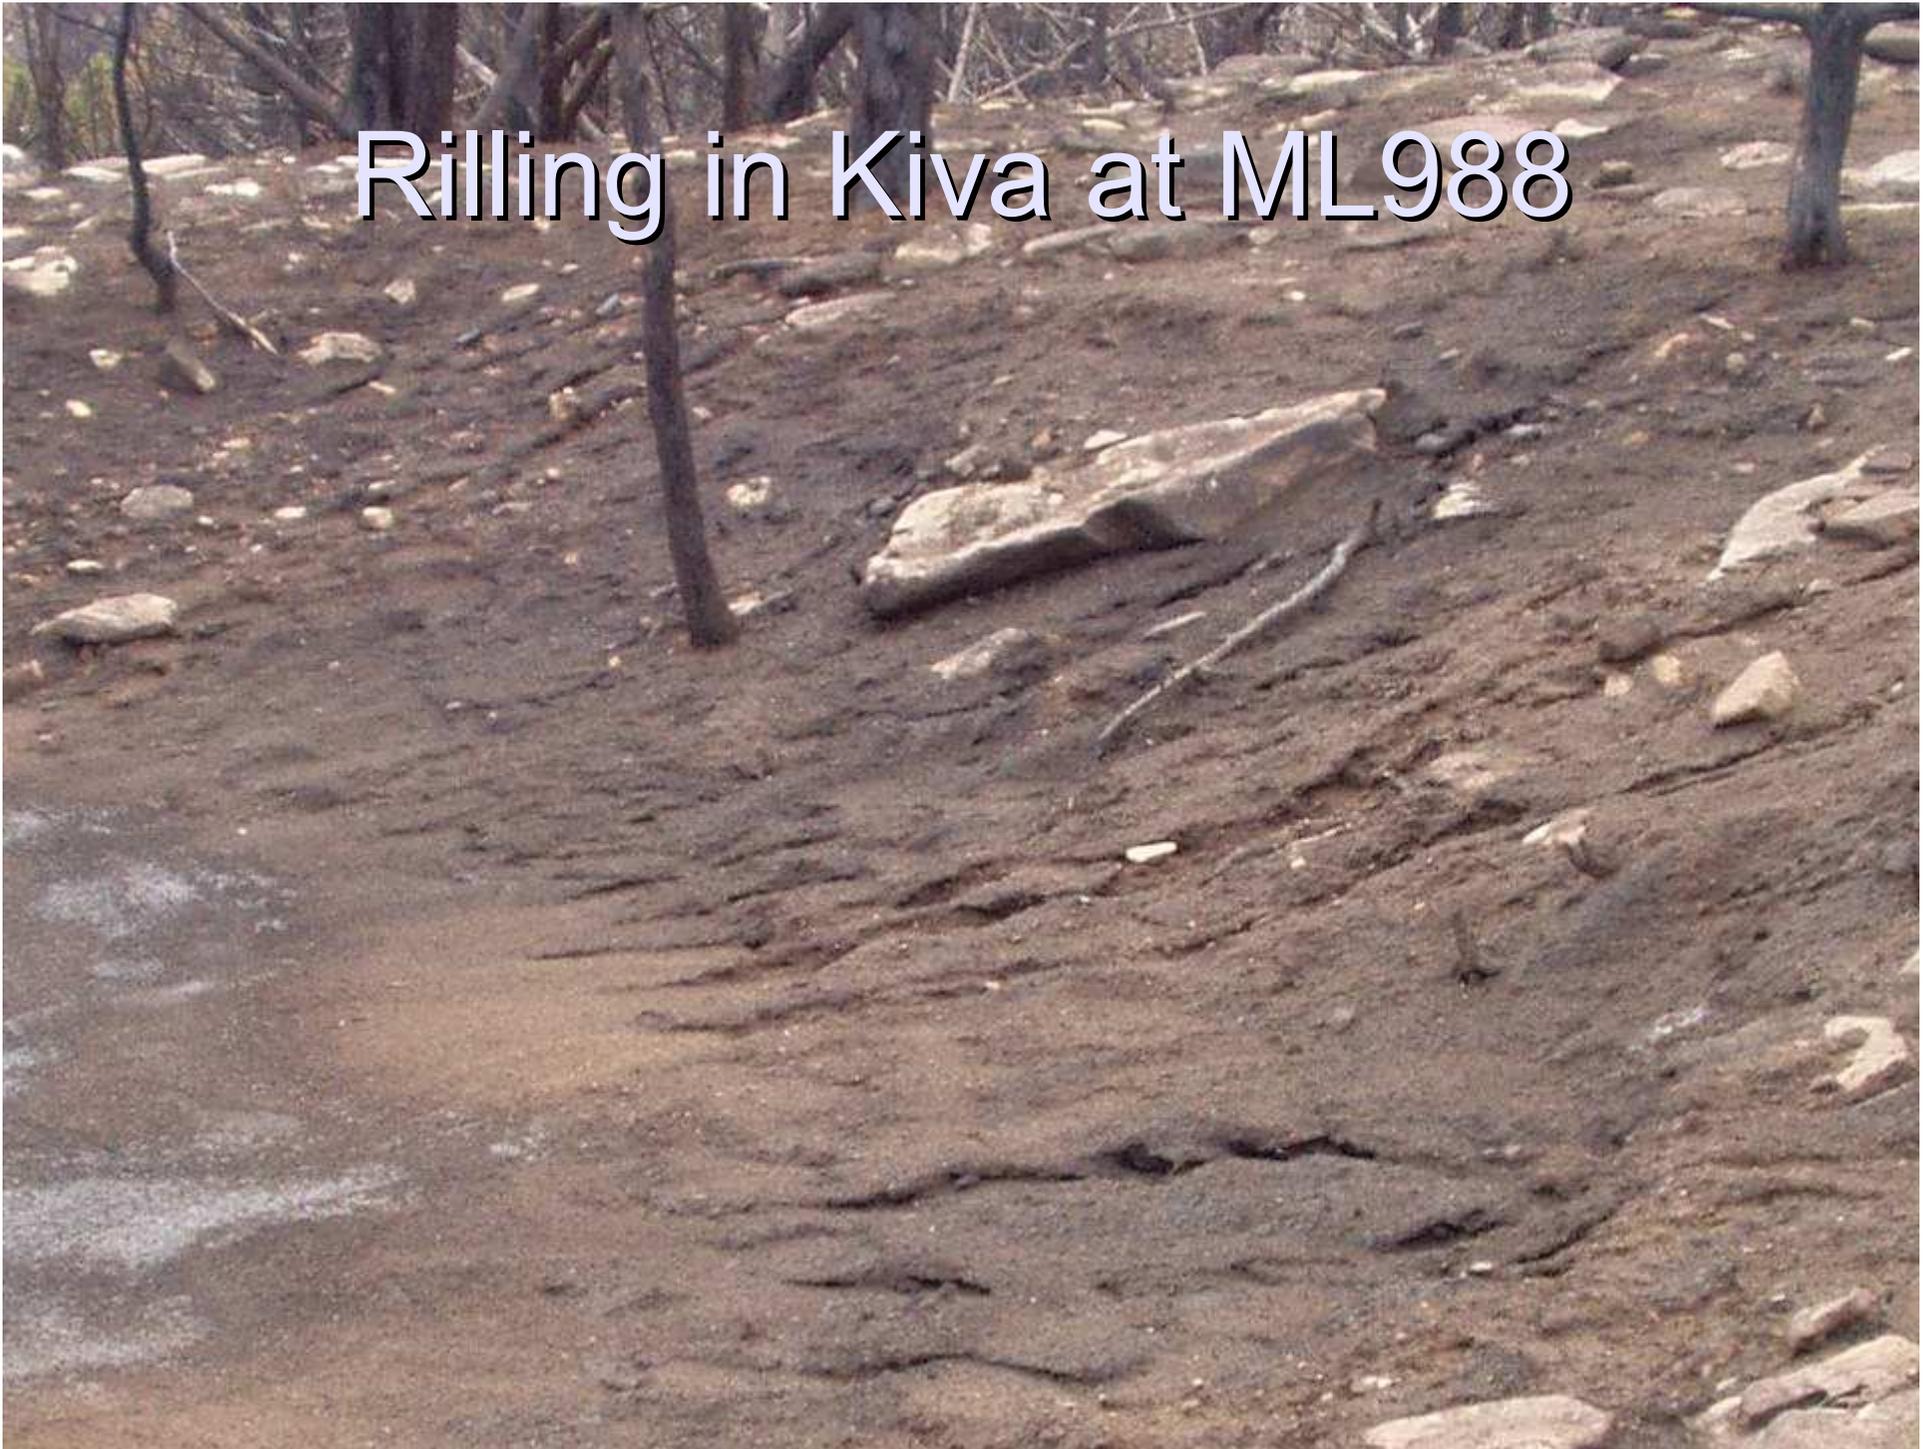
Rilling in Kiva at ML988

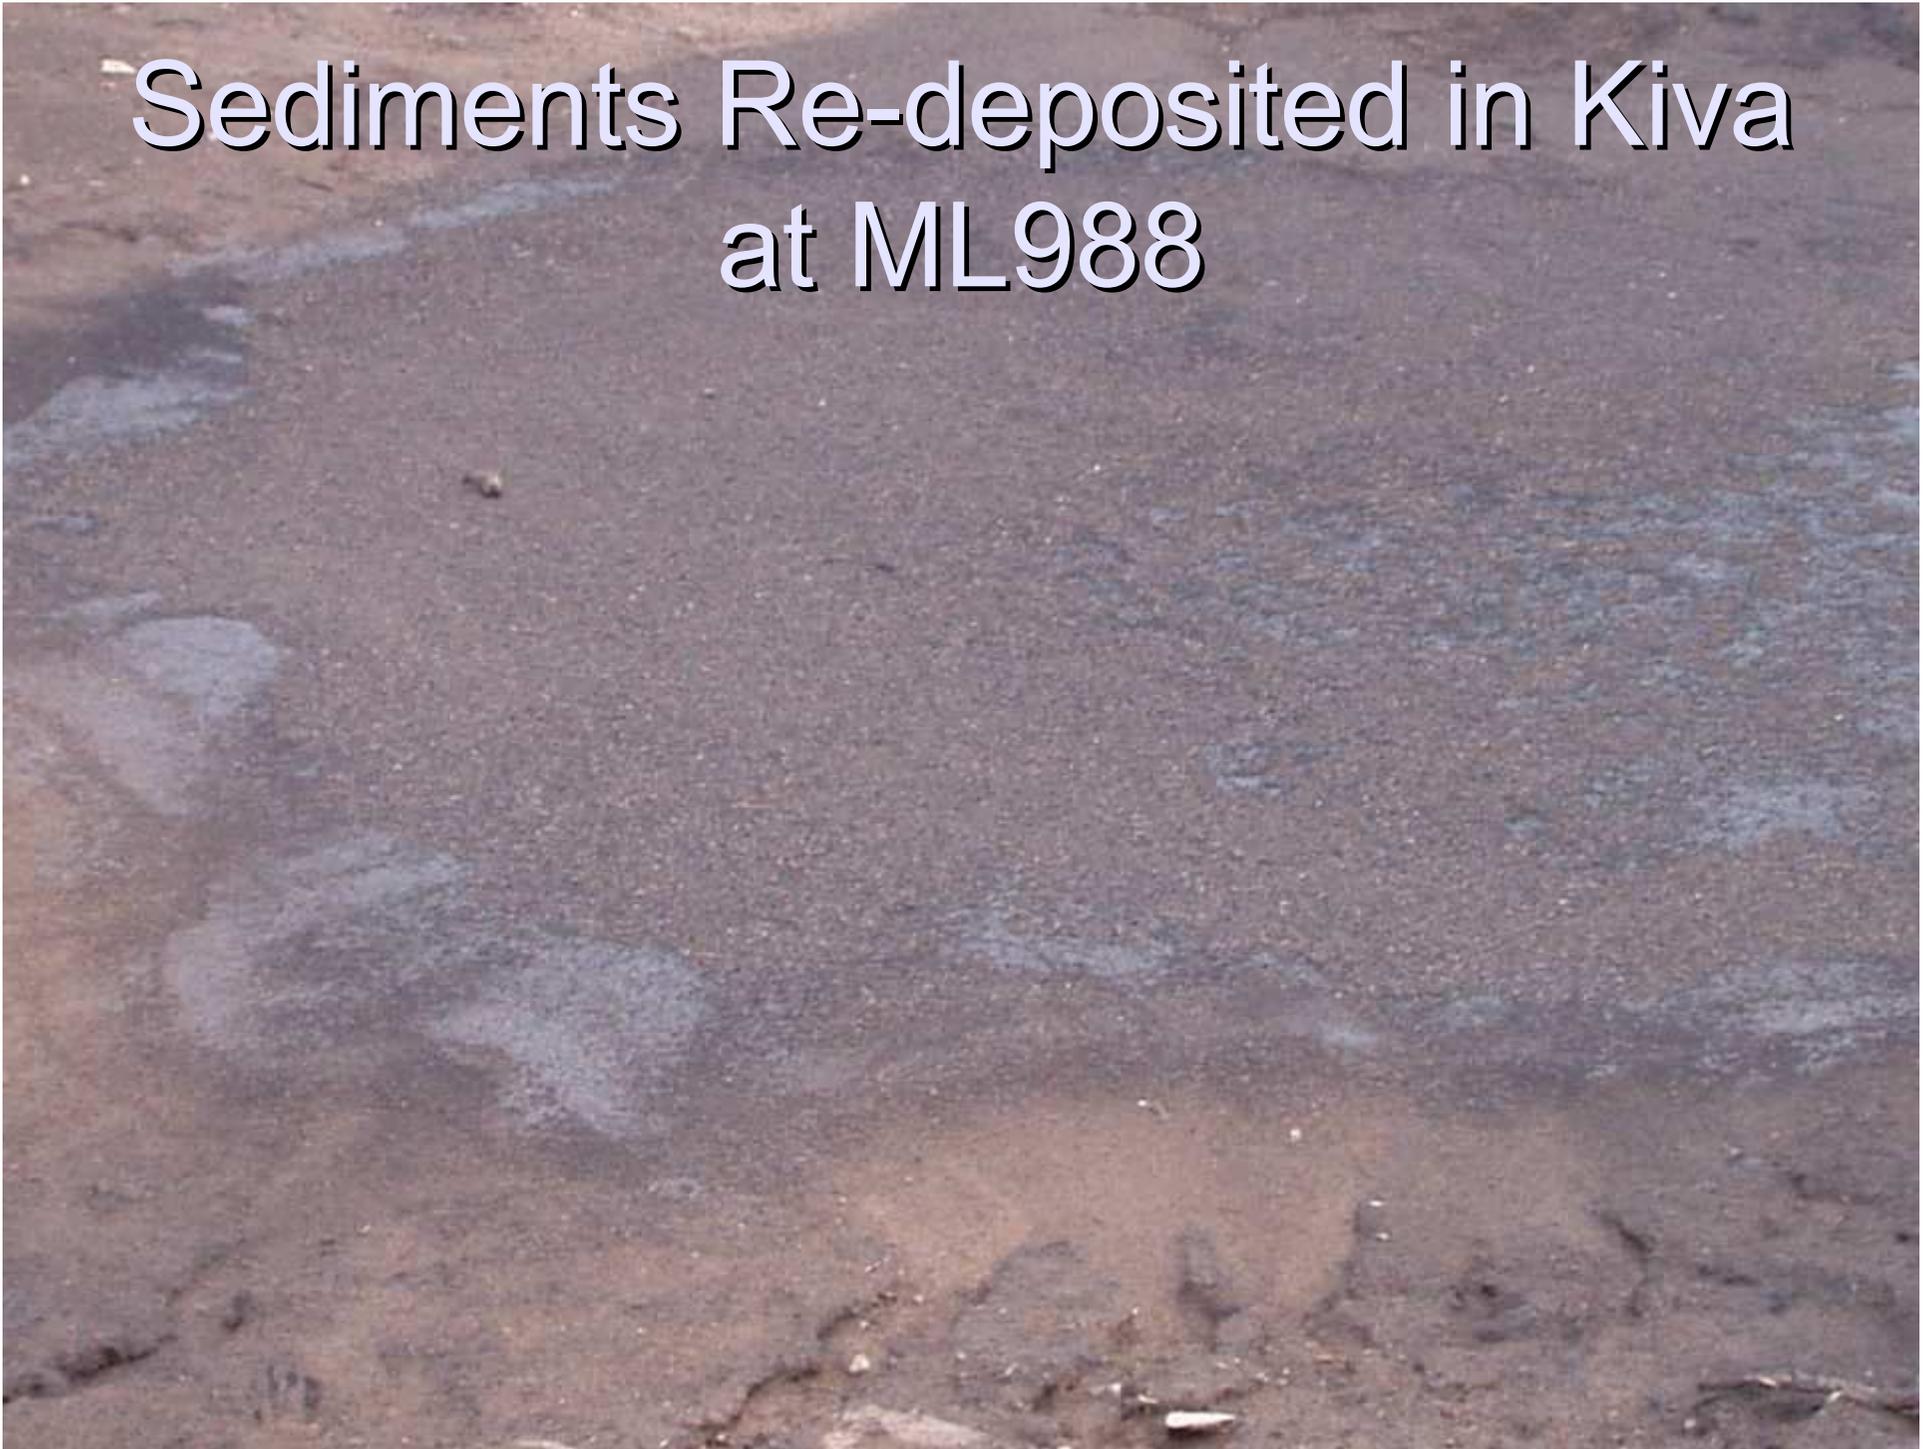
Sediments Re-deposited in Kiva at ML988
