The Effects of Fire

On Cultural Resources

THE HAMMOND FIRE

THE HAMMOND FIRE BAER PROJECT

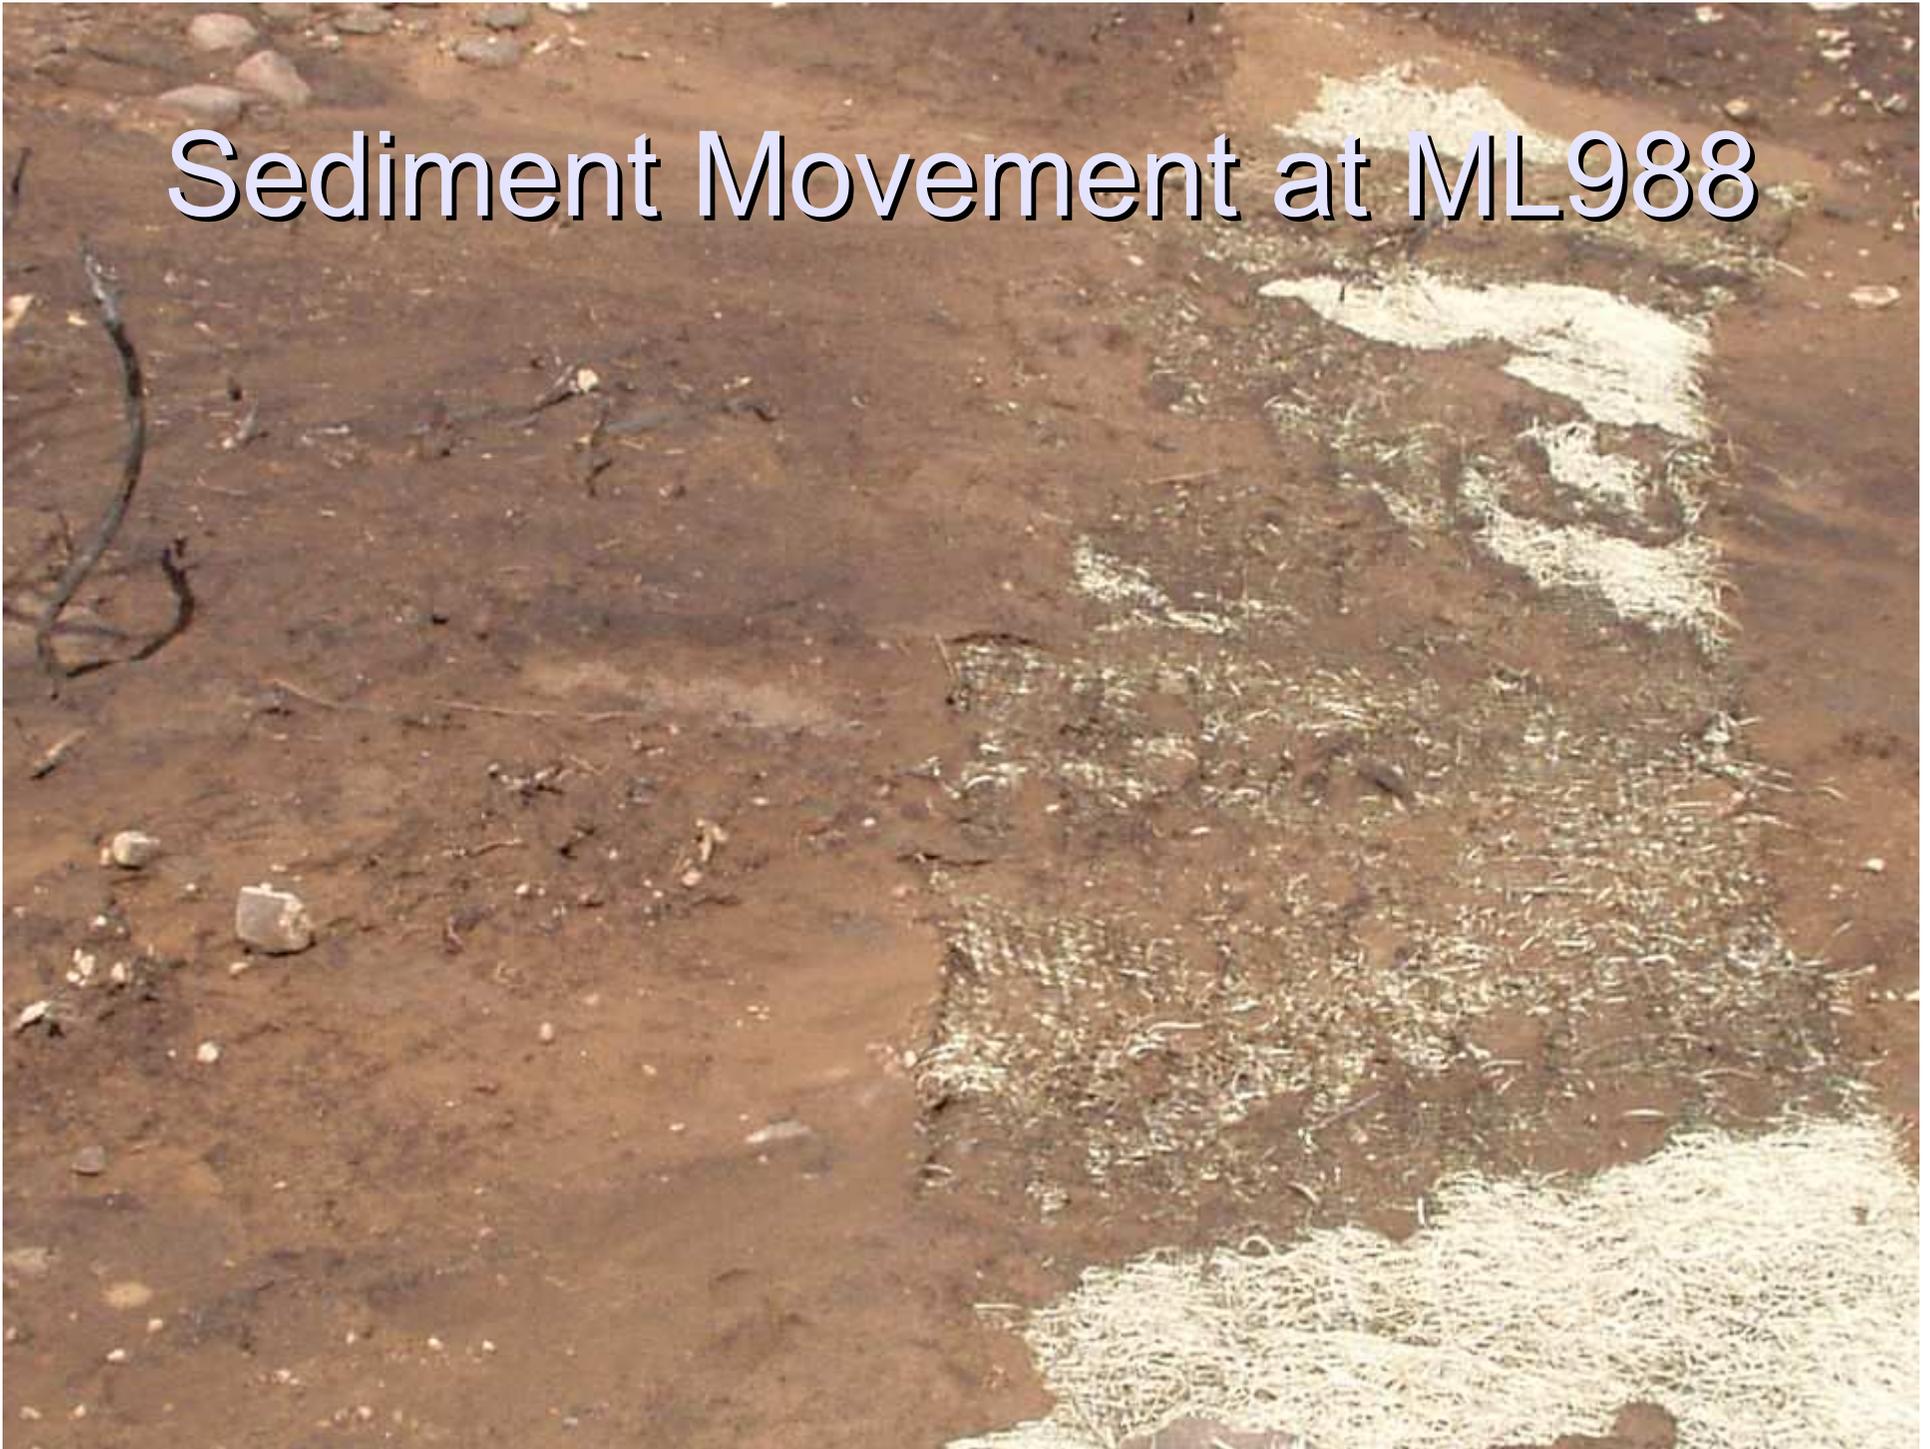
Sediment Movement at ML988

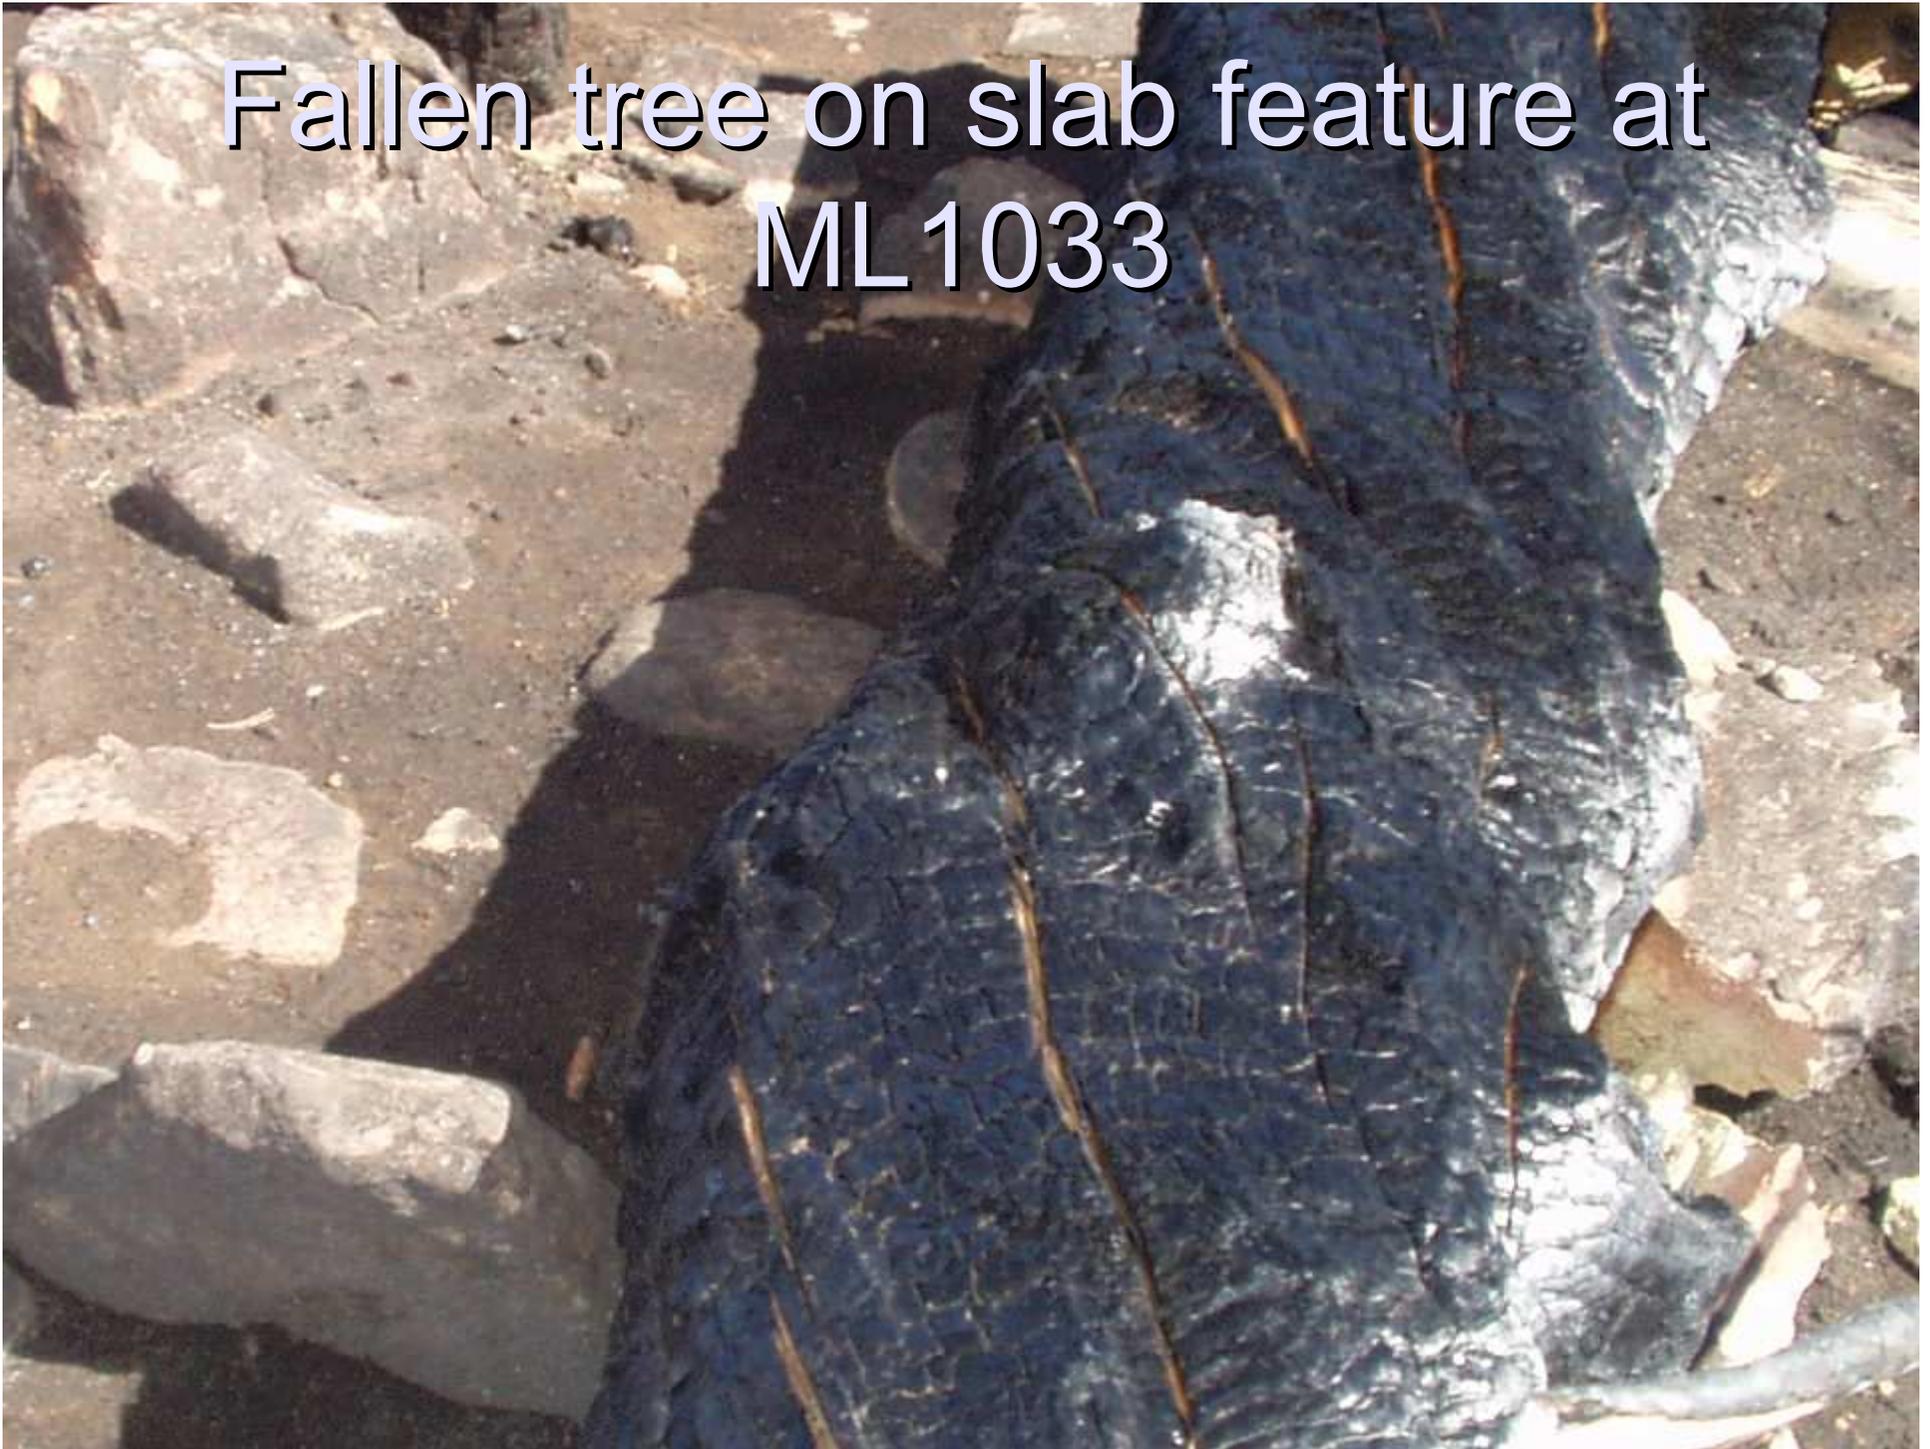
Fallen tree on slab feature at
ML1033

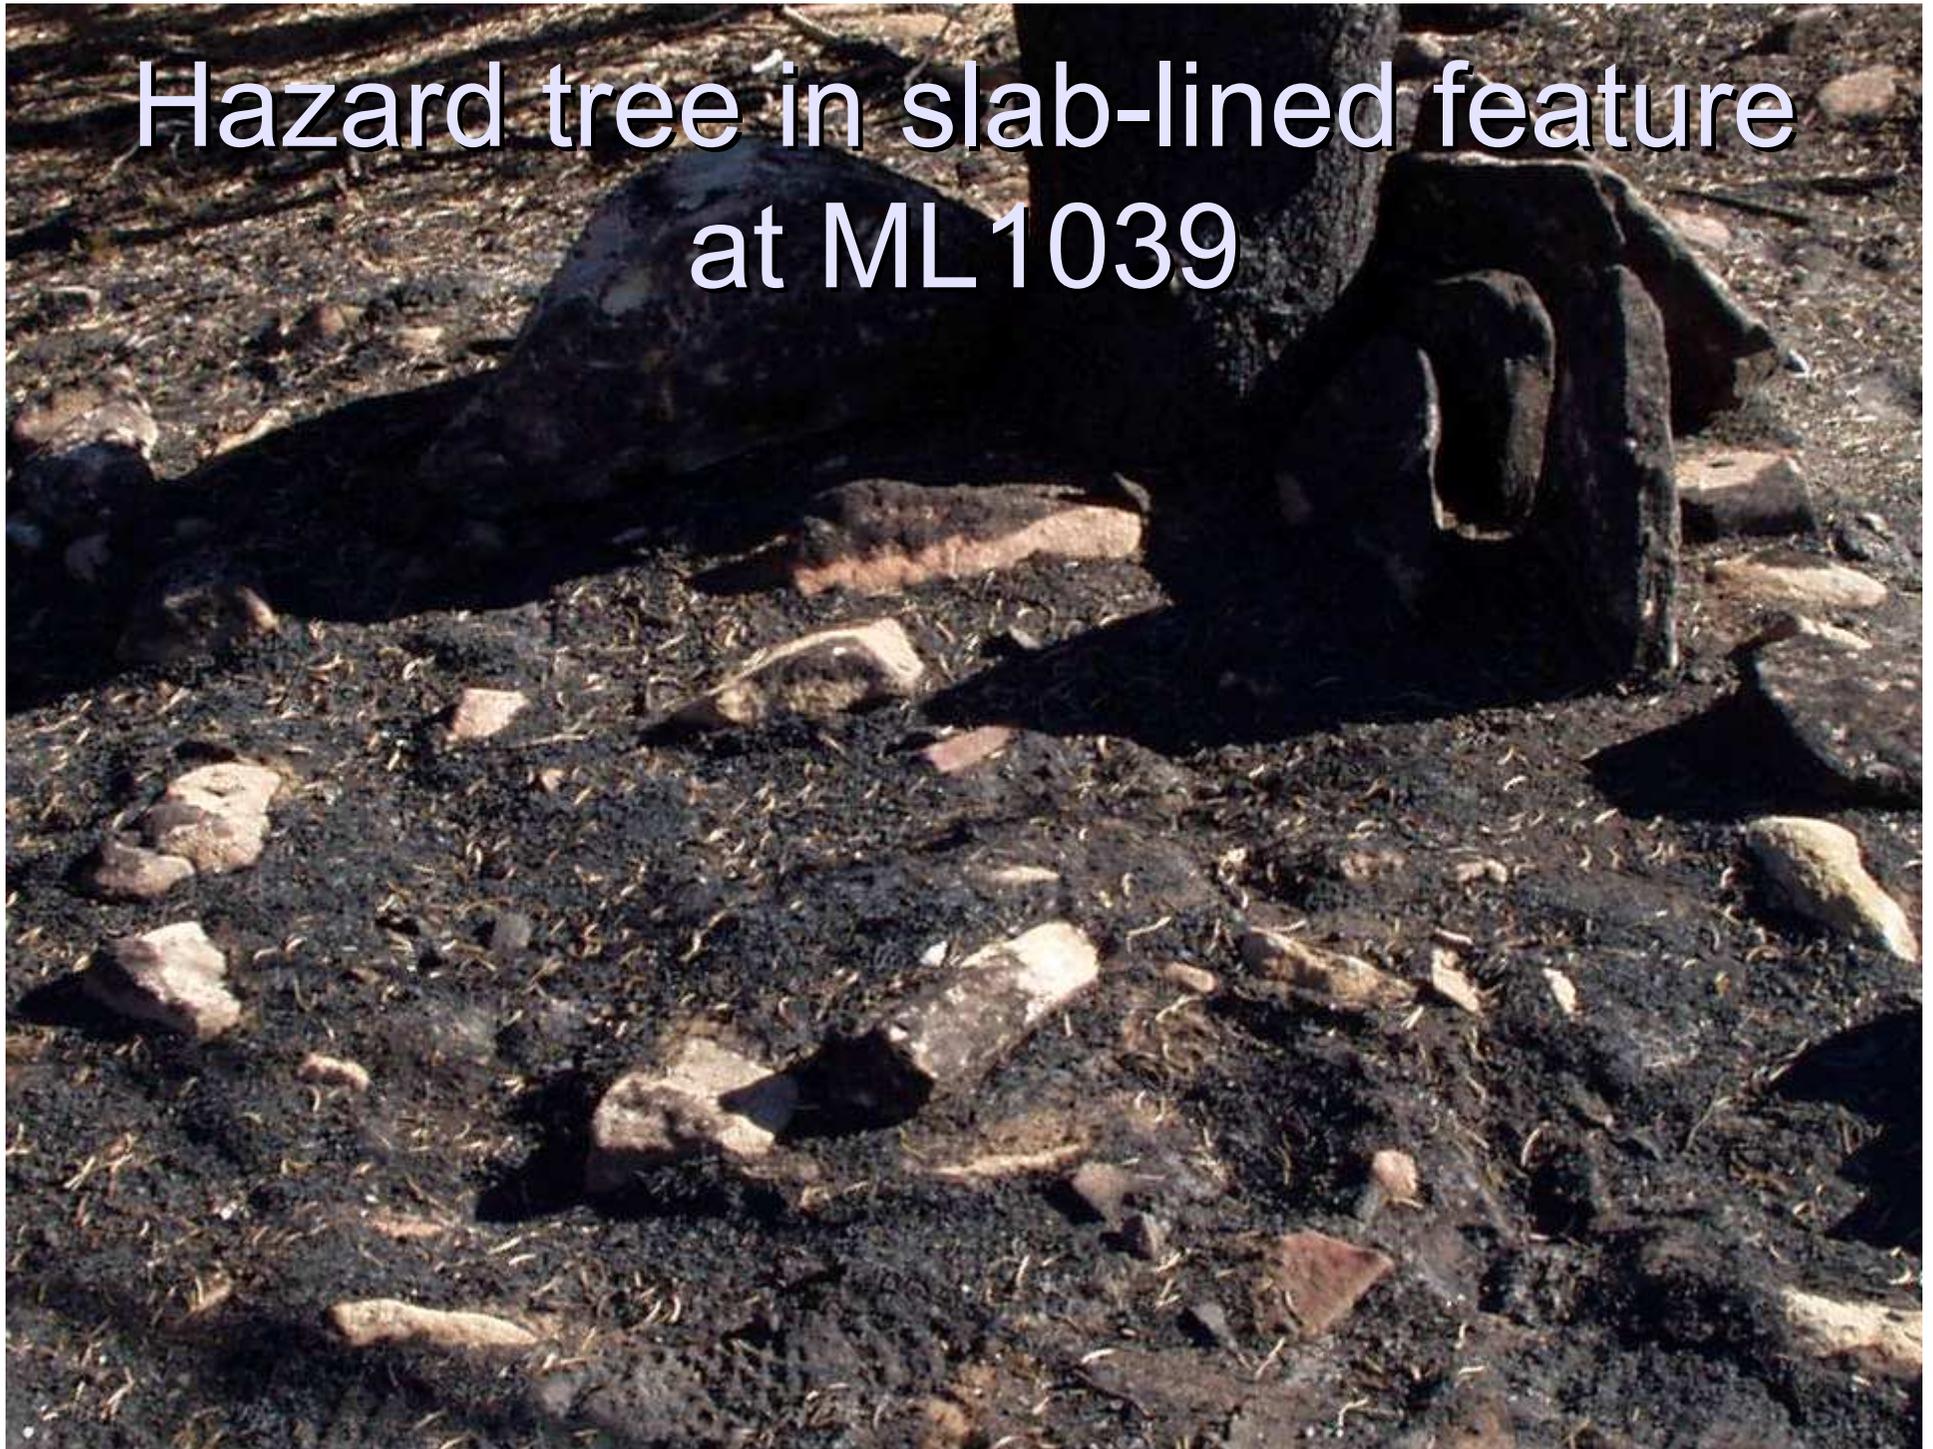
Hazard tree in slab-lined feature at ML1039

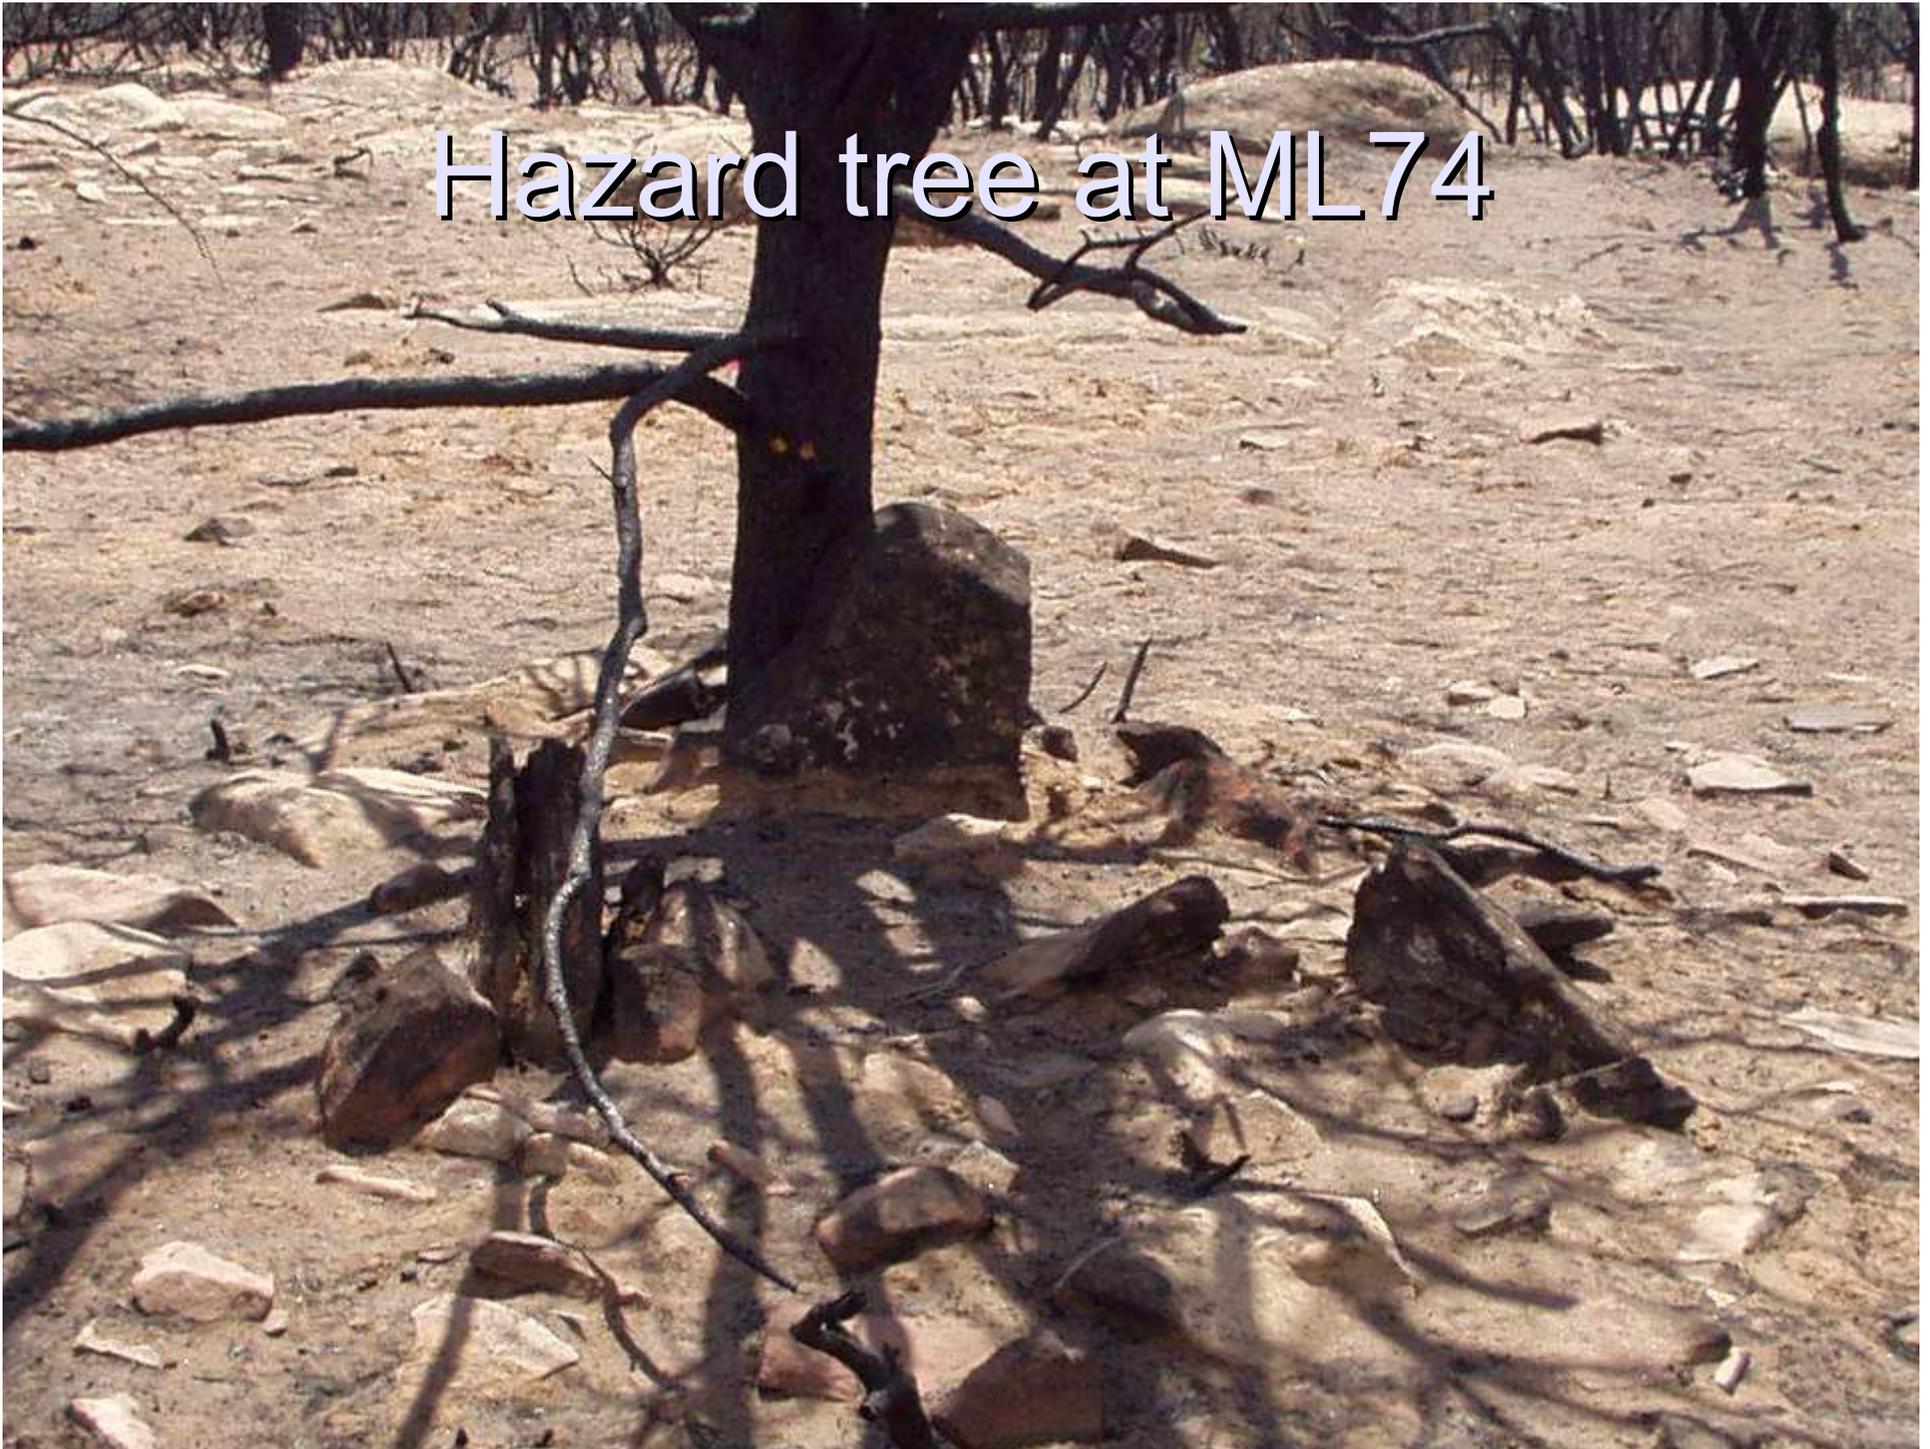
Hazard tree at ML74
