**HFQLG
Project Evaluation Form**

Project Name: Slapjack DFPZ and Hampshire Creek Riparian Restoration
Project Type: Underburn to create DFPZ and Road Decommissioning

Date: 23 Sept 2008

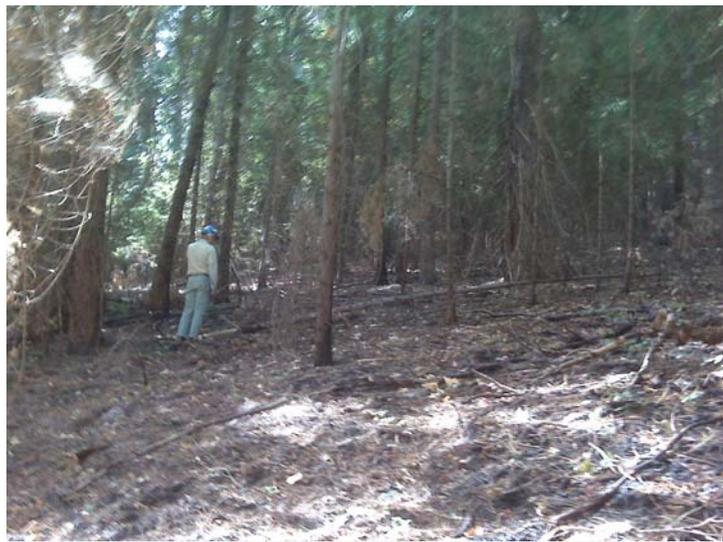
The first stop was at the Pike County Lookout with an overview of Slapjack DFPZ units 18sb and 18b. The group then proceeded to drive into unit 18b to get a better view of the effects of the underburn (Figure 1). Slapjack DFPZ Unit 18b was an underburn that reduced the surface fuels to below 5 tons per acre, which met the HFQLG DFPZ objectives for surface fuel loading. To prevent crown fire initiation, the HFQLG FEIS, Appendix J, recommends managing ladder fuels and crown base height at a sufficient level to prevent crown fire initiation. The underburn raised the live crown base height in some areas, but Rick Case said that there were still too many ladder fuels in portions of the units and a second treatment would be desirable. Some areas burned at too high a humidity and the burn did not consume enough ladder fuels.

Slapjack unit 18b did not reduce the canopy, and the stand does not meet DFPZ objectives of 40% canopy. During a project review with industry, there was a request to delete some of the cable units because it would have made the Slapjack project uneconomical. Set up costs are too great to remove small diameter understory trees. Therefore, canopy reduction objectives could not be met. The DFPZ could be used with wild fires at or below the 90% range when a running crown fire would not be expected.

Figure 1. Slapjack Unit 18b; shows results of underburn.

Slapjack Unit 18b underburn project met surface fuel objectives, partially met ladder fuel objectives, but did not reduce the canopy cover to meet reduced canopy cover objectives. The economics of cable yarding prevented meeting the canopy reduction objectives. A follow-up underburn is anticipated to be needed to reduce the fuel loading as the small diameter trees killed in the underburn begin to fall (2-5 years).

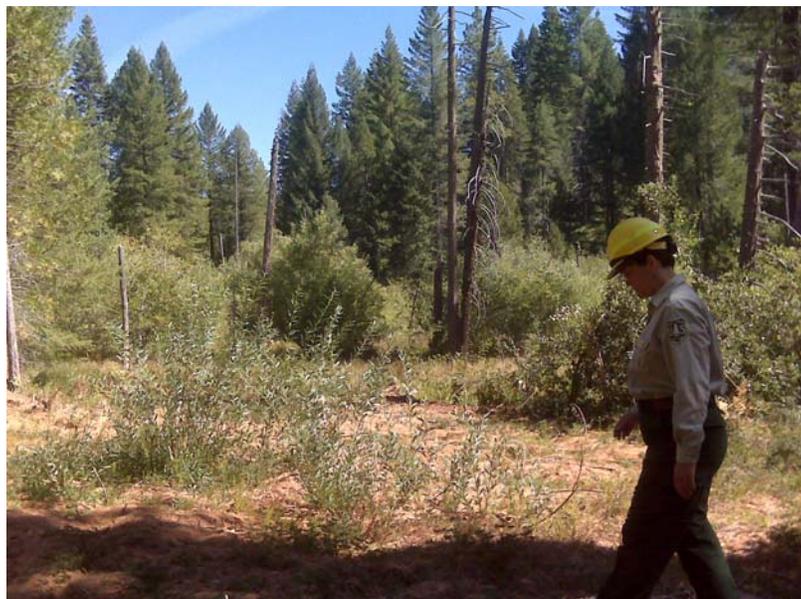
The site of the meadow restoration was a collaborative effort that included specialists from Hydrology, Wildlife and Botany. Kelly Whitsett, Feather River Hydrologist explained that the goal was to restore the forest meadow to a healthy functioning wetland. Western pond turtles and an undescribed species of sedge (*Carex species nova*) were found in the meadow. A road bisected the meadow and impeded the flow of water across the wetland. The erosive clay road surface was a large source of sediment to the wetland. The outer edges of the wetland began to dry out, allowing trees to encroach into the watershed. The meadow area has been restored to allow flow in certain areas across the road. The road was decommissioned but remains in place as a nesting site for the Western Pond Turtle.

Figure 2. Clay soil extends from the decommissioned road into the meadow providing nesting habitat for the turtle.

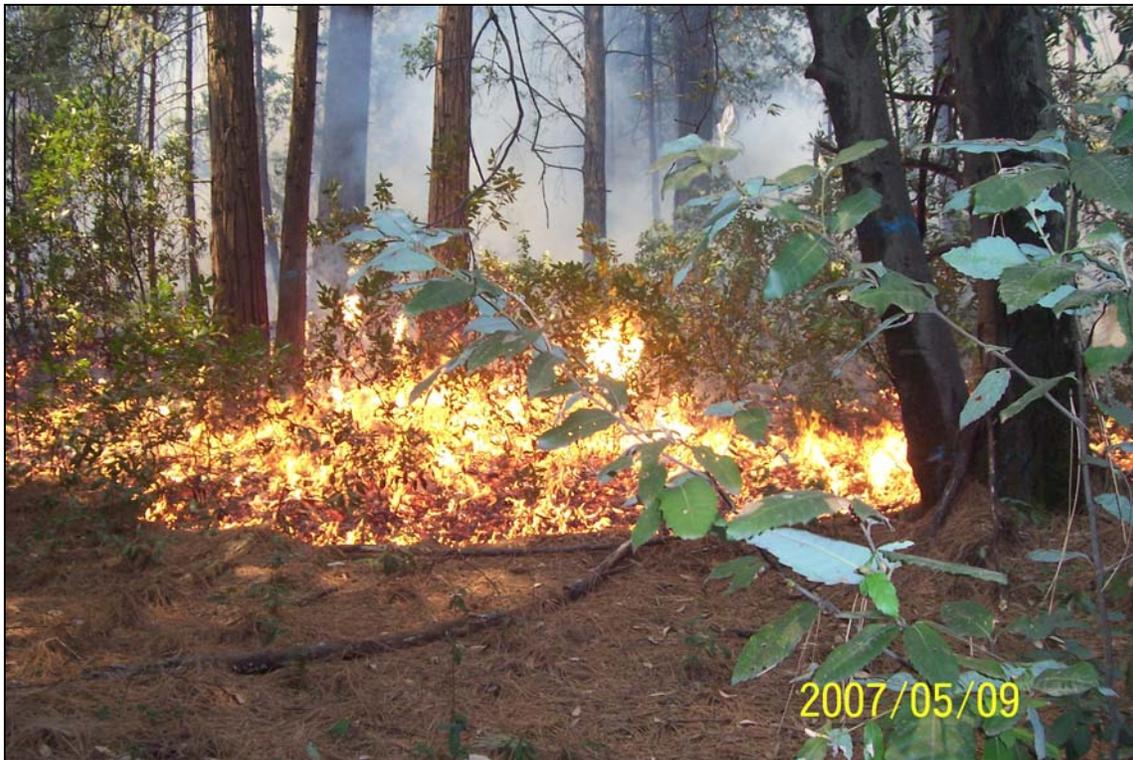
Under the original proposed action, Unit 18 was prescribed a thinning treatment with cable yarding and a follow-up underburn. The volume was determined to be uneconomical for cable logging. The final treatment prescribed to this unit was an underburn only, to reduce the surface and ladder fuels. A total of 145 acres were burned on April 10, May 2, and May 8, 2008 (Figure 1).

Figure 1: Prescribed Burning in Treatment Unit 18

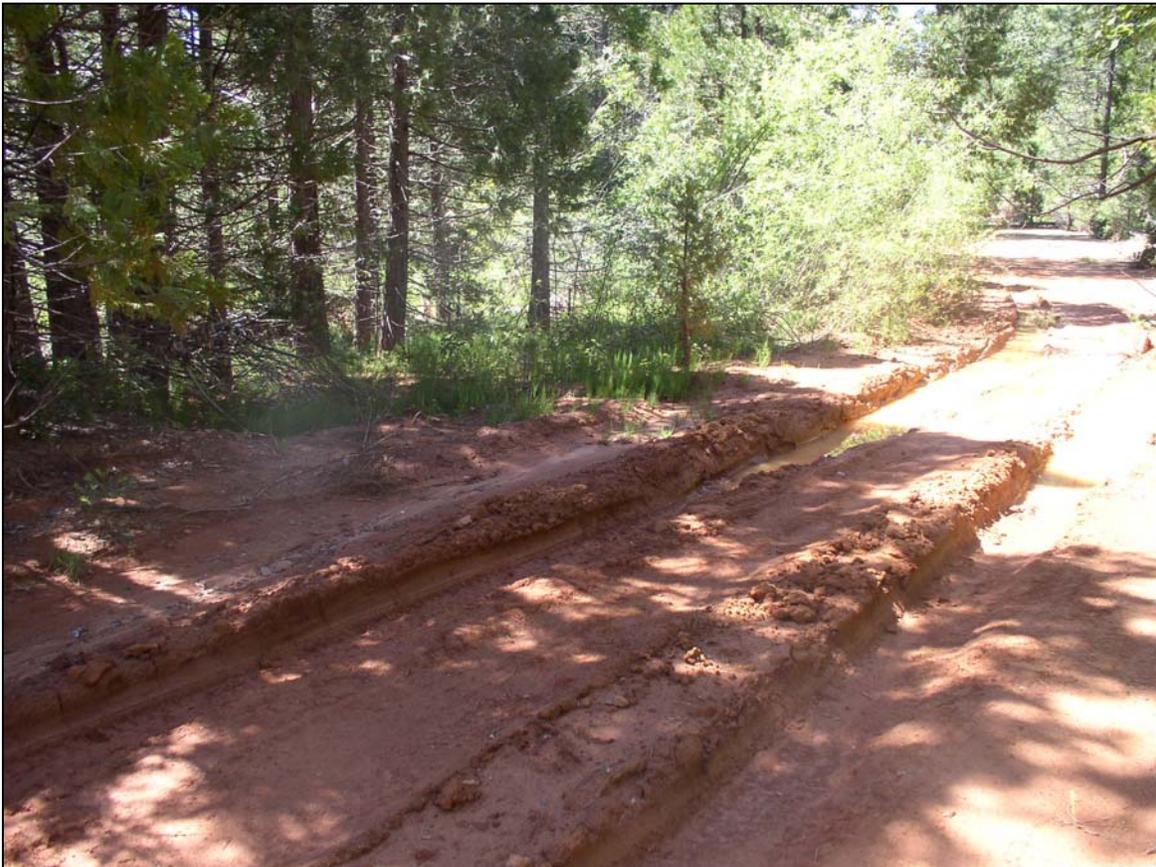
Hampshire Creek was dammed for use in a sawmill. This area was heavily logged. Due to the dam and logging, the water table rose, conifers could not grow back in, and a wet meadow formed. Later, a native clay road was built through the center of the meadow. The road was approximately two miles long with no constructed waterbars. Through time the road became severely rutted and clay sediment deposited into the meadow and started filling the meadow in, allowing conifers to grow back in and lower the water table (see Figure 2).

Figure 2: Before Picture - Meadow and Road Condition Prior to Restoration

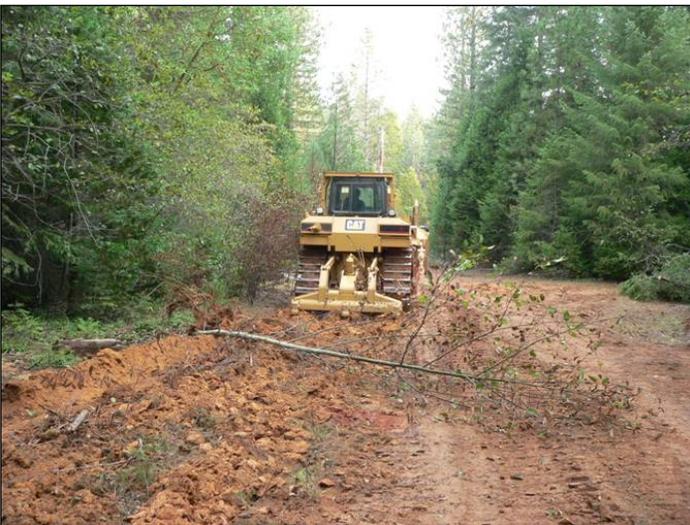
Figure 3A: Ripping Road Surface to Uncompact Soil

- 6) Decommissioned 20N25 from culvert stream crossing to boundary of the timber sale. This included removing three culverts, reshaping the channel at culvert locations, smoothing ruts, uncompacting road surface (Figure 3A), adding waterbars, and straw mulch along stream banks.

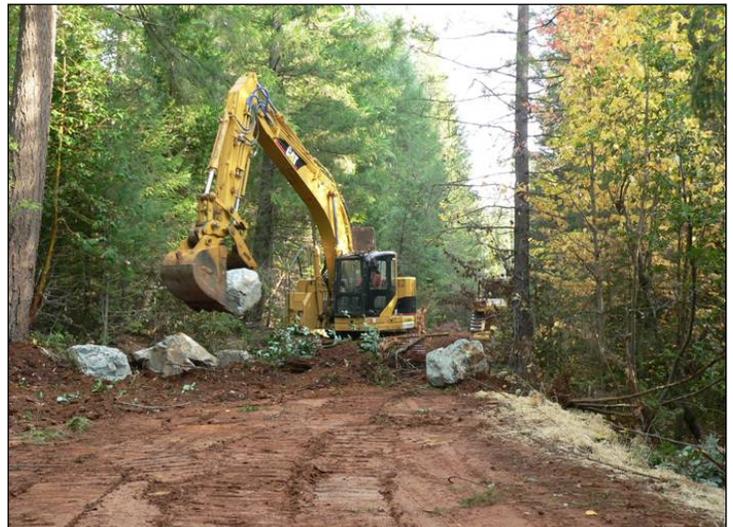
Figure 3B: Excavator Operator Placing Rock Barrier

- 8) In the Upper Meadow, removed encroaching conifers and put stream into original channel.
- 9) Blocked both ends of 20N25 with rock/log barriers to prevent motorized use (Figure 3B).

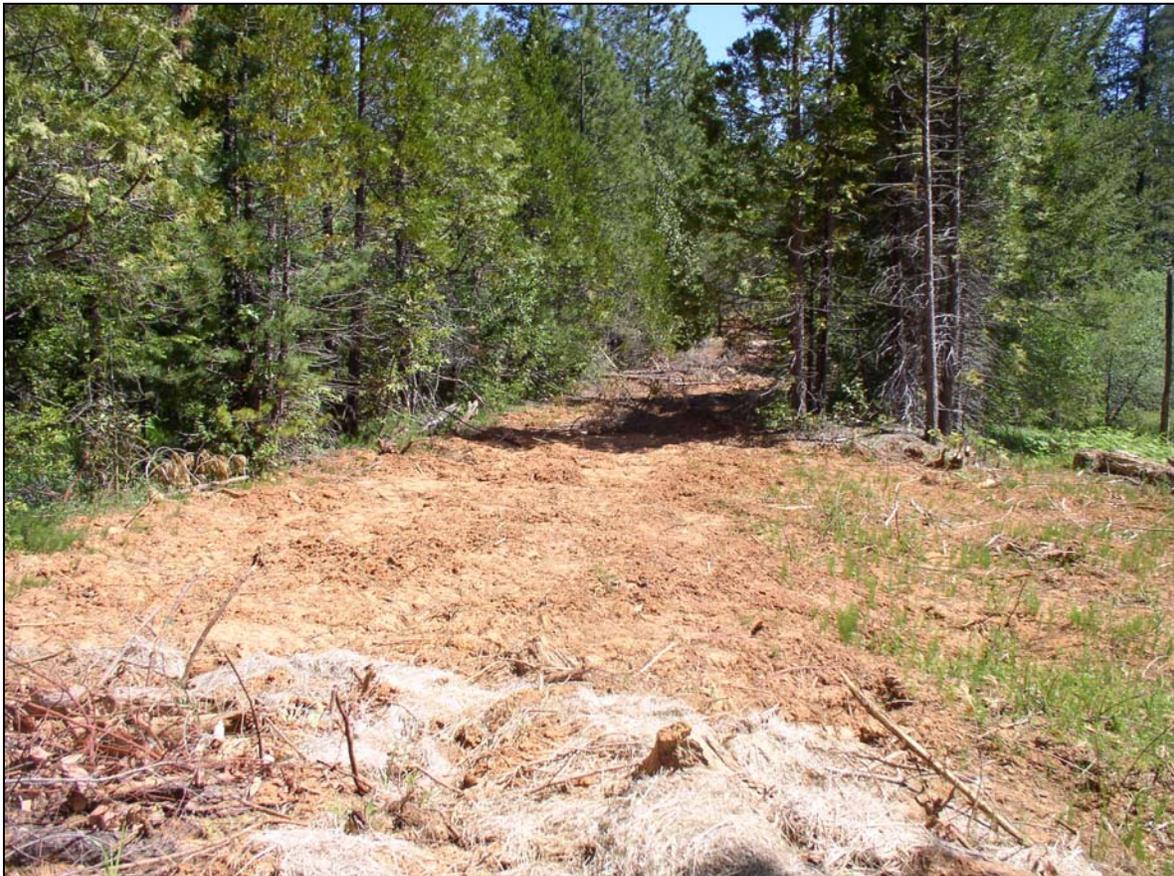
Total accomplishments include 0.4 miles of reconstruction, 1.5 miles of road decommissioning, and 5 acres of meadow habitat restoration (Figure 4).

Figure 4: After Picture of Road and Meadow Taken in May 2008
