**SISKON MINE MILL AND MINE TAILNGS CERCLA REMOVAL ACTION
PHASE 2, REHAB CONTRACT
STATUS REPORT #2**

October 12, 2004

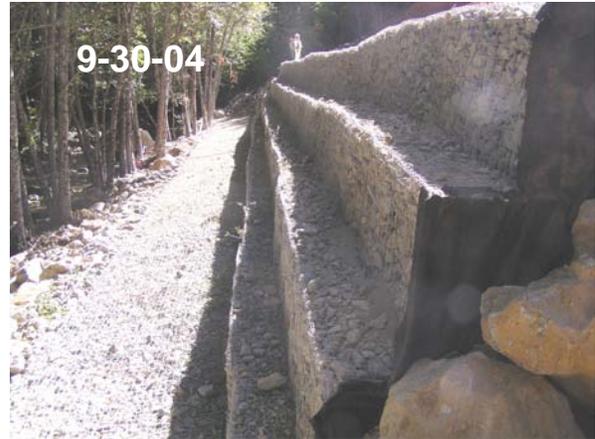
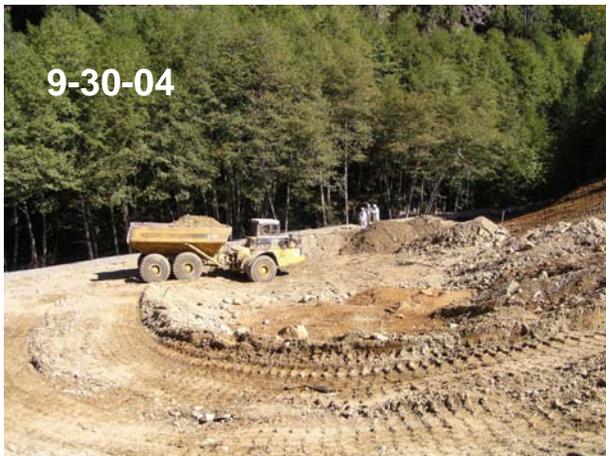
Construction was completed on the gabion wall andrevet mattress. Riprap was placed at both ends of the wall structure.

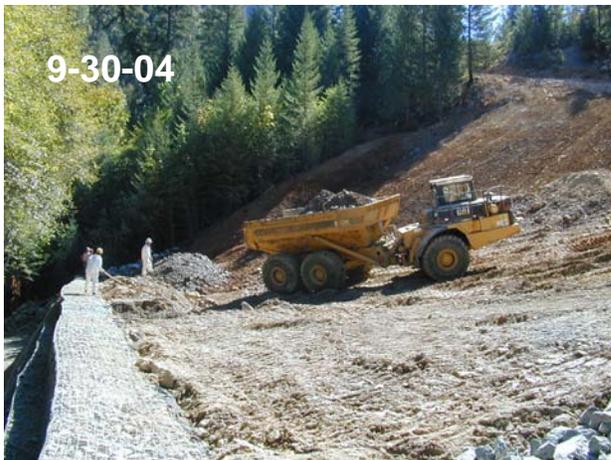
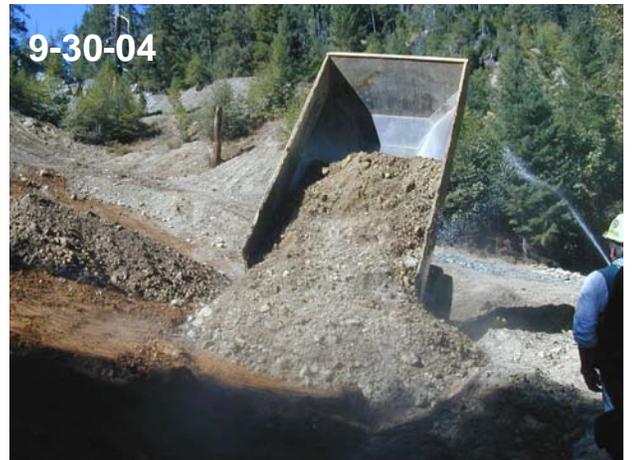
After completion of the gabion wall, the tailings were graded and capped with clean borrow soil material. The tailings are red colored--- the cap soil is gray.

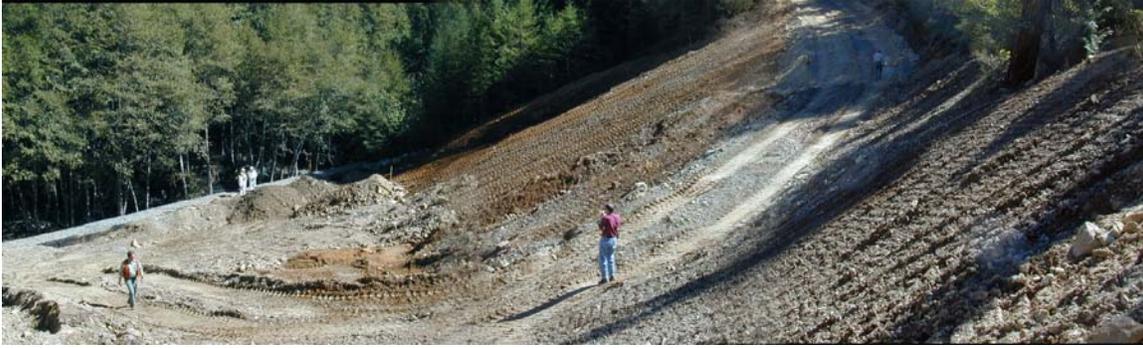
View of the capping process downhill toward Copper Creek.

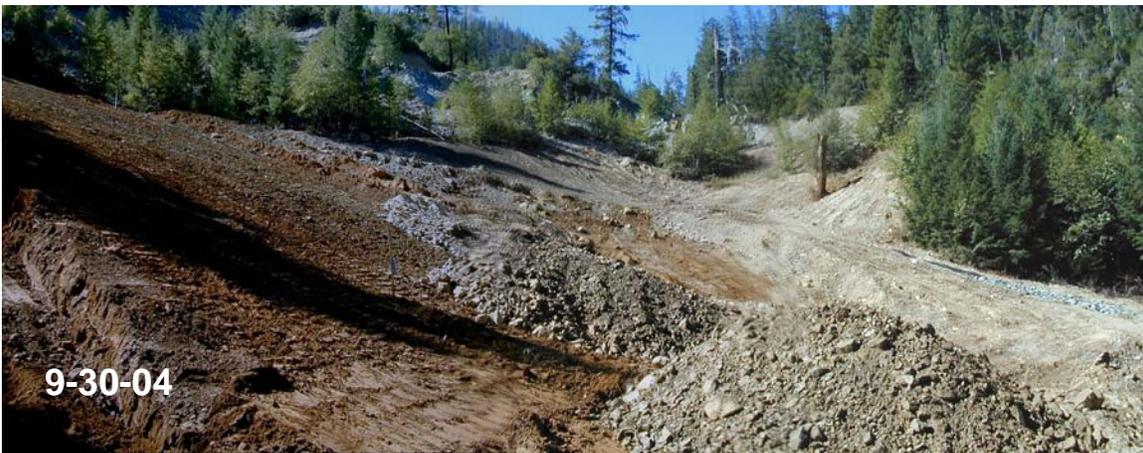
View of the cap being graded on top of the tailings, looking upslope of the gabion wall.

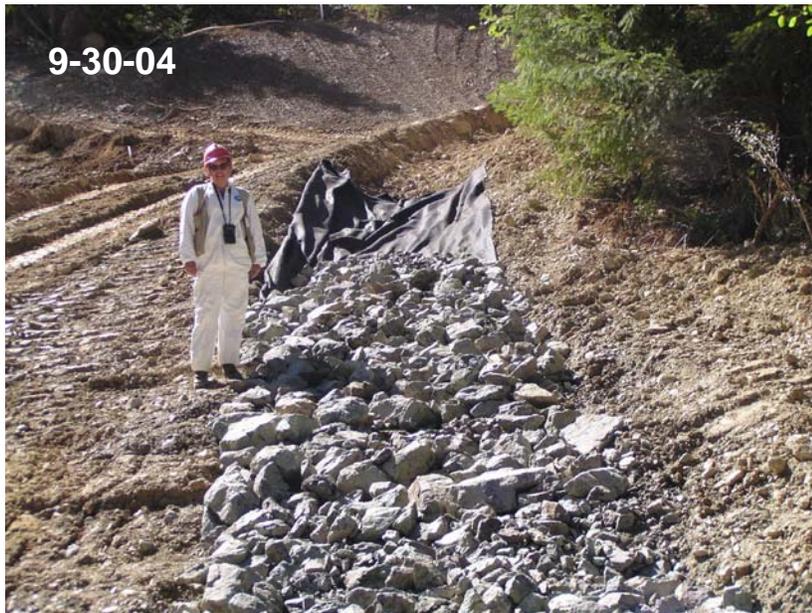
Riprap filled ditch construction was in progress on September 30, 2004. This ditch is on the north edge of the cap.

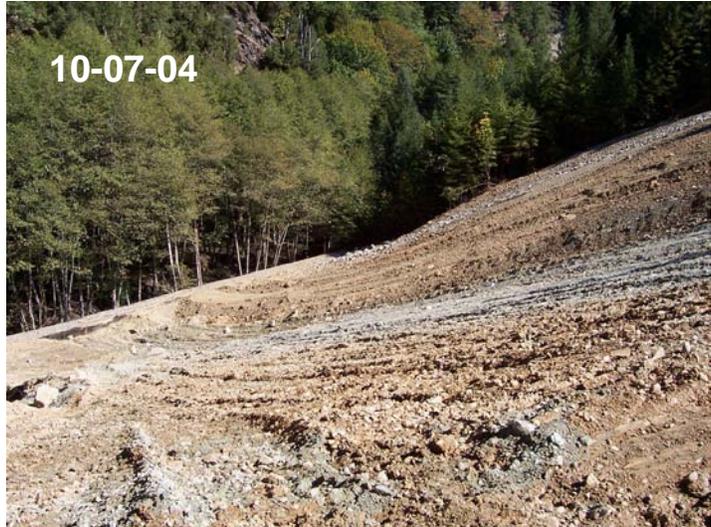
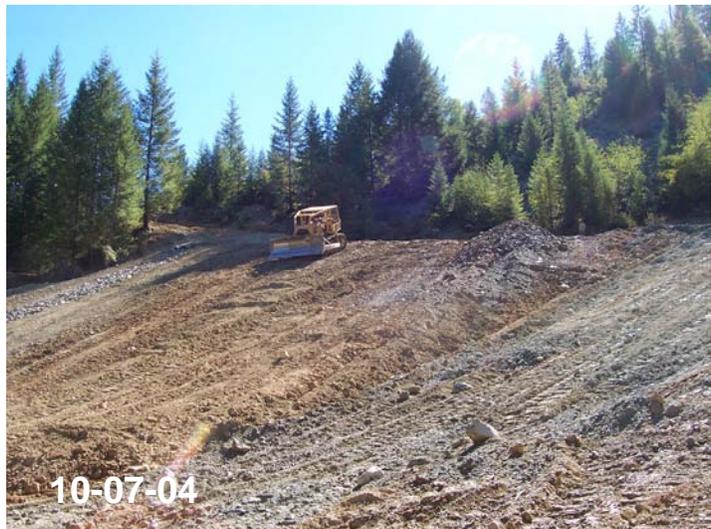
The cap has been completed, and construction of the riprap lined center ditch is ongoing. The slopes look steep in this picture but range from 10% (10H:1V) near the gabion wall to about 40% (2.5H:1V).

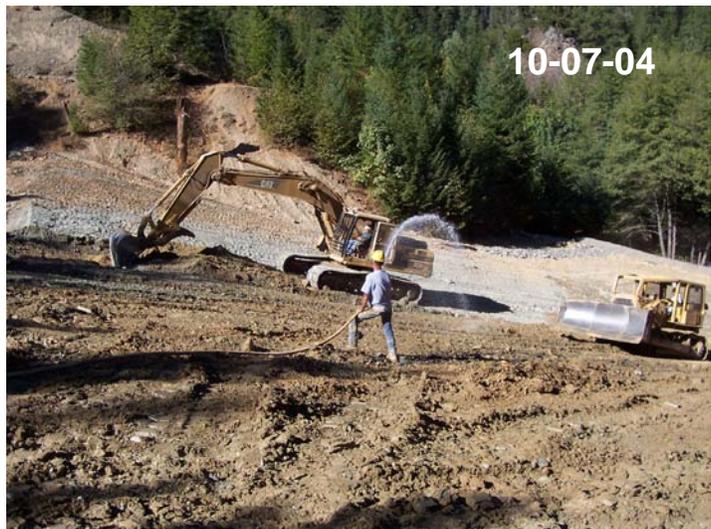
Construction of the riprap lined center ditch.
