**SISKON MINE MILL AND MINE TAILNGS CERCLA REMOVAL ACTION  
PHASE 2, REHAB CONTRACT  
STATUS REPORT #1**

**September 7, 2004**

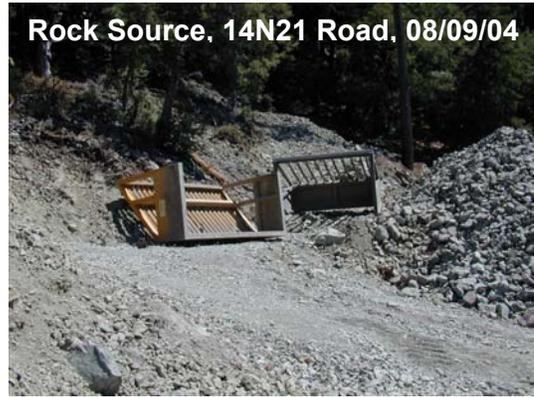
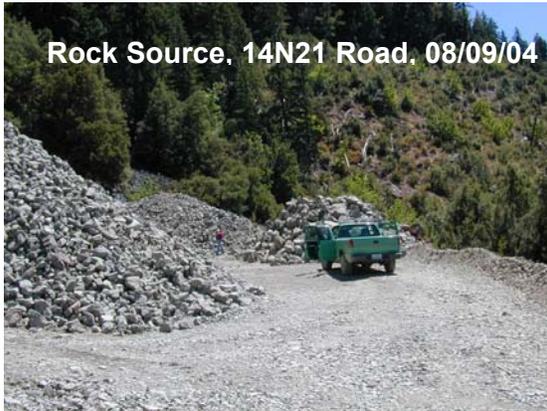
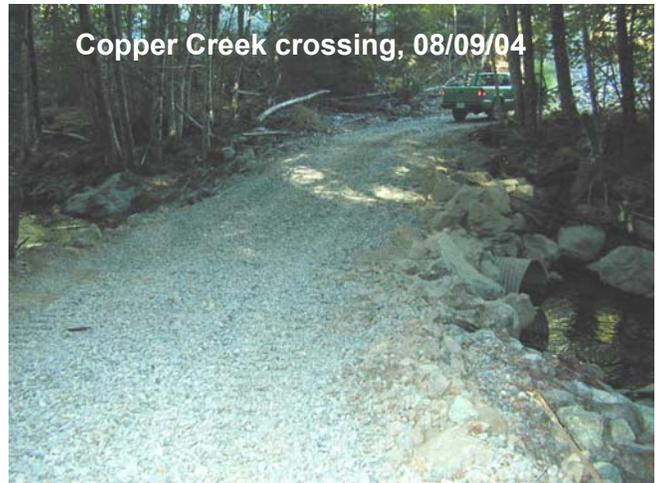
The notice to proceed for Phase 2 of the Siskon Mine Rehab Project was issued June 28, 2004. Work began at the rock pit where the rock was screened and sorted into sizes for Class III and Class V+ riprap, and rock for the gabion wall and revetment.

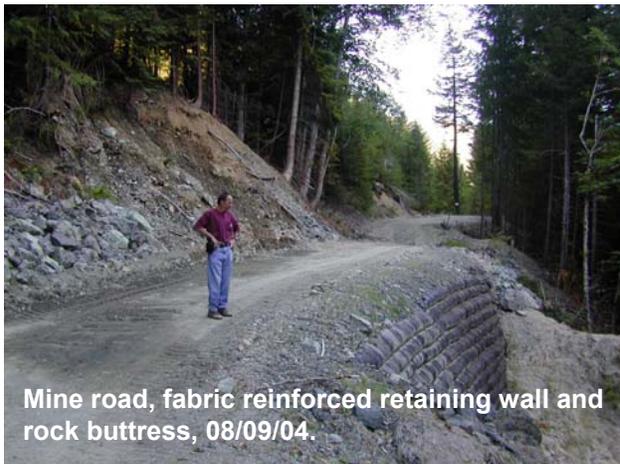
By the end of July, the 14N31 road was bladed and cleared, and the Copper Creek crossing cleared of debris and resurfaced. The mine road to the mill site was also cleared of material that had sloughed off the hill slope from the winter, at the retaining wall and rock buttress site.

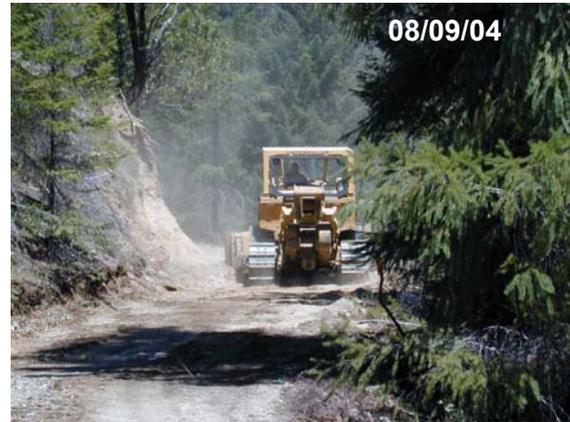
Work at the contaminated part of the site began on August 9, 2004 after the initial Site Safety Meeting held for all employees including the Forest Service contract implementation and design team. On that day, the access road into the mill was constructed and mill site demolition commenced. All contractor employees wore tyvek coveralls and respirators, and initial air quality monitoring was conducted for asbestos and metals.

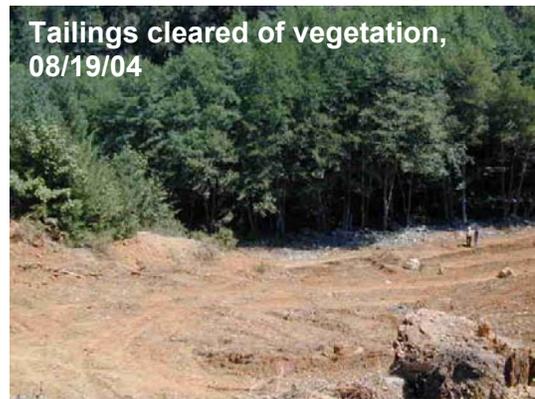
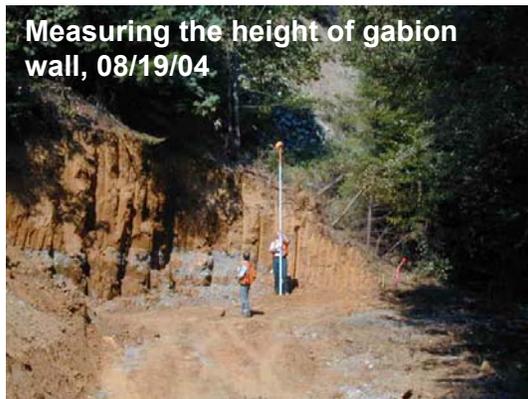
The tailings area was cleared of vegetation, and access roads into the former tailings pond and to the gabion wall site were constructed by August 12. Tailings were removed from the areas near the stream channel, and the footprint of the gabion wall was excavated as of August 16.

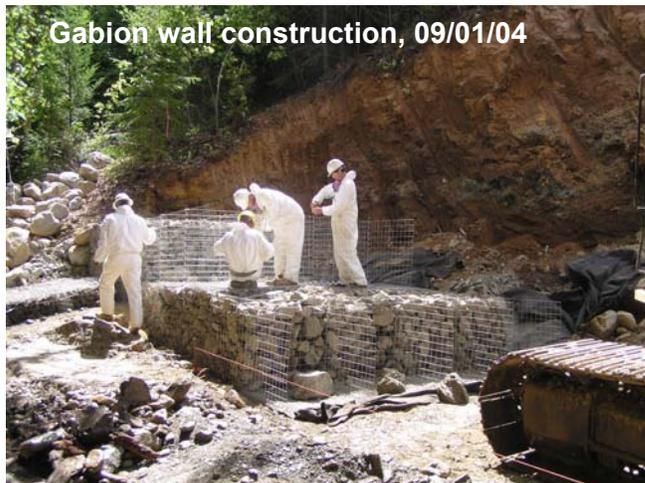
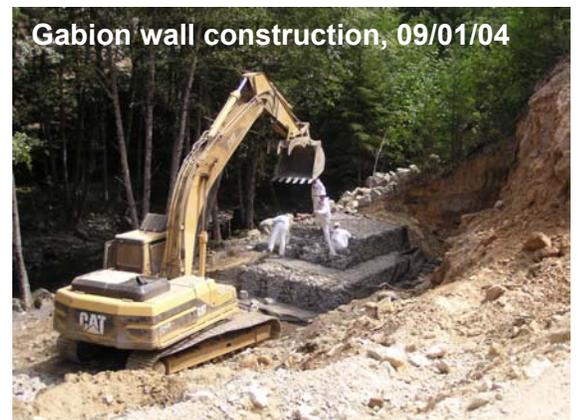
Work on construction of the gabion wall andrevet mattress began August 23, 2004, and is continuing to this date. The project is on schedule at this time to be completed prior to October 15, 2004.
