**2006 BEST MANAGEMENT PRACTICES EVALUATION
PROGRAM REPORT
USDA FOREST SERVICE
LAKE TAHOE BASIN MANAGEMENT UNIT**

**Wes Christensen and James Harris, Hydrologists
LTBMU Department of Ecosystem Conservation**

February 2007

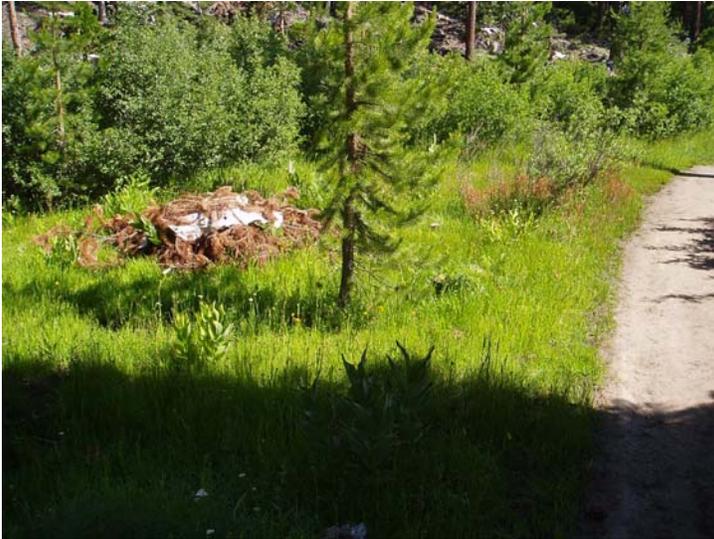
Meeks Meadow Unit 14-12 – Implemented & Effective

One SMZ evaluation was completed for the Meeks Meadow Unit 14-12 hand thinning unit, located on the north side of Meeks Meadow. A gated dirt road runs along the north boundary of this meadow and, with the exception of a few areas, defines the edge of the meadow environment from the hillside. During the layout of this project, the dirt road was used to define the edge of the meadow and hence the boundary within which burn piles were to be excluded. However, the presence of primary riparian indicator species on the north side of the road in some areas requires the meadow boundary to be extended north, beyond the road. The presence of the fuel piles in their current location does not threaten the integrity of the SEZ as long as they are left unburned. The Fire and Fuels Management personnel have been notified of the situation and their plans to burn these piles have been put off until arrangements can be made to relocate these piles or dispose of them in another manner.

Meeks Meadow Unit 14-12 – burn piles located within SEZ boundary as defined by primary riparian indicator species (2006).

- Ensure that burn piles located within the Stream Environmental Zone (SEZ) boundary at Meeks Meadow are removed from the SEZ before burning or disposed of in some other manner.

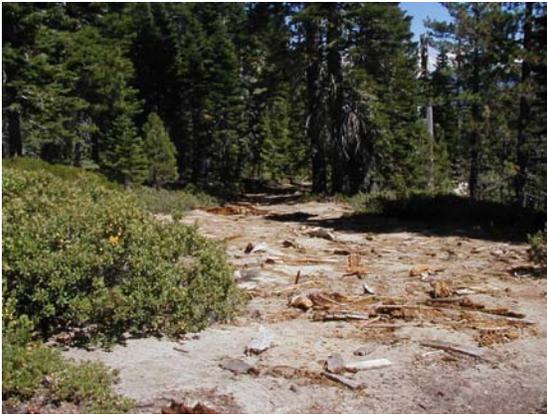
1330-Implemented and effective

This road accesses a recreation residence tract. At the end of the road, a 300-foot section was decommissioned by a local Forest Service road crew. Decommissioning entailed barricading the decommissioned segment with 2-foot and 4-foot boulders and scattering woody debris in the old road bed. The decommissioned section crosses no streams and there was no evidence of erosion or unauthorized use. A Forest Service gate at the entrance of the road and State Highway 89, which is always closed, aids in preventing unauthorized use.

Decommissioned road segment on FS Road 1330.

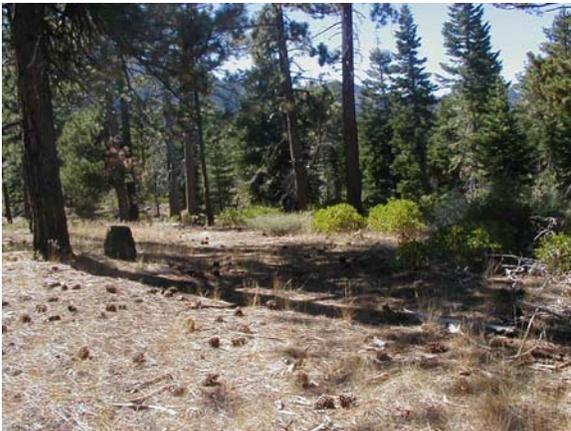
1379B.1-Implemented and effective

Seven hundred feet of this road was decommissioned with a local Forest Service road crew. Decommissioning was completed through ripping of the old road bed. The decommissioned section crosses no streams and there was no evidence of erosion or unauthorized use.

Decommissioned road 1379B.1

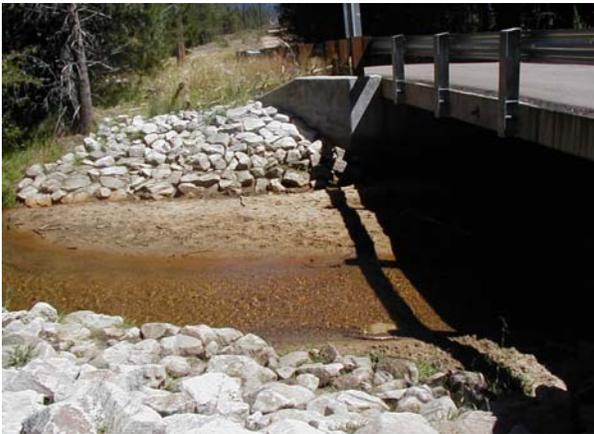
12N08-Implemented and Effective

Rip-rap composition was completed in 2005 for 12N08, where the road crosses Saxon Creek. This project was part of the Powerline Road/Fountain Place project and the BMPs evaluated were rated successful for implementation and effectiveness. Angular cobbles were placed upstream and downstream of the crossing. There was no evidence of scour and the rip-rap was designed so as to allow hikers and dogs access to the creek. Also, large woody debris was placed around the crossing to deter recreational enthusiasts from disturbing the streambanks.

12N08 at Saxon Creek on September 6, 2006.

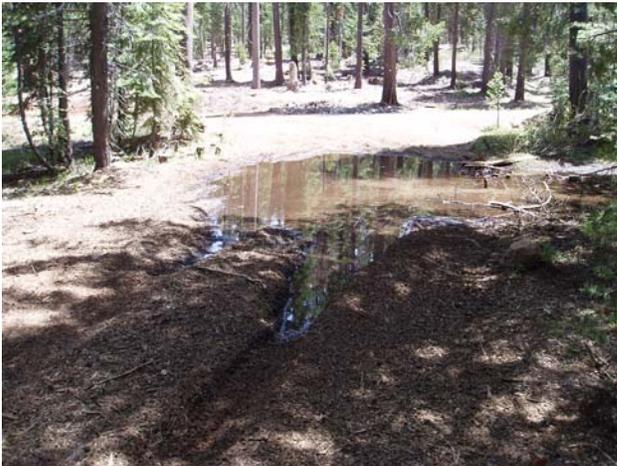
16N93-Implemented and Not Effective

This road has a native surface and is located between a residential area in Kings Beach and Highway 267, also known as the Fiberboard Freeway. On June 6, 2006 the gate on the Highway 267 end of the road was open and the gate near the neighborhood was closed. The Basin's Gate Management Plan states that "no gates should be opened in the summer without prior approval by the Road Manager." Discussions with the Engineering staff indicated that the gate was locked, but was subsequently opened by other than authorized Forest Service personnel because road conditions were unsuitable for use. The BMPs evaluated were rated not effective due to road-derived sediment impacting an ephemeral stream and the formation of ruts. Wood chips placed in the ruts were not effective, as seen in the photograph below. The Engineering Department will monitor this gate closure more frequently.

16N93 Road ruts and ponding water on June 6, 2006.

- Ensure all gates are closed during seasonal closures.
- Coordinate with permittee holders to redesign the Echo Lake parking lot and nearby trail to prevent runoff and sediment from reaching the channel.

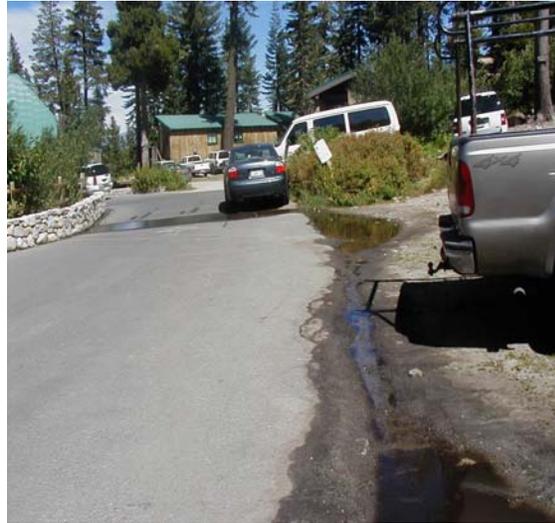
refuse removal, etc.” The Echo Lake Trailhead and parking area were included because they provide a building with vault toilets that are serviced by the Forest Service. Parking occurs at an upper parking area, a lower parking lot, and a road between the two parking areas. The BMPs for the trailhead were rated as not being implemented, due to the lack of design features necessary to convey runoff from the lower parking lot. The lower parking lot includes parking and structures for special use permittees. The evaluated BMPs were rated as not effective, as runoff and sediment from the lower parking lot reach the outlet stream from Lower Echo Lake. The source of runoff on August 28, 2006 was a spring in the lower parking lot, due to a plugged CMP. Runoff traveled down the lower parking lot and onto a trail between the parking lot and outlet stream. Eroded sediment from the trail, transported by uncontrolled runoff from the parking lot, was observed in the perennial stream. This site should be evaluated for future BMPs that would control and disperse the runoff from the lower parking lot. The CMP also needs to be unplugged and the trail needs adequate drainage.

Echo Lake Trailhead-Source of runoff in Lower parking lot. August 28, 2006.

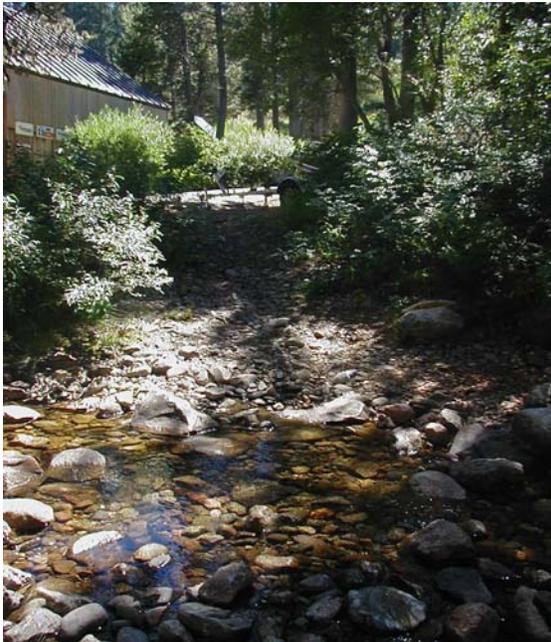
Echo Lake Trailhead-Trail and stream Downstream of the Lower parking lot. August 28, 2006.

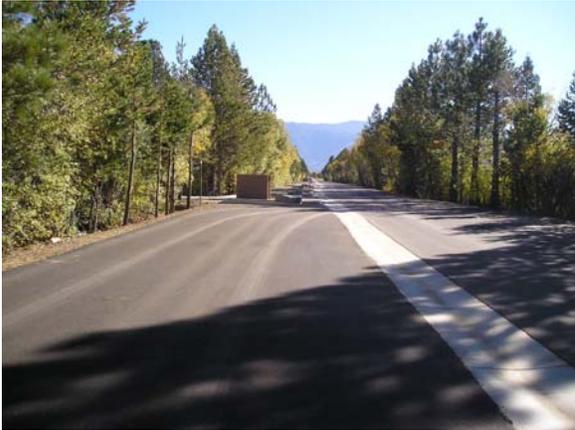
Pope Beach-Implemented and Effective

This recreational area is located on the south shore of Lake Tahoe and is operated by California Land Management. The recreational site provides parking, refuse disposal, bathrooms, and drinking water. The beach is one of the most popular beaches on the south shore of Lake Tahoe. The lake is less than 100 yards from the parking area. This site's BMPs were rated successful for implementation and effectiveness.

Pope Beach parking area upgraded in 2006. October 13, 2006.

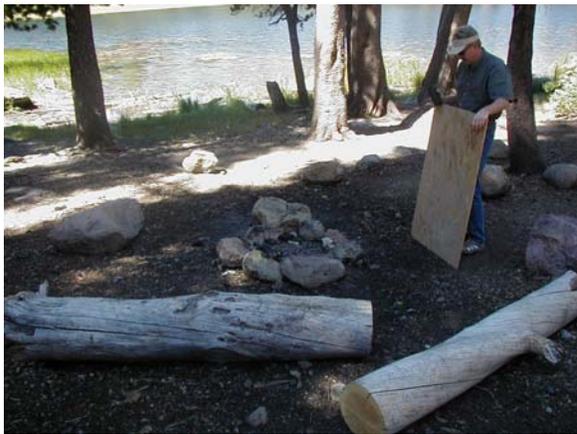
This area lacked needed BMPs and was therefore rated unsuccessful for implementation. The following problems were noted:

- There is insufficient ground cover between the northernmost campsites and the western shore of the lake.
- Vehicles are able to drive to the edge of the lake and, as a result, increase sediment transport to the lake.
- Two non-approved fire rings within 20 feet of the lake were found during both site visits.

Additionally, immediately following Labor Day weekend, considerable piles of discarded lumber were found throughout the site. According to the scoring rule set embedded in the Regional database, which gives primary weight to factors such as transport of human waste and refuse to a water body, the BMPs are effective. However, the LTBMU rates the BMPs as ineffective, because of evidence of sediment transported to the lake. Corrective action to provide a physical SEZ buffer and restore compacted and denuded areas is recommended.

Watson Lake - Unapproved fire ring and Discarded lumber following Labor Day weekend.

- Install physical barriers and signage to create SEZ buffer around Watson Lake. Establish ground cover near the northern most camp site to prevent sediment from entering the lake.

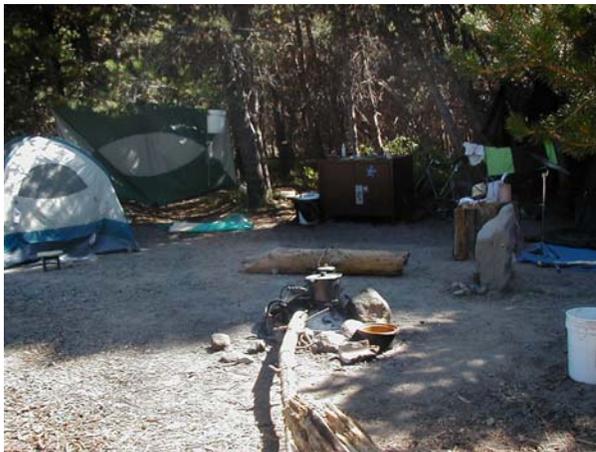
Blackwood Canyon Dispersed Camping-Implemented and Effective

This dispersed camping area is located off Forest Service Road 15N38. Campsites are located on either side of the road and away from Blackwood Creek. Campsites are numbered and have bear-proof food storage lockers and Forest Service-provided campfire rings. A building houses two vault toilets and there is a dumpster for refuse. The road and parking area are graveled and there were no indicators of erosion. Within this area is a day use area with picnic tables. The entire area does not pose a risk to the water quality of Blackwood Creek. The BMPs were rated for effectiveness after the Labor Day weekend and were rated successful for implementation. It was noted, however, that an illegal BBQ full of trash was found in the day use area. In addition, an illegal fire ring associated with an illegal campsite was found next to an abandoned gravel mine pit. Neither site posed a risk to water quality.

*Blackwood Canyon Dispersed Campsite
September 5, 2006*

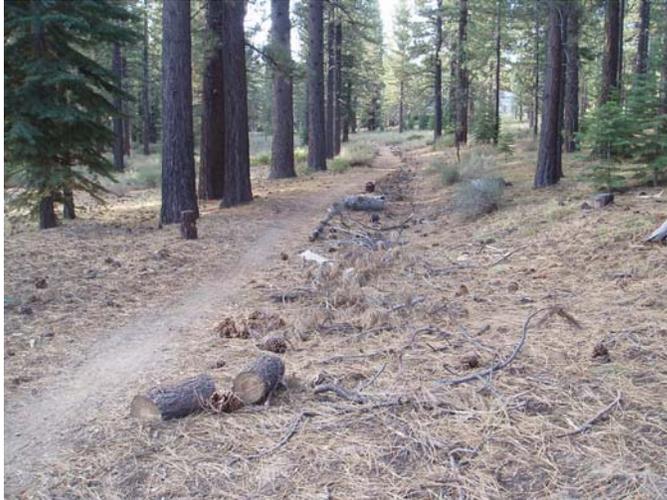
Hartoonian Trail – Implemented & Effective

This evaluation was completed on a section of roads located northwest of the Cold Creek crossing on Pioneer Trail. This project involved converting a section of road to a trail and establishing ground cover to prevent erosion. Ground cover was approximately 50-60% on sections of the old road that had been converted to trails. No problems were observed during this evaluation.

Hartoonian Trail – >60% ground cover over most of the rehabilitated trail.
