## **BATTLE CREEK: LESSONS LEARNED FROM TINKERING AT A CONFLUENCE**

**Steven E. Yochum, Hydrologist**, US Forest Service, National Stream & Aquatic Ecology Center, Fort Collins, CO, [stevenyochum@fs.fed.us](mailto:stevenyochum@fs.fed.us)

prepared for the 10<sup>th</sup> Federal Interagency Sedimentation Conference  
April 19-23, 2015, Peppermill Hotel, Reno, Nevada, USA

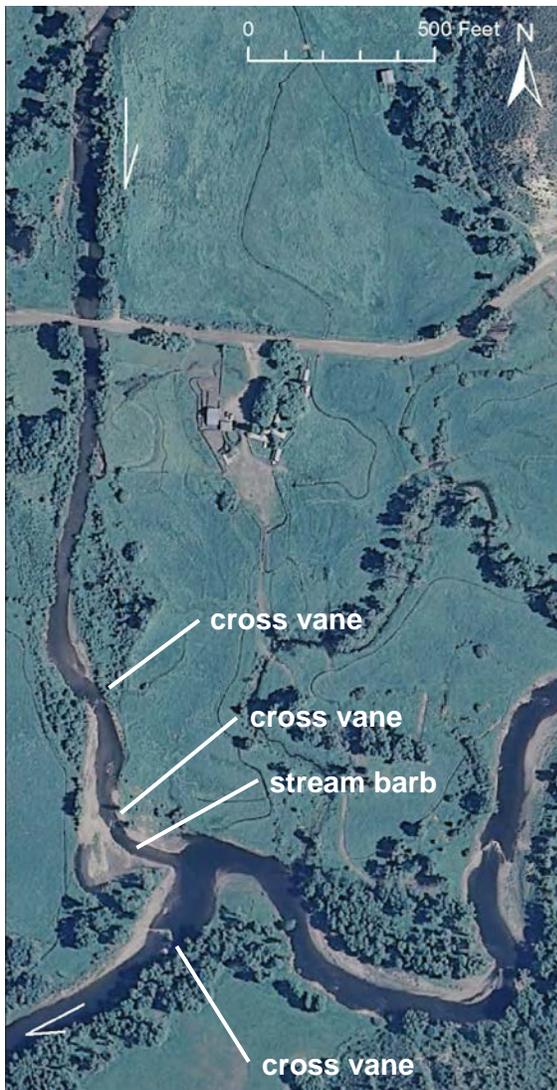
Figure 1: Battle Creek at the Little Snake River confluence (7/23/2009).

A substantial amount of sediment was deposited on and just upstream of the upper cross vane installed on Battle Creek (Figures 2 and 3). This local aggradation extends for a length of about 200 feet. This deposition forced an avulsion of the stream channel to the west of its previous location (Figure 1). The channel has a braided form within this short extent, with the preferential flow channel currently on the west edge of this depositional bar. A meander bend and point bar is forming to the east of this channel. In the vicinity of this depositional bar, both sides of the channel have willows along much of the banks, but coverage is patchy with grazing apparent on both banks, negatively impacting willow- and sedge-induced bank stability. The streambank on the west side of the depositional bar, adjacent to the principal flow channel, is actively eroding (Figure 4). A few of the patchy willows that were once present along this bank were laying in the channel. The fenceline and aerial imagery indicate rapid bank erosion rates.

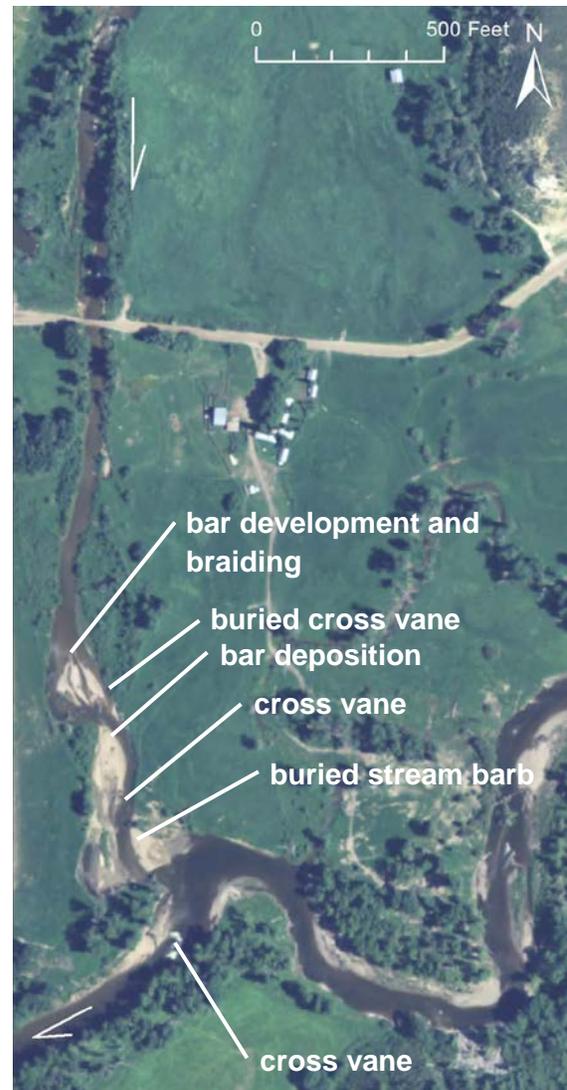
cottonwood gallery. Battle Creek enters the Little Snake with an atypical upstream orientation. Substantial sediment deposition is evident in Battle Creek just above the confluence (Figure 2). Combined with the impacts of grazing practices on riparian vegetation, this deposition resulted in rapid bank erosion rates that are problematic for the landowner.

Figure 2: Battle Creek at the Little Snake River confluence (7/23/2011).

An additional bar has been deposited downstream of this location, on the west bank between the two cross canes (Figures 2 and 5). Opposite this point bar, a second rapidly-eroding bank is present (Figures 5) as the stream attempts to increase its meander planform. A cross vane that appears to be functioning properly is located just downstream of this eroding bank. No willows are present on this bank. The aerial imagery (Figures 1 and 2) indicate that this bank is not eroding as quickly as the upstream bank. Heavy grazing was apparent along this bank, along with indications of additional feeding in this pasture.

The third and final depositional bar is at the confluence (Figures 2 and 6), with the bar extending from north to south across the constructed channel location. This bar consists of multiple sediment sizes, with coarse material deposited on fines. A portion of a stream barb can be seen protruding from the bar (Figure 6). The growth of this bar mirrors the erosion of 20 to 30 feet of the confluence point between 2009 and 2011. Alongside this erosion the pool in the Little Snake just upstream of the confluence has been reported to have filled substantially. Additionally, flood debris is present on the fenceline on the west side of Battle Creek, showing the approximate high flow elevation for the Little Snake in 2011.

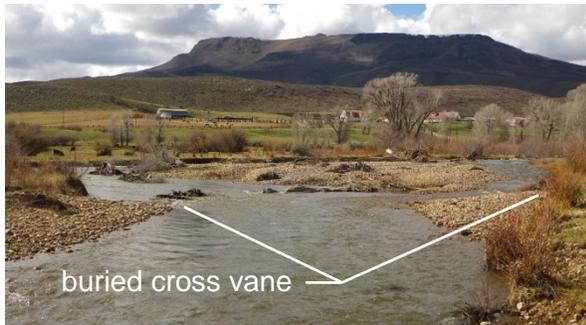
Figure 3: Upper cross vane, with sediment deposition and braiding just upstream.

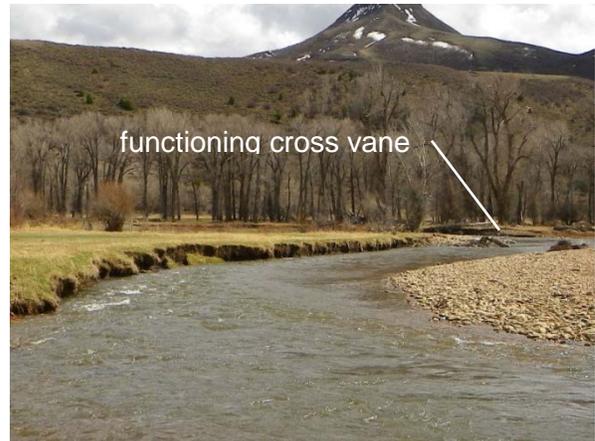
Figure 5: Rapidly-eroding streambank, opposite of an additional depositional bar.

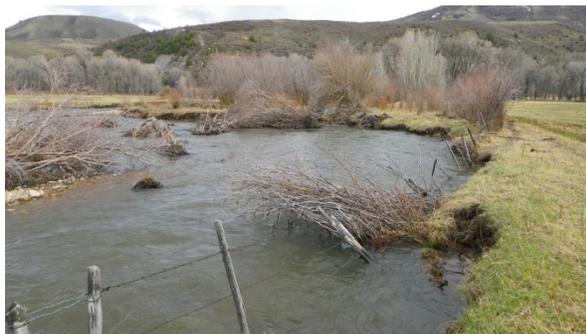
Figure 4: Rapidly-eroding streambank adjacent to depositional bar.

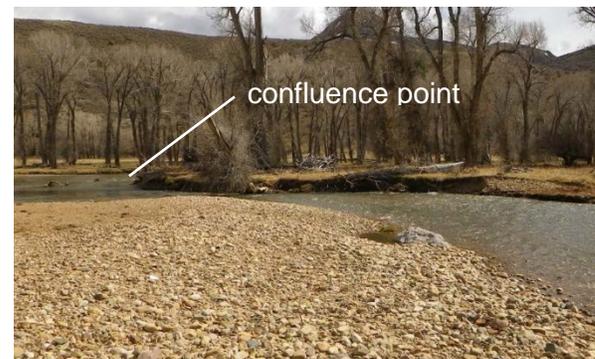
Figure 6: Confluence bar, with variable bed material size.

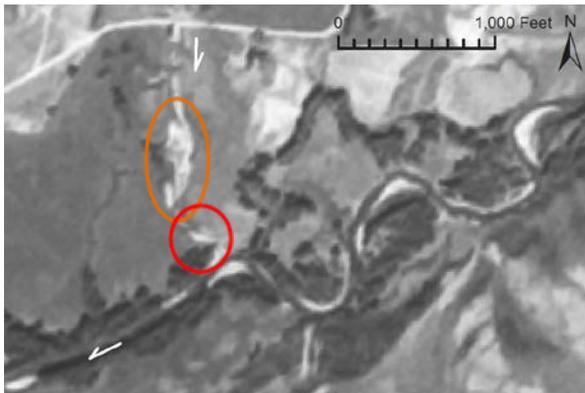
Over this period, the aerial images indicate cyclic sediment deposition and vegetative colonization along the last 1000 feet of Battle Creek upstream of the confluence. In 1953 (Figure 7), an upper depositional bar is apparent in Battle Creek (orange oval). This bar is in a similar location as the bar deposited in 2010 and 2011. A couple of small unvegetated bars are also visible in the lowest portion of Battle Creek (red circle). By 1968 (Figure 8) the upper depositional bar (orange oval) has become well vegetated though an avulsion across the bar is visible. Flow appears to be split at this point in time. The lower depositional bar has enlarged a bit, with a short series of exaggerated meanders at the confluence. Between 1968 and 1980 (Figure 9) the (streamwise) left channel has filled in the formerly unvegetated upper bar (orange oval) and Battle Creek flows in a single, relatively strait channel through this upper reach. This portion of the floodplain appears to be well vegetated. The increasing meandering form indicated in 1953 and 1957 straitened in 1968 and maintained this form in 1980. The lower depositional bar (red circle) has again increased in size and maintained little vegetative growth, with a growing point

Figure 7: Aerial image (8/23/1953).

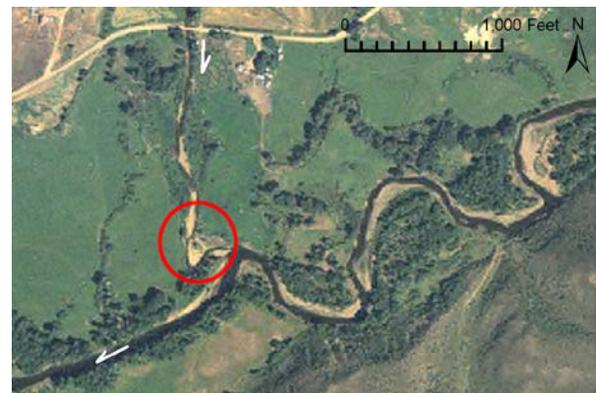
Figure 10: Aerial image (8/4/2004).

bar and increasing meander extent along the well-vegetated confluence point (green oval). In 2004 (Figure 10), the upper reach in Battle Creek is again increasing its meander form while the meander at the lower reach (red circle) is becoming tortuous, as Battle Creek attempts to flank the dense stand of vegetation at the confluence point. Side bars are apparent in the upper reach. Following the flood events of 2010 and 2011, the 2011 image (Figure 2) shows Battle Creek above the confluence to be once again increasing its meander form and depositing substantial quantities of sediment in similar locations as those indicated in 1953 (upper depositional bar) and 1968 and 1980 (lower depositional bar). Some of the vegetated confluence point has eroded, despite the armoring provided by the dense vegetation. The cyclical sediment deposition, vegetative colonization, and erosion is likely due to decreased velocities, shear stress and stream power from backwater effects induced by the Little Snake, with the location varying due to relative peak flow timing, flood magnitude, and flood duration. This bar material is subsequently colonized by vegetation, with a slightly sinuous form repeatedly initiating and straightening.

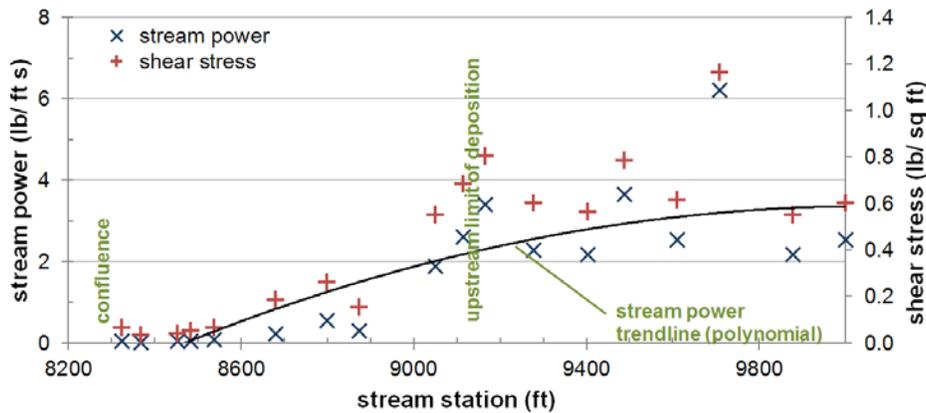
Modeled stream power and shear stress for the ~bankfull, 10-year, and 100-year flows in Battle Creek are illustrated (Figure 11 through 13). In all tested cases, stream power and shear stress decrease substantially at the point where deposition in the stream channel occurred in 2010 and 2011. Since sediment transport capacity is directly proportional to stream power, the modeling results indicate that the sediment deposition (and subsequent bank instability) is the result of backwater effects from the Little Snake reducing flow velocity and sediment transport capacity.

Figure 11: Modeled stream power and shear stress, ~bankfull flow in Battle Creek.

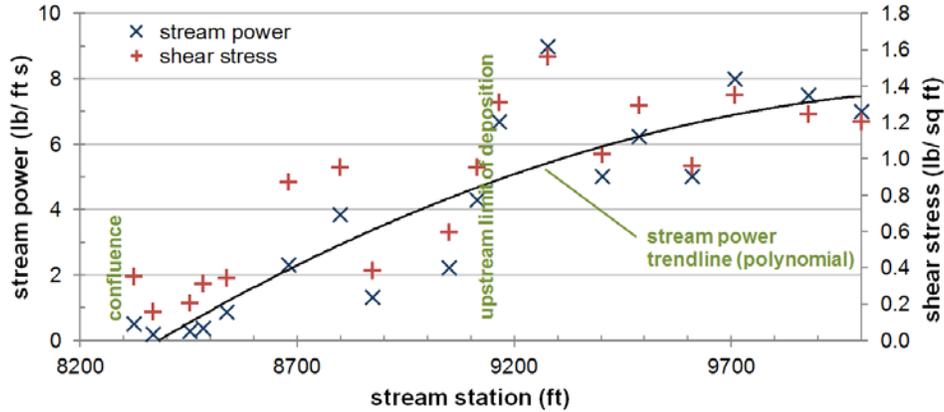
Figure 12: Modeled stream power and shear stress, 10-year flow in Battle Creek.

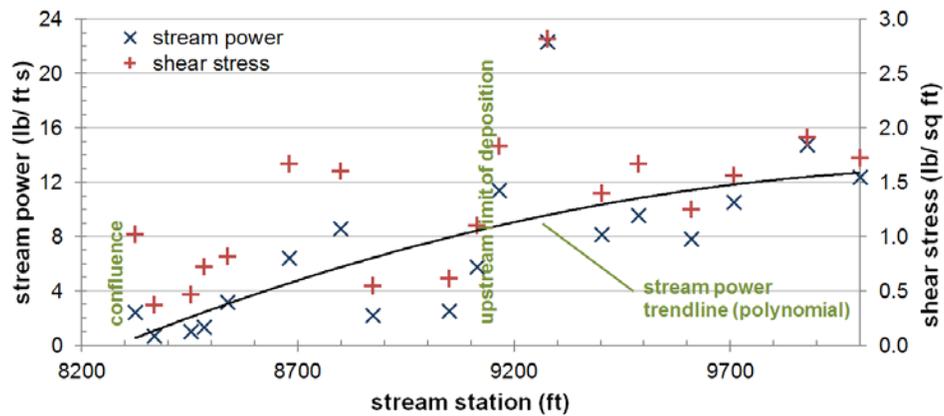
Figure 13: Modeled stream power and shear stress, 100-year flow in Battle Creek.
