BUCK CREEK

Site Information

Culvert Scour Assessment

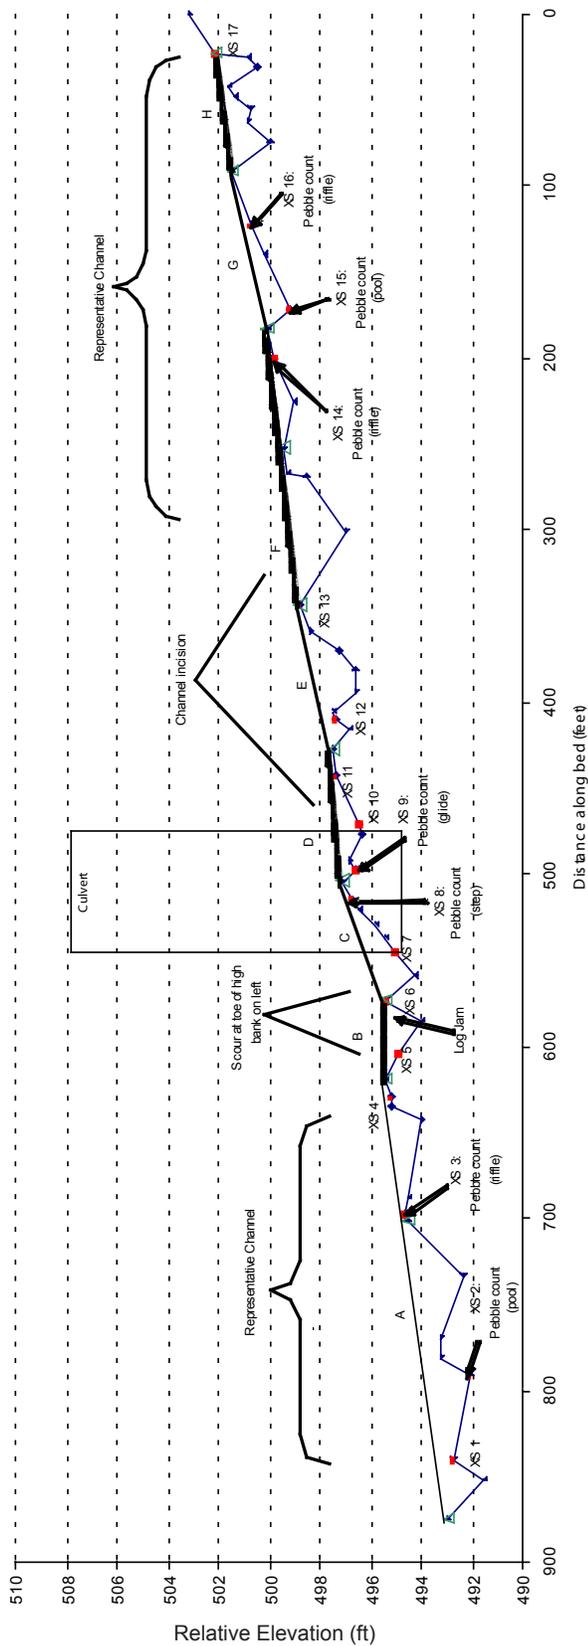
Figure 2—Buck Creek longitudinal profile.

Profile characteristics—The most characteristic feature of the profile is a steep segment in the downstream portion of the culvert (figure 2). There is also an overall segment of steeper gradient extending from the first hydraulic control downstream of the outlet to the second hydraulic control upstream of the inlet. There was also channel incision noted both upstream of the inlet (extending 250 feet) and downstream of the outlet (extending approximately 80 feet). It is unknown whether this incision is related to this culvert or a previous installation. Downstream of the outlet, the channel abuts a high terrace along the left bank where it causes erosion of

While the culvert shows no significant bed scour, evidence of bed adjustment exist. The convex channel profile through the crossing indicates heavy incision through the downstream portion of the culvert and the downstream channel with minor aggradation through the upstream portion. Based on observations of meander pattern and valley slope at this site, it is likely that the channel migration zone has been truncated by the culvert and associated roadfill. Such a change in channel planform, i.e., a shorter channel length, would likely result in a greater bed slope. As the channel has eroded away into the high terrace forming a deep scour pool, the downstream segment of the culvert has steepened into a high-gradient riffle as the larger placed rock serves to control grade. The drop in grade creates a backwater condition through the upstream culvert during high flows resulting in minor aggradation. Additionally, 250 feet of channel upstream of the crossing shows evidence of incision.

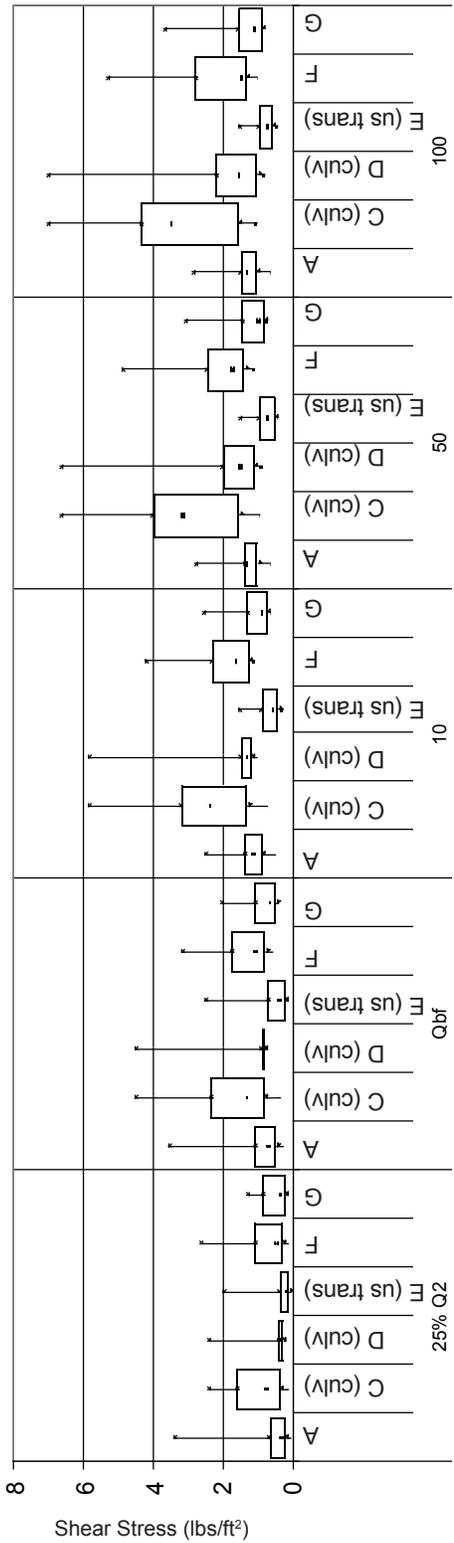
Figure 19—Shear stress (channel).

Shear stress—Shear stress in the culvert is similar to the upstream and downstream channel for the range of flows (figure 19). However, the downstream segment of the culvert has higher median values than the upstream channel segment (G). The difference between the two culvert segments can be attributed to the change in slope. This transition between segments C and D experiences the highest shear stress values in the entire reach (figure 10). The upstream transition segment E's shear stress is similar to, if not slightly less than, the upstream channel segment G for all flows, a phenomenon related to backwater effects of the culvert.

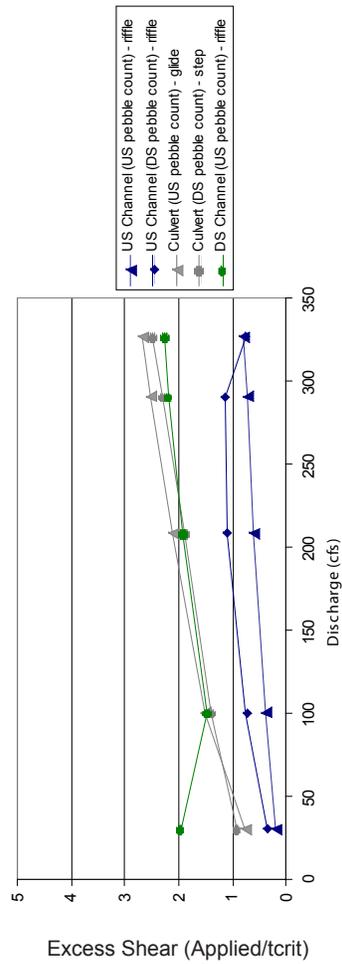
Figure 20—Excess shear stress.

Excess shear—The excess shear analysis shows that the culvert has greater potential for bed mobilization than the upstream channel at all flows and similar potential to the downstream channel for flows above the Q_{bf} (figure 20). The

excess shear analysis shows that the DS channel has a greater potential for bed mobilization at the 25 percent Q_2 than does the culvert having a value above the threshold value of "1," dropping back to similar values as found in the culvert. While this phenomenon may be real, it may most likely be attributed to model instability.

Excess shear stress is the channel shear divided by the critical shear for bed entrainment of the D84 particle size. Values of excess shear greater than 1 indicate bed movement for the D84 particle size.

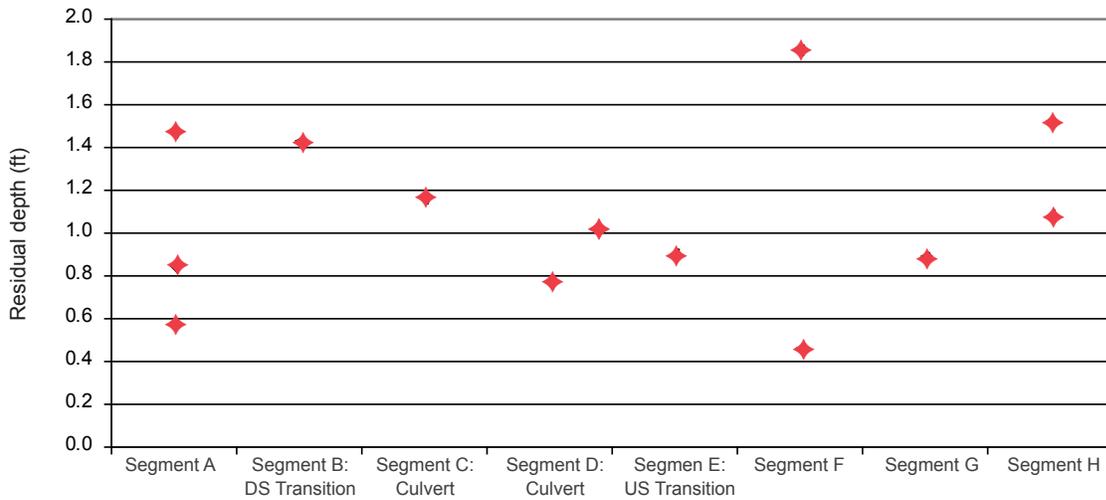
Figure 21—Residual depths

Residual depths—Culvert residual depths ranged from 0.77 to 1.17 feet and were within the range of channel conditions (figure 21). This suggests no significant scour beyond what is found in the channel outside of the crossing.

Residual depths—Culvert residual depths are within the range of channel conditions (figure 21).

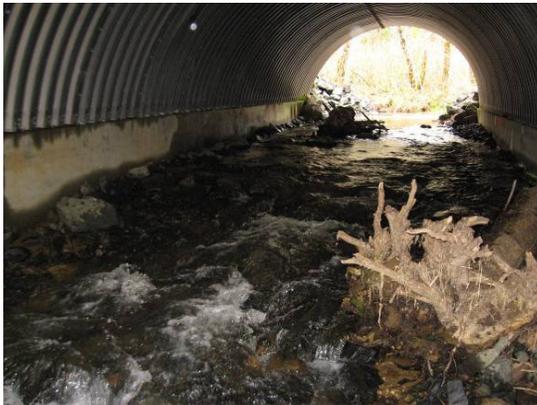
Bed Conditions: Angular material in culvert bed; possibly from riprap from inlet that has been incorporated into culvert bed, or from constructed riprap banks within culvert.

View upstream through culvert.

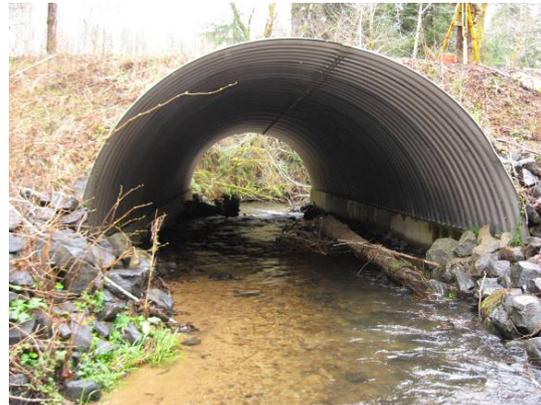
Alignment Conditions: Culvert angled towards high bank at downstream end, likely exacerbating erosion conditions on bank. Possible that meanders were cut off as part of original culvert installation (older culvert).

View downstream through culvert.

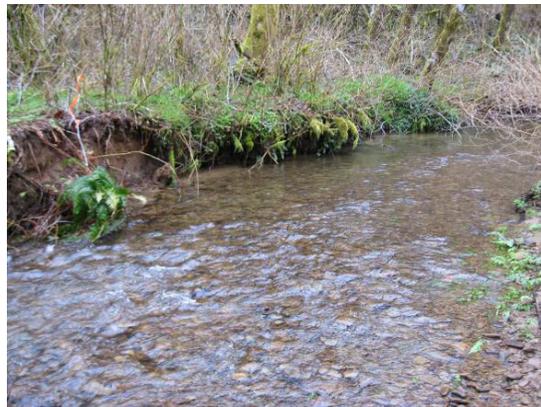
Upstream of the culvert, extending approximately 250 feet, there is evidence of channel bed incision characterized by steep, actively eroding vertical banks. The incision is on the order of 3 feet at the downstream end near the inlet and tapers off upstream over approximately 250 feet. The upstream representative reach is located upstream of this incised area. The reach has well-defined riffles separated by moderately deep pools. Sandstone bedrock was present along upstream portions of the channel bed in the reach. There is a broad flood-plain terrace (especially on the right side) that appears to be active at frequent flood events.

Incision induced bank erosion in channel upstream of culvert.
