COOL CREEK

Site Information

Site Location: Mt. Hood NF. 2.5 miles off US 26 on Still Ck Rd (FR 2612)
Year Installed: 1984
Lat/Long: 121°53'11.02"W **Watershed Area (mi²):** 1.7
 45°17'53.01"N
Stream Slope (ft/ft)¹: 0.0519 **Channel Type:** Step-pool
Bankfull Width (ft): 19.5 **Survey Date:** 4-6-2007

Culvert Scour Assessment

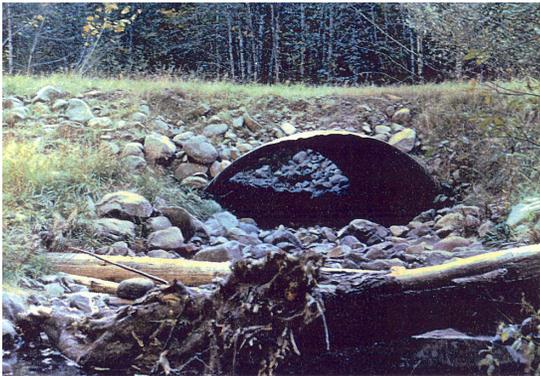
The exact installation date is unknown, but the culvert was included in the 1987 Western Federal Lands Highway Division (WFLHD) “Oregon Culvert Fish Passage Survey.” The field survey for the WFLHD study was conducted on 10/19/1987. Special features that were noted included the observation that the footings were 4 feet below the streambed and “manmade pools were built at outlet with log and rock barriers.” With respect to fish passage, Oregon Department of Fish and Wildlife (ODFW) staff described the culvert as a “very good open bottom arch,” but they note that the “manmade pools at outlet may require periodic maintenance.” WFLHD staff rated overall culvert condition as “poor,” culvert capacity as “fair,” condition of foundation as “fair,” and with “negligible” outlet scour. The culvert hydraulics were considered “compatible” with the natural stream hydraulics. In their comments they note that “despite the poor installation procedures, the Cool Creek culvert is a good fish passage design.”

Culvert inlet.

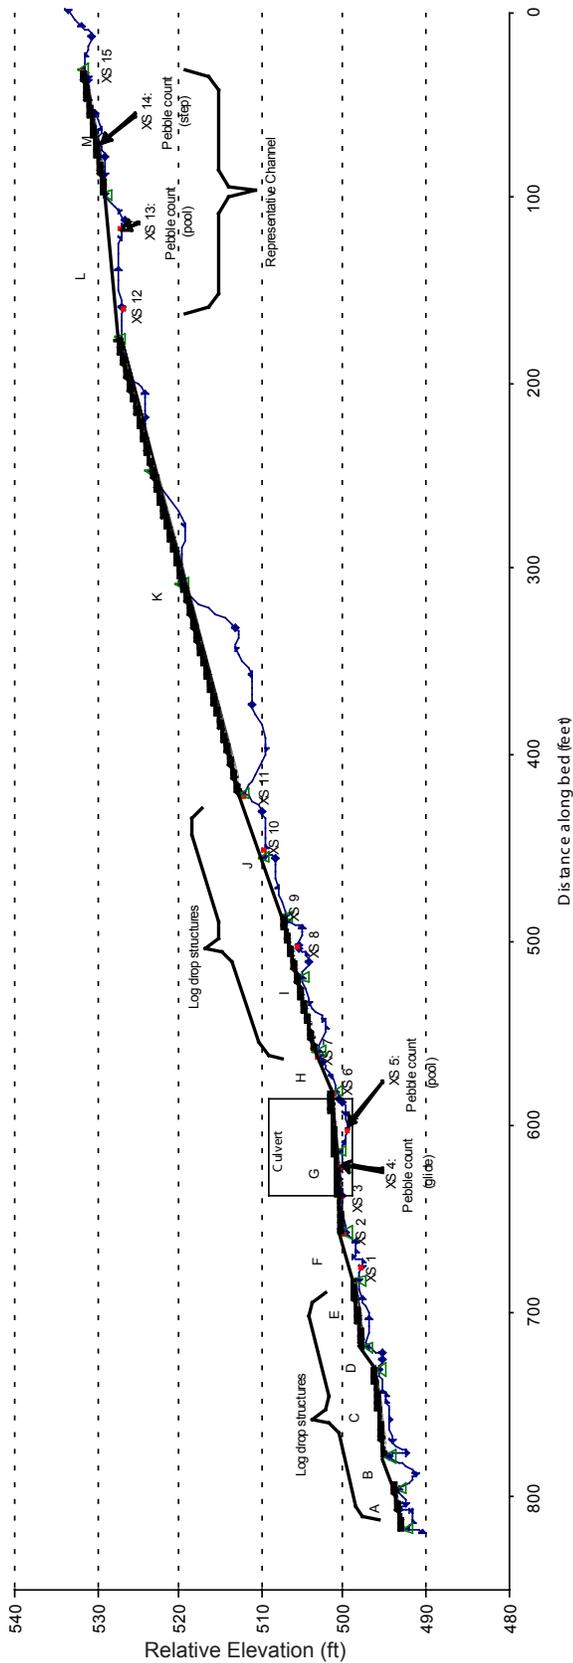
Figure 2—Cool Creek longitudinal profile.

Profile characteristics—The profile has a concave shape through the crossing (figure 2). This shape reflects scour at the inlet region, combined with aggradation in the downstream portion of the culvert and in the channel downstream of the culvert. A significant transition in the channel gradient occurs at the inlet to the culvert as the channel flows through a series of log-drop structures. It is this transition, along with the contraction of flow through the culvert that has created the scour along the left edge of the culvert.

The low crown elevation of the culvert and the deep level of embedment suggest that the

installation of the Cool Creek crossing may have been placed too low in relation to the original channel profile, which may have occurred in order to avoid raising the road bed. Deep embedment during construction and/or deposition (partially related to the downstream drop structure) is contributing to reduced capacity during flood flows.

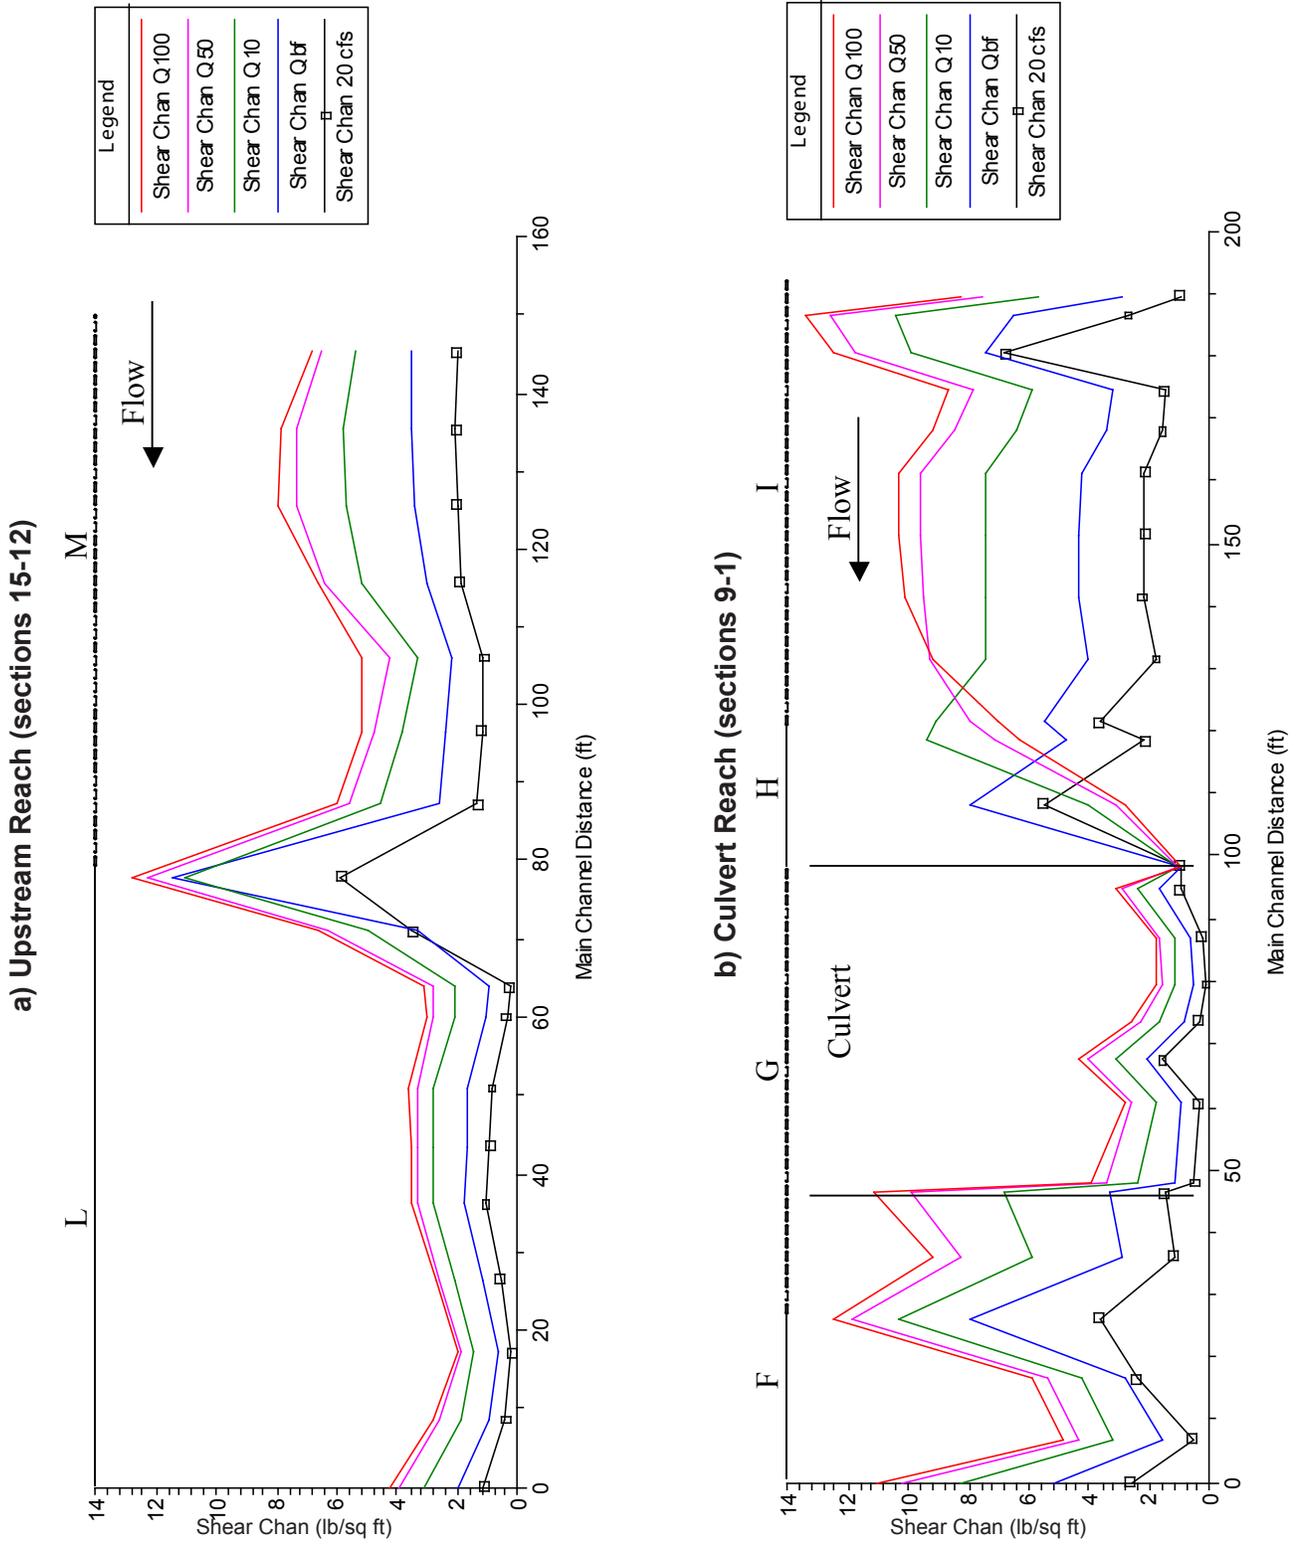
Figure 10—Shear stress (channel) profile.

Shear stress—The shear stress within the culvert (segment G) is similar to that of the upstream channel (segment L) for all flows modeled (figure 10, figure 19). Similarly, the shear stress of the downstream transition segment (F) is similar to the upstream channel segment (M) for all flows modeled. However, the range of shear-stress values found in the transition segment is great and the median value is greater than the median value of the upstream channel.

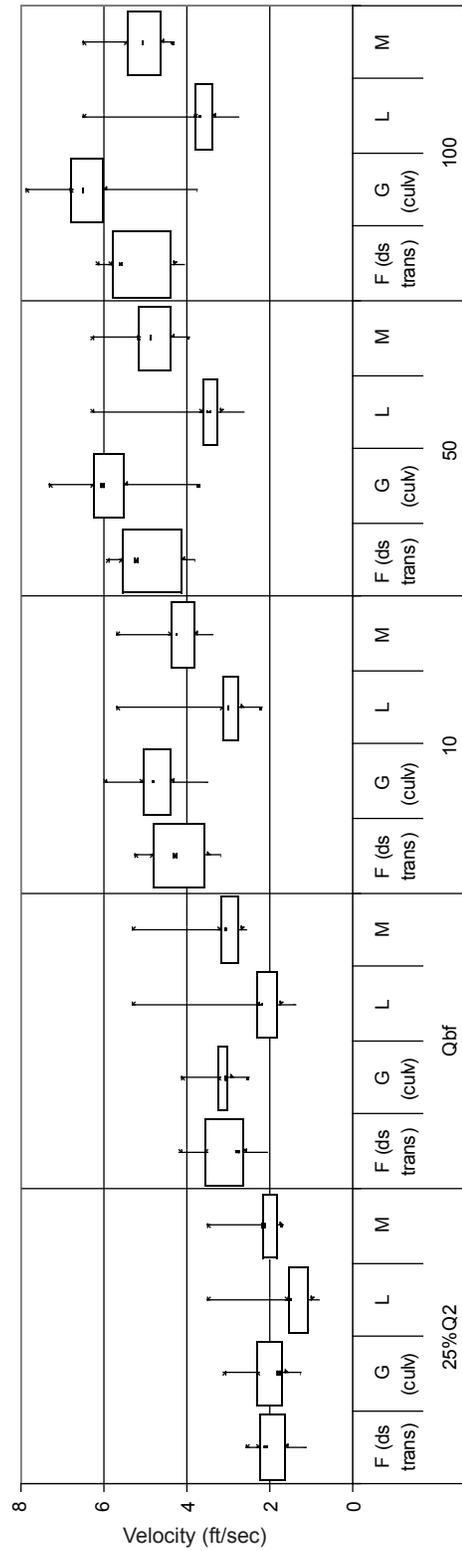
Figure 18—Velocity (channel).

Velocity—Velocity in the upstream culvert segment (G) is higher than the downstream representative segment (L) for all flows modeled (figure 11, figure 18). These higher culvert velocities correspond to the flow contraction

(reduction in flow area) caused by the culvert. Velocity at the downstream transition (F) is similar to the upstream representative segment (M) at all flows.

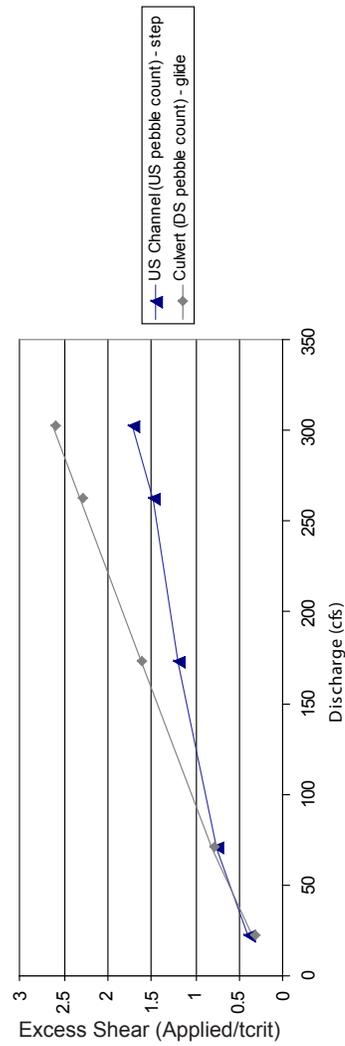
Figure 20—Excess Shear Stress.

Excess shear—The excess shear analysis shows that the culvert and upstream channel have similar excess shear values for the 25-percent Q_2 and the Q_{bf} , but diverge above the Q_{bf} (figure 20). It is above the Q_{bf} that the potential for bed mobilization in the upstream channel increases at a greater rate than in the culvert. This corresponds with lower shear in the culvert at higher flows.

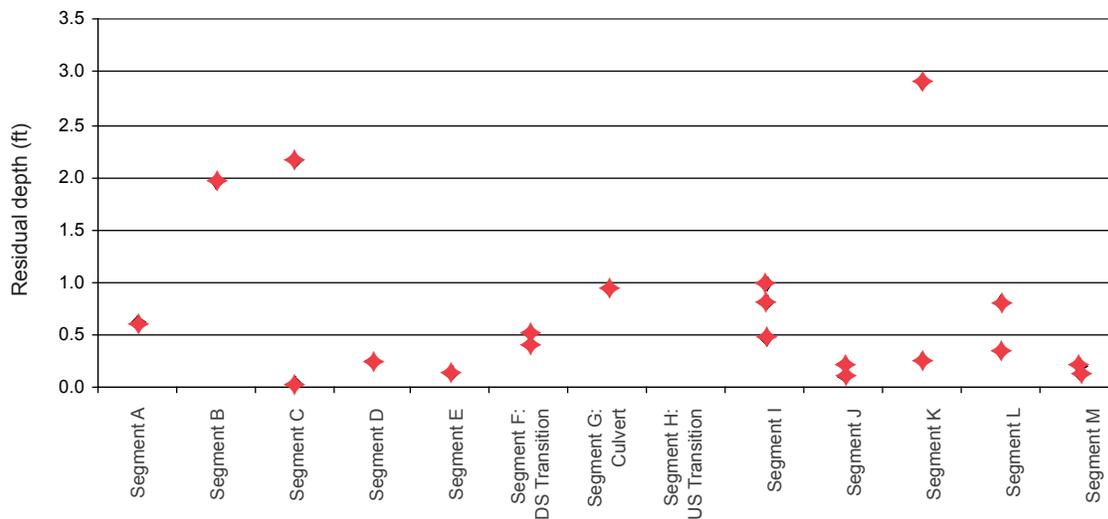
Figure 21—Residual depths.

Residual depths—The residual depth of the single pool within the culvert (segment G) is greater (0.94) than the upstream channel (0.36-0.82) (figure 21). Additionally, the downstream transition segment (F) has greater residual depths (0.43-0.54) than does the upstream channel (0.15-0.23). This suggests that the culvert has experienced additional scour beyond what is found in the channel outside of the crossing. No units of measure.

Residual depths—The residual depth of the plunge pool in the culvert (0.95) is greater than that found in the upstream channel (0.36-0.82) (figure 21). Similarly, residual depths in the downstream transition (0.43-0.54) are greater than those in the upstream channel (0.15-0.23).

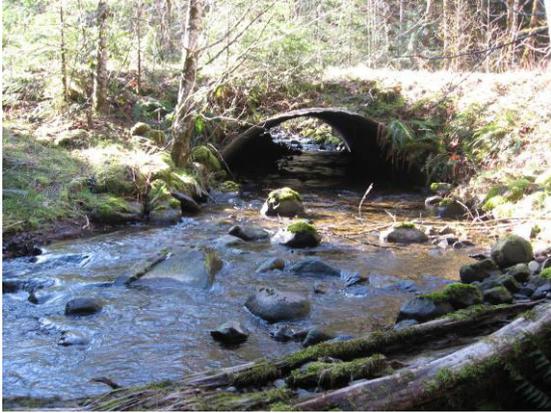
View upstream through culvert.

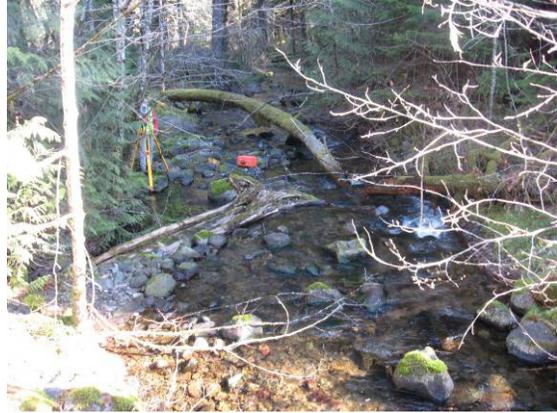
It is unknown whether the log-drop structure 15 to 20 feet downstream of the outlet was placed during construction or was placed in response to scour of the culvert bed at some point following construction. The drop structure was present at the time of these 1987 photos.

View downstream from culvert (log step in center).
