Culvert Scour Assessment

Deadwood Creek Tributary North

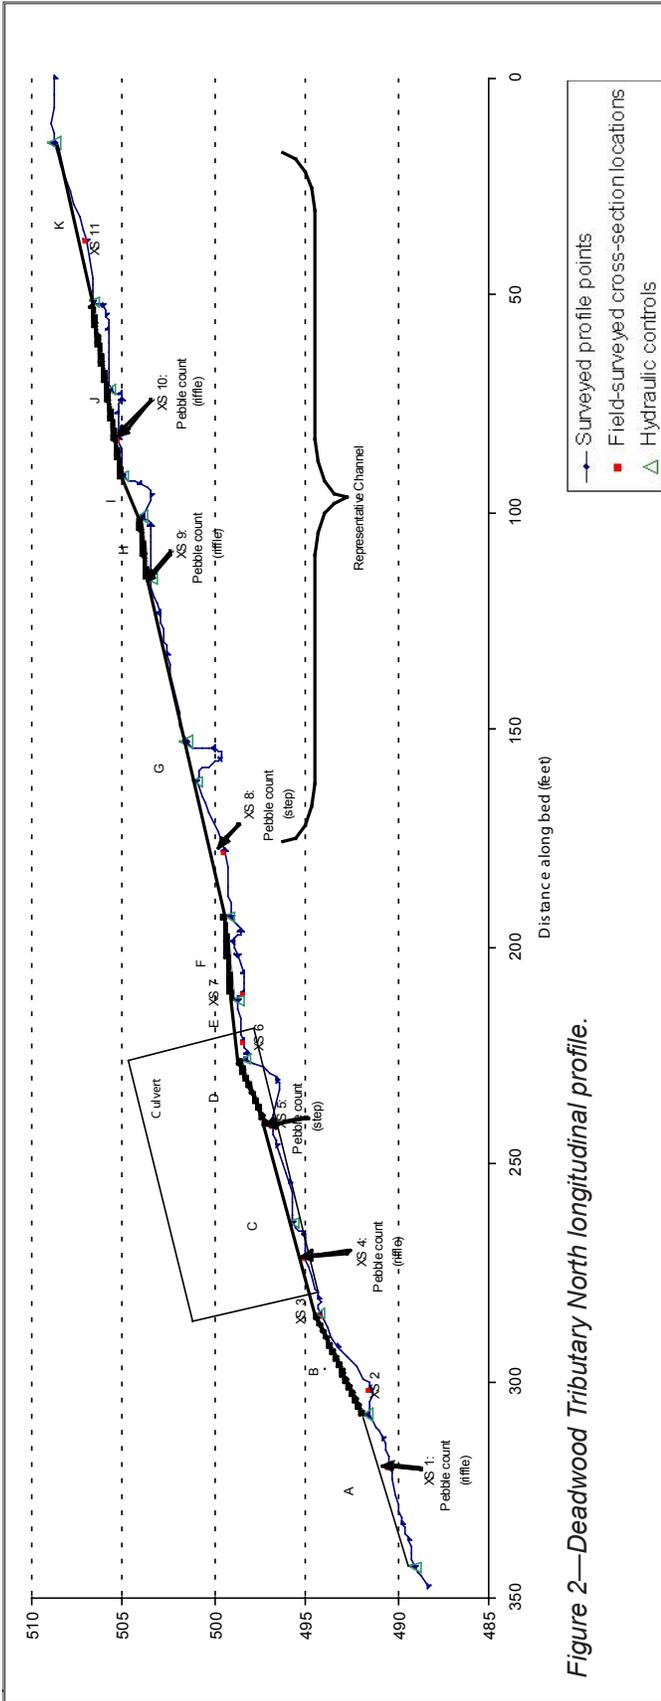
Figure 2—Deadwood Tributary North longitudinal profile.

The profile analysis resulted in a total of 11 profile segments. The culvert consisted of two profile segments. The downstream segment in the culvert was compared to three different representative profile segments in the upstream channel. There was no suitable comparison segment for the upstream segment in the culvert. The upstream transition segment was compared to two representative profile segments in the upstream channel. There was no suitable comparison segment for the downstream transition segment. See figure 2 and table 1.

Profile characteristics – The profile has a convex shape (figure 2). This shape reflects a gradually steepening profile in the downstream direction. The structure is not placed in alignment with the stream valley and instead takes a more direct

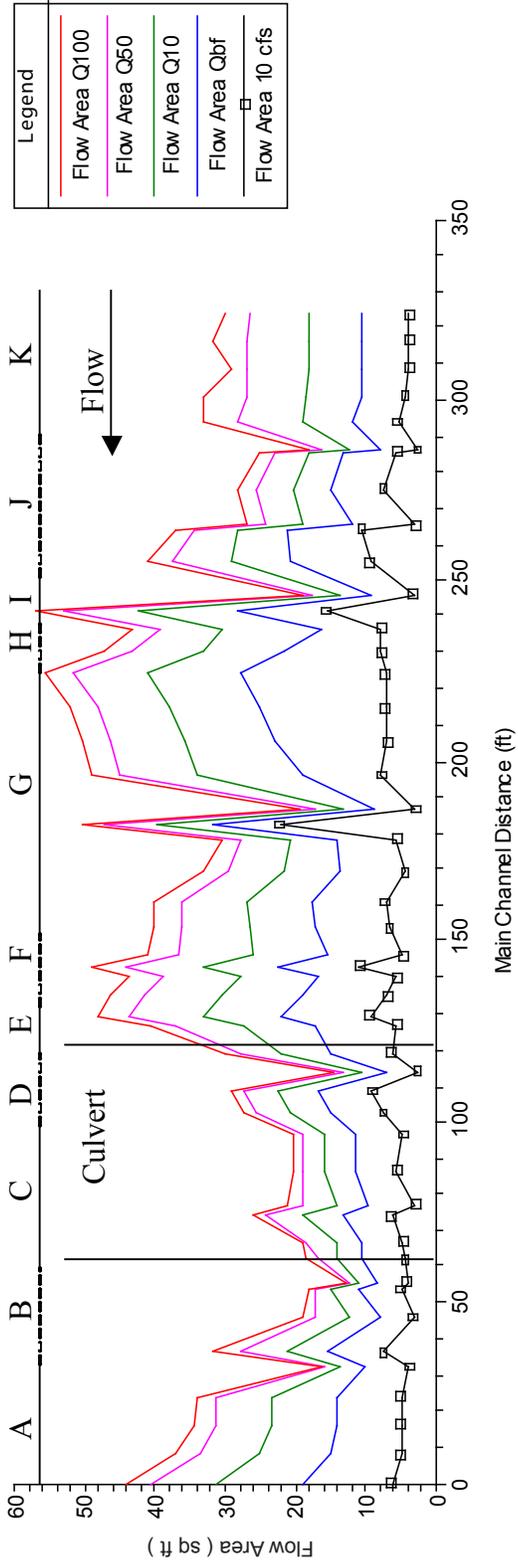
Figure 5—Flow area (total) profile plot.

Cross-section characteristics – Cross-sectional flow area, wetted perimeter, and top width are considerably reduced by the culvert (figure 5, figure 6, figure 8). Conditions are similar at the 25 percent Q_2 (except for top width) but diverge beginning at the Q_2 and higher. The box plots indicate that flow area, wetted perimeter, top width, and width-to-depth are much lower in the culvert when compared to comparable slope segments in the natural channel. Maximum depth and hydraulic radius in the culvert are mostly within the range of that found in comparable

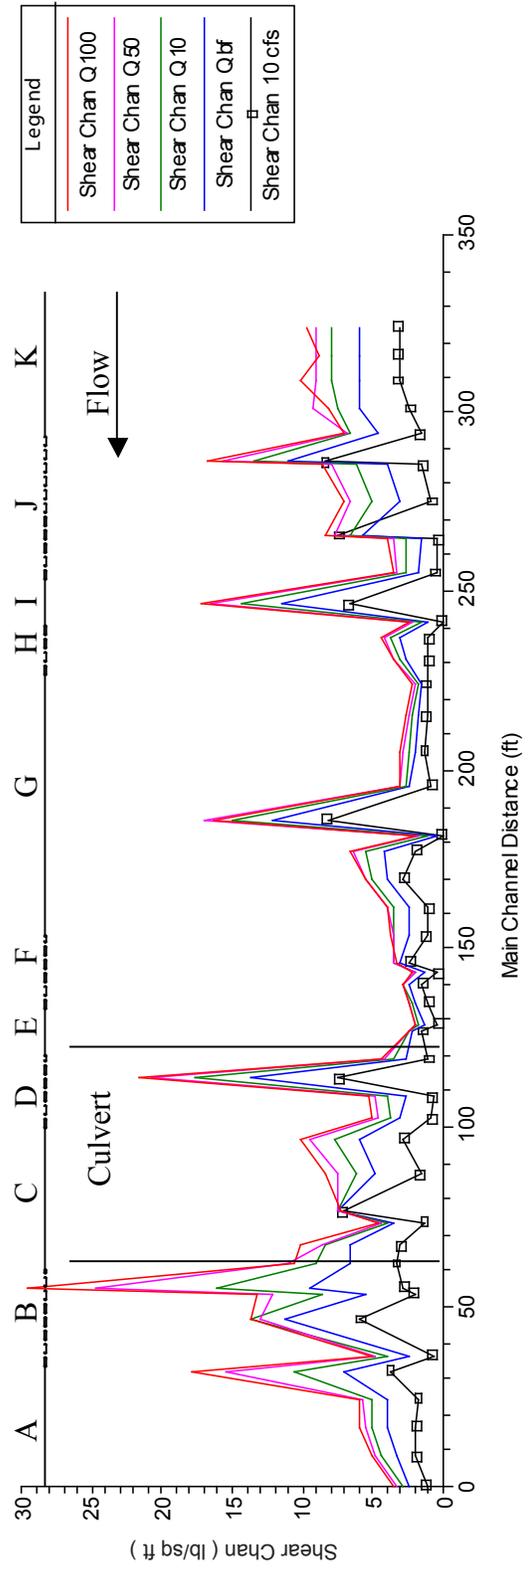
Figure 10—Shear stress (channel) profile.

Shear stress – Shear stress appears to increase in the culvert compared to the upstream channel (figure 10) and then increases even more just downstream of the culvert. When compared to comparable slope segments, the culvert shear stress values are mostly within the range of natural channel conditions (figure 19); however, the maximum value for shear in the culvert is nearly twice the maximum value found in any of the comparable slope segments. The upstream transition segment shear is also within the range of its comparable slope segments.

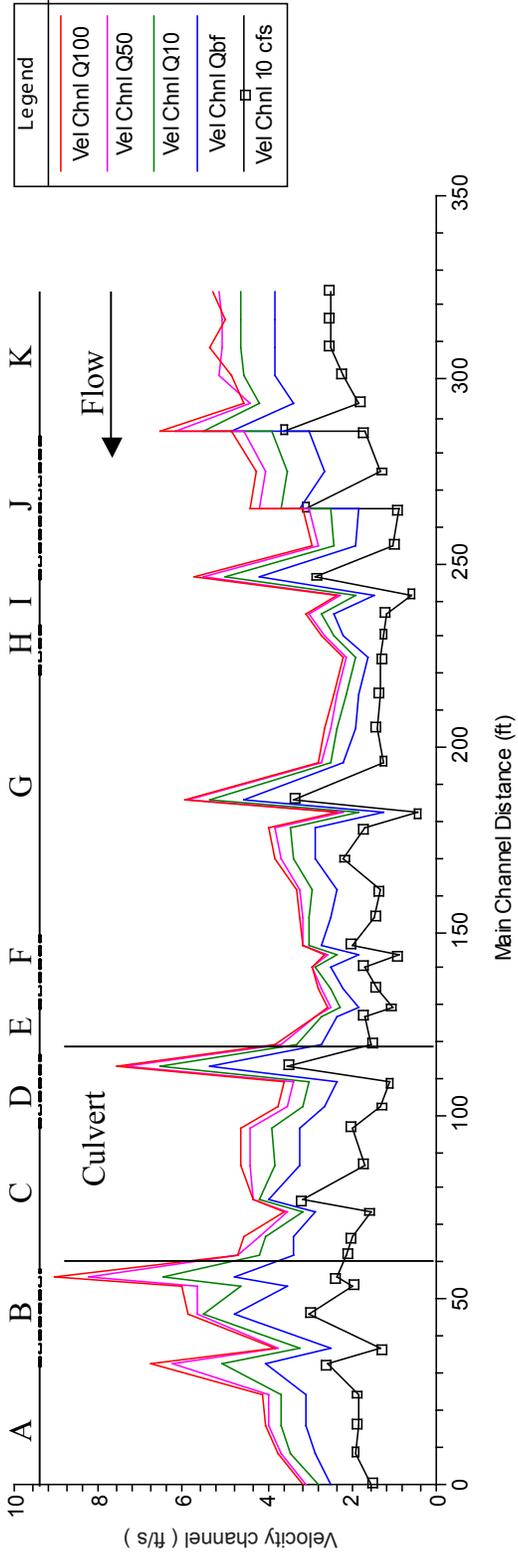
Figure 11—Velocity (channel) profile plot.

Velocity – Although velocity appears to generally increase within the culvert and just downstream (figure 11), the culvert velocity is mostly within the range of velocity of the comparable slope segments (figure 18), with the exception being a greater maximum velocity in the culvert than in the comparable segments. Velocity in the upstream transition is also mostly within the range of that found in comparable slope segments, except with greater maximum velocities in the transition area.

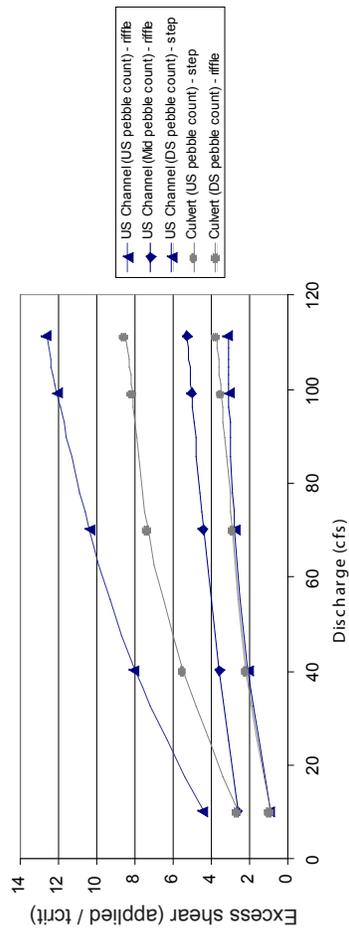
Figure 20—Excess shear stress.

Excess shear – The excess shear analysis shows that the potential for bed mobilization in the culvert is mostly within the range of that in the natural channel (figure 20).

Excess shear stress is the channel shear divided by the critical shear for bed entrainment of the D_{64} particle size. Values of excess shear greater than 1 indicate bed movement for the D_{64} particle size.

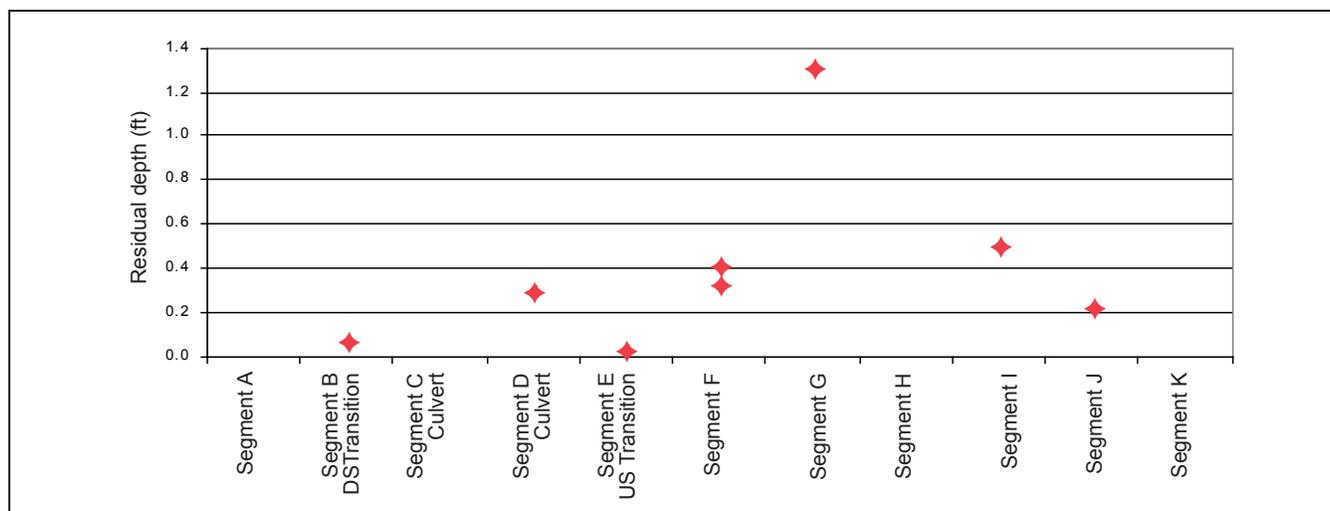
Figure 21—Residual depths.

Residual depths – The one residual depth in the culvert is 0.3 feet, which was in the upstream profile segment that has no comparable slope segment in the representative channel. Nevertheless, the 0.3 feet is within the range of the total population of residual depths from all the representative channel segments, which ranged from 0.06 to 1.3 feet (figure 21). This suggests no significant scour beyond what is found in the channel outside of the crossing.

Residual depths – The one residual depth in the culvert is 0.3 feet, which was in the upstream profile segment that has no comparable slope segment in the representative channel. Nevertheless, the 0.3 feet is within the range of the total population of residual depths from all the representative channel segments, which ranged from 0.06 to 1.3 feet (figure 21).

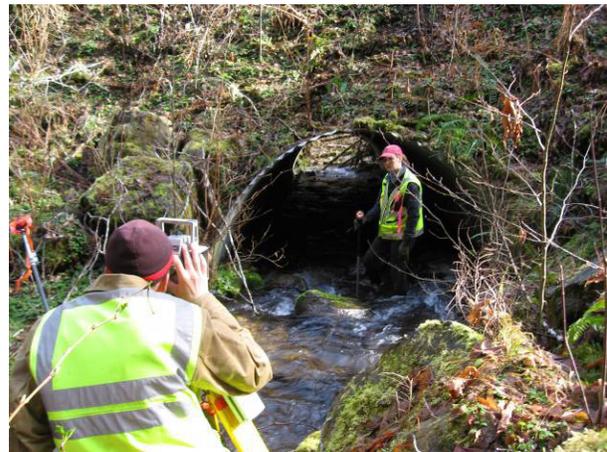
Culvert bed adjustment – A step (just downstream of the inlet) has formed from large angular material sourced from riprap that was placed on the right bank upstream of the inlet at construction. There is a scour pool downstream of the step. This step and scour pool have developed since construction of the bed. Angular material is still visible throughout the culvert, suggesting that much of the originally placed material has remained in the pipe.

View downstream towards culvert inlet.

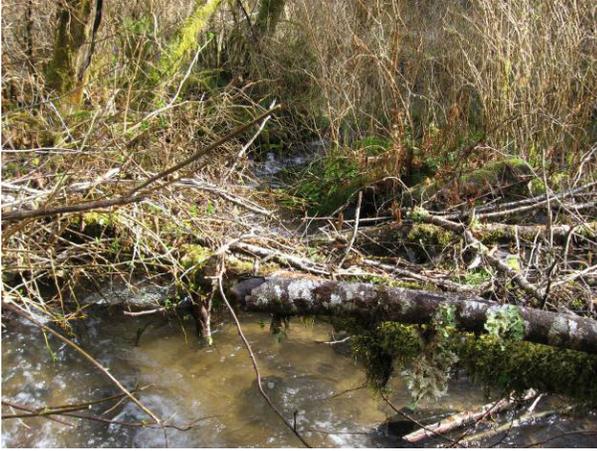
Downstream of the culvert, there was a steep riprap step and the ability for fish to pass this step is unknown but based on visual observation may be a concern. Below the step, the stream levels off as it enters the flood plain of Deadwood Creek. Large quantities of brush from roadside clearing were present downstream of the crossing.

Currently, the steep riprap step downstream of the outlet may not be passable by upstream migrating fish.

View downstream from outlet.

With respect to AOP, conditions in the culvert appear less suitable than the channel outside the crossing. Construction of step sequences in the culvert would be more favorable to fish passage than the current plane bed that provides little velocity refuge for migrating fish. No channel banks were constructed in the culvert and flow was wall-to-wall during the survey. Concentrating flow into a more defined thalweg through construction of channel banks would aid in fish passage and would provide banks for terrestrial organism passage. Use of a wider culvert would have provided more ability to provide these features. Construction of step sequences would improve passage in the downstream channel, where upstream passage is likely currently blocked by the steep riprap step.
