Culvert Scour Assessment

Eames Creek

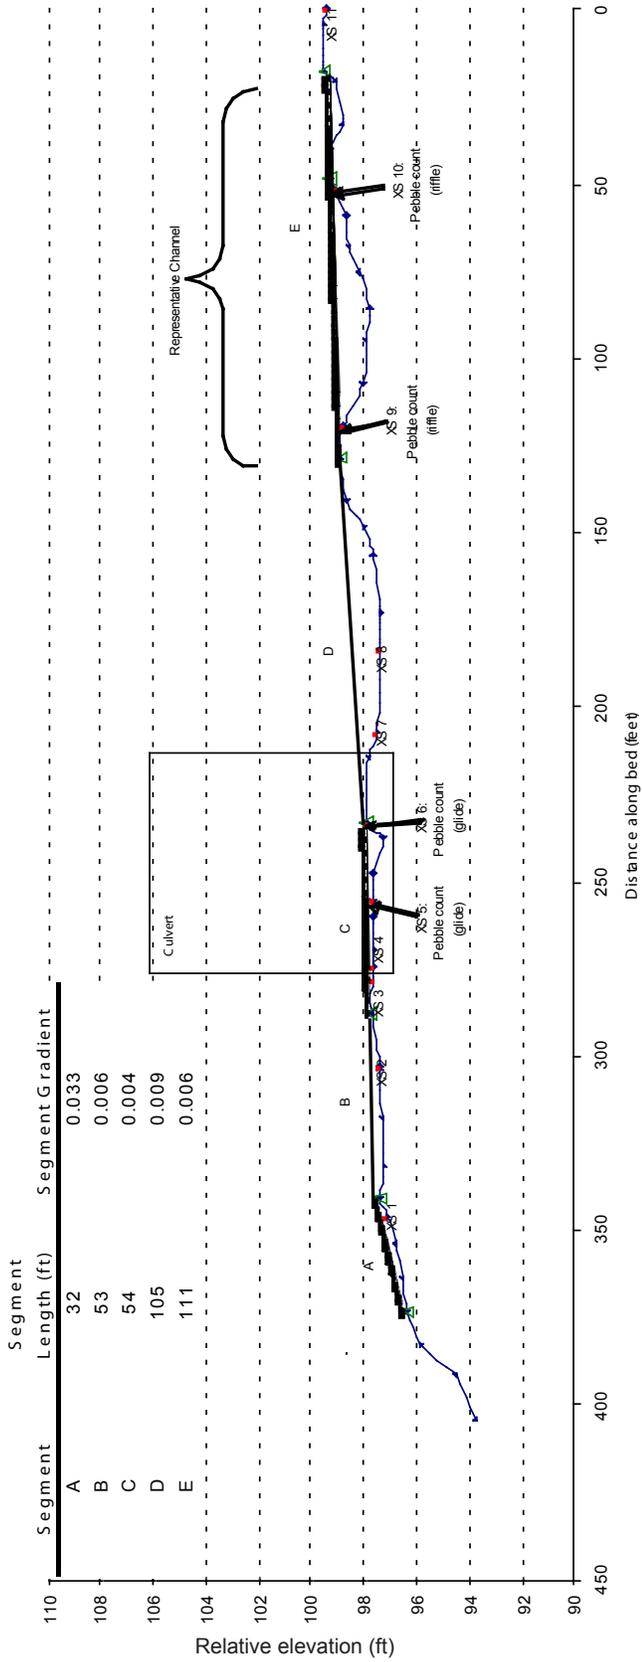
Figure 2—Eames Creek longitudinal profile.

Profile characteristics – The profile has a uniform slope through the crossing but drops off at a steeper gradient beginning 50 feet downstream of the outlet (figure 2).

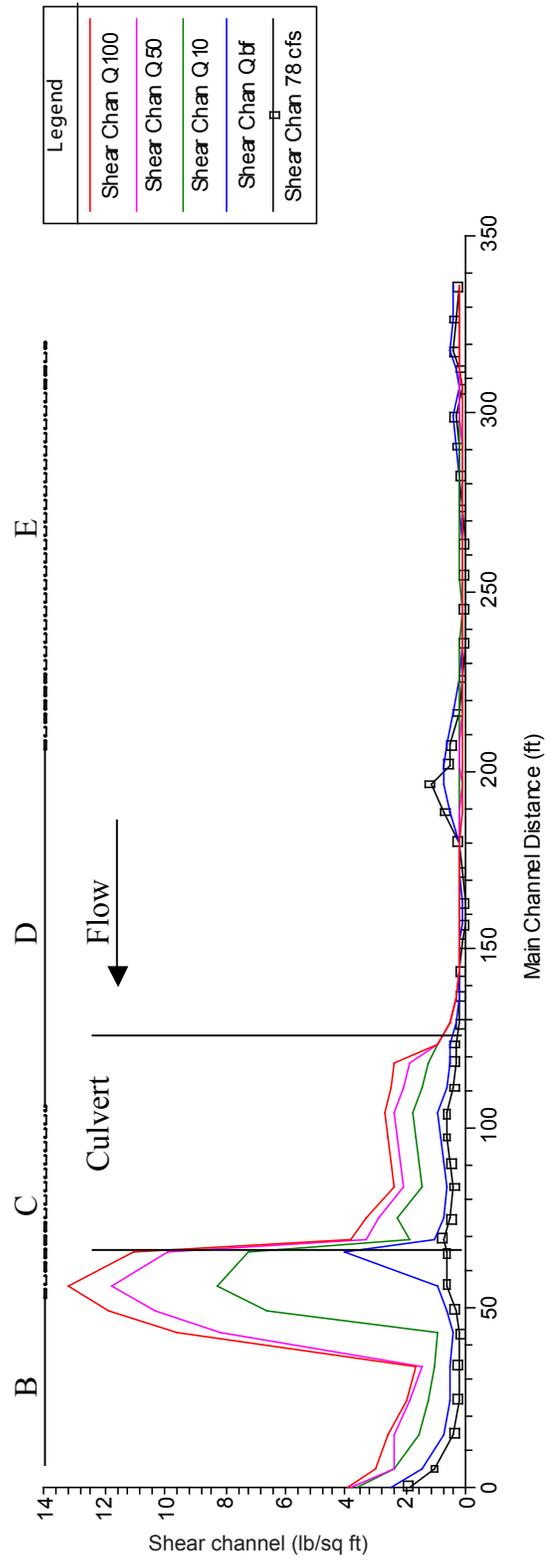
Figure 10—Shear stress (channel) profile.

Shear stress – Due to backwater effects, the culvert has a large effect on shear stress in the upstream and downstream channel, and these segments cannot be considered suitable reference conditions. The backwater reduces the energy slope upstream of the inlet and therefore reduced shear stress. Shear stress increases moderately within the culvert and then increases dramatically downstream of the outlet because of the sharp increase in energy slope (figure 10).

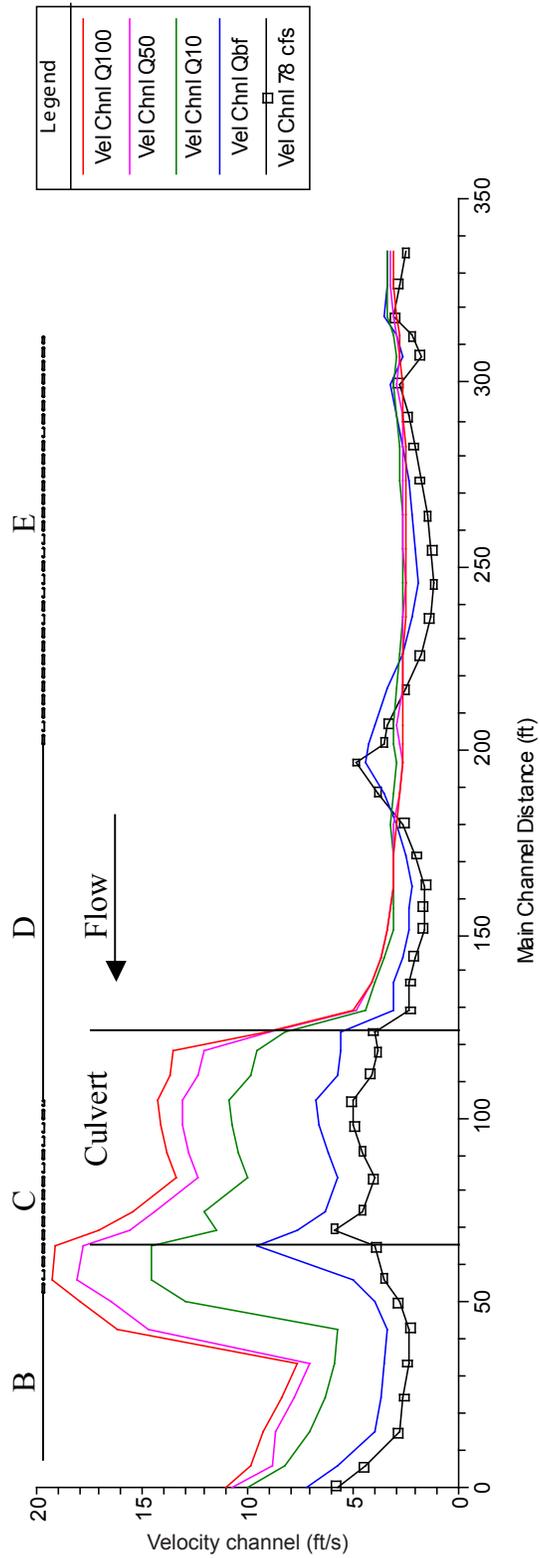
Figure 11—Velocity (channel) profile plot.

Velocity – Due to backwater effects, the culvert has a large effect on velocity in the upstream and downstream channel, and these segments cannot be considered suitable reference conditions. The backwater reduces the velocity upstream of the inlet (figure 11). Velocity increases within the culvert and then increases dramatically at the outlet and just downstream as the flow passes through critical depth.

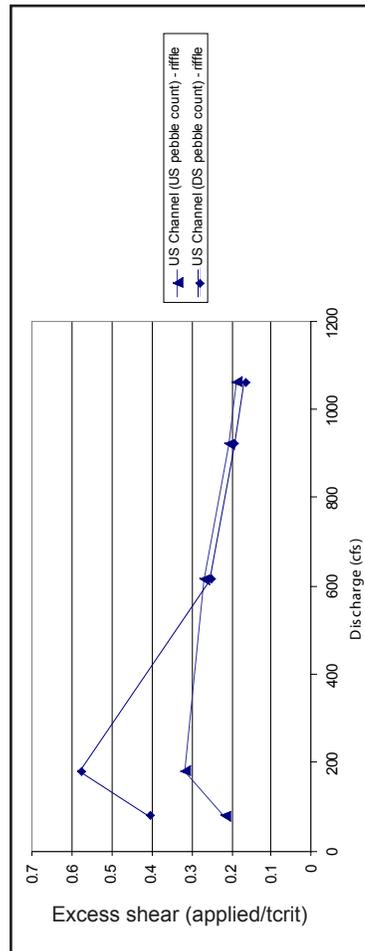
Figure 20—Excess shear stress.

Excess shear – The excess shear analysis shows very little excess shear in the upstream channel because of the low shear stress values that result from the culvert backwater (figure 20). Excess shear could not be calculated in the culvert because of a lack of mobile bed material.

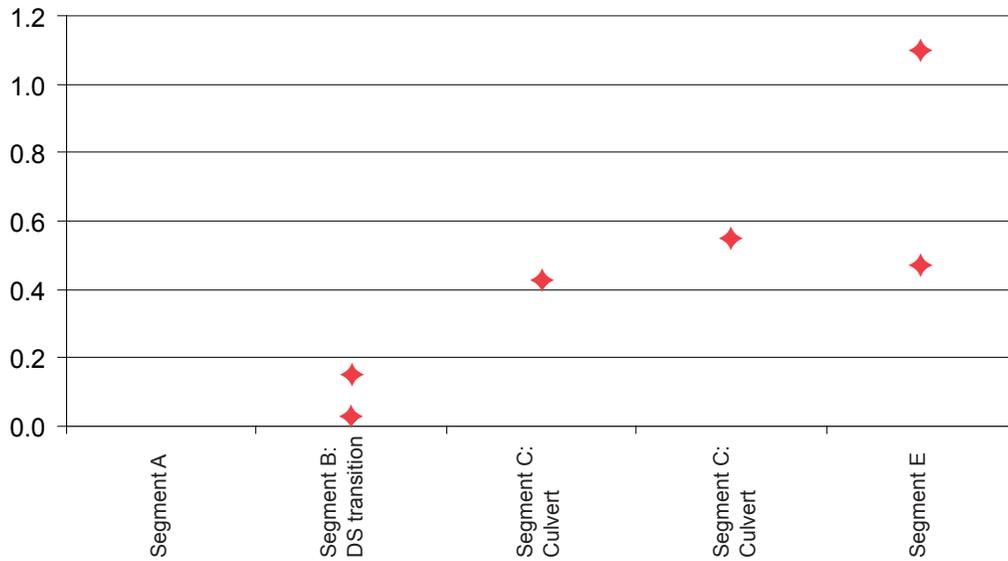
Figure 21—Residual depths.

Residual depths – The one culvert residual depth (in segment C) is just below the lower range of those in the corresponding profile segment (figure 21).

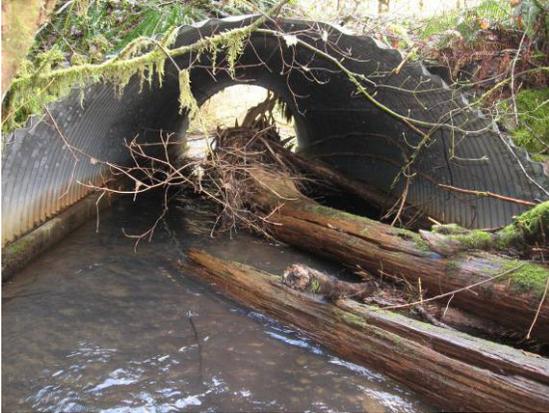
View downstream through culvert.

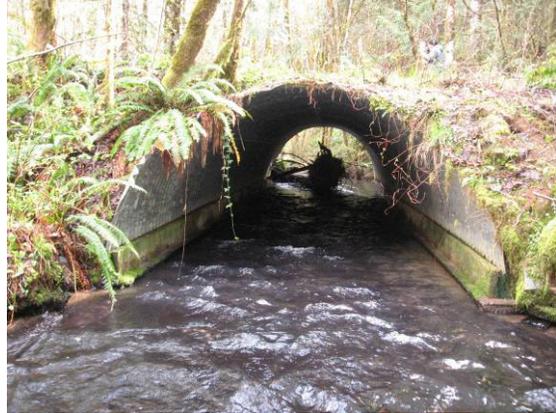
View upstream through culvert.

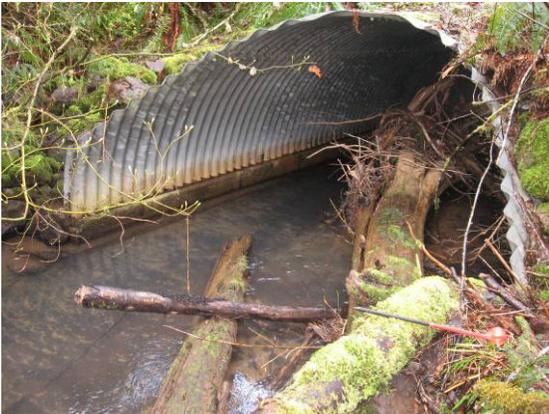
The Eames Creek culvert is a bottomless arch with mitered ends that sits on a concrete foundation. The channel bed is sandstone bedrock. Three large logs have become lodged between the left bank upstream of the crossing and the inlet to the pipe. Additional smaller debris has been deposited around these pieces. Scour around the logs is apparent, notably in the form of a scour pool which extends from the upstream of the culvert through the inlet around the rootwad of one of the logs. Downstream of the influence of the wood, the channel consists of a bedrock (sandstone) glide. Small amounts of sand were deposited along the lower velocity margins of the culvert, but little to no gravels were present.

Large woody debris – There were three pieces of LWD present in the upstream portion of the culvert (table 8). The wood in the culvert posed a plugging and scour risk to the culvert. The culvert was not large enough to transport this size of material through the pipe without risk of plugging. The representative channel had high LWD abundance. LWD formed small steps and scour pools in the channel outside the crossing and played a primary role in habitat-unit creation and complexity. Wood drop structures were present upstream of the representative channel.

View of culvert inlet.

This installation exhibits poor conditions with respect to scour and AOP. The footings are being undermined in places, there is no natural streambed material in the pipe, and AOP conditions are likely impaired. A larger culvert with greater capacity would reduce the backwater effects of the culvert and would prevent the high shear stress and velocity that occur within and at the outlet area of the pipe. It may also allow for bed material to remain within the pipe. Constructing banks using stable bed elements (i.e., boulders) within the culvert would protect the footings from being undermined by scour of the sandstone bedrock and would allow for passage of terrestrial organisms. A longer culvert that is more in line with the original stream channel may reduce the incidence of inlet scour.

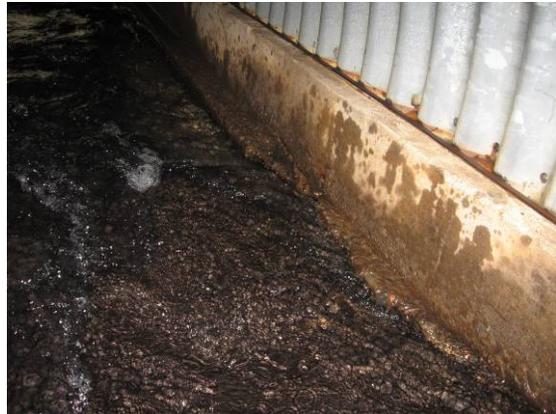
Pipe Condition: Three pieces of large wood at inlet could contribute to capacity and scour issues. Some undercutting has occurred at right bank footing at downstream end of pipe. The base (spread) footing is compromised in some areas.

Footing scour – The culvert has a 22-inch-wide spread footing that sits on top of the bedrock bed. An 18-inch-wide stem wall rises from the spread footing. The spread footing is scoured and undermined in a number of locations, including the upstream end right bank for 6-foot length (undercut depth 4 inches) and the downstream end right bank for 3- to 4-foot length (undercut depth 4 inches). In these cases it appears the sandstone bedrock has been scoured out beneath the footing at these locations. The concrete footings themselves also show minor signs of scouring.

View of damaged footing along right side of culvert.

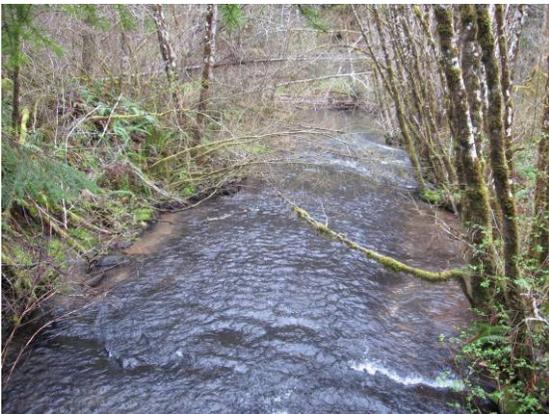
View downstream from road.

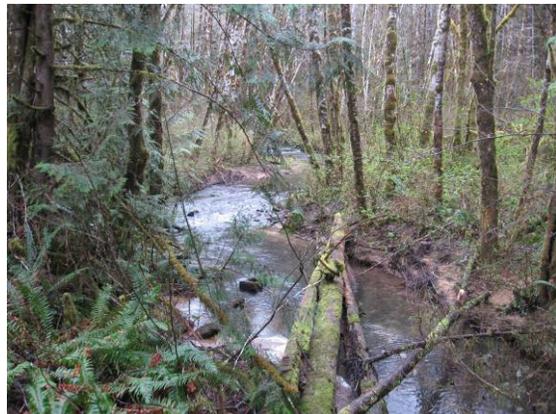
View upstream from road.
