FALL CREEK

Site Location:	Willamette NF, S Willamette Valley, Fall Cr Rd west of Eugene		
Year Installed:	Circa 1999		
Lat/Long:	122°22'3.96"W	Watershed Area (mi²):	3.55
	43°59'56.83"N	Channel Type:	Step-pool
Stream Slope (ft/ft)¹:	0.0359	Survey Date:	April 4, 2007
Bankfull Width (ft):	21

Culvert Scour Assessment

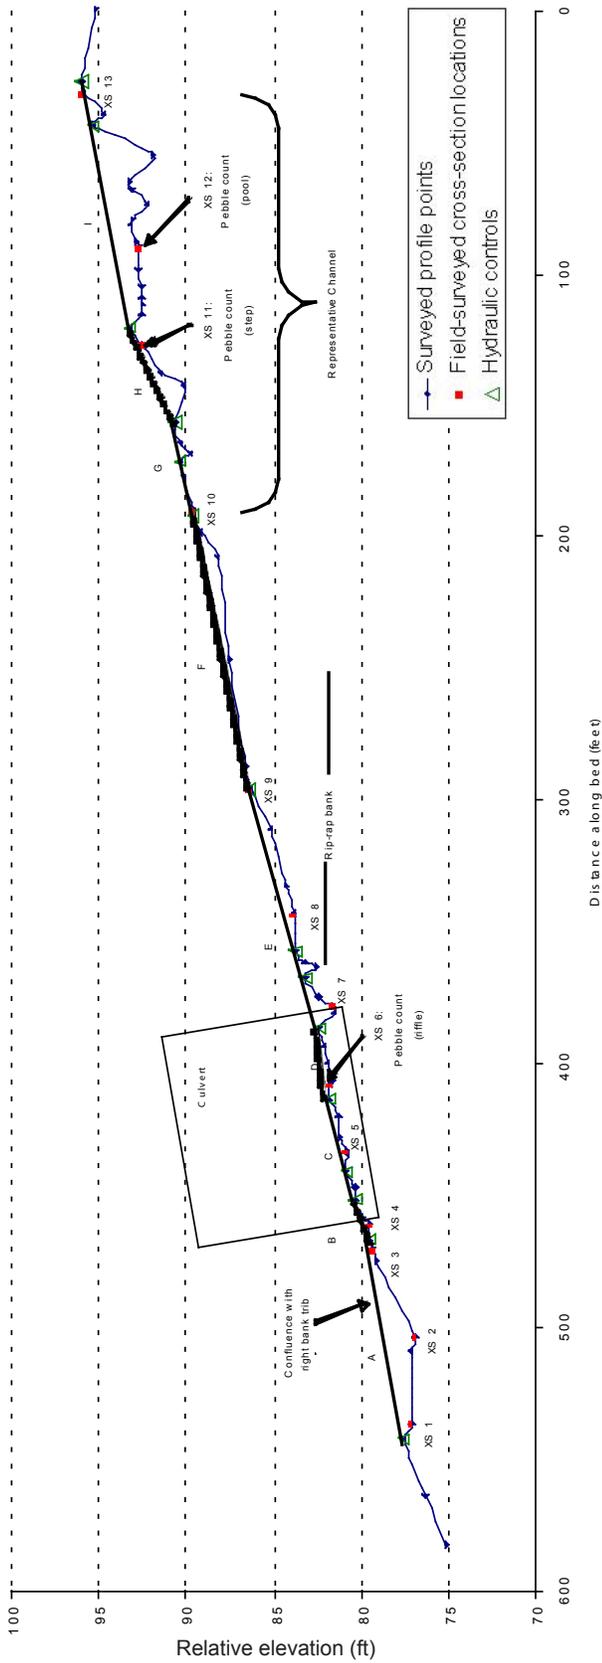
Figure 2—Fall Creek longitudinal profile.

Profile characteristics – The profile has a uniform shape through the crossing (figure 2). There is a valley transition in this area where the Fall Creek valley widens as it approaches the tributary junction located just downstream of the culvert.

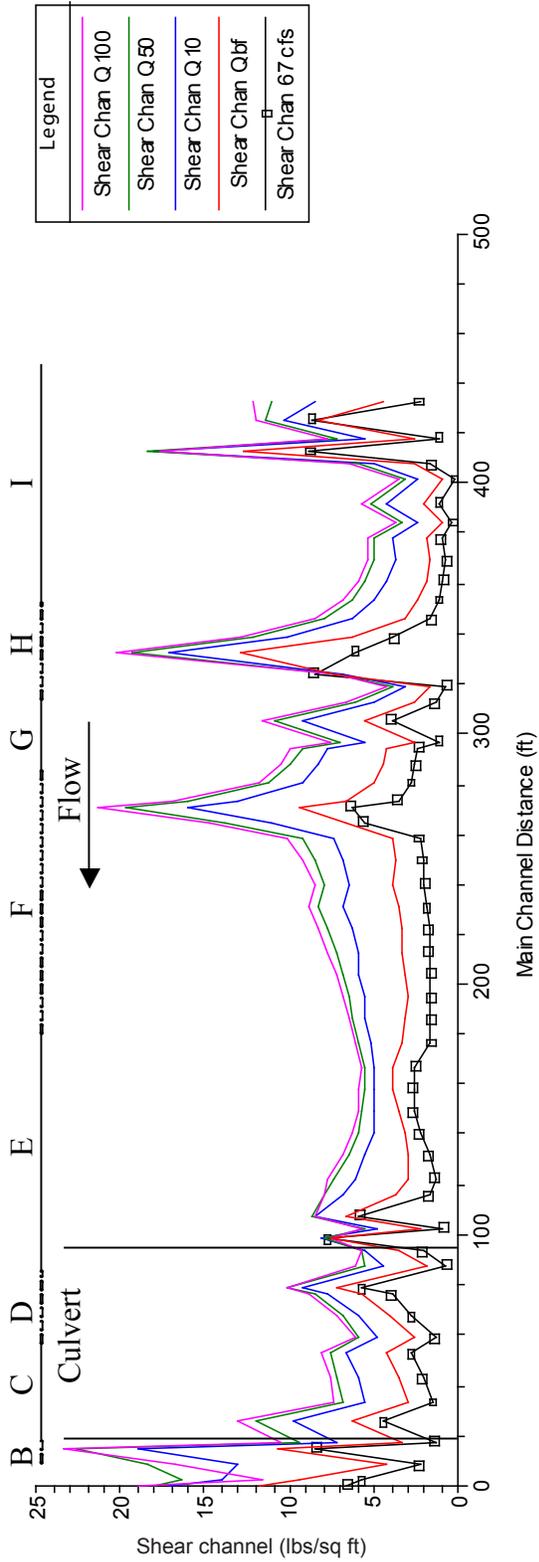
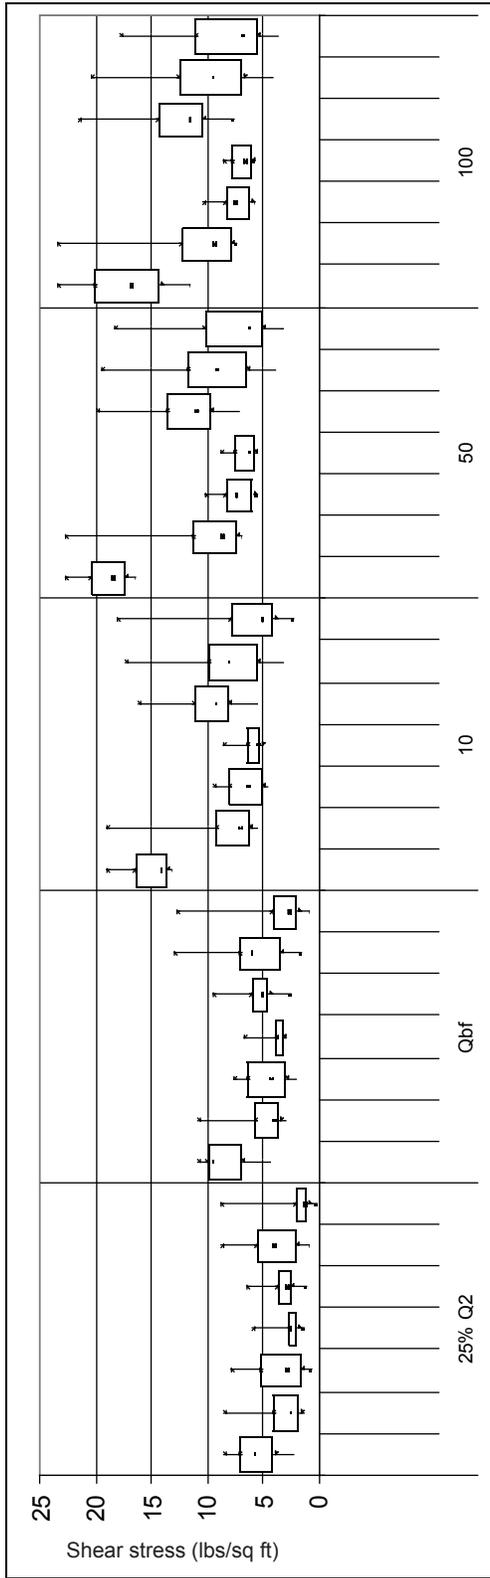
Figure 10—Shear stress (channel) profile.

Shear stress – Shear stress in the culvert is mostly within the range of that found in the natural channel except for at the downstream end of the culvert where shear stress spikes sharply and the maximum values exceed those in corresponding profile segments (figures 10 and 19). Shear stress in the upstream transition segment (E) is within the range of the corresponding profile segment (G).

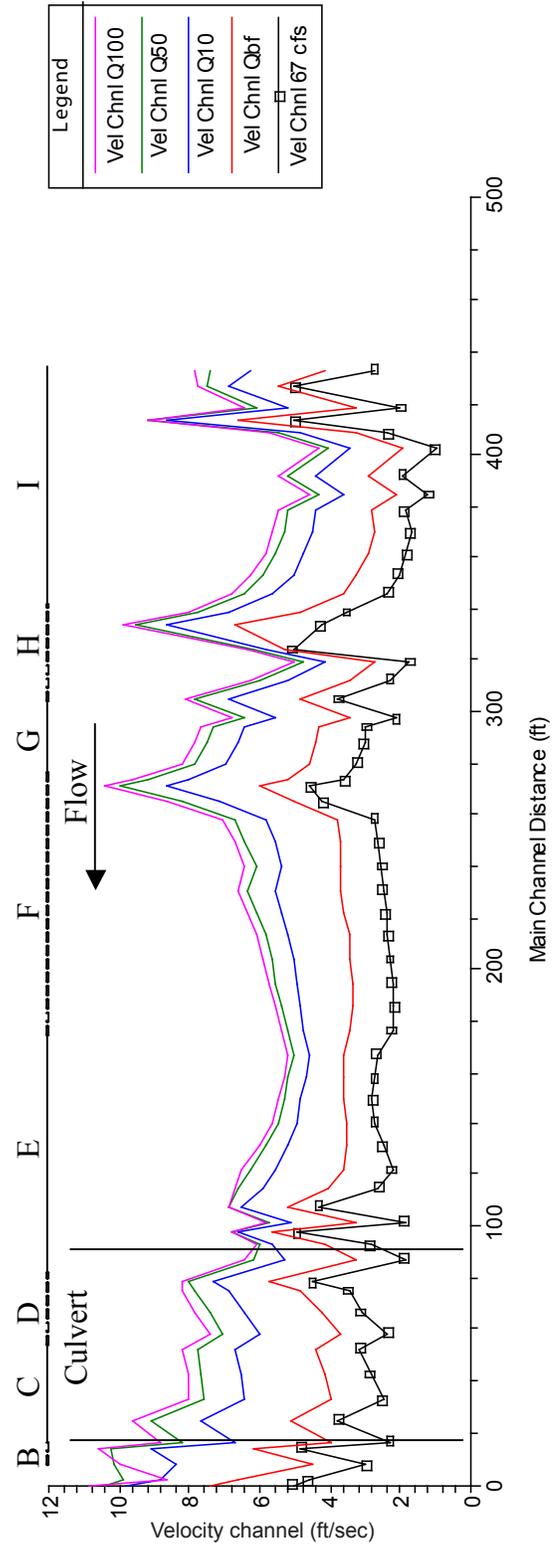
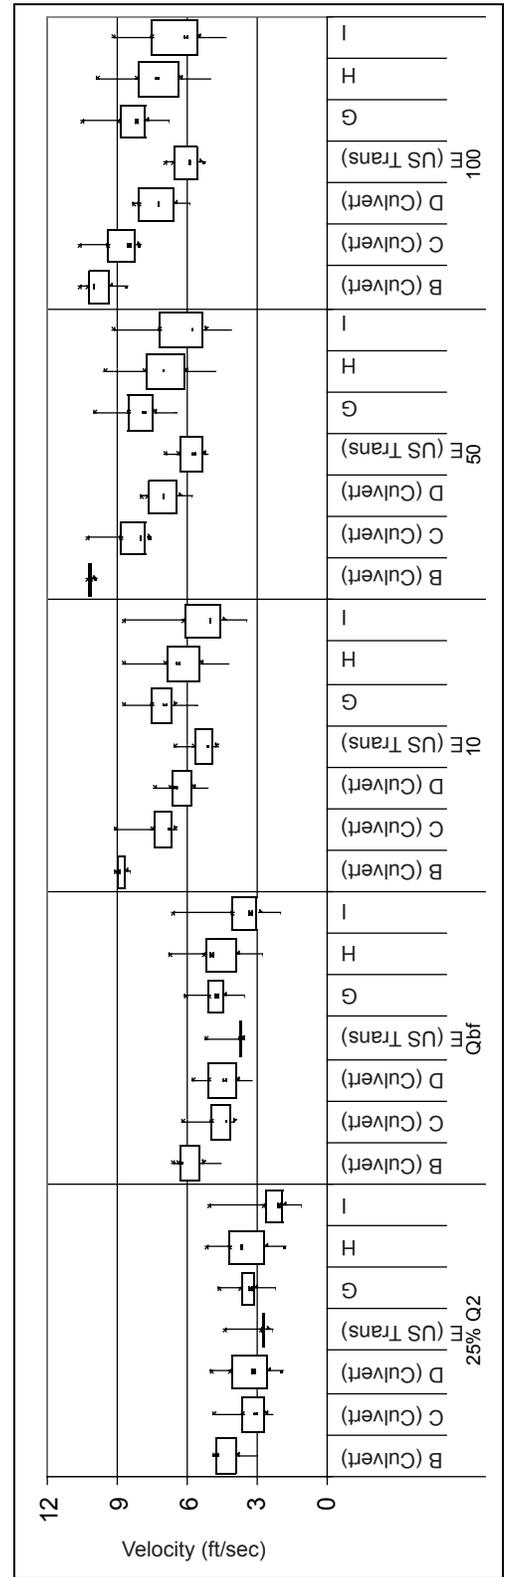
Figure 11—Velocity (channel) profile plot.

Velocity – Model results suggest that velocity in the culvert is mostly within the range of the natural channel except for at the downstream end of the culvert where velocity rises and values exceed that of corresponding channel profile segments (figures 11 and 18). Velocity in the upstream transition segment (E) is within the range of the corresponding profile segment (G).

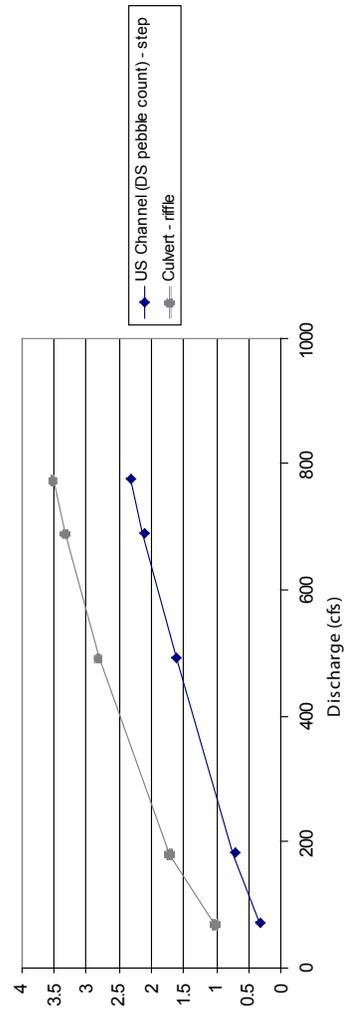
Figure 20—Excess shear stress.

Excess shear – The excess shear in the culvert is greater than the excess shear in the natural channel (figure 20). This is mainly attributable to low applied shear values from the model at the sample site in the upstream channel. Critical shear-stress values are similar, and based on the similar range of applied shear-stress values in the culvert and the natural channel, excess shear would be expected to be relatively similar as a whole.

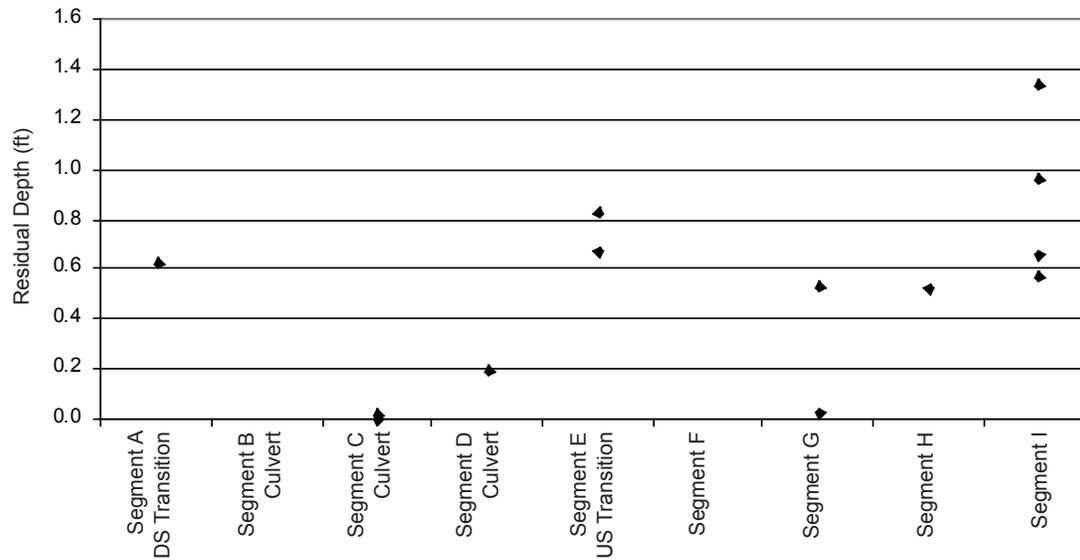
Figure 21—Residual depths.

Residual depths – Culvert-residual depths are at the lower end of the range or lower than residual depths in corresponding profile segments (figure 21).

Residual depths – Culvert residual depths are at the lower end of the range or lower than residual depths in corresponding profile segments (figure 21).

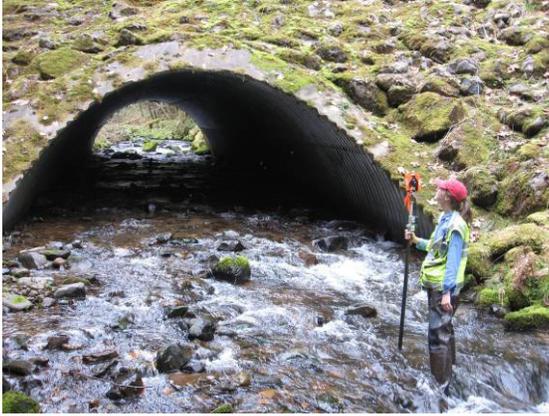
Bed Conditions: Large cobble to small boulder sized material forming very small steps and plane-bed conditions.

Pipe Condition: Good condition. Minor rust in places.

View upstream through culvert.

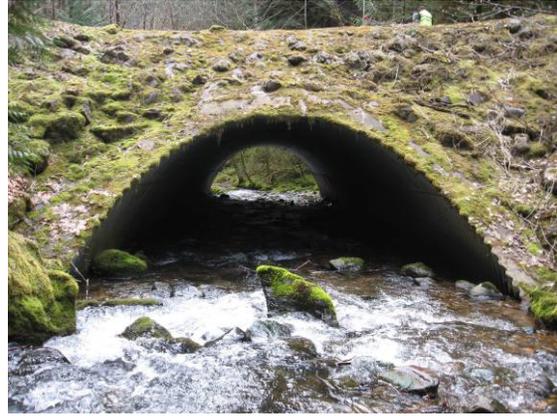
Culvert-bed adjustment – The culvert bed shows no obvious signs of adjustment. Some gravel and cobble material appears to have recently aggraded in the pipe but it is unknown whether the bulk of the streambed material observed during the survey was placed in the pipe or recruited from upstream. It is assumed that the larger material found in the culvert (small boulders) was placed there during construction.

View downstream through culvert.

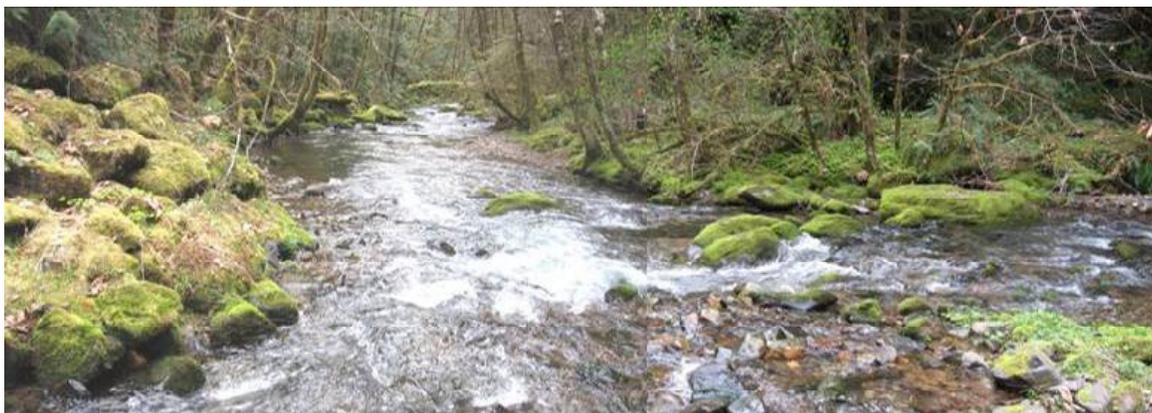
View downstream from outlet at confluence with tributary on right.
