Culvert Scour Assessment

PINE CREEK

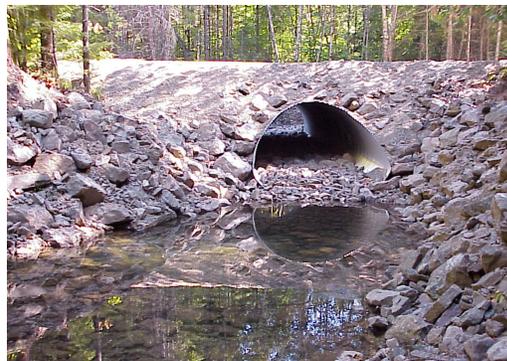
Pine Creek culvert post construction (Fall 1999, Kim Johansen, U.S. Forest Service).

Culvert-bed adjustment – Most, if not all, of the original bed material installed in the culvert has scoured out (see photo of post-construction conditions in History section). Bed material has aggraded adjacent to the scour pool along the right bank and through the lower two-thirds of the pipe resulting in a relatively flat bed. The slope of the culvert bed has been reduced through scour and aggradation (assuming the original culvert bed was constructed at the same slope as the structure).

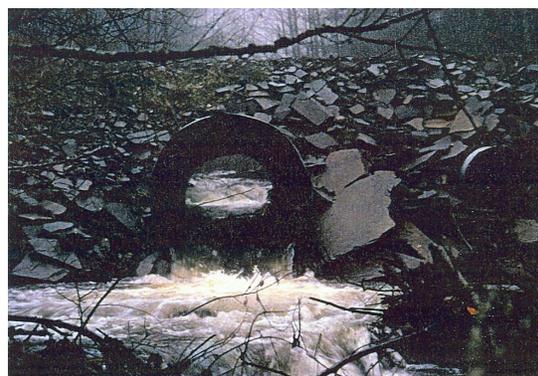
The previous culvert at this site was included in the 1987 Western Federal Lands Highway Division (WFLHD) "Oregon Culvert Fish Passage Survey." The field survey for the WFLHD study was conducted on December 1, 1987. The previous culvert was a 7.5-foot-diameter corrugated metal pipe with an additional 36-inch-diameter pipe installed for flood relief. Oregon Department of Fish and Wildlife (ODFW) staff rated the previous culvert as a "good" installation for fish passage but WFLHD staff noted high velocities (nearly double that of the natural channel) and a 2- to 3-foot-deep scour hole, and considered the pipe to not be a good installation for fish passage.

Culvert inlet.

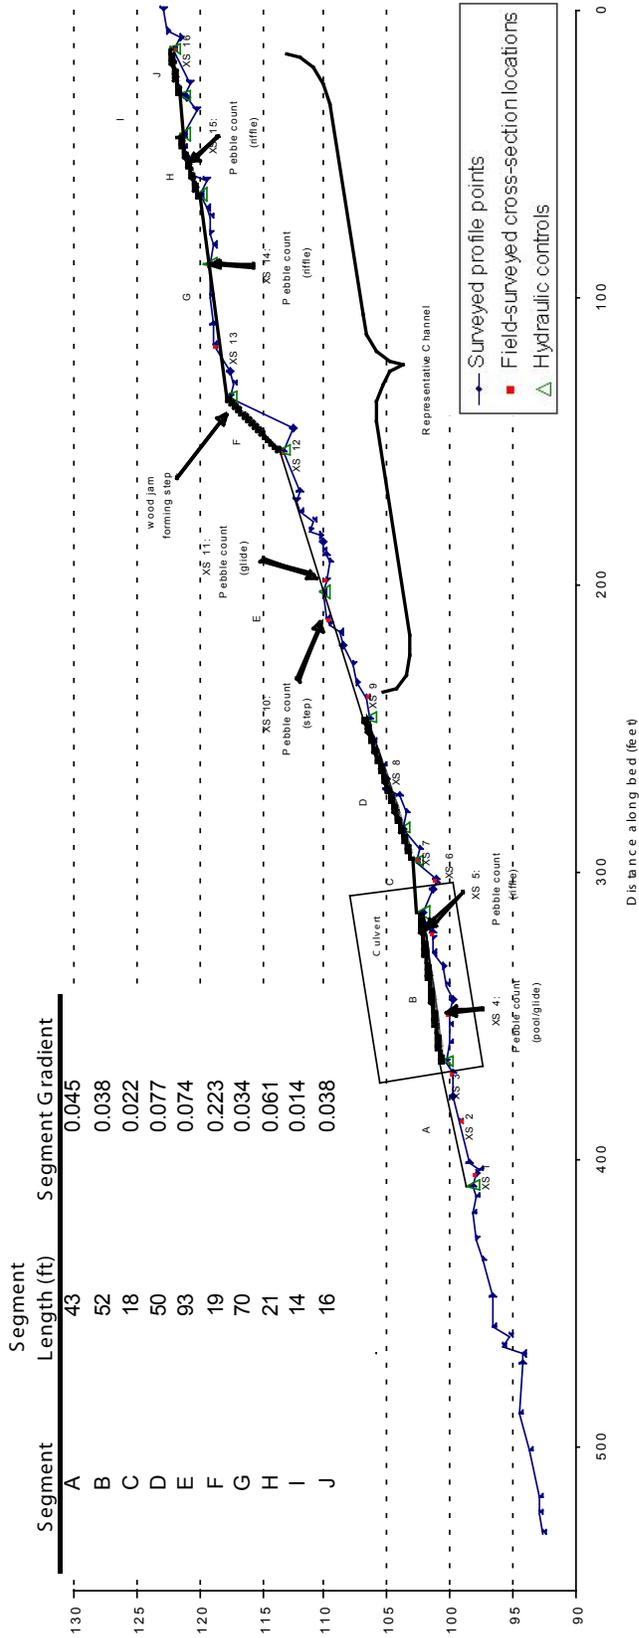
Figure 2—Pine Creek longitudinal profile.

The profile analysis resulted in a total of 10 profile segments. Two segments with similar gradients upstream of the inlet were not combined in order to separate out the inlet transition segment for analysis. The culvert consisted of two profile segments. The downstream segment in the culvert had comparable gradient to two representative profile segments in the upstream channel. There was no suitable comparison segment for the upstream segment in the culvert. The upstream transition segment had comparable gradient to two representative profile segments in the upstream channel. The downstream transition segment had comparable gradient to three upstream representative segments. See figure 2 and table 1.

Profile characteristics – The profile has a concave shape through the crossing, with the maximum concavity focused near the inlet (figure 2). This shape reflects the inlet scour and upstream channel incision combined with aggradation in the downstream portion of the channel and downstream of the outlet.

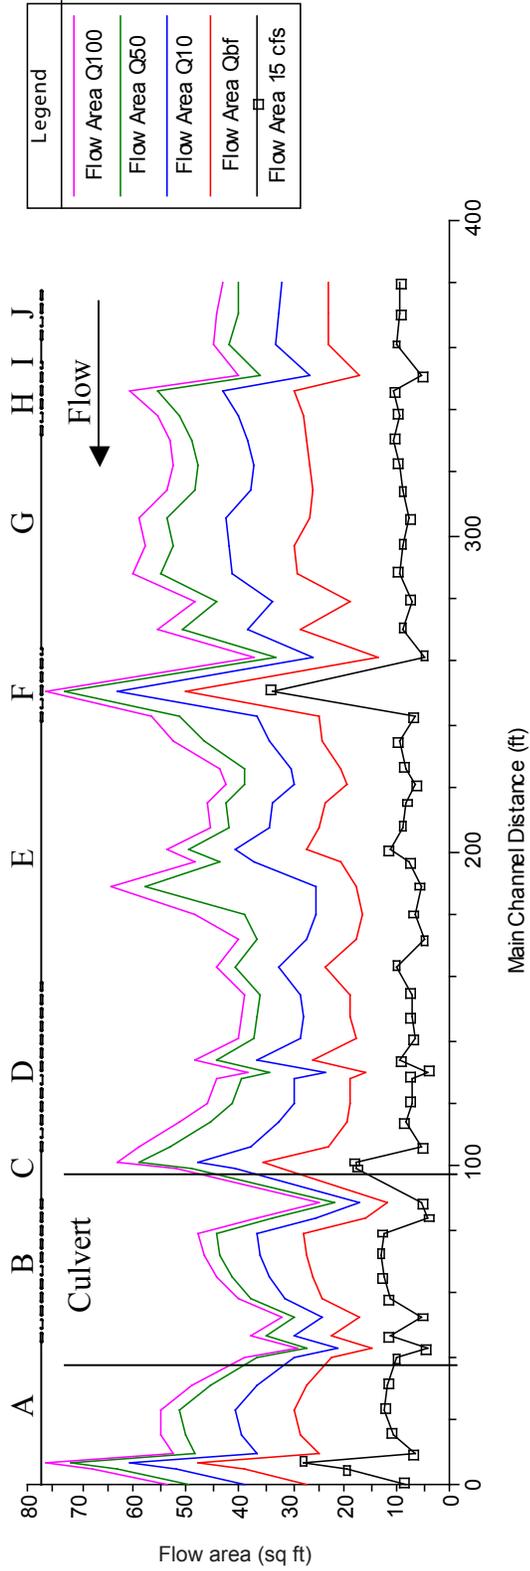
Figure 5—Flow area (total) profile plot.

Cross-section characteristics – Hydraulic modeling estimates that the culvert reduces flow area, top width, and wetted perimeter but increases hydraulic radius and depth (figures 5 through 7 and 12 through 19). These impacts are apparent even at the lowest modeled flow (25 percent Q_2). Flow geometry in the upstream transition (D) remains mostly within the range of corresponding profile segments (E and H) at all flows. The downstream transition segment (A) exhibits greater depths and lower wetted perimeter than corresponding profile segments (G, H, and J).

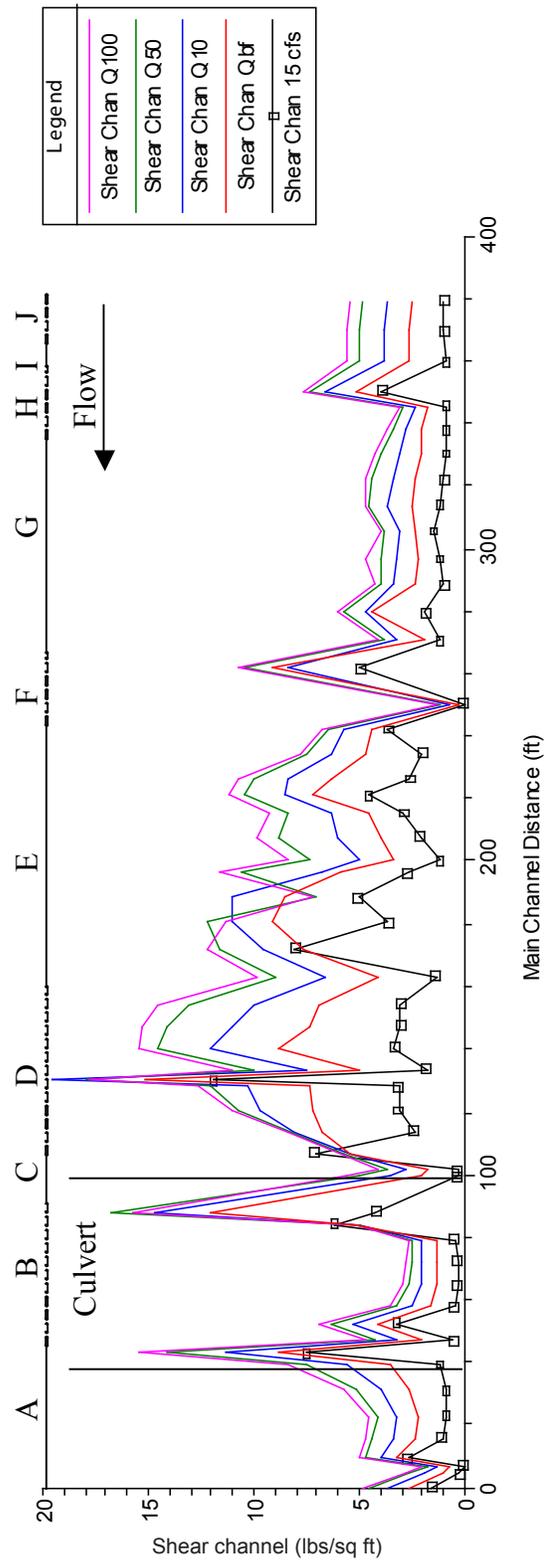
Figure 10—Shear stress (channel) profile.

Shear stress – Shear stress in the culvert and in the upstream transition segment (D) spikes to higher values than in corresponding profile segments (figures 10 and 19). Shear stress in the downstream transition (A) has a wider range than that found in corresponding profile segments (G, H, and J).

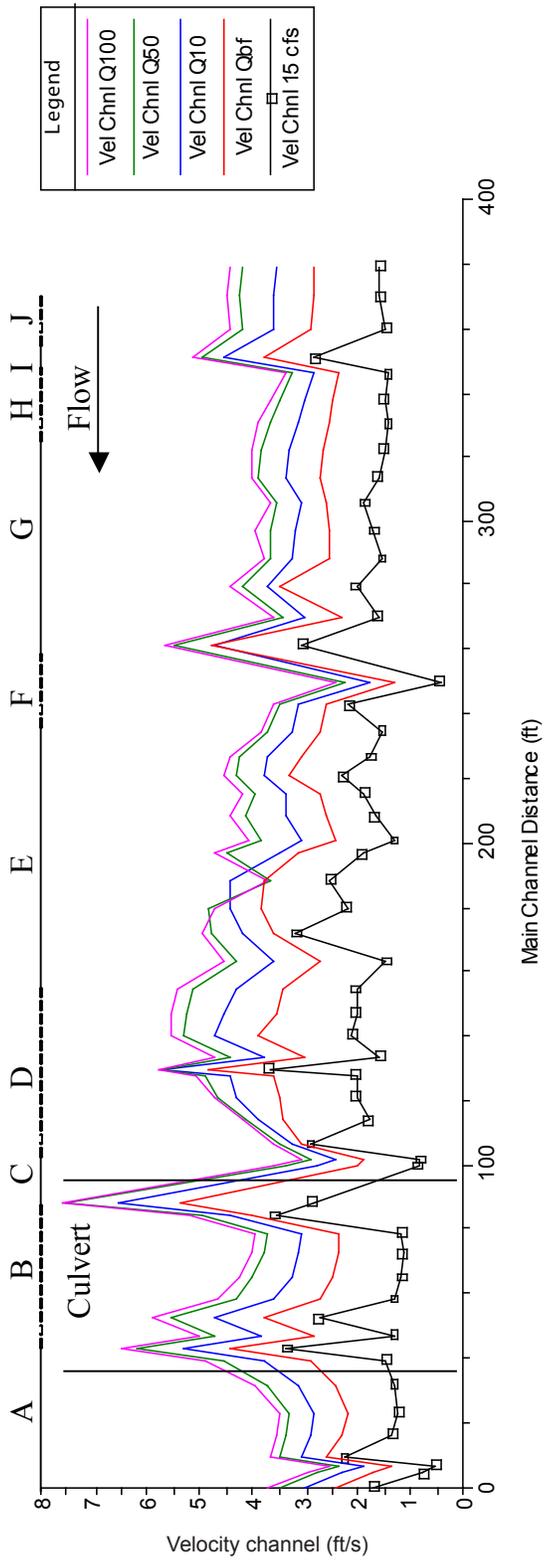
Figure 11—Velocity (channel) profile plot.

Velocity – Velocity in the culvert and in the upstream transition segment (D) spikes to higher values than in corresponding profile segments (figures 11 and 18). Velocity in the downstream transition (A) has a wider range than that found in corresponding profile segments (G, H, and J).

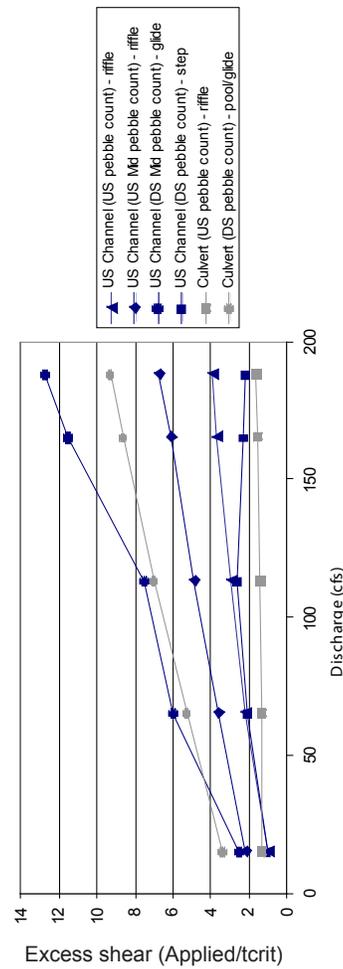
Figure 20—Excess shear stress.

Excess shear – Modeling suggests that excess shear in the culvert is mostly within the range (or slightly lower) than the excess shear in the natural channel (figure 20).

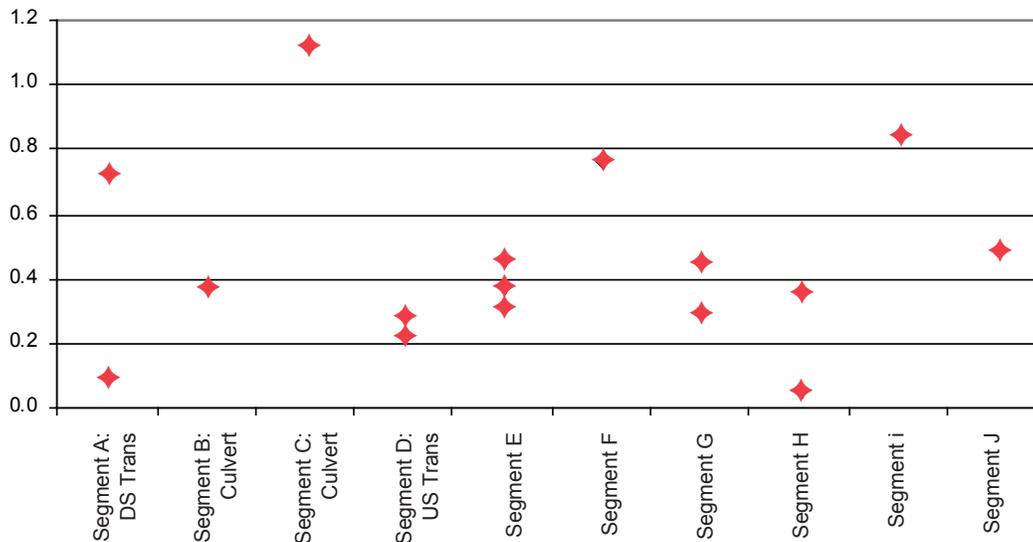
Figure 21—Residual depths.

Residual depths – The upstream culvert segment (C) residual depth is greater than any residual depth found in the natural channel (figure 21). This is the location of inlet scour. Residual depth in the downstream portion of the culvert (B) is within the range of residual depths in corresponding profile segments (G and J). Residual depth in the downstream transition segment (A) is within or above the range of depths in corresponding profile segments in the natural channel (G, H, and J). Residual depth

in the upstream transition segment (D) is within the range of depths in corresponding profile segments in the natural channel (E and H).

Residual depths – The upstream culvert segment (C) residual depth is greater than any residual depth found in the natural channel (figure 21). This is the location of inlet scour. Residual depth in the downstream portion of the culvert (B) is within the range of residual depths in corresponding profile segments (G and J). Residual depth in the downstream transition segment (A) is within or above the range of depths in corresponding profile segments in the natural channel (G, H, and J). Residual depth in the upstream transition segment (D) is within the range of depths in corresponding profile segments in the natural channel (E and H).
