Deadwood Creek Tributary South

Site Information

Culvert Information

Culvert Scour Assessment

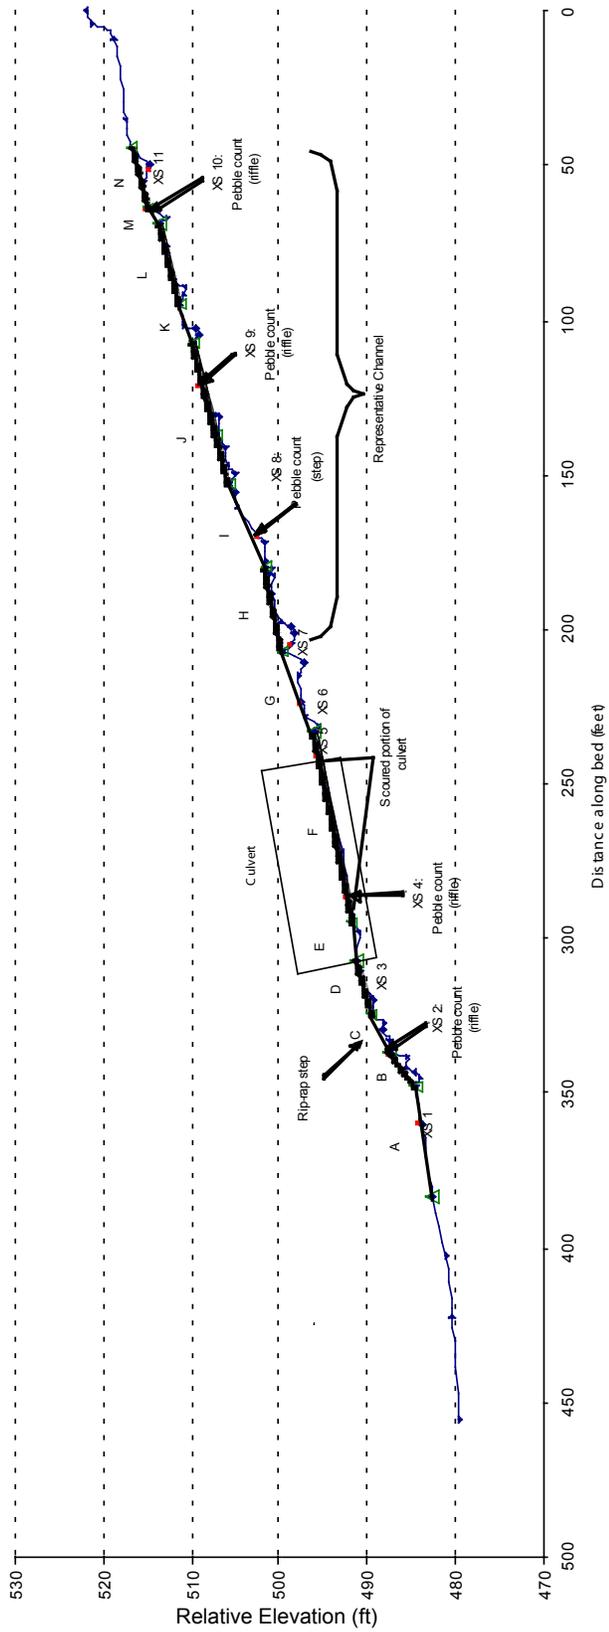
Figure 2—Deadwood Creek Tributary South longitudinal profile.

consisted of three distinct profile segments where the stream falls off quickly from the culvert outlet to the mainstem valley floor of Deadwood Creek. See figure 2 and table 1.

Profile characteristics – The profile is concave at the crossing but convex downstream of the outlet (figure 2). The profile was described as a “dual grade break” by the designer (see History section). The site is located at the transition from the small, confined valley of the tributary to the broader valley of mainstem Deadwood Creek. The profile shape is very likely an artifact of the previous culvert at this site, which had a large scour pool at the outlet and then dropped off steeply to Deadwood Creek. The steep downstream segment is now a steep riprap step.

This is a steep stream and an even steeper culvert, and a very challenging installation to keep from scouring. Regrading the profile to eliminate the dual grade break may avoid the steeper sections that currently pose a passage issue for migrating fish. Using an open-bottom pipe and constructing stable steps through the crossing may provide more stability and scour resistance. Constructing channel banks within the pipe would allow for terrestrial organism passage. A series of wood and rock steps between the outlet and Deadwood Creek similar to those above the culvert would also improve passage conditions.

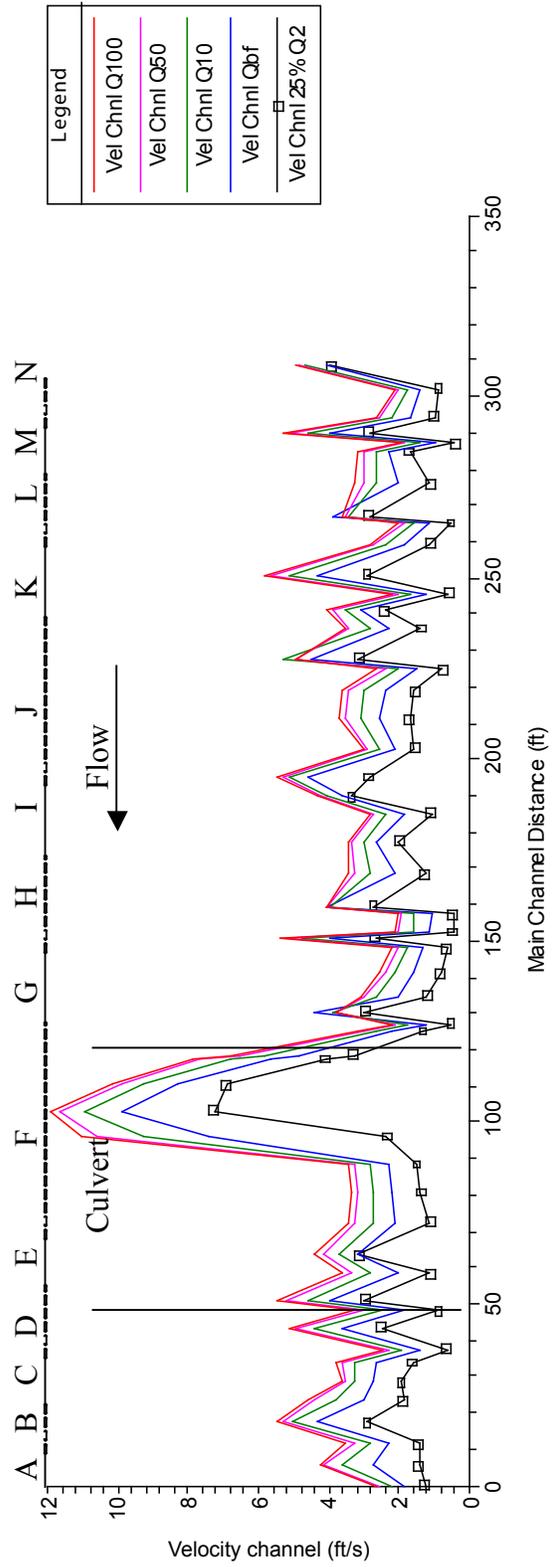
Figure 11—Velocity (channel) profile plot.

Velocity – Velocity in the upper portion of the culvert is extremely high in relation to the natural channel (figure 11). The downstream portion of the culvert and the transition segments have velocities that are more in line with the channel outside the crossing.

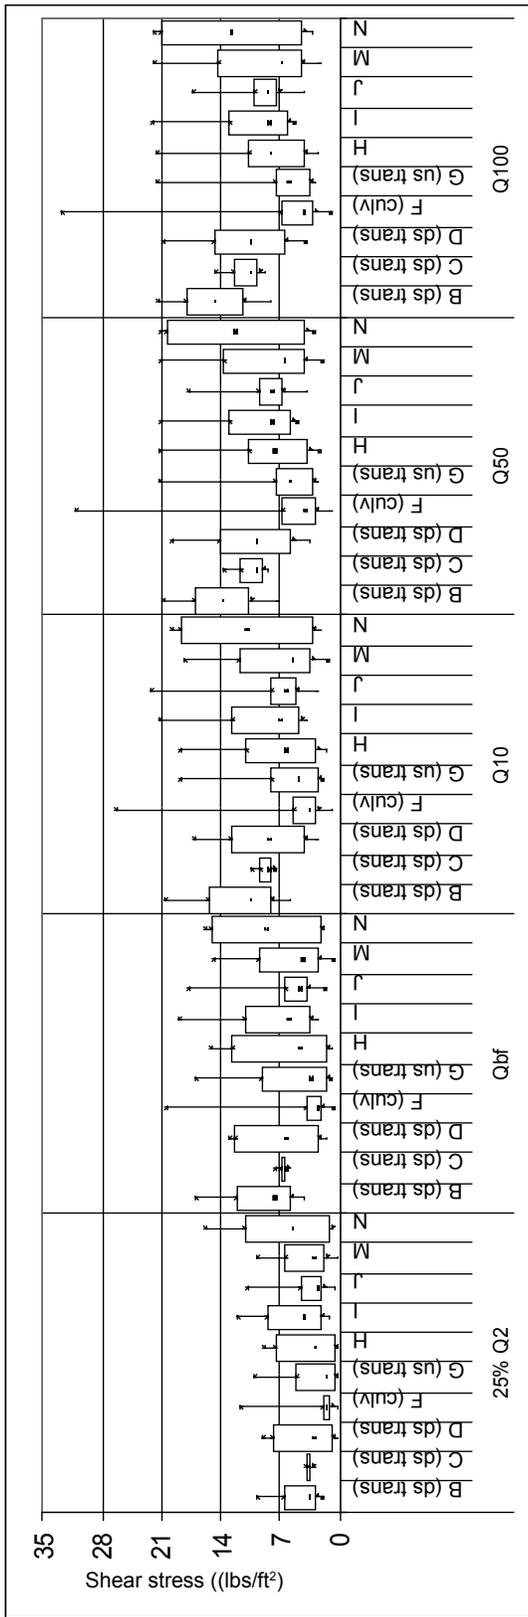
Figure 19—Shear stress (channel).

Shear stress – Modeled shear stress in the culvert has a greater range than the natural channel at the Q_{10} and above, with more extreme (lower as well as higher) values (figure 19). Transition segments do not differ significantly from the natural channel.

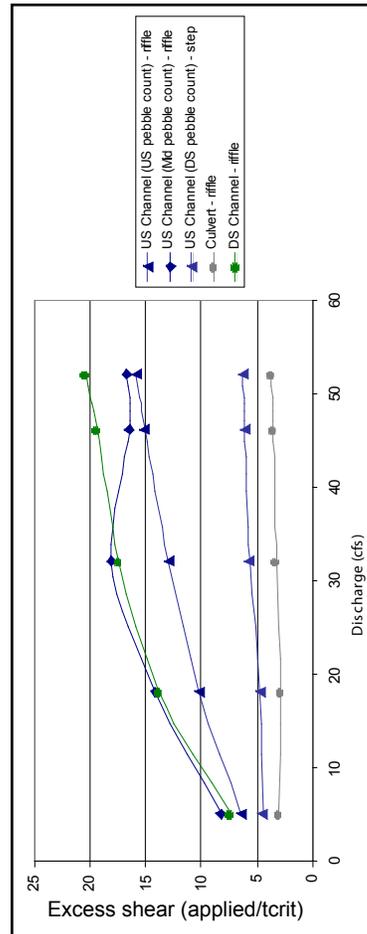
Figure 20—Excess shear stress.

Excess shear – The excess shear analysis suggests that bed material in the culvert is mobilized less frequently than material in the natural channel (figure 20). Past scour of culvert material may have served to stabilize the bed by scouring out smaller material and leaving larger material that is capable of withstanding high flows.

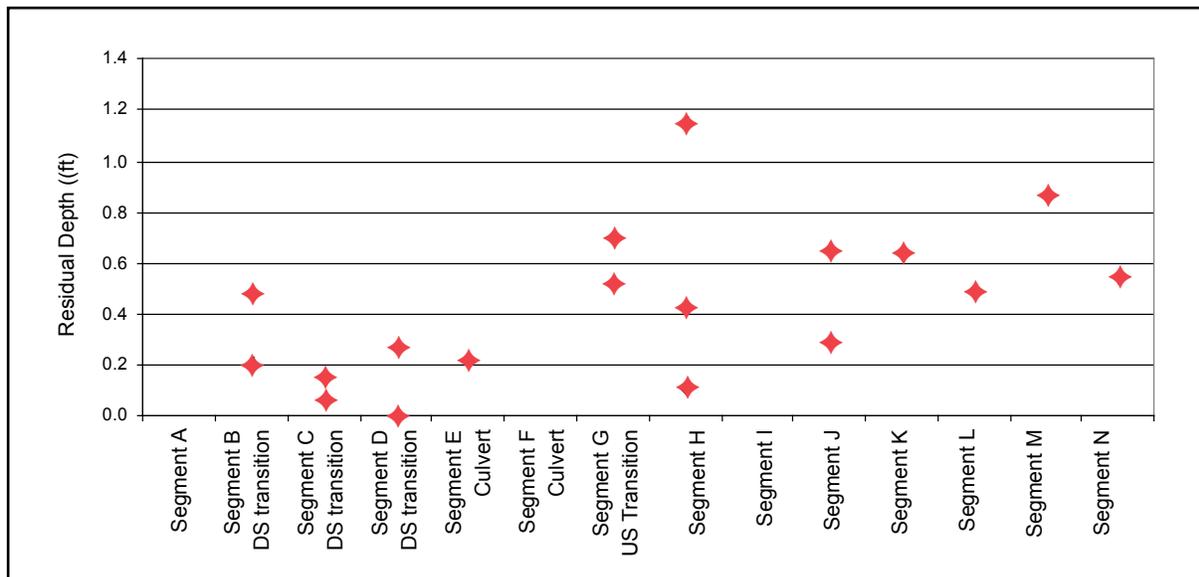
Figure 21—Residual depths.

Residual depths – The one residual depth in the culvert is located in a profile segment that has no comparable profile segment in the natural channel; however, this depth is at the lower end of the range of residual depths found within all the profile segments in the channel outside the

crossing (figure 21). Transition segments have residual depths that do not vary substantially from corresponding profile segments.

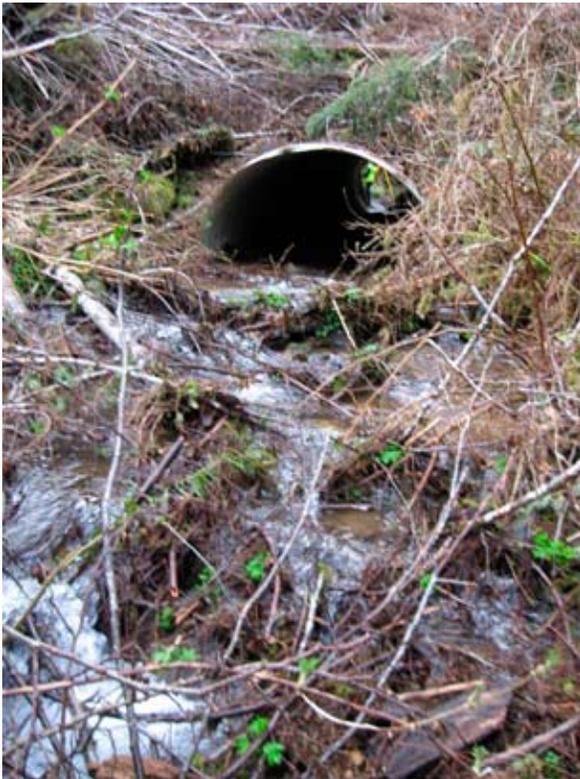
Structure scour – The upstream half of the pipe was scoured to the culvert base. Supercritical flow was present along the exposed culvert base at the time of the survey.

View upstream through culvert.

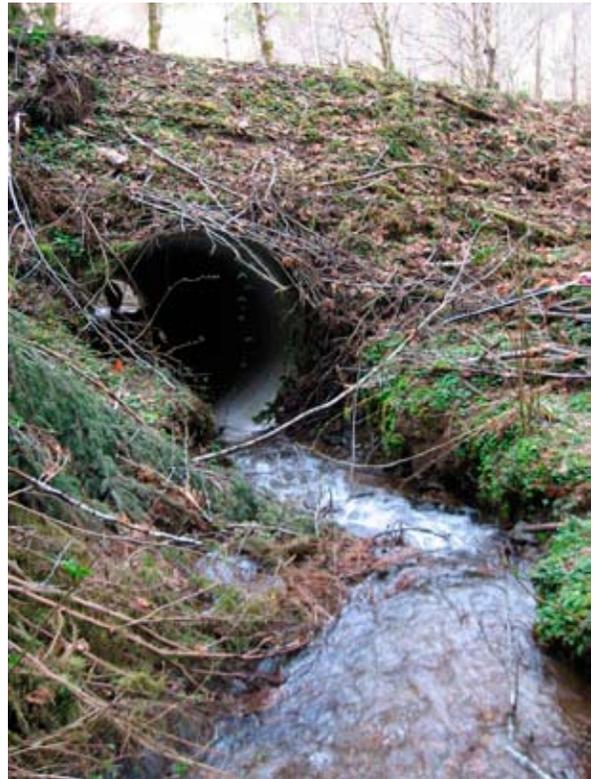
View downstream through culvert.

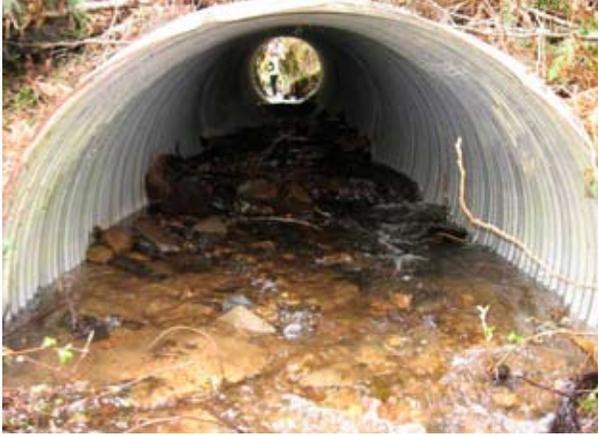
View upstream in culvert.

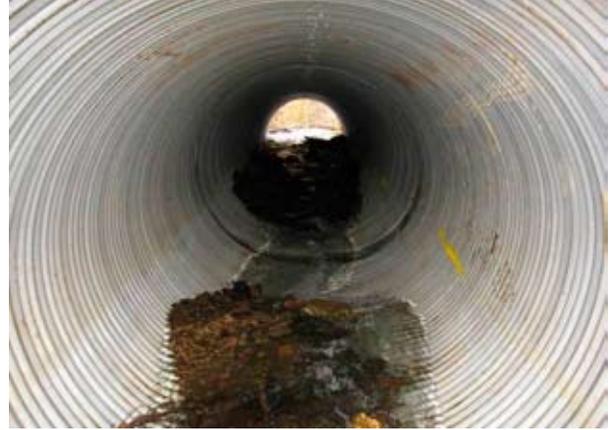
View downstream in culvert.

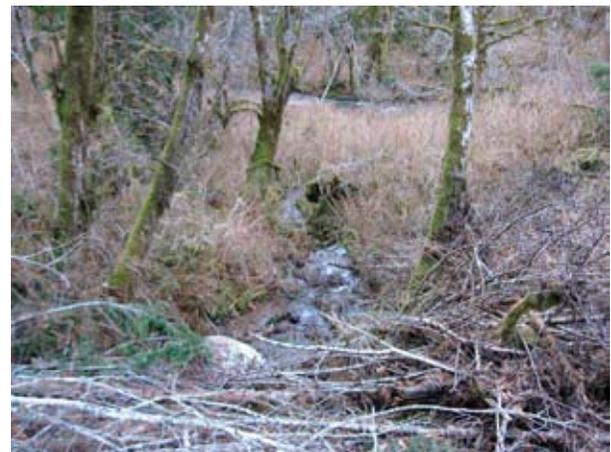
At the outlet to the culvert, the channel drops over a steep riffle. Downstream of the outlet there is a steep riprap step/cascade possibly built during or following construction to control the grade up to the outlet. After the step, the stream flattens out before entering the flood plain of Deadwood Creek. Large quantities of brush from roadside clearing were present downstream of the crossing.

View downstream from road.

Vegetation-clearing activities along the road should avoid depositing material in the inlet or outlet areas. This material can plug the culvert and can affect fish passage conditions.
