Lower Eightmile Creek

Site Information

Culvert Scour Assessment

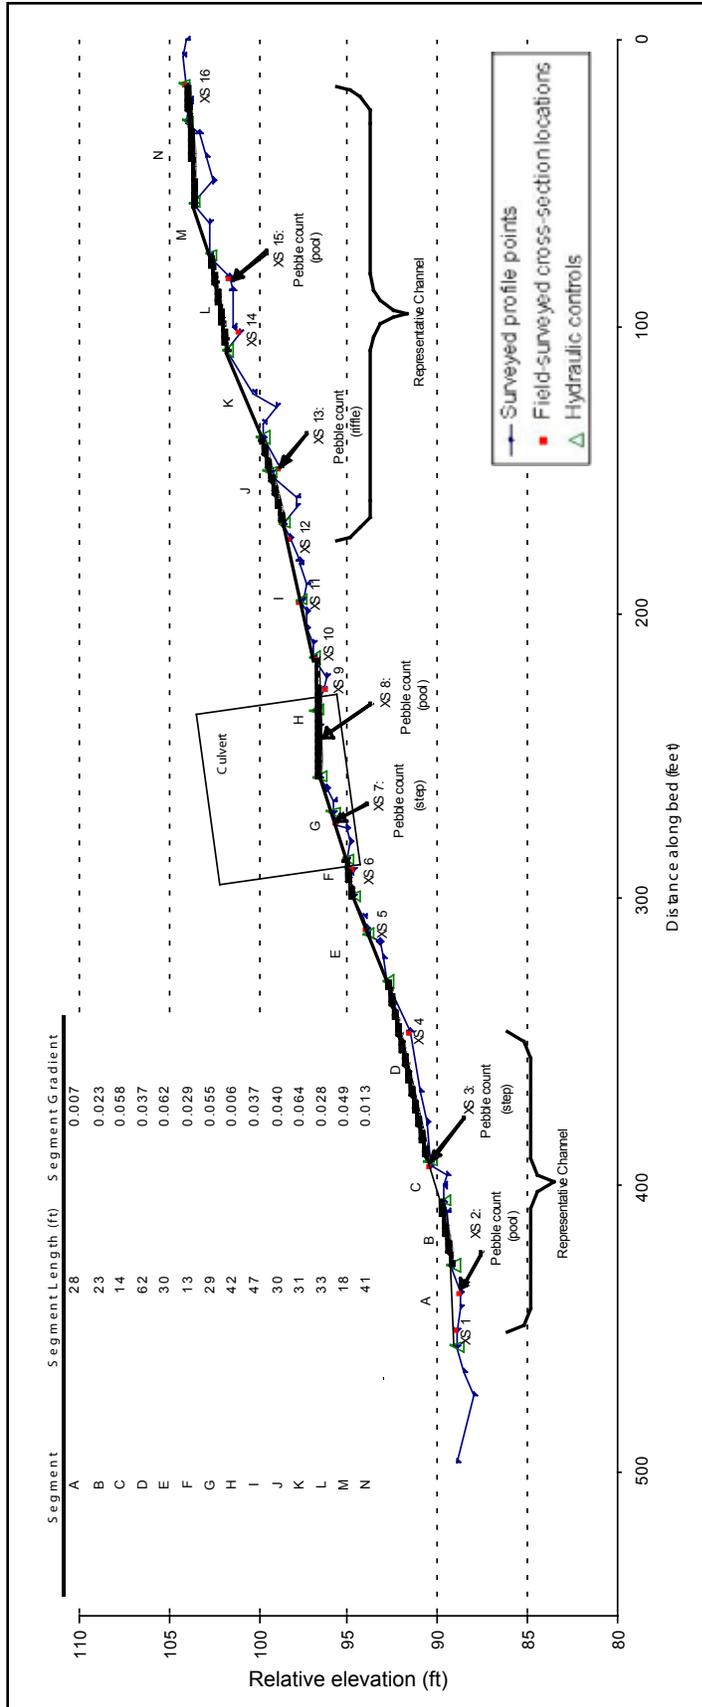
Figure 2—Lower Eightmile Creek longitudinal profile.

segment was comparable to three representative profile segments, two in the upstream channel and one in the downstream channel. One downstream transition segment was comparable to an upstream and a downstream representative segment and one was comparable just to a downstream representative segment. See figure 2 and table 1.

Profile characteristics – The profile has a convex shape through the crossing with a rise in bed elevation within the culvert (figure 2).

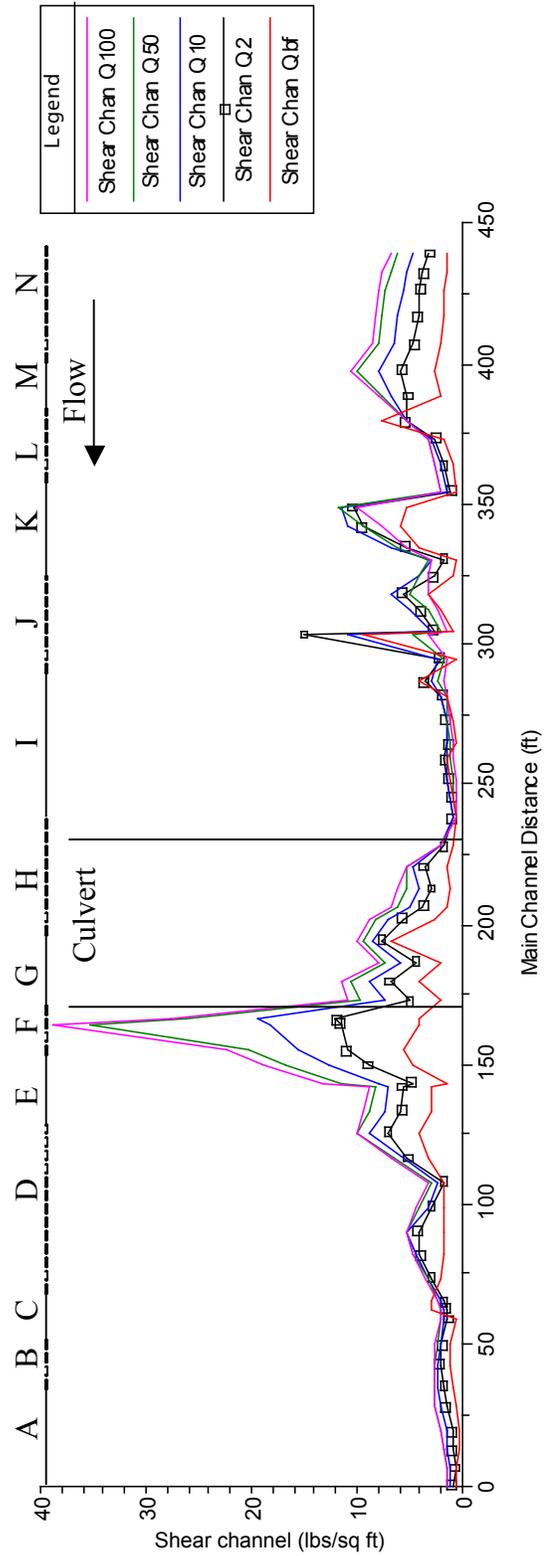
Figure 10—Shear stress (channel) profile.

Shear stress – Shear stress is low at the inlet because of backwater effects but increases towards the downstream end of the culvert and is very high at the outlet area (figure 10). The downstream transition area (F) exhibits the greatest shear stress (figures 10 and 19). The upstream transition (I) has low shear stress because of the effect of culvert backwater on the energy grade slope.

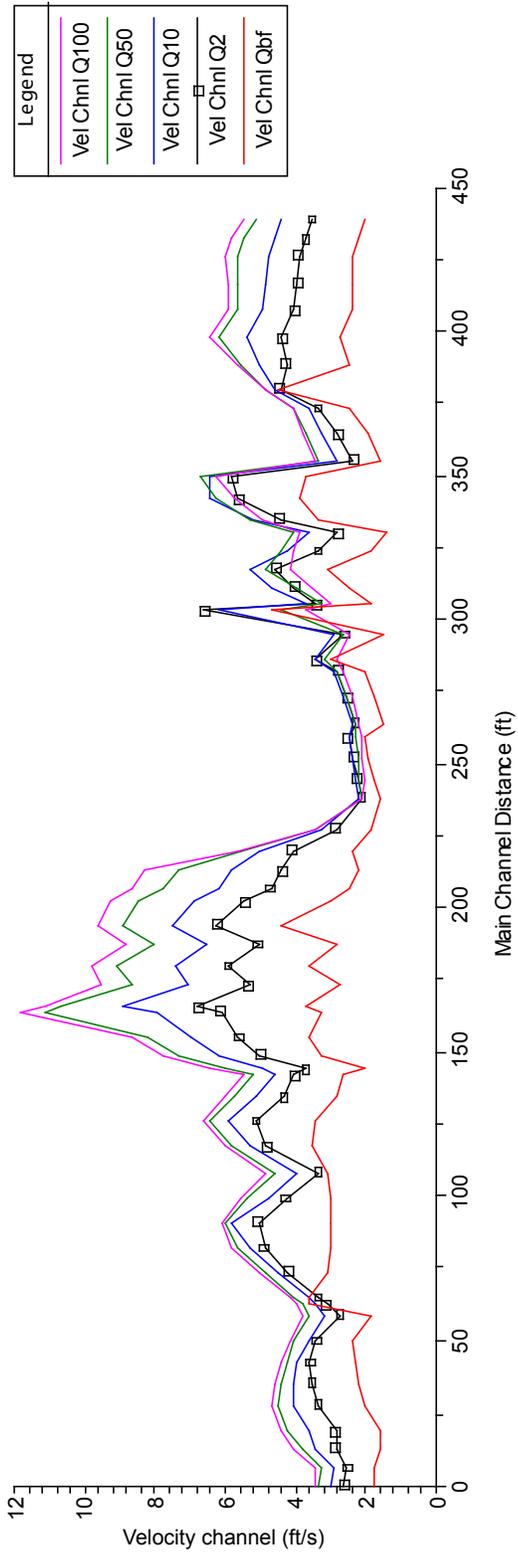
Figure 11—Velocity (channel) profile plot.

Velocity – Velocity is low at the inlet because of backwater effects but increases towards the downstream end of the culvert and is very high at the outlet area (figure 11). The downstream transition area (F) exhibits the greatest velocity (figures 11 and 18). The upstream transition (I) has low velocity because of the effect of culvert backwater on the energy grade slope.

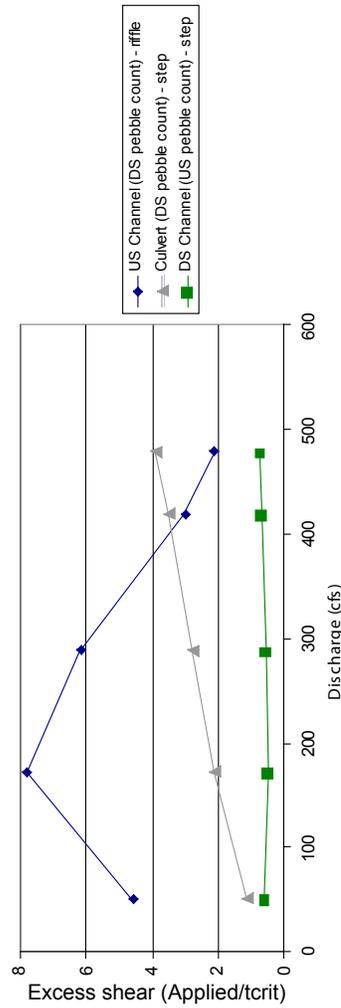
Figure 20—Excess shear stress.

Excess shear – Model results show that the culvert excess shear stress is within the range of channel conditions (figure 20) except at high flows (Q_{50} and above) where culvert bed mobility may exceed that of the natural channel.

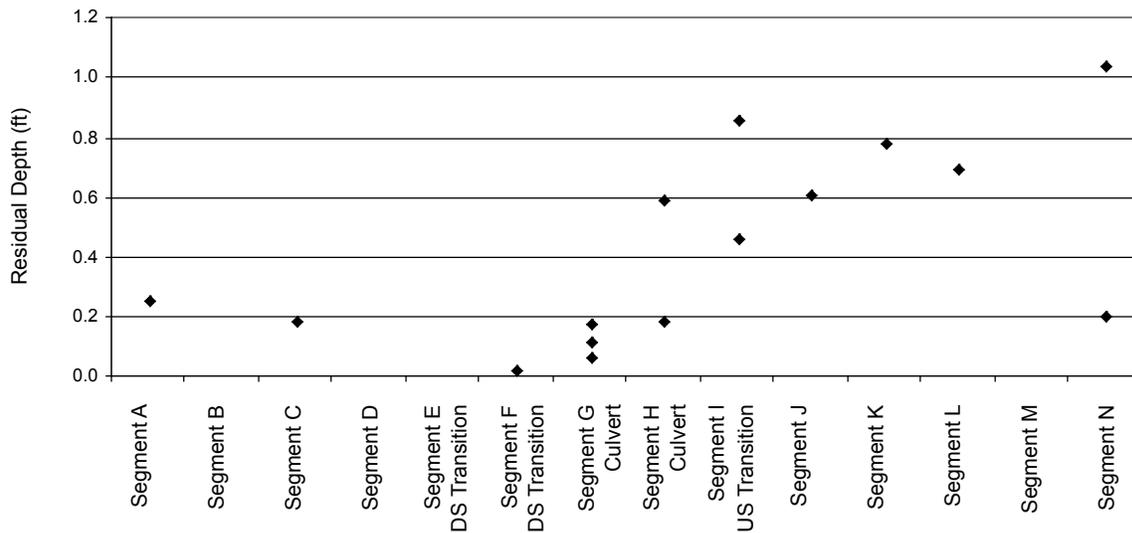
Figure 21—Residual depths.

Residual depths – Culvert residual depths are lower than residual depths in corresponding channel segments (C, J, and A) (figure 21). The upstream transition segment (I) has residual depths that are both greater and less than the range of residual depths in corresponding profile segments (D, J, and L). The single residual depth in downstream transition segment F is lower than the single depth in corresponding profile segment L.

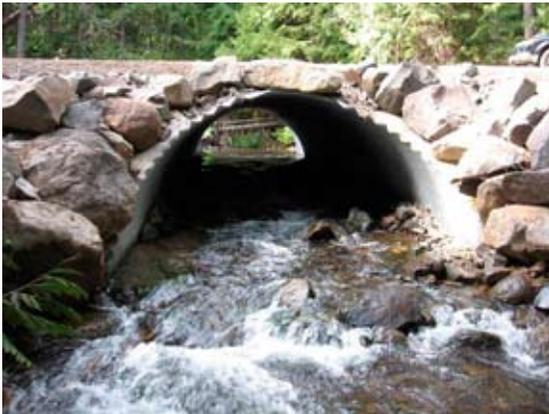
Culvert-bed adjustment – There are no obvious signs of bed adjustment except for some recently aggraded sediment in the upstream half of the culvert. There is angular rock forming a step in the downstream portion of the culvert; it is unknown whether this was placed during construction or if it washed in from the riprap banks at the inlet.

Currently there are no significant signs of scour in the pipe. The rise in bed elevation in the culvert appears to be related to the step that makes up the downstream half of the pipe. This step is composed of angular large cobbles and small boulders and may be riprap material washed into the culvert from the banks at the inlet. There is streambed material (rounded alluvium) that has aggraded upstream of this step. The grade control provided by the step, and the associated aggradation in the upstream half of the pipe, may be limiting culvert capacity and creating scour risk during high flows.

View upstream through culvert.

Hydraulic analysis and observations at other sample sites suggest that this site may experience bed adjustment during future high flows. The culvert appears to have insufficient capacity to adequately convey high flows. Contributing factors may include an inadequate culvert size and the presence of aggraded material within the pipe. Design improvements would include a larger culvert (current culvert is less than 75 percent of the bankfull width) and a properly constructed bed that creates a more uniform profile through the crossing. Constructed bed elements could include banks that provide flow concentration and roughness (velocity refuge) for fish passage and that also would provide exposed banks to facilitate passage of terrestrial organisms.

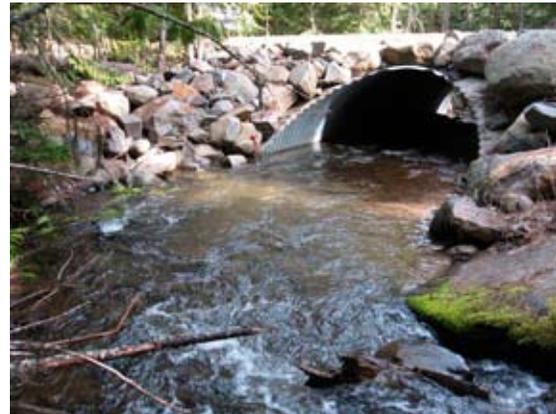
Flow in the culvert was wall-to-wall throughout much of its length at the time of the survey. At low summer flows, wide shallow flow may create fish passage issues. At higher flows, the high velocity in the downstream portion of the pipe may also impede passage, especially considering the lack of bank roughness that can provide velocity refuge.

View downstream through culvert.

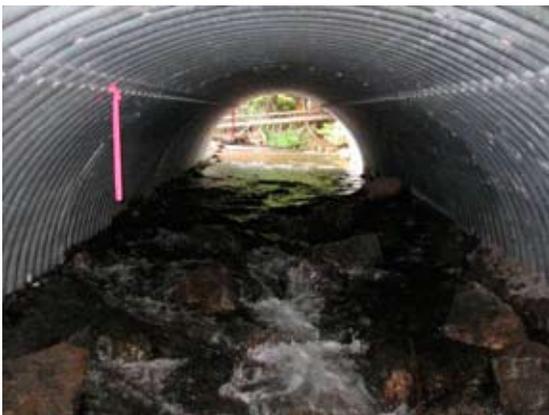
Culvert - downstream pebble count, riffle.

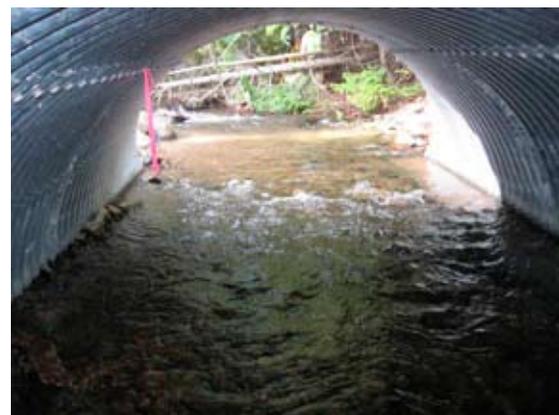
Culvert - upstream pebble count, pool.
