Culvert Scour Assessment

UPPER EIGHTMILE CREEK

Site Location:	Mt Hood NF, Forest Road 4430 150 spur. Middle culvert in upper Eightmile Campground area		
Year Installed:	2000		
Lat/Long:	121°27'21.9"W	Watershed Area (mi²):	4.1
	45°24'24.7"N		
Stream Slope (ft/ft)¹:	0.0422	Channel Type:	Step-pool
Bankfull Width (ft):	20.5	Survey Date:	April 26, 2007

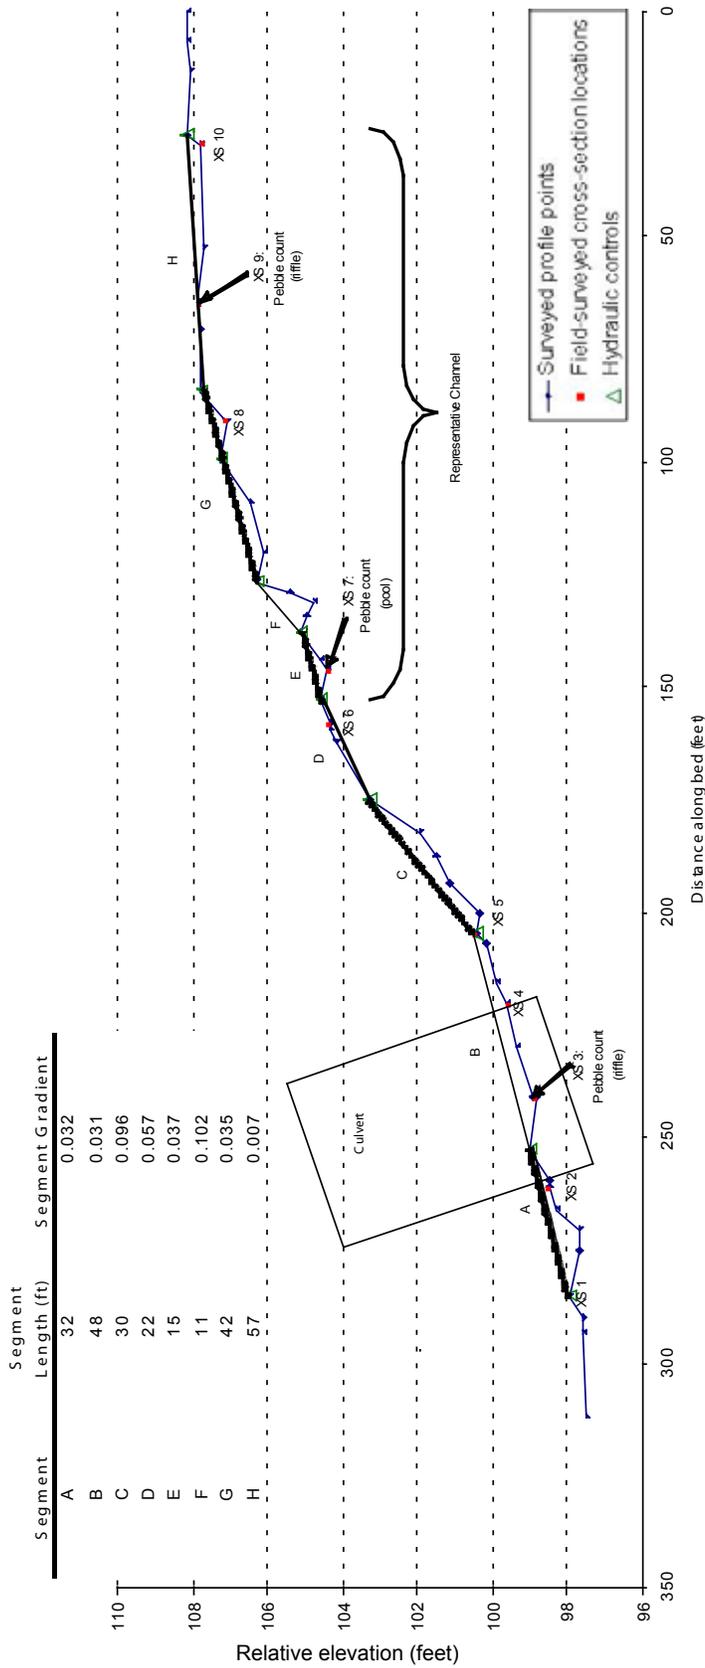
Figure 2—Upper Eightmile Creek longitudinal profile.

The profile analysis resulted in a total of eight profile segments. The culvert consisted of one profile segment. This segment extends just above the inlet. The culvert segment was comparable to two representative profile segments in the upstream channel. The downstream transition segment was comparable to the same two representative segments. There was no suitable comparison segment for the upstream transition segment. See figure 2 and table 1.

Profile characteristics – The profile at the crossing has a concave shape that reflects the reduction in slope that begins at the culvert inlet and extends downstream of the outlet. Slope is partly controlled by a constructed step of large cobbles downstream of the outlet; a feature that would likely wash out at high winter flows. There is evidence of incision upstream (steep eroding

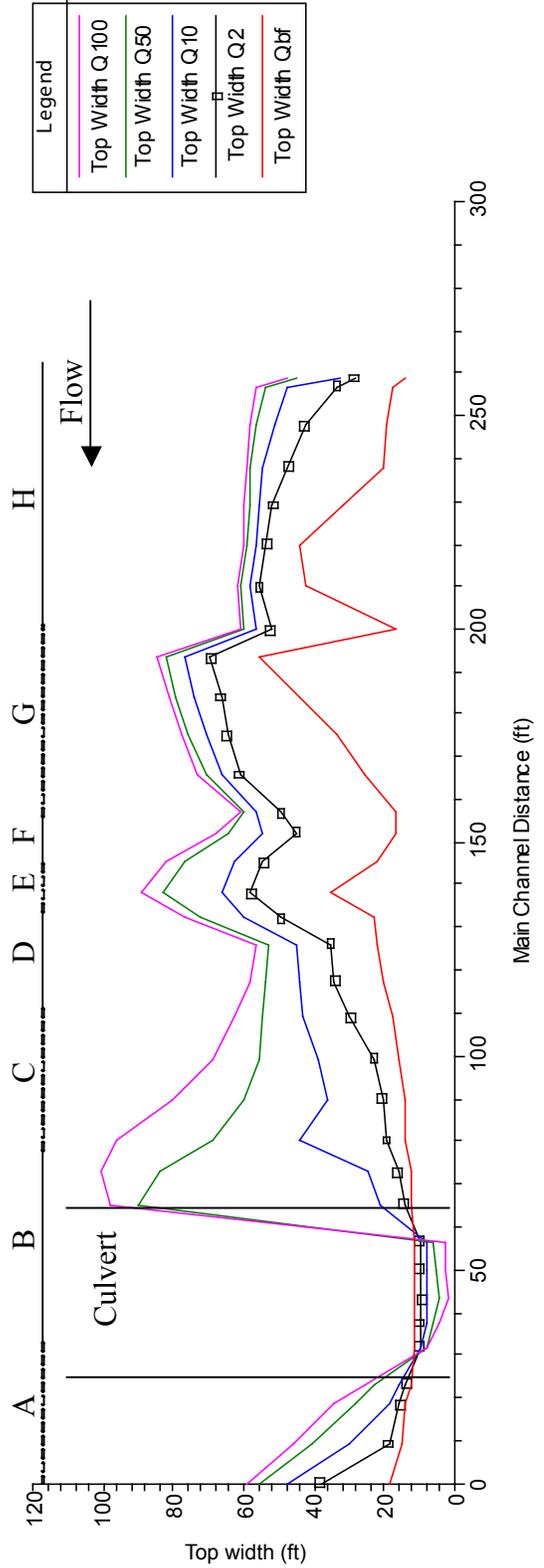
Figure 8—Top width.

Cross-section characteristics – The culvert has a dramatic effect on cross-section characteristics at nearly all flows, but particularly at flows exceeding bankfull (figures 5 through 9 and 12 through 17). For top width (figure 15), the culvert segment shows some widths exceeding the width of the corresponding profile segment at high flows (Q_{50} and Q_{100}). This is because the culvert segment extends upstream of the culvert inlet and the model shows the culvert inlet backwatering flow at these high flows. Relationships are similar between the downstream transition segment and the natural channel, except for maximum depth, which is within the range of the natural channel.

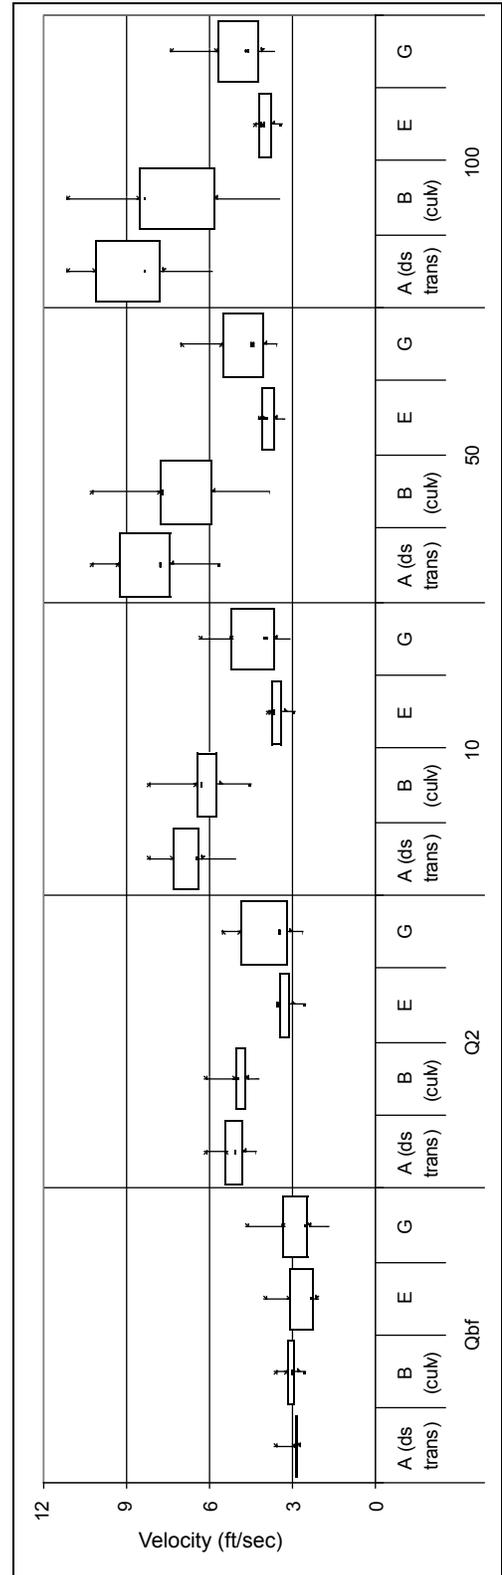
Figure 18—Velocity (channel).

Velocity – Velocities in the culvert and the downstream transition segments are greater than the corresponding channel segments above the Q_{bf} (figure 18).

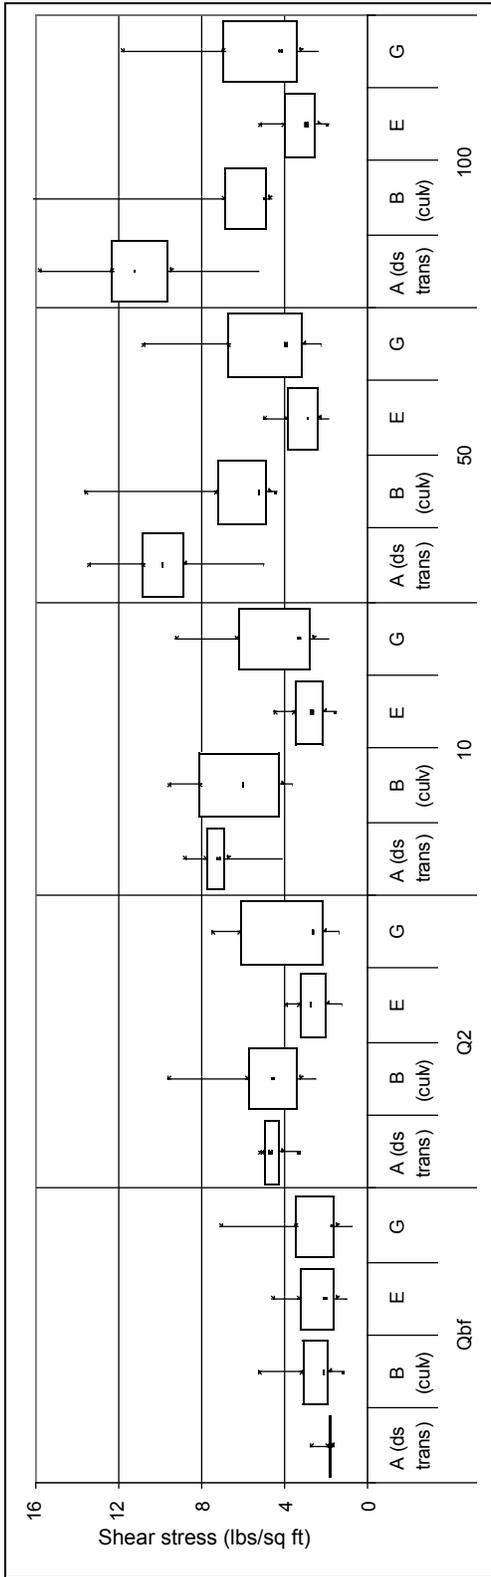
Figure 19—Shear stress (channel).

Shear stress – Most of the shear-stress values in the culvert are similar to corresponding profile segment G, except for at high flows (Q_2 and above) where the maximum shear in the culvert is greater than the maximum shear in the natural channel (figure 19). Shear stress in the downstream transition segment is greater than the natural channel at the Q_{10} and greater.

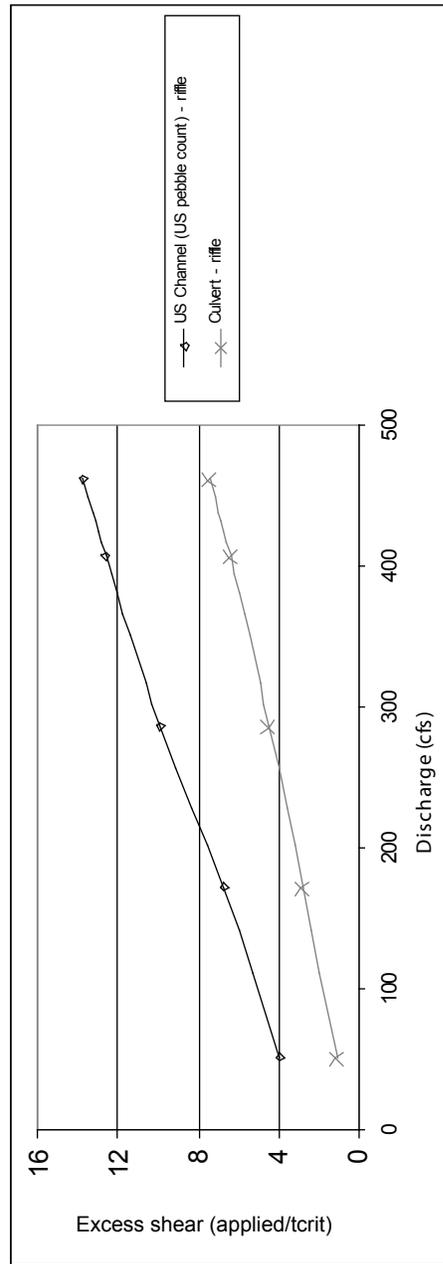
Figure 20—Excess shear stress.

Excess shear – The culvert excess shear is about half that of the excess shear in the upstream channel (figure 20). This is mainly due to differences in the D_{50} s of these cross sections. The greater D_{50} in the culvert results in a higher critical shear stress due to the accounting for less particle protrusion of the D_{84} , which is similar between the sections.

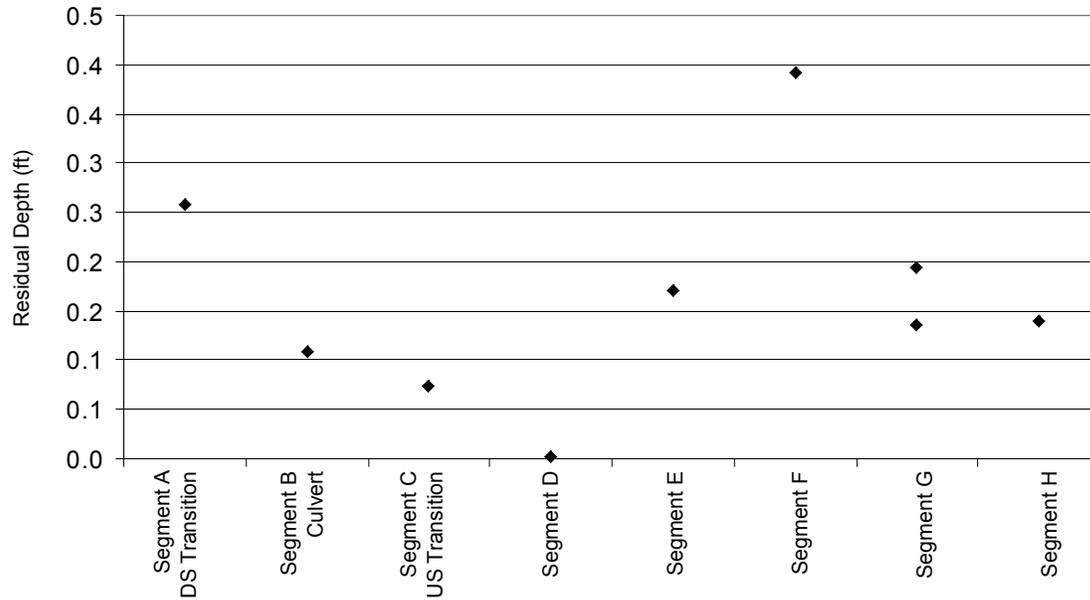
Figure 21—Residual depths.

Residual depths – The single culvert residual depth is just below the lower end of the range of the corresponding profile segments (E and G). The single downstream transition residual depth is only a tenth of a foot greater than the greatest residual depth in the corresponding profile segments (E and G) but is below the deepest residual depth in the natural channel (figure 21).

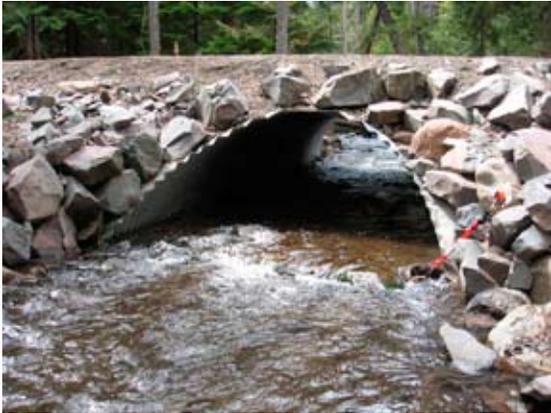
Culvert bed adjustment – The culvert bed slope has adjusted to a flatter slope since construction (assuming the culvert bed was originally constructed at the same gradient as the structure). Angular cobbles and small boulders are present in the culvert bed. These were either placed there or have been recruited from the riprap banks at the inlet and outlet. Fines and small gravels have aggraded inside the culvert.

View upstream through culvert.

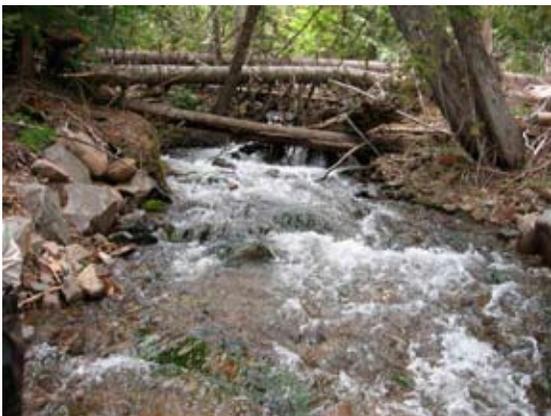
banks) that suggests that the new culvert may have been installed below the profile of the original stream. This may have occurred to avoid raising the road prism.

There is evidence of incision upstream that suggests that the new culvert was installed below the profile of the original stream. This may have occurred to avoid raising the road prism.

View upstream from inlet. Moderate incision can be seen in upstream channel.

The culvert placed at this site is undersized to effectively convey flows without significant impacts to flow geometry and culvert scour. No significant scour was observed during the survey but the site is a relatively recent installation and has likely not yet experienced flows greater than a 5- or 10-year event. The limited capacity may create outlet control conditions at high flows, with the flow passing through critical depth within the pipe, which may result in future scour of the culvert bed. The culvert was calculated as being only 59 percent of the bankfull width of the stream. A wider culvert at this site would improve conveyance and reduce scour risk. The installation may also have benefited from being at a higher elevation along the profile, thus reducing what appears to be channel incision in the channel upstream of the inlet. The pipe may have been installed low because of limitations imposed by the height of the road surface.

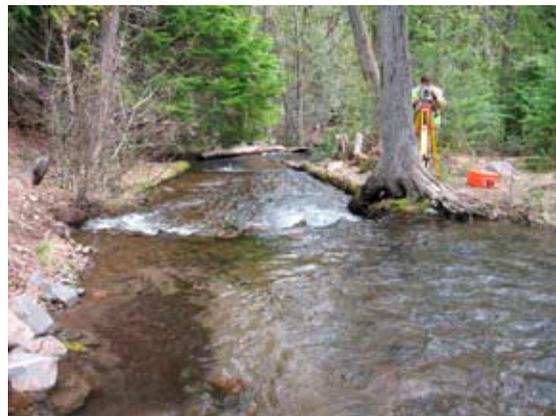
View downstream from outlet. Rock step created for grade control.
