Culvert Scour Assessment

LITTLE ZIGZAG CREEK

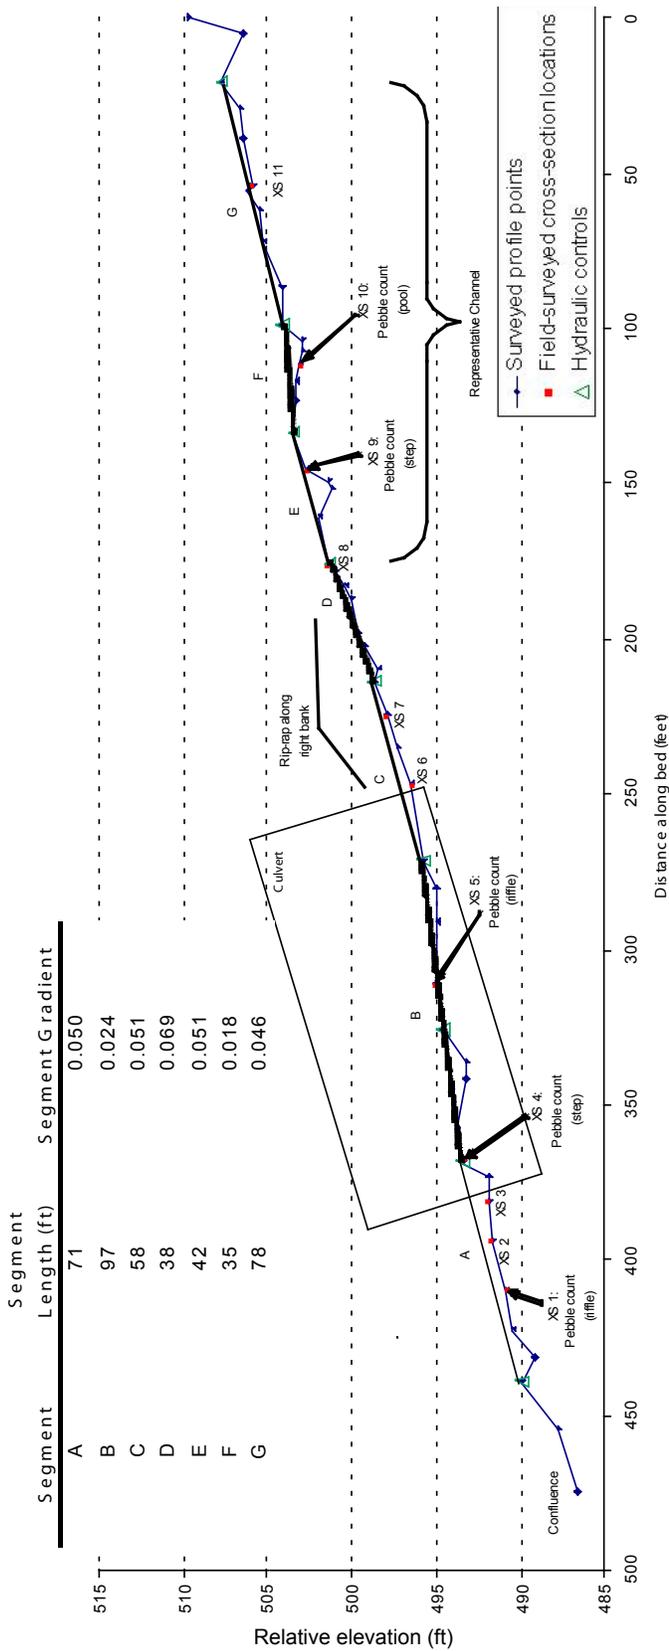
Figure 2—Little Zigzag Creek longitudinal profile.

Culvert-bed adjustment – The channel within the culvert has reduced slope to less than the constructed slope (assuming the channel bed was originally constructed at the same gradient

as the structure). This may be related to the large step at the downstream end of the culvert that controls grade and has aggraded bed material behind it.

Profile characteristics – The profile is mostly uniform, with a slight concavity centered near the culvert inlet. Natural valley transition from the Little Zigzag valley to the mainstem Zigzag valley may account for some of this, but it may also be partly related to slope adjustment (flattening) of the culvert bed (figure 2) as discussed above.

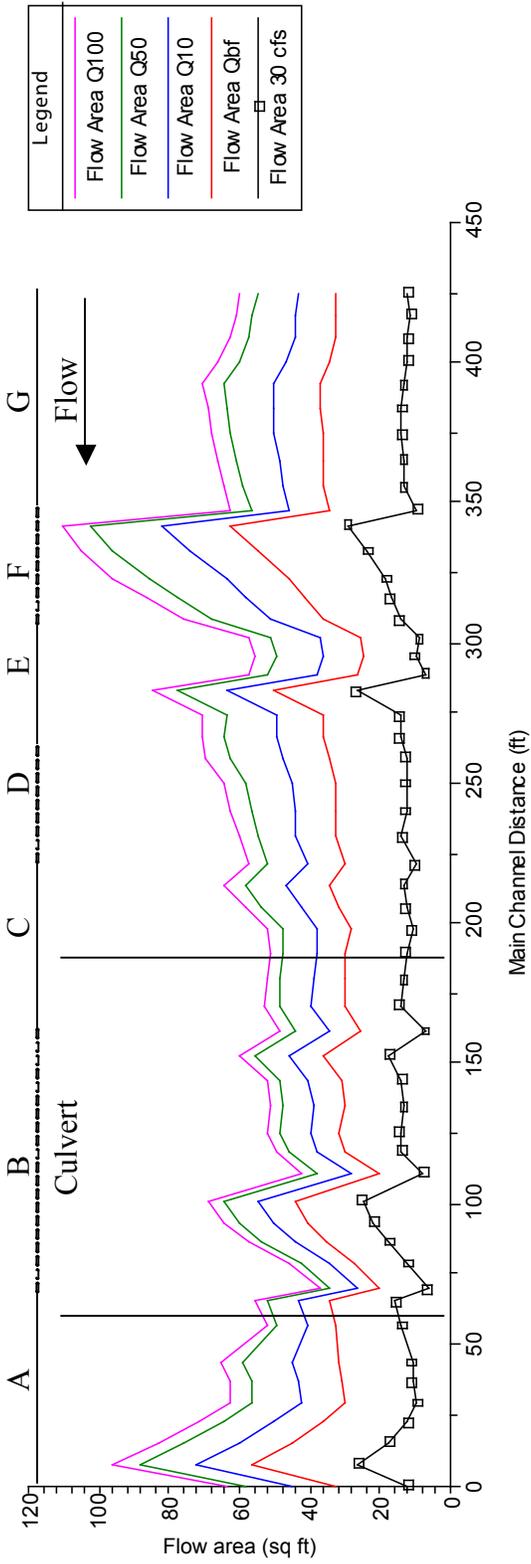
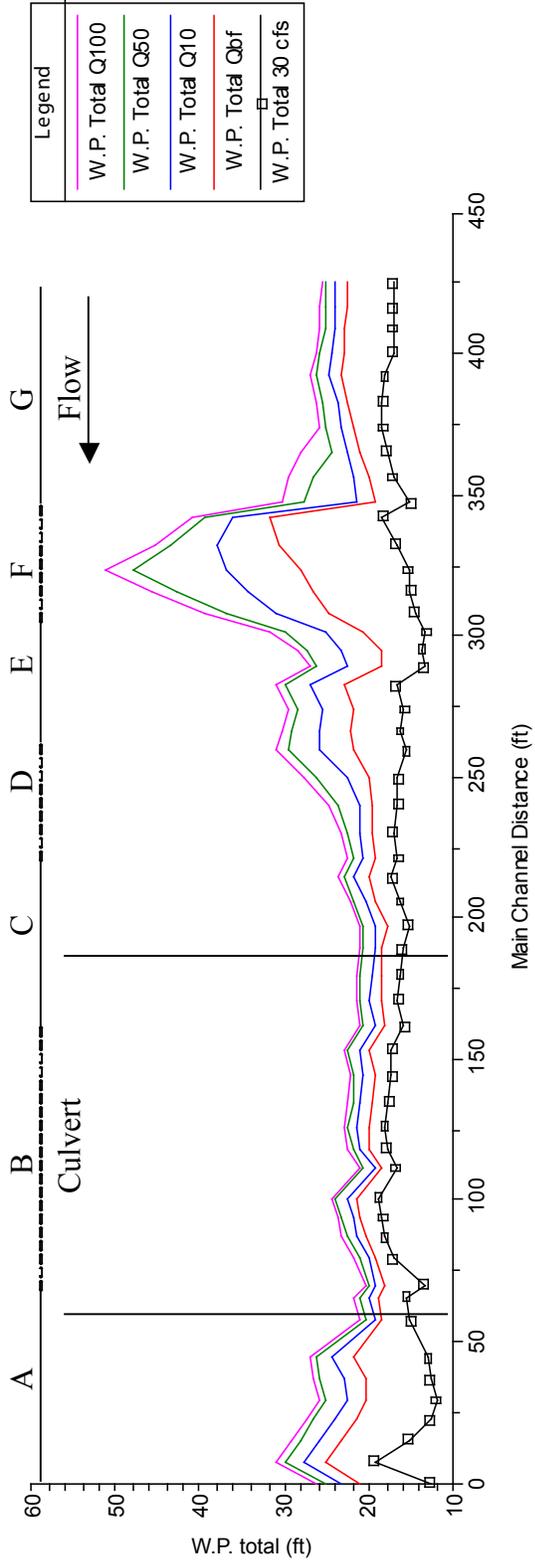
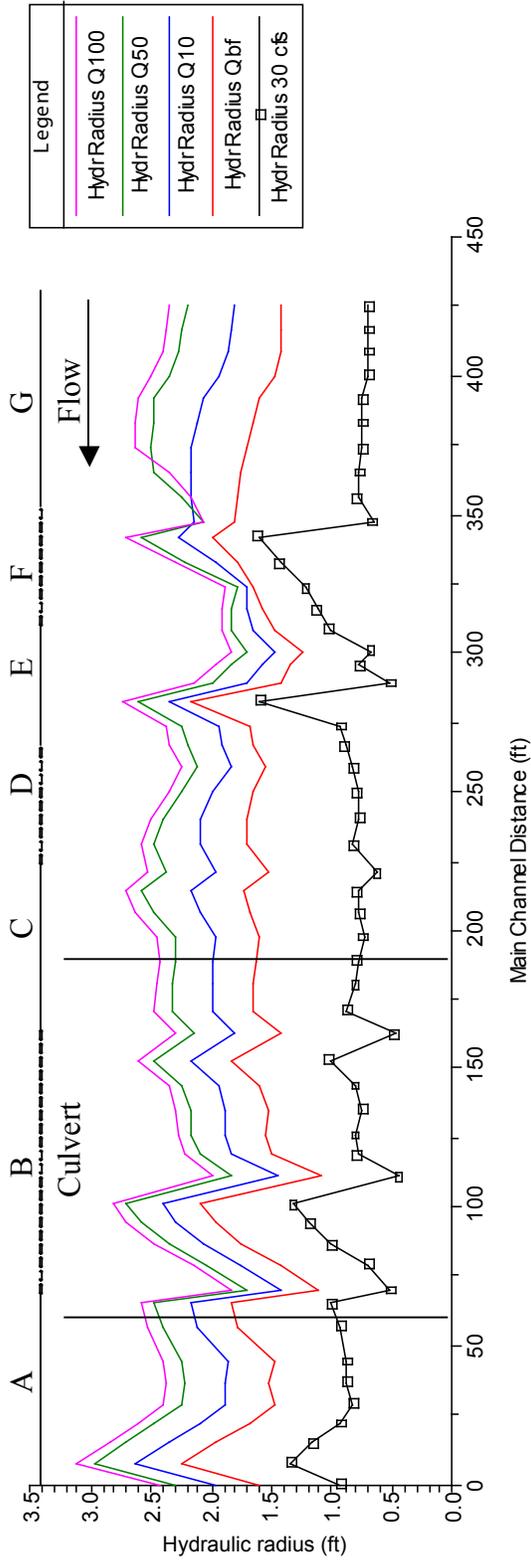
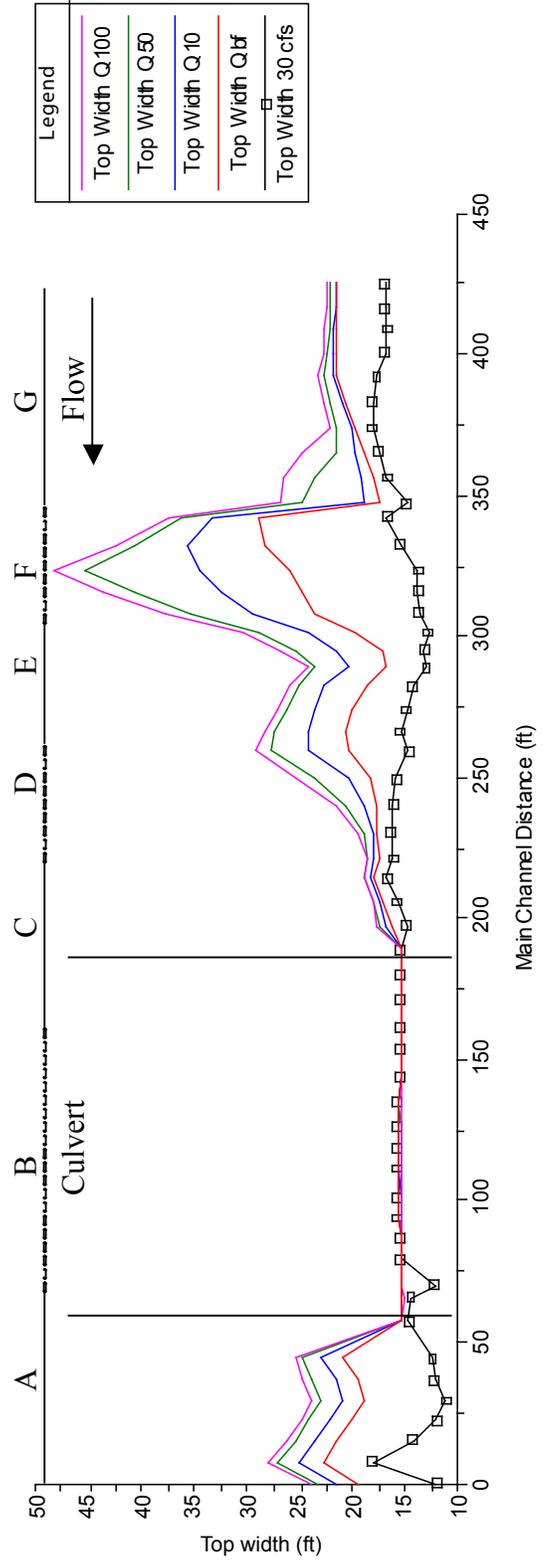
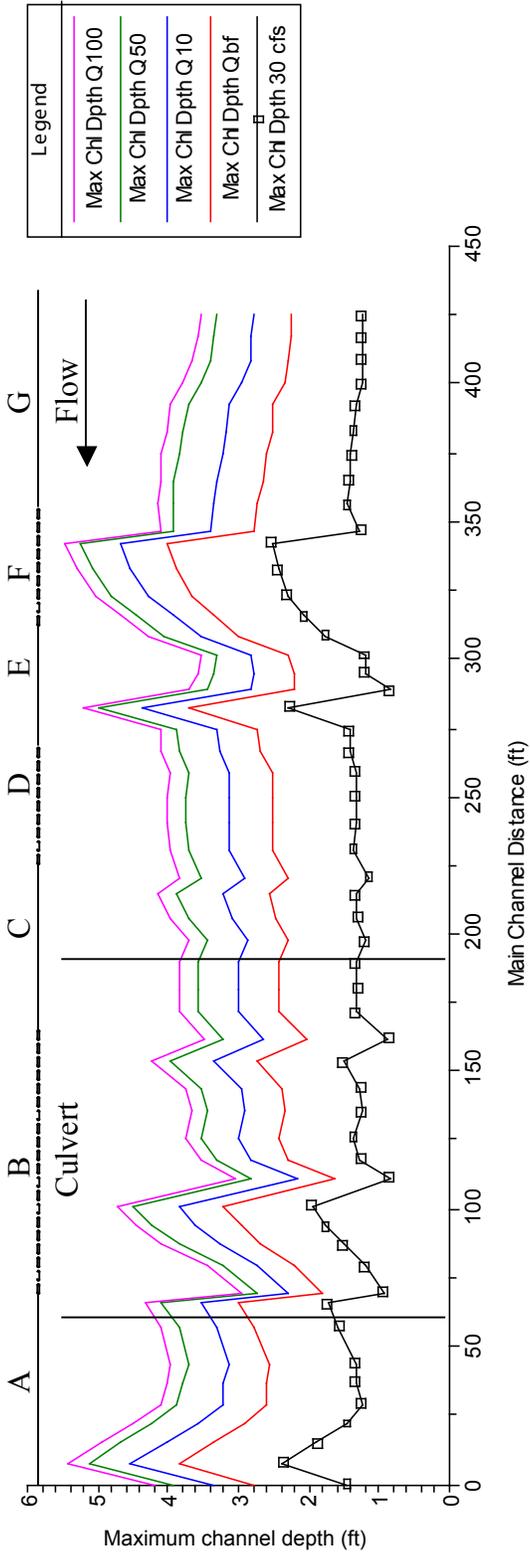
Cross-section characteristics – Flow area, top width, and wetted perimeter are reduced considerably by the culvert, but hydraulic radius and maximum depth do not dramatically differ (figures 5-9 and 12-17). Differences are most

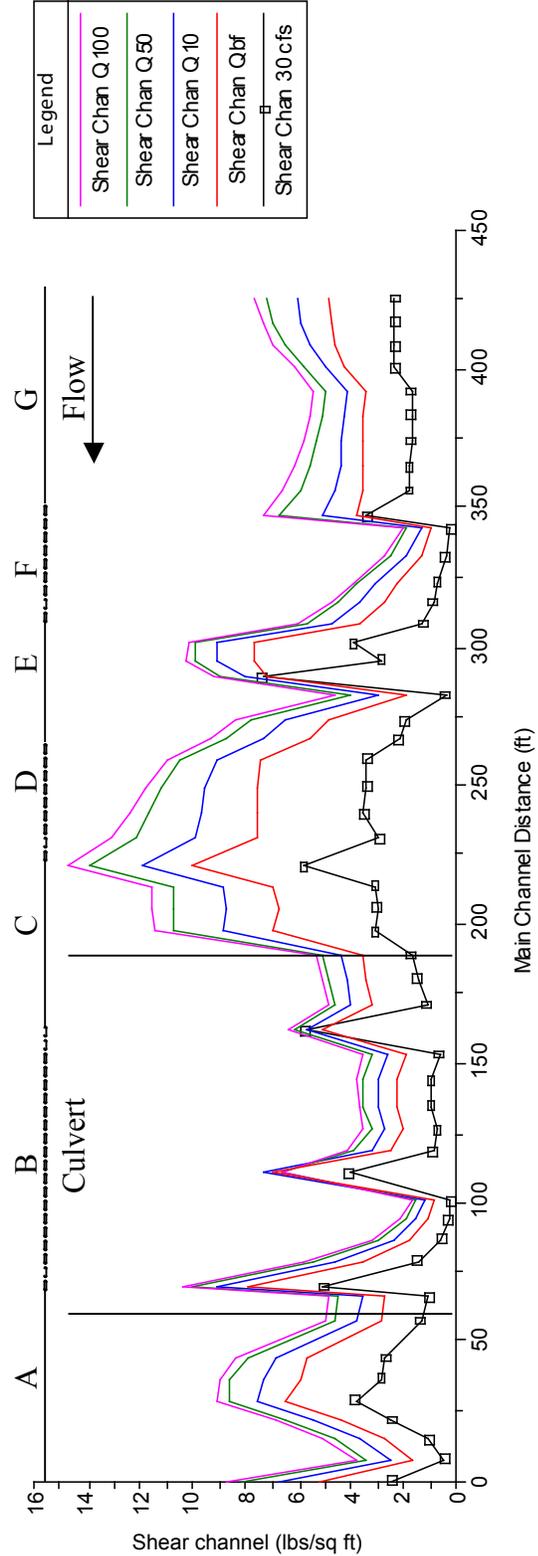
Figure 10—Shear stress (channel) profile.

Shear stress – Shear stress in the culvert is very similar to that found in the corresponding profile segment (F) (figure 10). Shear-stress values in the upstream transition segments are similar to or greater than their corresponding profile segments. Shear in the downstream transition segment is within the range of the corresponding profile segments (E and G).

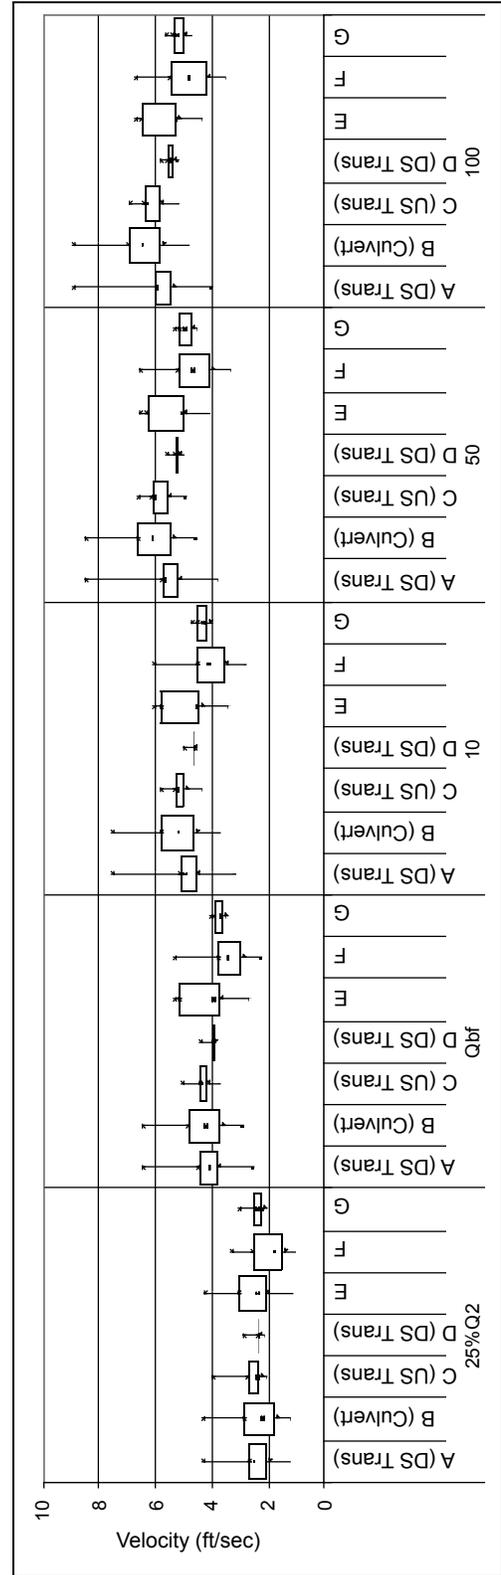
Figure 18—Velocity (channel).

Velocity – Velocity in the culvert is greater than the corresponding profile segment for all flows but is most pronounced at the Q_{br} and above (figure 18). Velocity in the upstream transition segments is within the range of that found in corresponding profile segments. Velocity in the downstream transition segment has a greater range than the natural channel but the median values are similar.

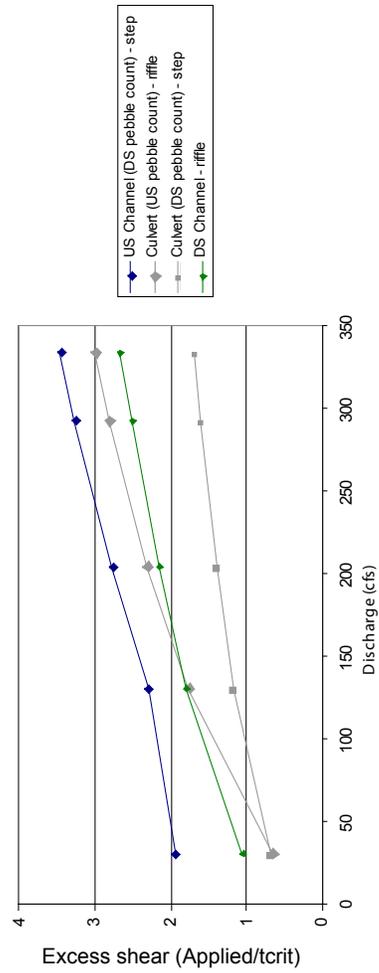
Figure 20—Excess shear stress. Excess shear stress is the channel shear divided by the critical shear for bed entrainment of the D_{84} particle size. Values of excess shear greater than 1 indicate bed movement for the D_{84} particle size.

Excess shear – The excess shear values in the culvert are just within or lower than the range of values in the natural channel (figure 20). This is a result of a combination of lower applied shears and higher critical shears depending on the cross section and modeled flow.

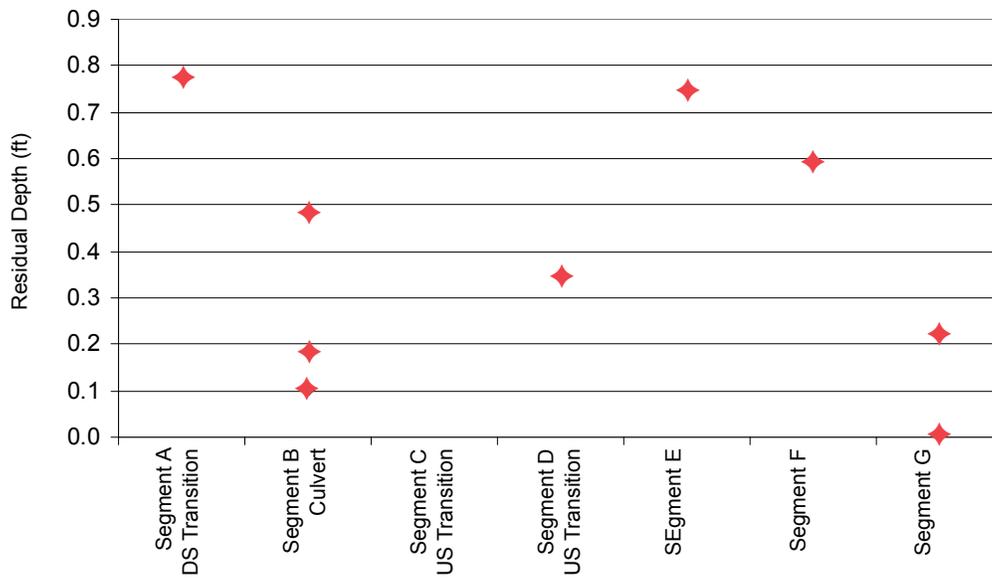
Figure 21—Residual depths.

Residual depths – Culvert residual depths are lower than the single residual depth in the corresponding profile segment (F) (figure 21). The single residual depth in the upper of the upstream transition segments (D) is less than half the residual depth of the corresponding profile segment (E). The residual depth in the downstream transition segment is at the upper end of the range of depths in corresponding profile segments (E and G).

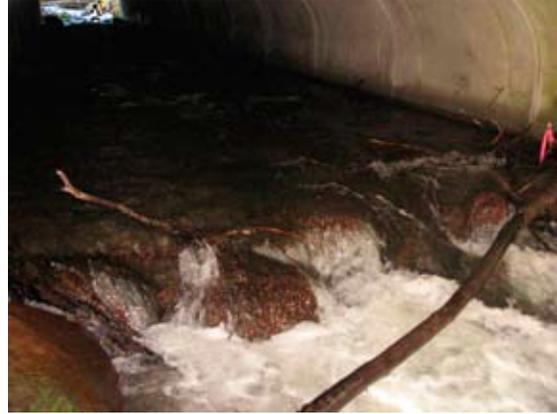
View of step in culvert near outlet (pebble count count, step location).

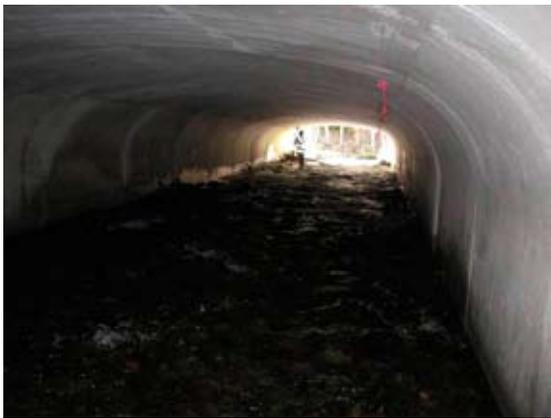
Site observations suggest that AOP conditions may be less desirable at this site than the metrics suggest. Nearly 80 percent of the length of the culvert is made up of a plane-bed riffle type unit that has very little complexity. The substrate also appeared embedded in fines, with few protrusions of larger substrate that can provide important velocity refuge for fish passage. The flows spread out over the entire channel during low flows, and

View downstream in culvert – upstream pebble count at flagging (riffle).

This is a good installation with respect to scour and structure integrity. The greatest impacts with this site relate to AOP. This site could benefit from the placement of stable boulders as bank structures intermittently along the structure edge in order to concentrate flows for low water fish passage and to provide banks for terrestrial passage. Additional rock steps could also be placed across the channel to better mimic conditions found in the channel outside the crossing.
