LOWE CREEK

Site Information

Culvert Scour Assessment

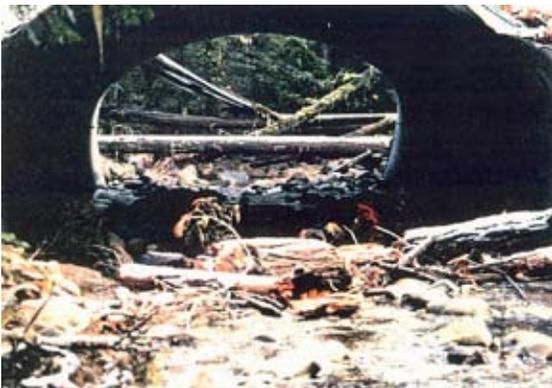
Culvert inlet.

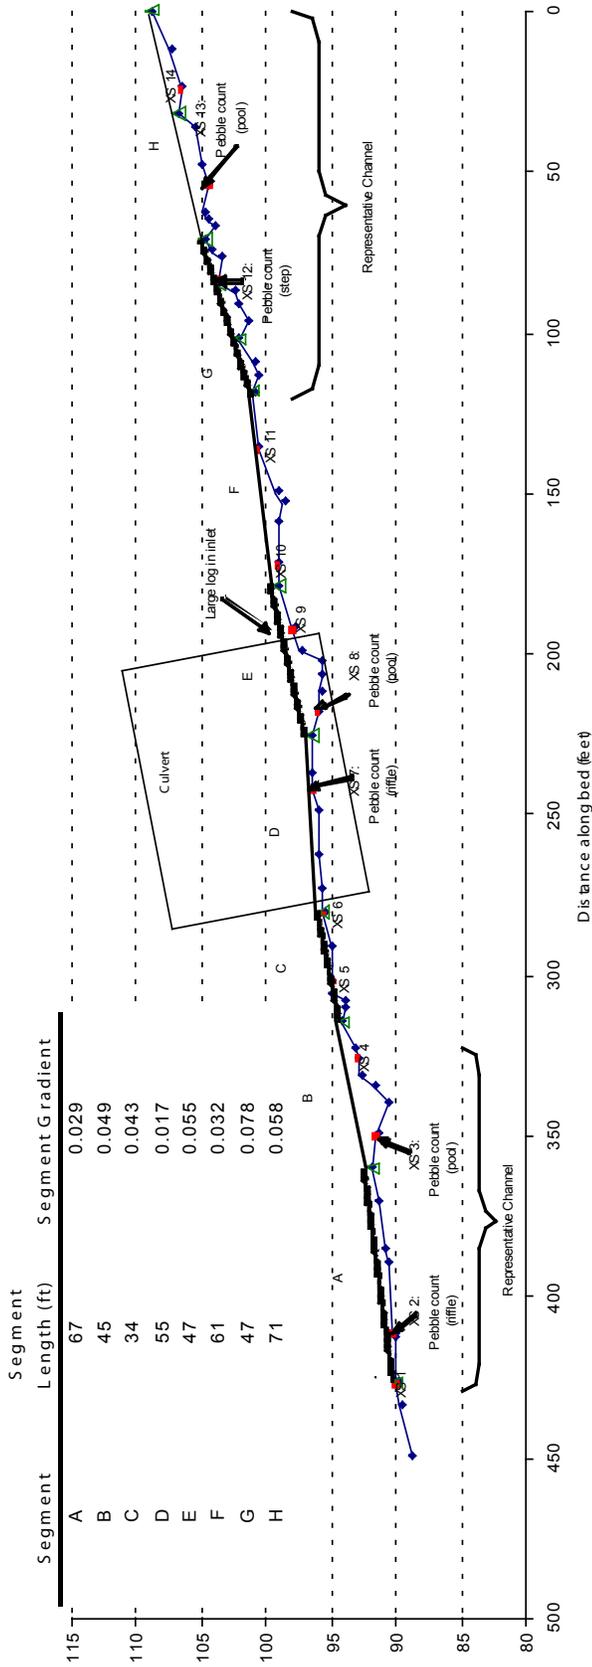
Figure 2—Lowe Creek longitudinal profile.

Profile characteristics – The profile has a concave shape through the crossing (figure 2). This shape reflects scour at the inlet region. There is a natural valley transition in this area. Upstream is more confined with higher and less active floodplain terraces than the downstream reach.

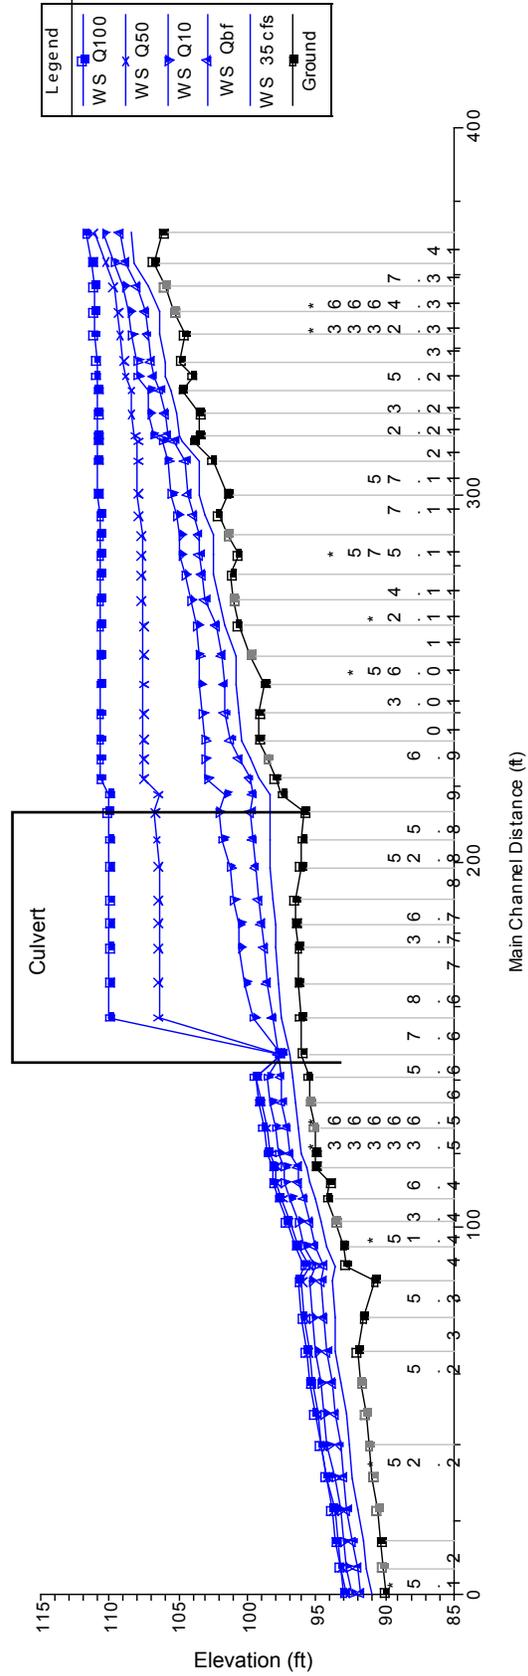
Figure 3—HEC-RAS profile.

*Note: As estimated in the model, backwater from the culvert affects portions of the upstream reach (figure 3). The backwater affects the upstream representative reach for the Q_{50} and Q_{100} . For this reason, hydraulic metrics for these flows are not used in the comparisons with culvert values.

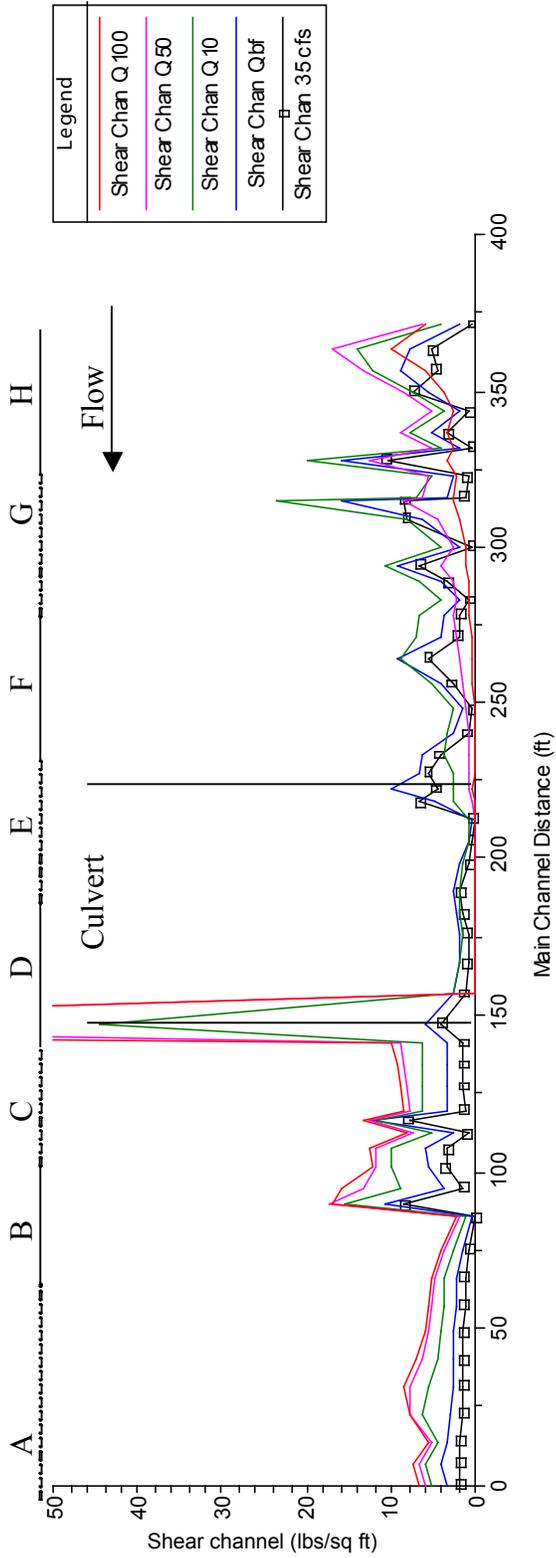
Figure 10—Shear stress (channel) profile.

Shear stress – The modeling suggests that shear stress is low in the culvert due to backwater conditions that reduce the energy grade. Shear stress near the downstream end of the culvert is high where the flow passes through critical depth (figure 10). Shear stress in the upstream

*Note: Shear at station 6.5 for the Q_{50} and Q_{100} are greater than 50 pounds per square foot and are therefore not shown.

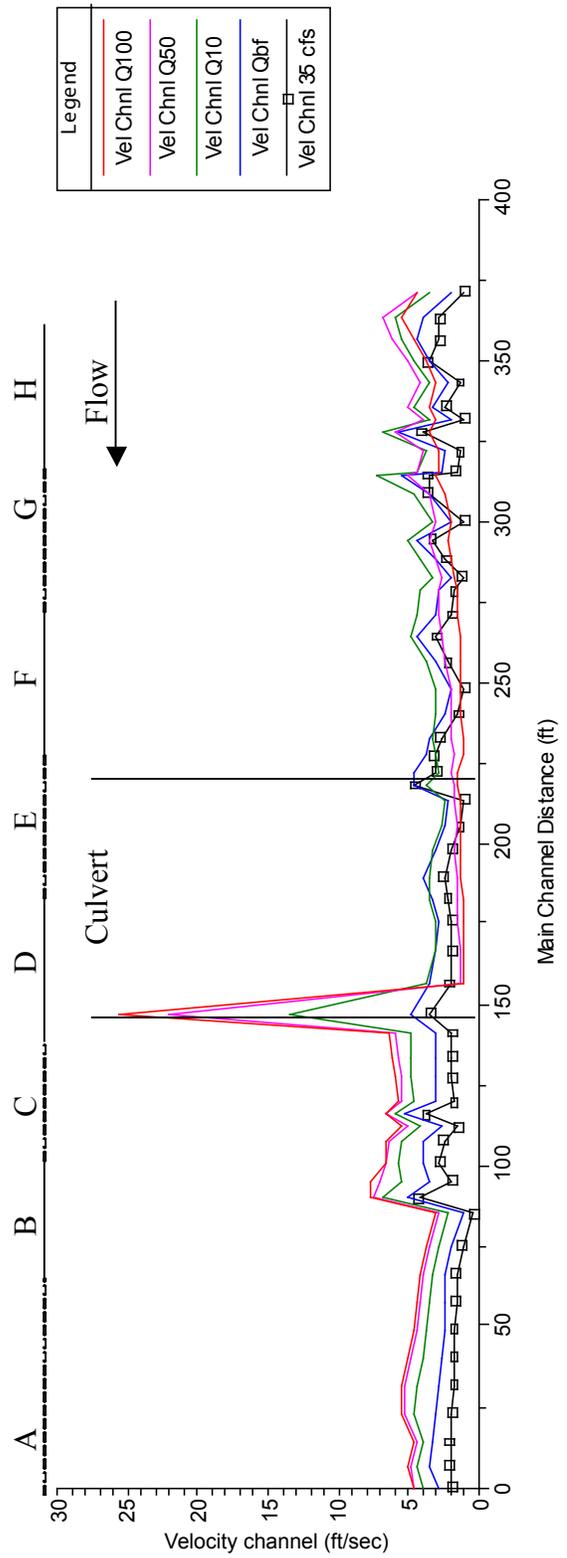
Figure 11—Velocity (channel) profile plot.

Velocity – The modeling suggests that velocity is low in the culvert due to backwater conditions that reduce the energy grade. Velocity near the downstream end of the culvert is high where the flow passes through critical depth (figure 11). Velocity in the upstream transition (F) is similar to the corresponding channel segment (A) at the Q_{10} and below but is lower than the channel at the Q_{50} and Q_{100} (figure 18) due to backwater effects. Velocity in the downstream transition (C) is within the range of corresponding channel segments (B and H) at all modeled flows.

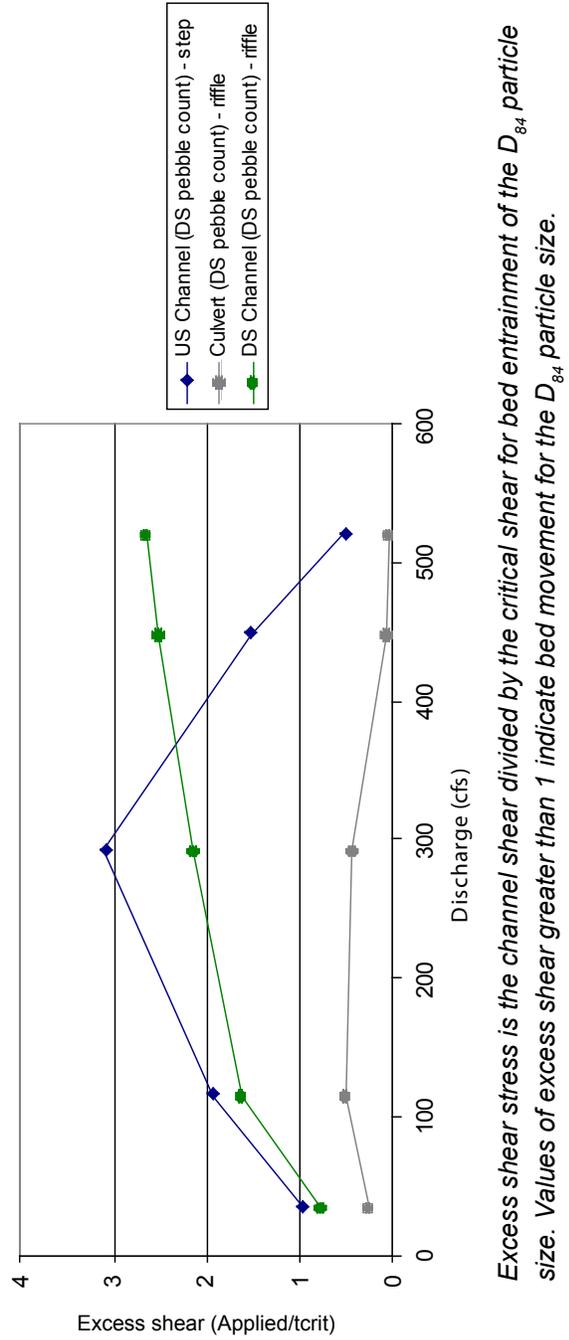
Figure 20—Excess shear stress.

Excess shear – The excess shear analysis shows the culvert as having lower potential for bed mobilization when compared to the upstream and downstream channels (figure 20). This is due to the backwater effect of the culvert that lowers the energy grade and therefore lowers the applied shear available to move material.

Excess shear stress is the channel shear divided by the critical shear for bed entrainment of the D_{84} particle size. Values of excess shear greater than 1 indicate bed movement for the D_{84} particle size.

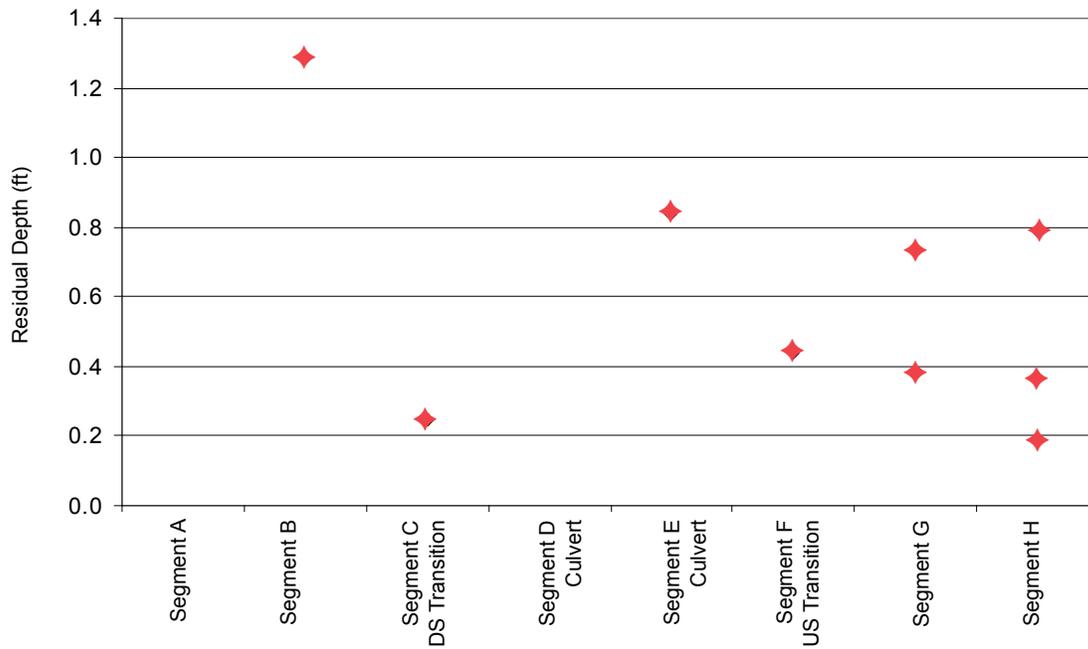
Figure 21—Residual depths.

Residual depths – The single culvert residual depth is within the range of residual depths in corresponding profile segments in the natural channel (B and H) (figure 21). The single residual depth in the downstream transition is also within the range of corresponding profile segments in the natural channel (B and H). There was no residual depth in the corresponding profile segment for the upstream transition.

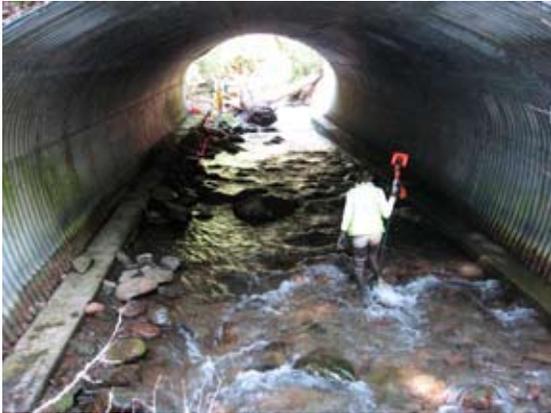
View upstream through culvert.

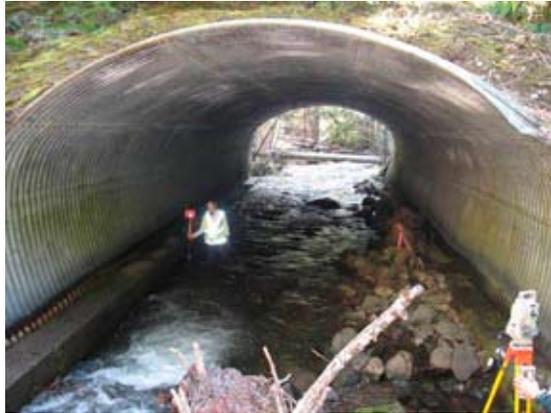
View downstream through culvert.

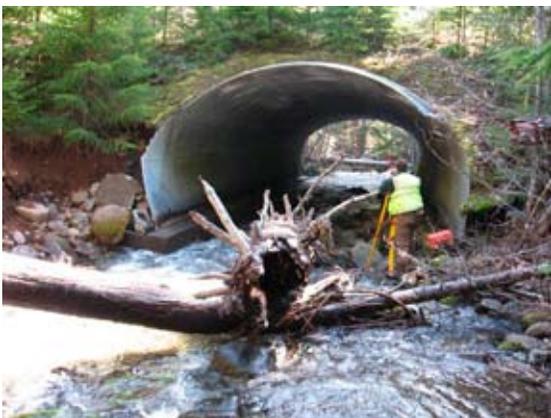
View downstream of culvert inlet.

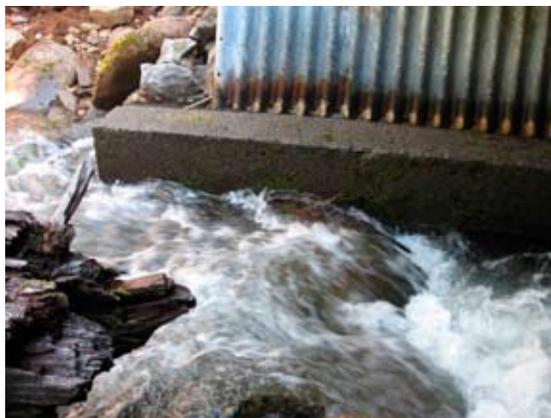
Footing scour – The greatest amount of footing scour is at the upstream end on the left bank where the footing is undermined. The base of the footing is suspended above the bed 2.5 feet at the maximum depth of the scour pool. The lateral extent of scour under the footing reaches 4 feet at one location. Some of this scour may be the result of a large log (greater than 2-foot diameter) located at the inlet. Approximately 40 percent of the footing on the left bank is undermined and all of it is exposed. There is also scour around the sides of the pipe at the inlet and outlet and there may be some piping of flow around the culvert in these areas. The “poor” foundation rating from the WFLHD study and the suggestion regarding foundation requirements suggest that some foundation undermining may have been present in 1987, but likely less than in 2007 or there would have been more mention of it.

There is severe scour of the left bank footing at the inlet and extending downstream approximately 30 feet. This is a serious maintenance issue that needs to be addressed to ensure that the structural integrity of the crossing is not compromised. This scour may be partially related to culvert capacity, deposition of coarse material upstream of the inlet, and a large (greater than 2-foot diameter) midchannel log just upstream and inside of the culvert. The drop into the scour pool is larger than any drops observed in the reference reaches. This has also resulted in the deposition of material along the right footing at the inlet and the shifting of the channel towards the left. Downstream of the scour pool, the bed is aggraded and levels off forming a consistent riffle.

View of undercut left bank footing at upstream end of culvert.

This site is a poor installation with respect to scour but appears to be suitable for AOP. There are serious concerns with the structural integrity of the structure that are primarily related to the undermining of the left-bank footing at the upstream end of the culvert. Additionally, modeling suggests a severe effect on flow geometry and hydraulics at the Q_{50} and above that may create future scour problems within the pipe. This design could be improved by use of a wider culvert with greater capacity to convey high flood flows. It is also clear that the footing depth needs to be increased to extend below the depth of maximum potential scour.
