SIMPSON CREEK

Site Information

Culvert Scour Assessment

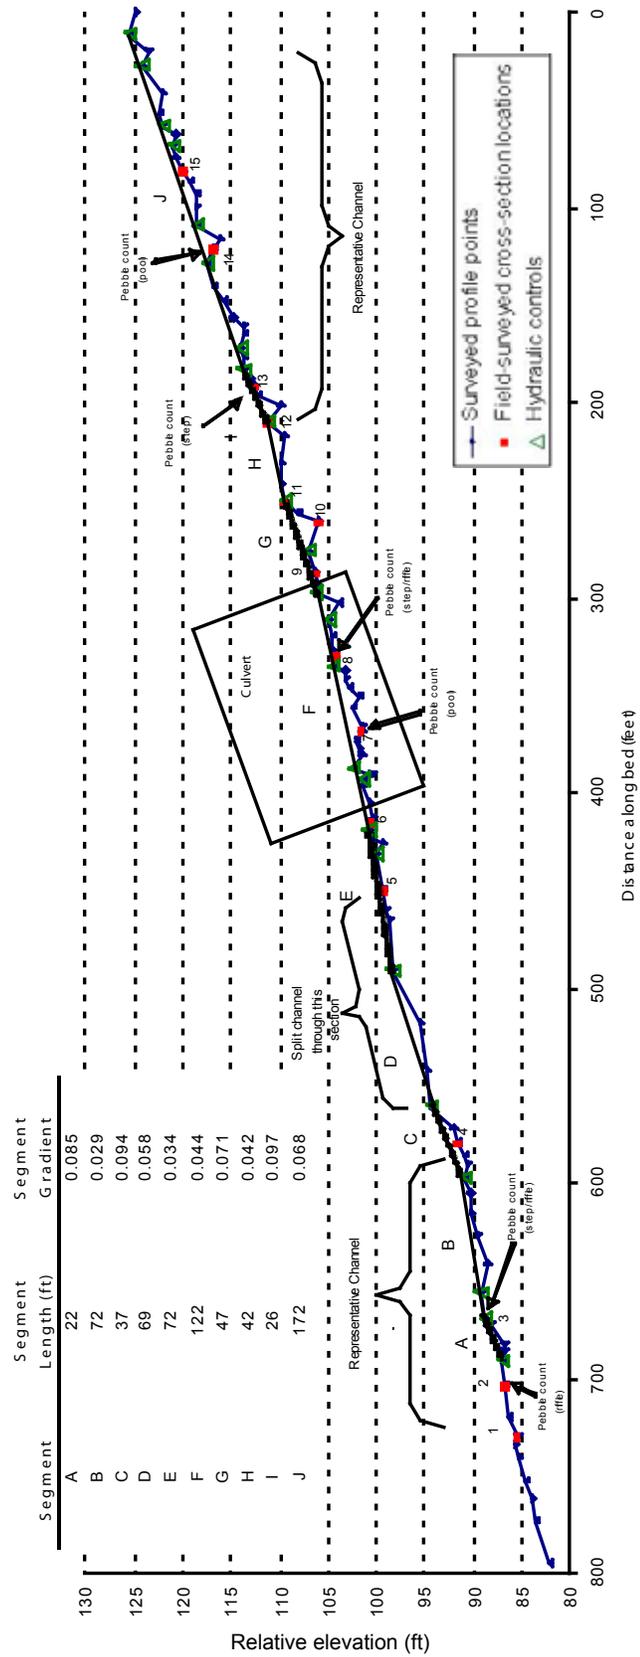
Figure 2—Simpson Creek longitudinal profile.

The profile analysis resulted in 10 profile segments (figure 2). The culvert consisted of one profile segment (F). The culvert segment matched the gradient of a representative segment in the upstream channel (H), which is affected by channel incision; interpretations of results take this into account. Another representative segment in the upstream channel (J) had a gradient difference of 35 percent, but was included as a potential comparison segment due to similarities in bed morphology (closely spaced step-pool sequences) (table 1).

Profile characteristics – The profile has a concave shape through the crossing (figure 2). This shape reflects channel incision in the upstream channel and scour at the inlet region, combined with aggradation in the downstream portion of the culvert and in the channel downstream of the culvert. Incision in the upstream channel potentially resulted from a headcut propagating upstream from inlet scour. In the absence of the culvert, natural concavity of the profile would be expected based on the geomorphic valley transition through this reach. The adjustments observed at this site may reflect the tendency towards this concave profile condition.

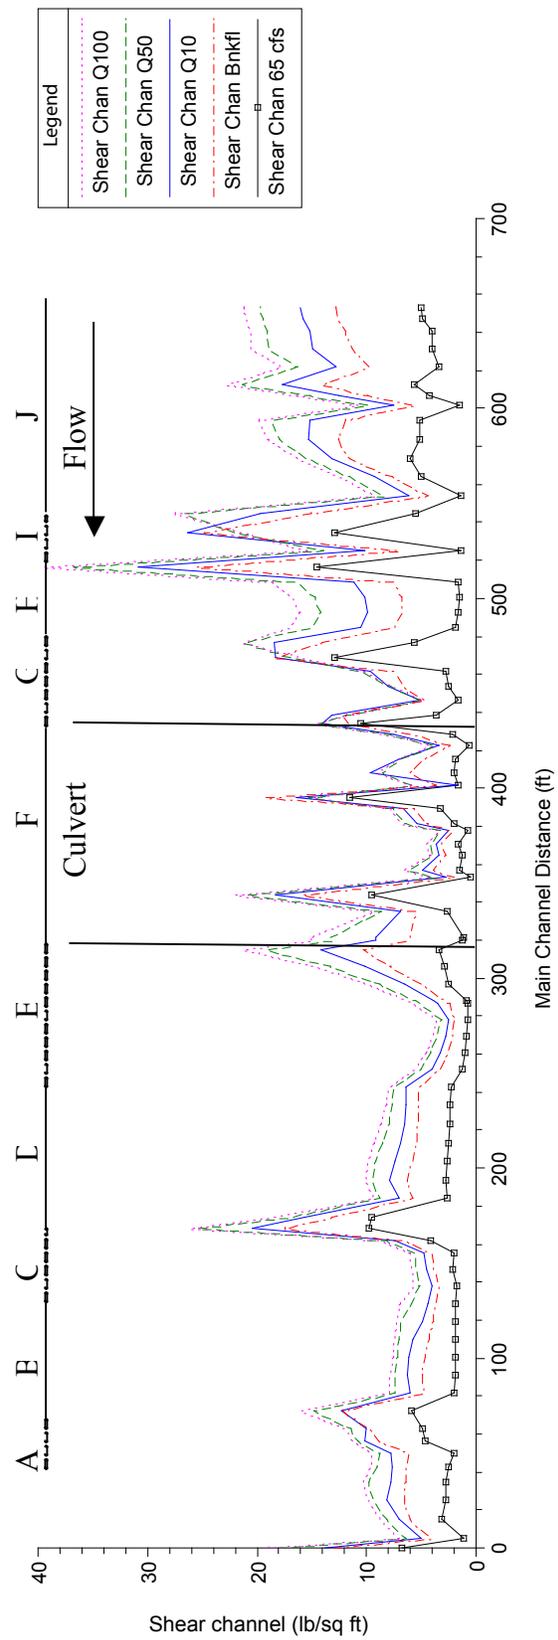
Figure 10—Shear stress (channel) profile.

Shear stress – The culvert (F) has lower shear stresses than the upstream comparative segments (H and J) (figures 10 and 19). Lower shear stress may be attributable to a lower energy slope in the pipe that is caused by outlet control conditions related to reduced pipe capacity from aggradation in the downstream portion of the pipe. The upstream transition segment (G) has similar shear to the upstream comparable segment (J) at the Q_{10} and below but less shear above the Q_{10} . Shear is comparable between G and the downstream segments with similar gradient (A and C). The downstream transition segment (E) has lower shear than comparable segment H.

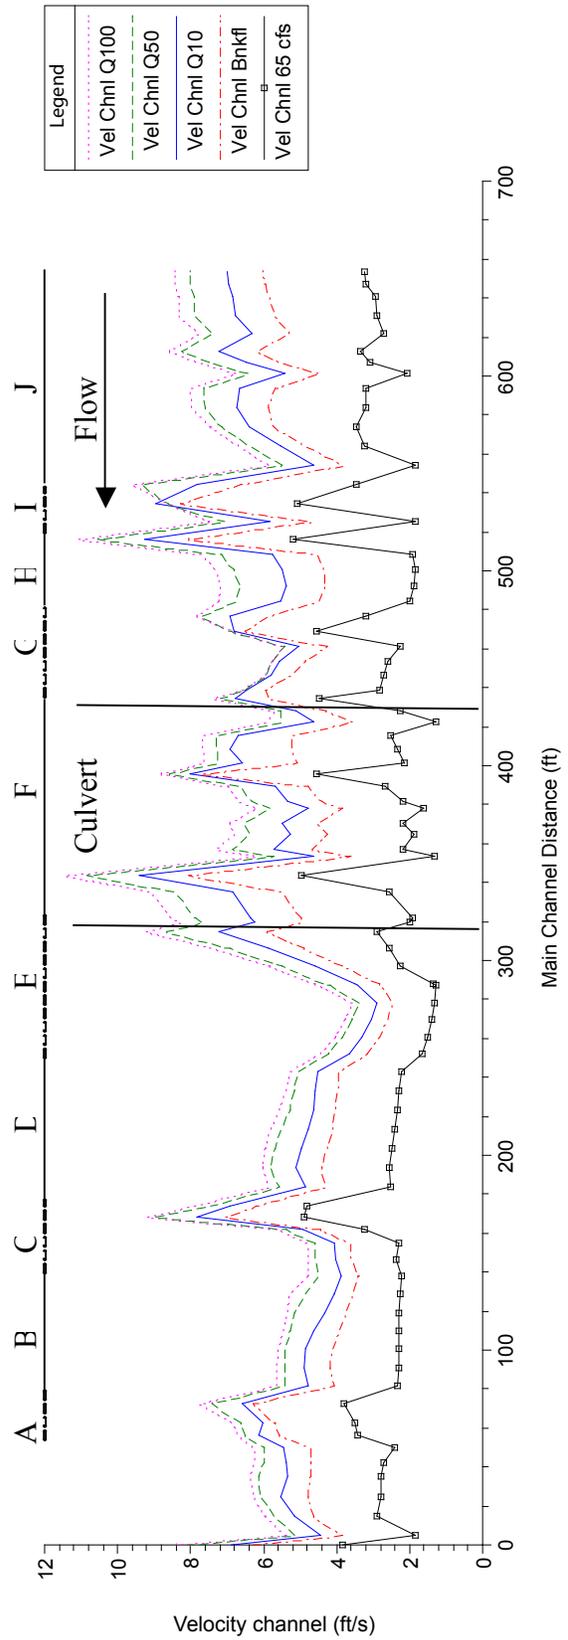
Figure 11—Velocity (channel) profile plot.

Velocity – The variation of velocity in the culvert segment is more similar to the upstream channel than the downstream channel (figures 11 and 18). Culvert velocity is generally similar to the comparative segments H and J for all modeled flows. The range of velocity in the upstream transition segment (G) does not substantially differ from the comparable slope segments (A, C, and J). Velocity in the downstream transition segment (E) is generally lower than the comparative segment H, especially at the higher flows.

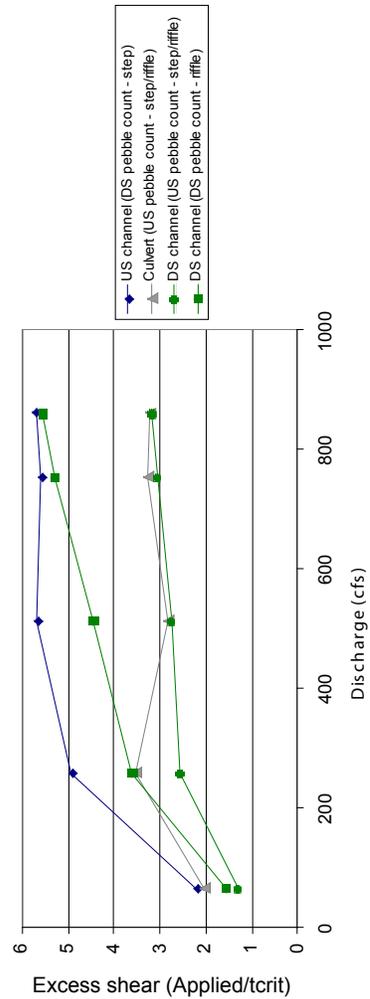
Figure 20—Excess shear stress. Excess shear stress is the channel shear divided by the critical shear for bed entrainment of the D_{84} particle size. Values of excess shear greater than 1 indicate bed movement for the D_{84} particle size.

Excess shear – The excess-shear analysis suggests that the potential for bed mobilization in the culvert is within the range of the downstream channel (figure 20) but is lower than the upstream channel. Higher channel shear in the upstream channel and slightly smaller D_{84} contribute to higher estimated bed mobility in the upstream channel when compared to the culvert.

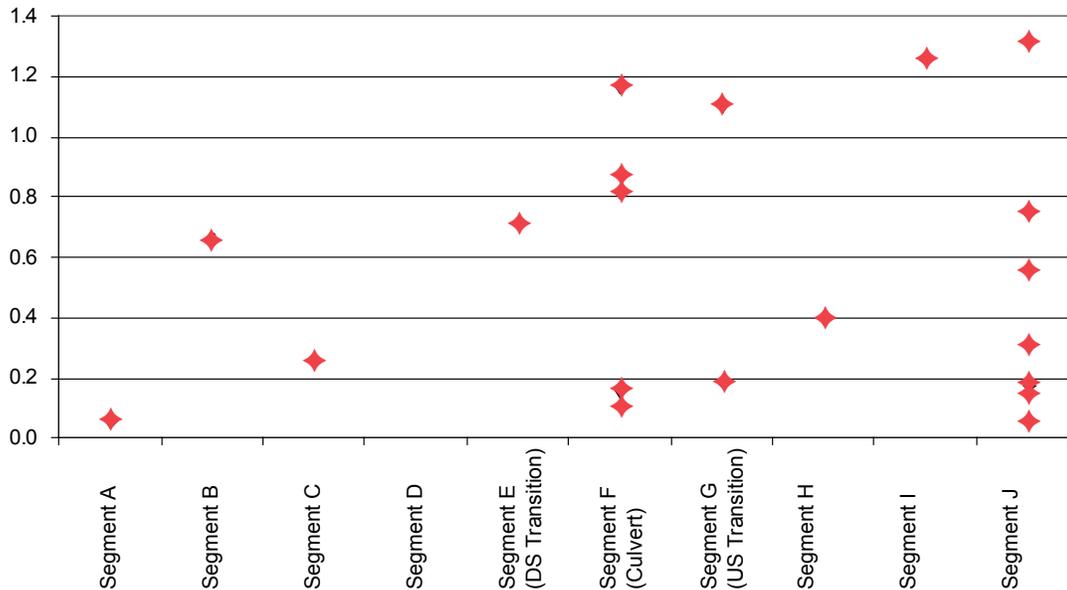
Figure 21—Residual depths.

Residual depths – Culvert residual depths ranged from 0.11 feet to 1.17 feet and were within the range of the comparable slope segment J (figure 21). The upstream transition segment was also within the range of comparable slope segments. Residual depth in the downstream transition segment was within a few inches of that found in the comparable slope segment H. These results suggest no significant local scouring at the channel-unit scale beyond what is found in the channel outside of the crossing.

Residual depths – Culvert-residual depths ranged from 0.11 feet to 1.17 feet and were within the range of the comparable slope segment J (figure 21). The upstream transition segment was also within the range of comparable slope segments. Residual depth in the downstream transition segment (E) was within a few inches of that found in the comparable slope segment H.

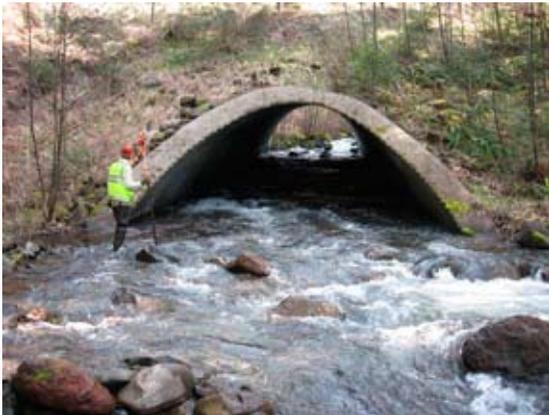
View upstream towards outlet.

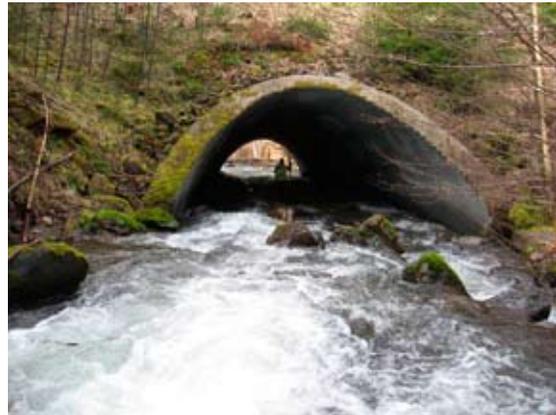
View downstream towards inlet.

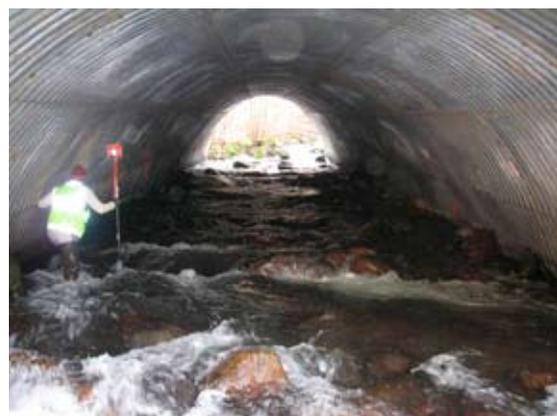
View upstream in culvert.
