TIRE CREEK

Site Location: Willamette NF, Forest Rd 5826 MP 2.63
Year Installed: 1996
Lat/Long: 122°32'3.95"W **Watershed Area (mi²):** 3.9
 43°48'44.85"N
Stream Slope (ft/ft)¹: 0.0523 **Channel Type:** Step-pool
Bankfull Width (ft): 22 **Survey Date:** March 23 2007

Culvert Scour Assessment

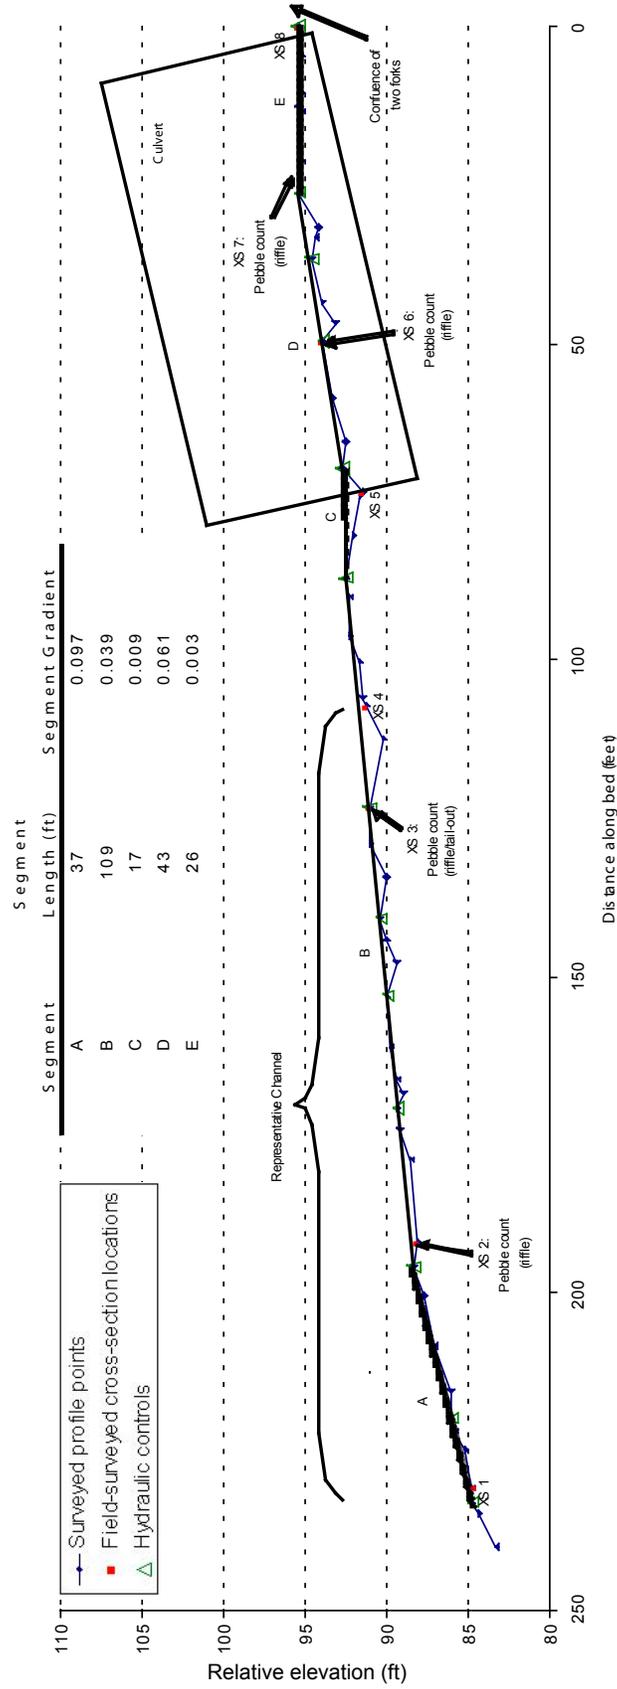
Figure 2—Tire Creek longitudinal profile.

Profile characteristics – The profile has a convex shape through the crossing (figure 2) which is a result of the reorganization of material as some of the material was scoured out from the inlet and the channel upstream of the crossing and deposited downstream.

Generally a flattening of the bed results in a concave bed profile. However, the profile through the Tire Creek crossing is convex with a relatively flat segment through the inlet which transitions to a steep riffle as the channel goes towards the outlet. This might be a falling limb signature from a recent flood.

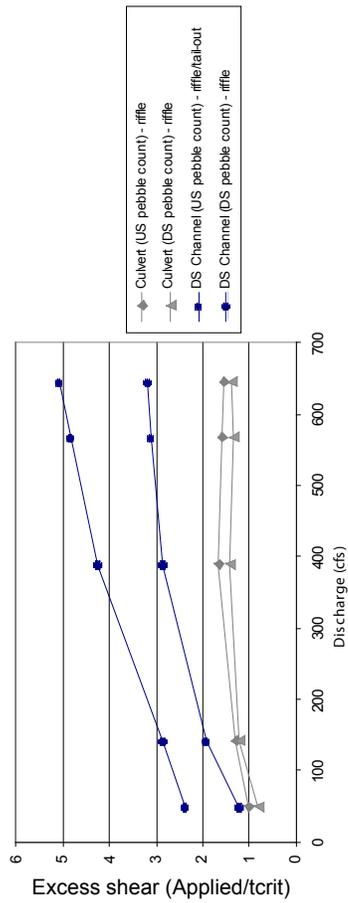
Figure 20—Excess shear stress.

Excess shear – The excess-shear analysis shows that the downstream channel has greater potential for bed mobility than does the culvert, especially at higher flows (figure 20). This corresponds with lower shear in the culvert at higher flows due to outlet-control conditions in the culvert.

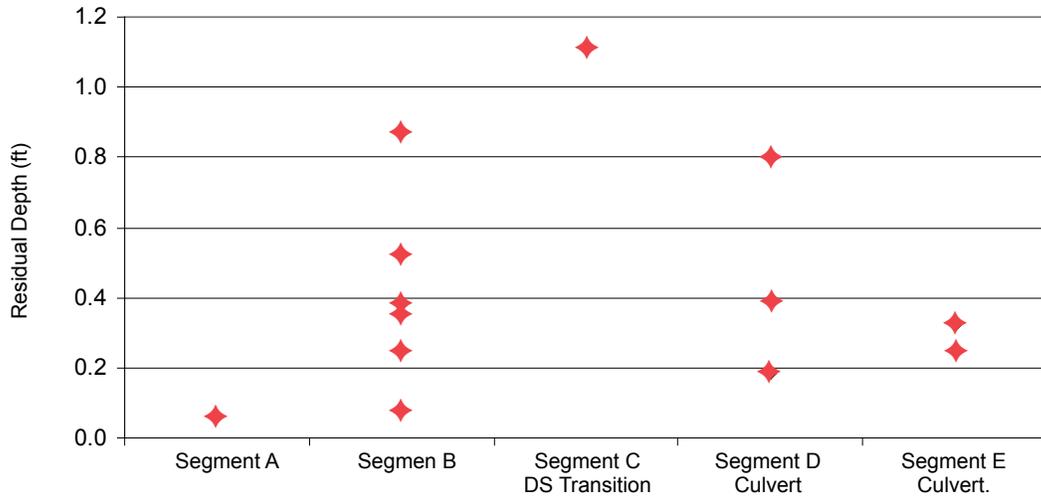
Figure 21—Residual depths.

Residual depths – Culvert-residual depths in segment D ranged from 0.19 feet to 0.80 feet. These values were greater than the single value found in the downstream representative channel segment A (0.06 feet), but well within the range of those found in downstream representative channel segment B (0.08 feet to 0.87 feet) (figure 21). This suggests no significant scour beyond what is found in the channel outside of the crossing.

Residual depths – Culvert-residual depths are within the range of channel conditions (figure 21).

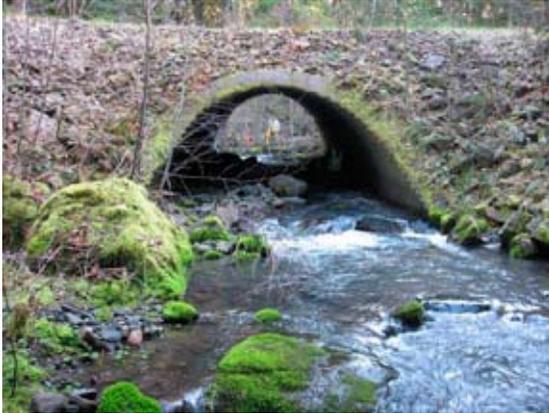
View upstream towards culvert outlet.

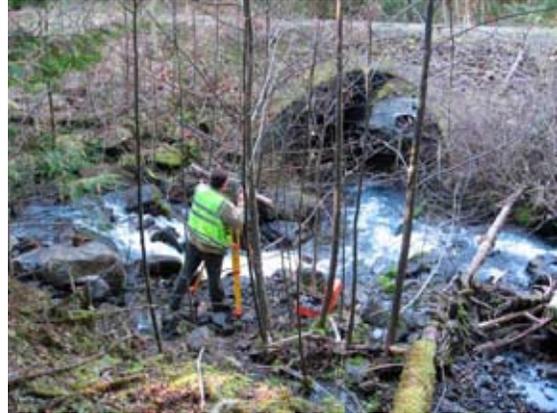
Footing scour – There was evidence of inlet scour along the right bank where the footing is scoured to the depth of the base footing. Observed scour does not appear to be undermining footings or threatening structure integrity.

View downstream towards culvert inlet.

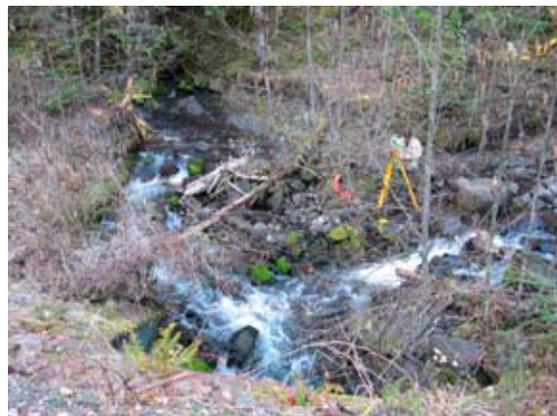
Assuming that the culvert and the culvert bed were originally constructed on the same grade, significant bed adjustment has occurred. The entrance to the culvert sits at the junction of two steep step-pool streams of relatively equal size. The angle at which they join is roughly 45 degrees off the main channel and culvert. Placement of the culvert close to this confluence

has likely altered upstream conditions. Flow contraction at the inlet has resulted in scouring of the banks, resulting in the upward retreat of the channel junction. In order to match this, the channels have steepened their profiles, further increasing stream energy and scour upstream as well as around the culvert inlet. The transition in profile at the inlet to the culvert has resulted in scour at the upstream end of the culvert. Reorganization of material has resulted in downstream deposition. The exposure of the footings at the inlet and not at the outlet is likely a result of this adjustment.

*View upstream from roadway –
confluence of tributaries.*

The Tire Creek culvert was placed very close to the junction of the two tributaries, likely resulting in the observed scour, upstream channel incision, and the upward retreat of the junction location. Placing the culvert further downstream may have lessened these impacts. At high flows, the modeling indicates the potential for outlet-control conditions in the culvert. This condition reduces the energy slope and may cause material to aggrade within the culvert and further limit hydraulic capacity. The culvert may be undersized to adequately convey these high flows. Use of a larger culvert would reduce the risk of significant bed adjustments. Other than these considerations, this is considered a good installation with respect to scour and AOP. There are stable bed elements within the culvert that maintain grade and create habitat complexity. Exposed banks during low flows help to concentrate flows for passage and also allow for passage of terrestrial organisms.

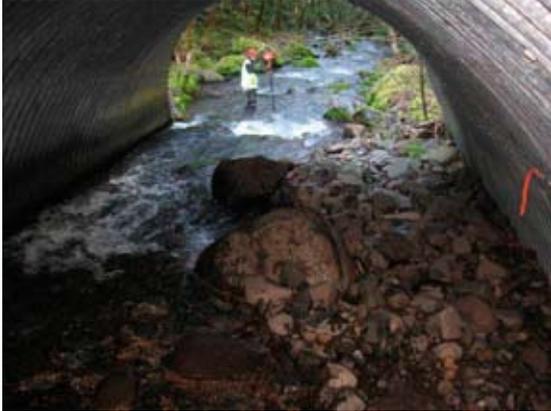
Culvert – downstream pebble count, riffle/step.

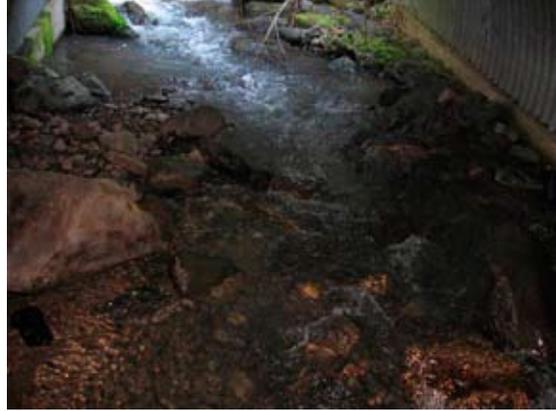
Culvert – upstream pebble count, riffle.
