Culvert Scour Assessment

YOUNGS CREEK

Site Location:	Willamette NF, Forest Rd 21		
Year Installed:	Circa 2002		
Lat/Long:	122°26'10.61"W		
	43°30'40.77"N	Watershed Area (mi²):	2.92
Stream Slope (ft/ft)¹:	0.0635	Channel Type:	Step-pool
Bankfull Width (ft):	13.5	Survey Date:	March 21 2007

Culvert Type:	Pipe arch	Culvert Material:	Annular CMP
Culvert Width:	14 ft	Outlet Type:	Mitered
Culvert Length:	62 ft	Inlet Type:	Mitered

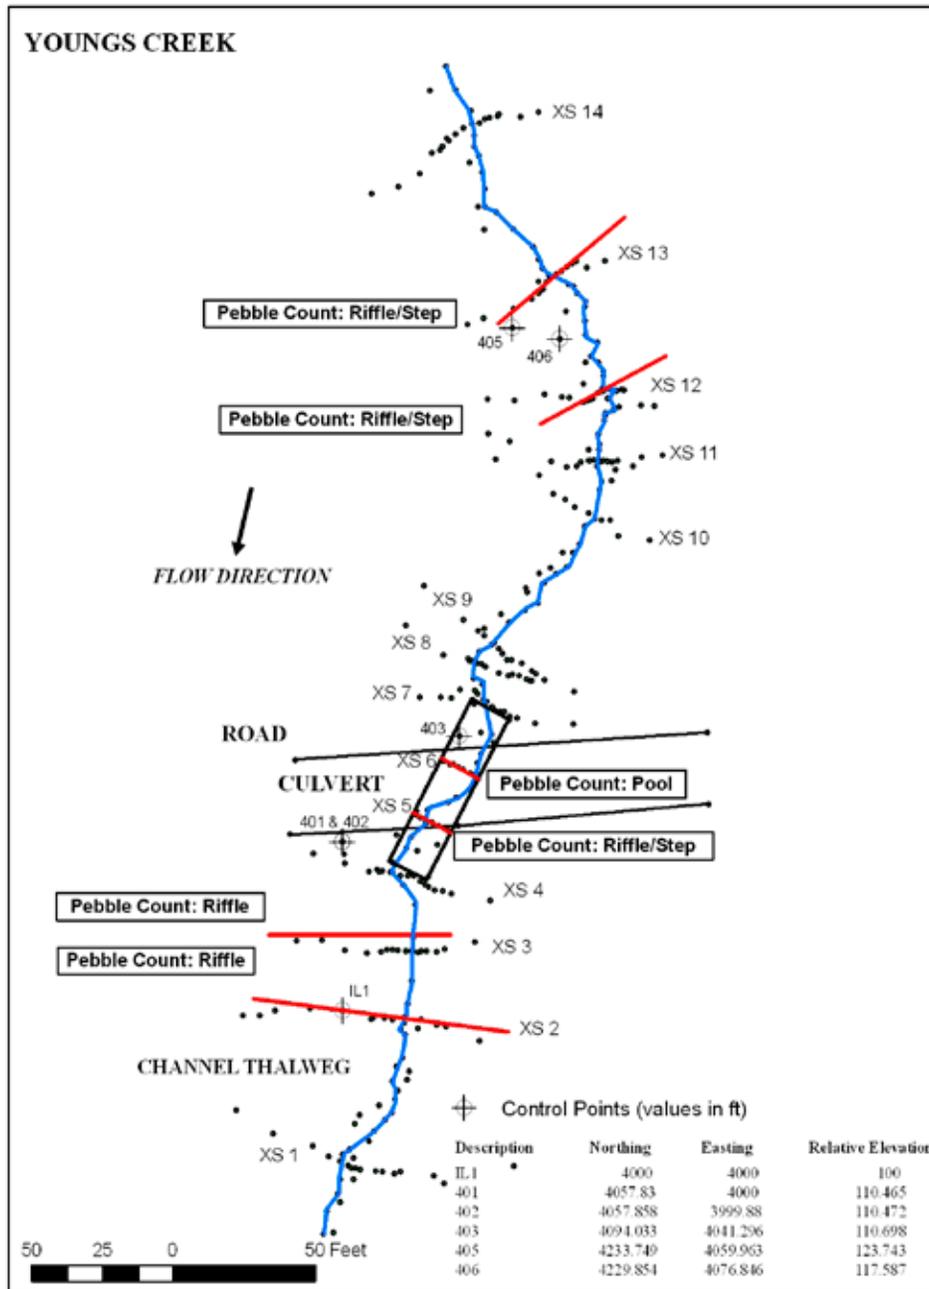
Figure 1—Plan view map.

Alignment Conditions: May have been constructed in alignment with previous channel location but channel adjustment upstream has resulted in the culvert being off-alignment. Scour of culvert bed on left side at inlet may be partially due to alignment.

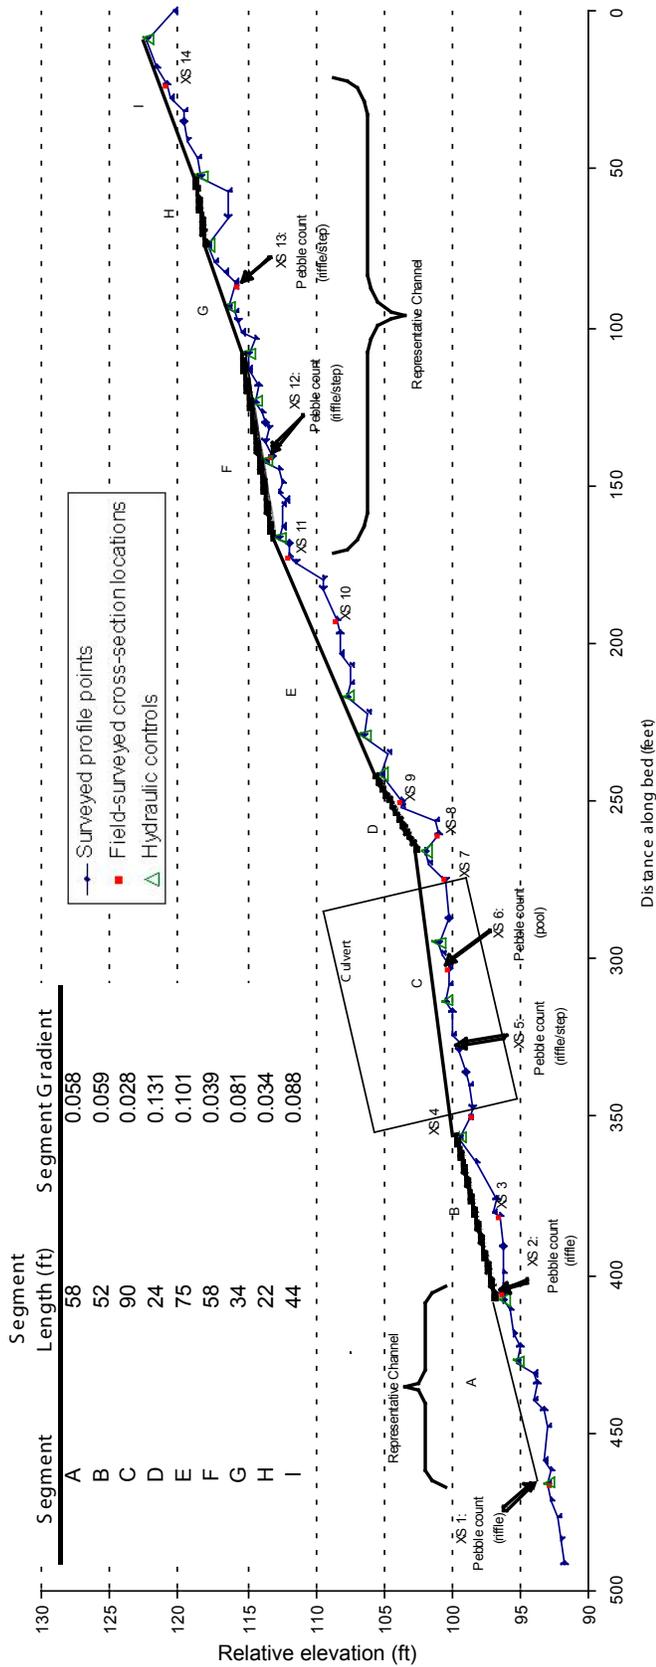
Figure 2—Youngs Creek long profile.

The profile analysis resulted in a total of nine profile segments. The two segments downstream of the outlet, which had similar gradient, were not combined in order to separate out the outlet transition segment for analysis. The culvert consisted of one profile segment. The culvert segment had gradient comparable to one representative profile segment in the upstream channel. Two upstream transition segments were each comparable to one representative profile segment in the upstream channel. The downstream transition segment was comparable to two representative profile segments, one in the upstream channel and one in the downstream channel. See figure 2 and table 1.

Profile characteristics – The profile has a concave shape through the crossing, with the maximum concavity occurring at the inlet and just upstream. The profile shape may be partly due to the natural valley transition occurring in this area as the Youngs Creek valley meets the broad valley of the Middle Fork Willamette. However, site observations suggest that much of the shape is also due to crossing-related channel incision at the inlet and upstream. The culvert may have been placed lower in the profile than the original stream. This could relate to channel adjustments from the previous culvert or may also be a result of restrictions in height imposed by the height of the road prism.

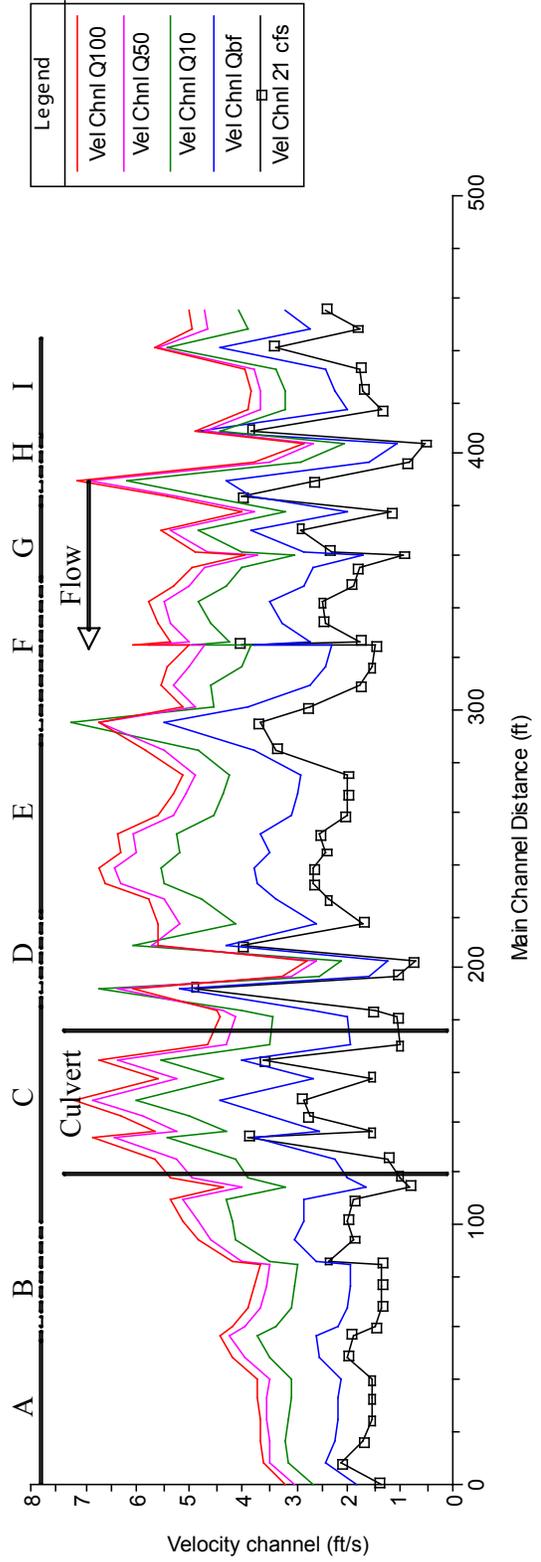
Figure 11—Velocity (channel) profile plot.

Velocity – Velocity in the culvert has a broader range of that found in the natural channel but the median values remain similar for all flows (figures 11 and 18).

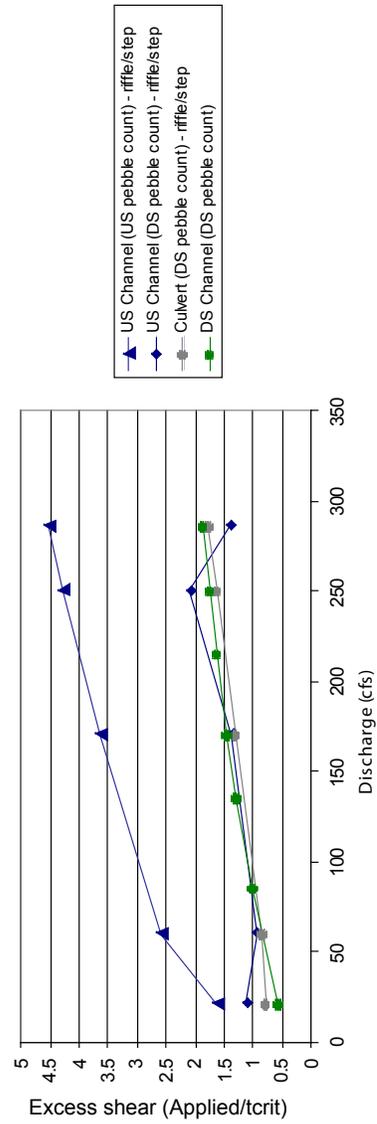
Figure 20—Excess shear stress.

Excess shear – The excess shear analysis suggests that the culvert excess shear may be at the lower end of the range of that found in the natural channel (figure 20).

The historical occurrence of material scouring out of the culvert indicates a risk of loss of bed material; however, the excess shear analysis and the fact that the culvert re-filled suggest that any scour will likely be replaced by material moving in from upstream.

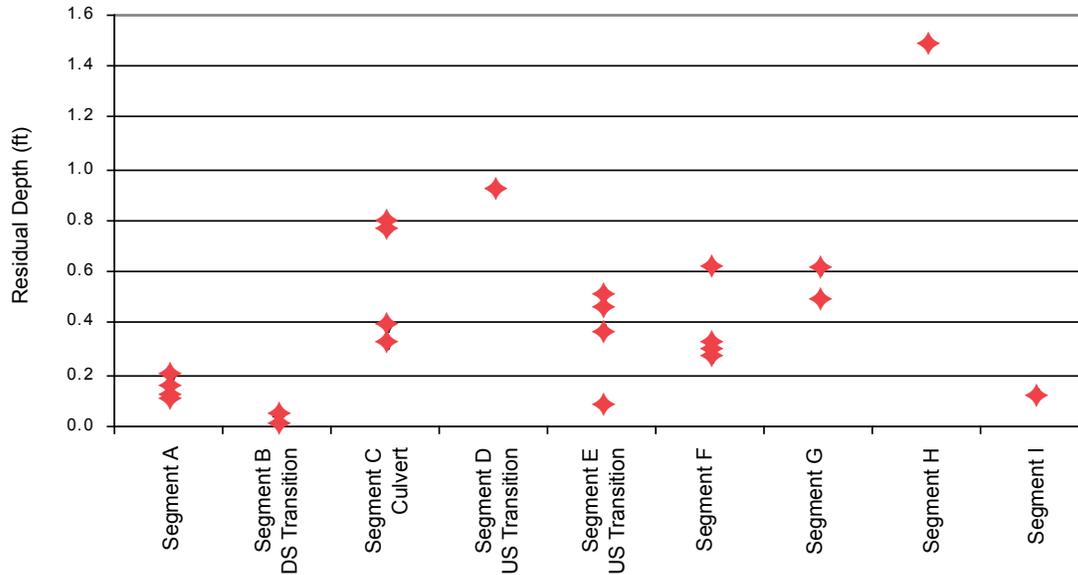
Figure 21—Residual depths.

Residual depths – Culvert residual depths have a similar and slightly greater range than those in the representative profile segment (F) (figure 21). The upstream transition segments (D and E) have greater residual depths than the corresponding profile segment (I), but there was only one residual depth in segment I. The downstream transition segment had lower residual depths than corresponding profile segments.

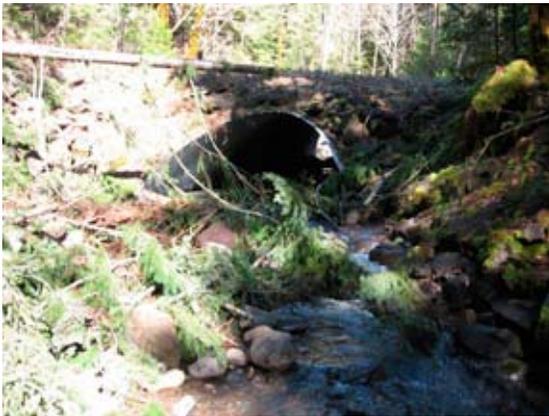
View upstream towards culvert outlet.

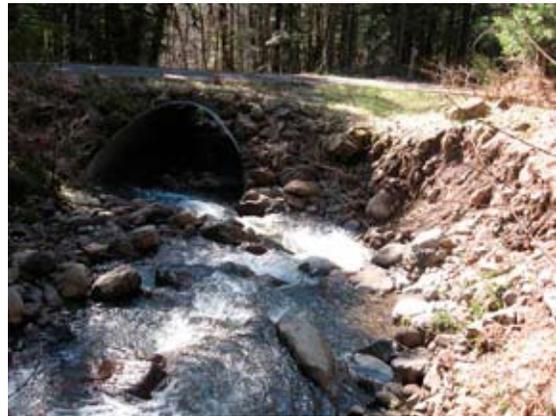
View downstream towards culvert inlet.

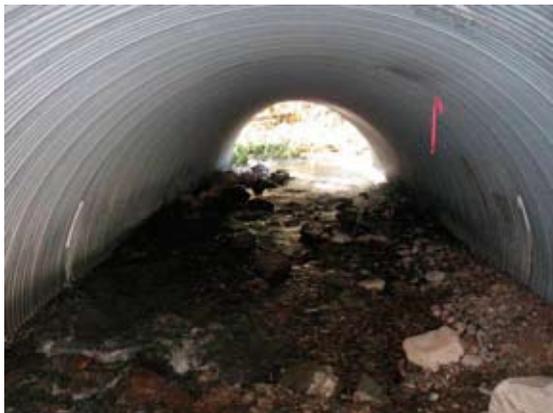
View downstream within culvert – pebble counts at flagged locations.

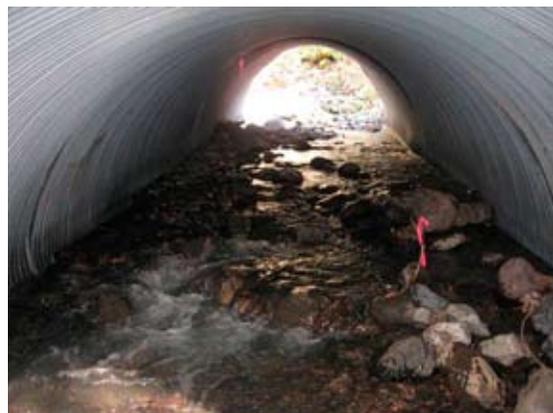
View upstream within culvert – pebble counts at flagged locations.
