Case Study 10. Black Canyon Concrete Plank Ford

North central Idaho. Clearwater National Forest. North Fork Clearwater River. Road 250, about 45 miles from Superior, Montana, and 55 miles from Pierce, Idaho.

This vented ford is one of several built in 1998 on a valley bottom road that crosses the lower end of several steep (greater than 70 percent) perennial streams prone to debris and snow slides. This structure consists of concrete planks and riprap, with a 24-inch culvert installed below the planks.

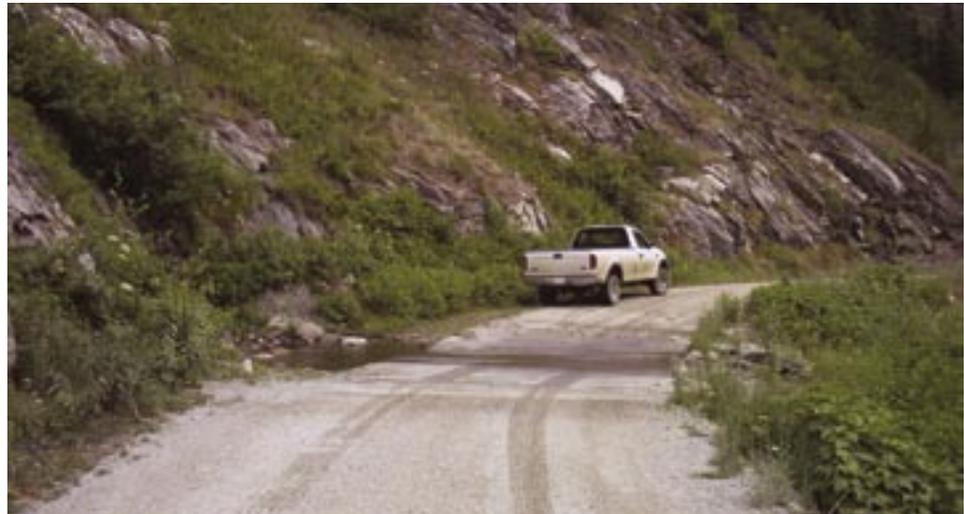
Figure A60. Ford is located on a valley bottom road at the base of an avalanche chute.

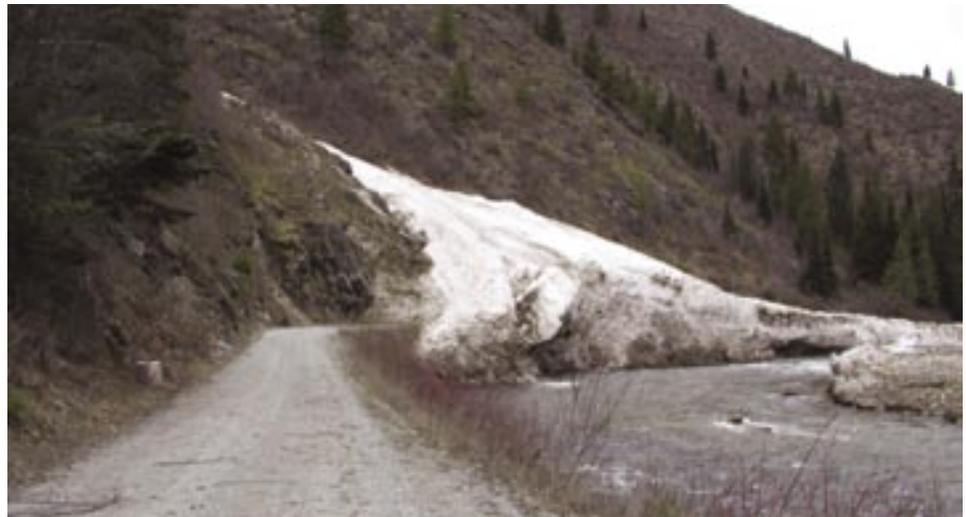
Hydrology: The North Fork Clearwater River is a steep perennial river. The side drainages experience massive snow slides most years (figure A61). Summer low flows on the side drainages are generally about 1 to 2 feet wide and a few inches deep.

Figure A61. Spring snow slide on top of ford, April 2003.

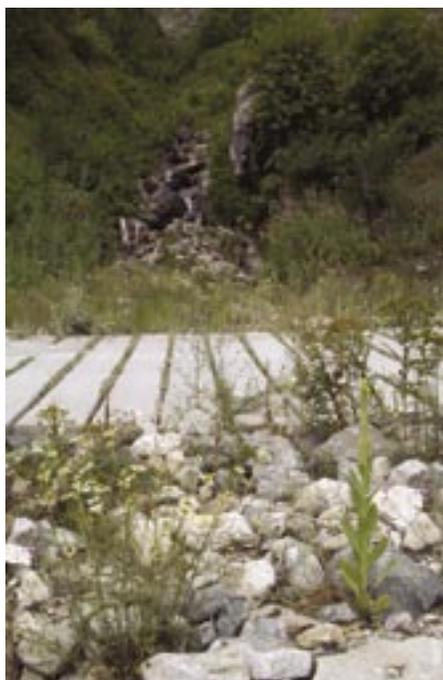
Channel Description: The ford is located on a steep tributary channel, a Rosgen A1a+ in a bedrock avalanche chute (figure A62). Drainage area is approximately 320 acres, and near the bottom of the slope the channel is approximately 6 feet wide. Banks are not well vegetated or particularly stable.

Figure A62. Looking upstream across the ford to the channel. The culvert is to the right out of the frame.

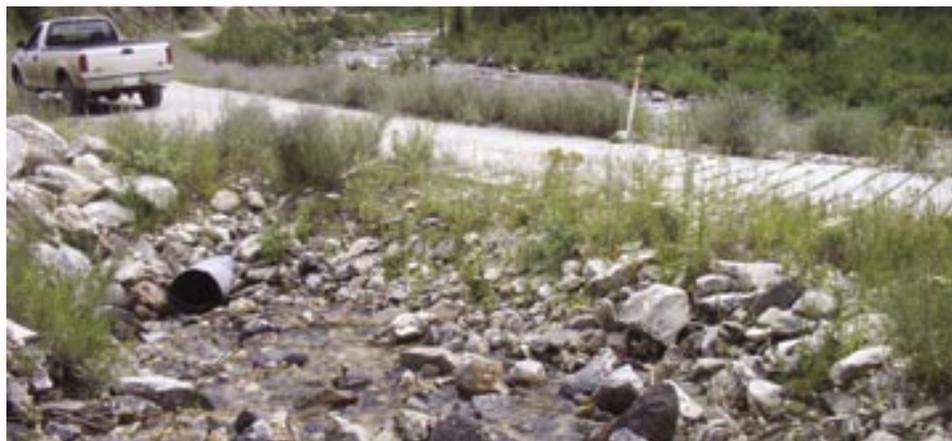
Figure A63. Looking downstream toward the North Fork Clearwater River. Note the sediment catch basin in foreground.
