Case Study 11. Babcock Crossing Vented Ford

Northeastern California. Plumas National Forest, Mount Hough Ranger District, at the Indian Creek crossing of Road 26N10, near Road 29N43 (Antelope Lake Road). The site is between Taylorsville, California and Antelope Lake, 14 miles northeast of Taylorsville.

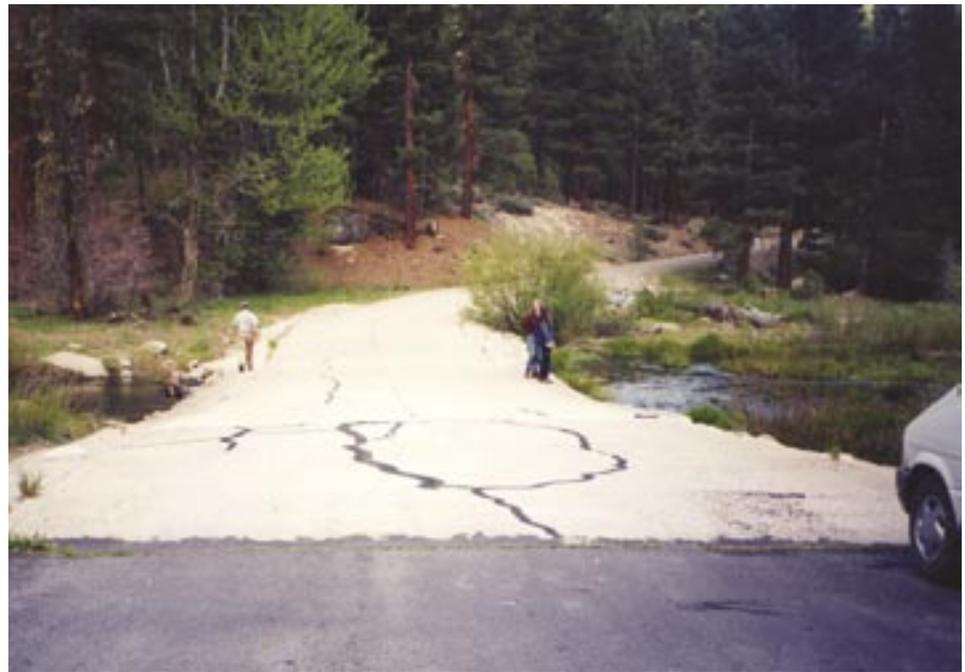
Figure A64. Babcock crossing roadway has a slight vertical curve.

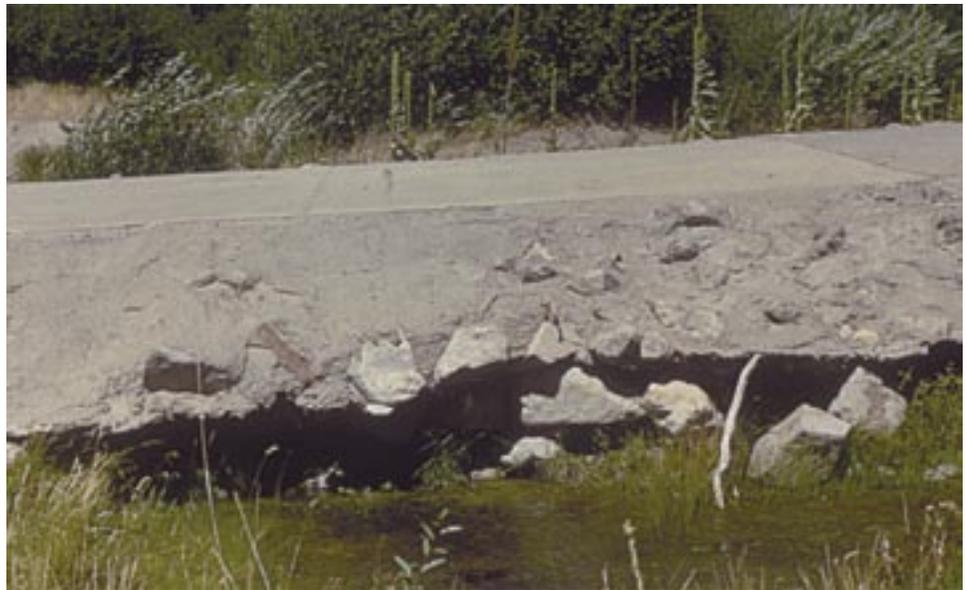
The original crossing at this site was probably an unimproved ford. A 65-foot-long bridge was designed for this site in 1966 but was never built. This gabion, concrete, and culvert structure was designed and built in the late 1960's by the forest. Flooding in 1982 undermined the central part of the concrete slab, and significant repairs were required (figure A65). Since that date the structure has required little maintenance.

Figure A65. Downstream scour under the slab after the 1982 flood. The repair was to add a 5-foot-deep vertical concrete cutoff wall.

A vented ford has existed at this site for about 30 years. The initial structure was a concrete slab roadway over the four 32- by 44-inch arch corrugated metal pipes. In 1982 the original ford was damaged and underwent significant repairs. Portions of the original upstream and downstream gabion slope protection were scoured away and the mid portion of the concrete slab over the culverts along the downstream edge was undermined, causing part of the slab to crack and settle (figure A65). Much of the roadway cross-section over the pipes was refilled, a new concrete slab was poured, cutoff walls were added, and rock riprap was replaced and grouted along the upstream and downstream edges of the roadway. Repairs in 1982 required a total of 103 cubic yards of concrete and nearly 200 cubic yards of grouted Class IV riprap.

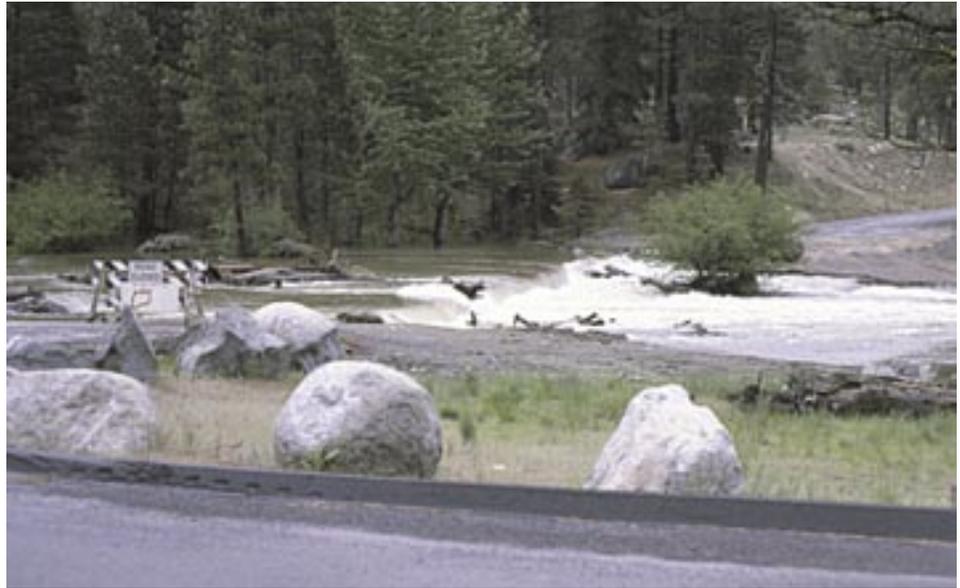
Figure A66. Crossing during a flood event. It is clearly not passable at this time. Note the amount of energy and “scour power” where the flow drops several feet over the structure.

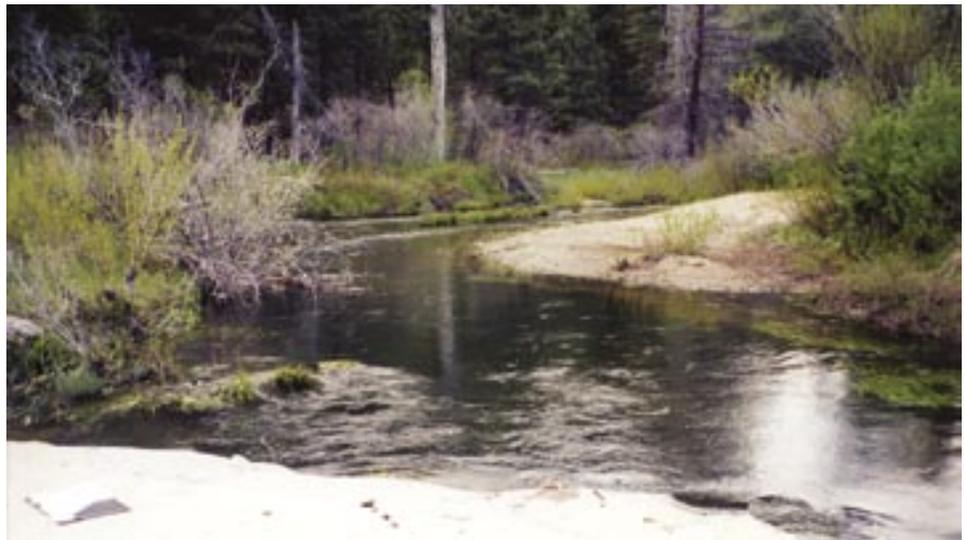
Figure A67. Indian Creek looking upstream from the ford.

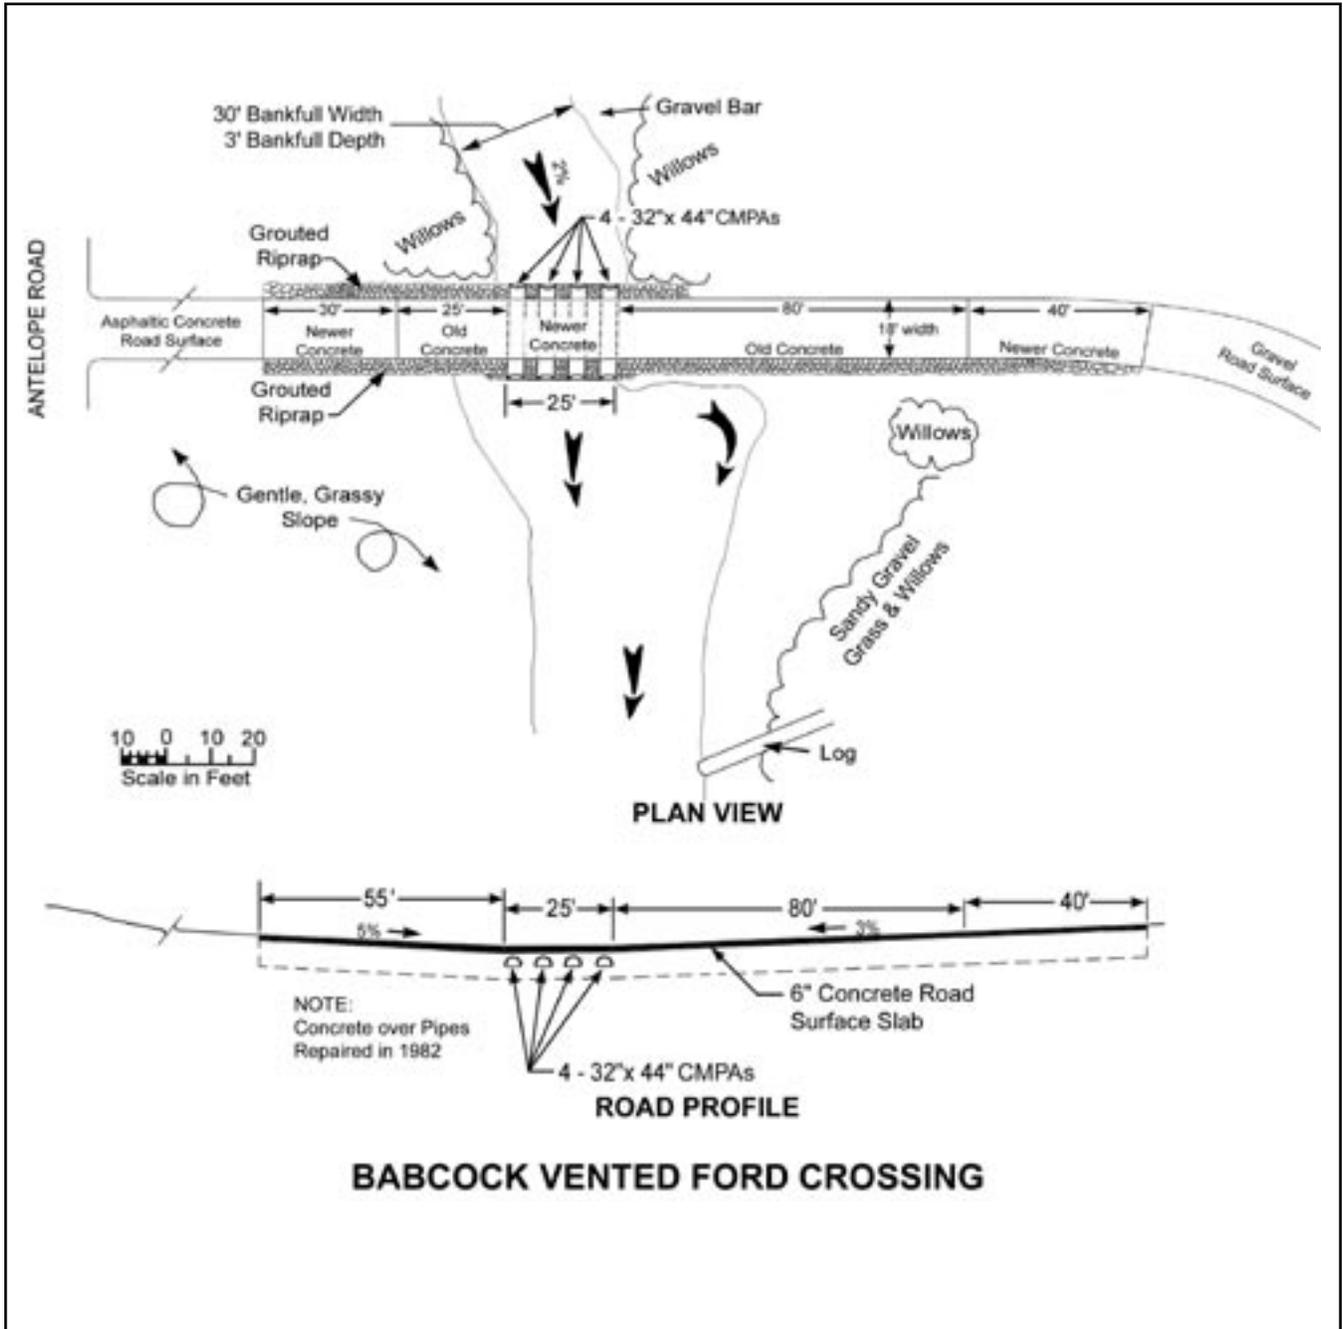
Structure: This structure is a 6-inch thick concrete slab roadway over four 32- by 44-inch corrugated metal pipes. It was originally constructed 130 feet long, but after the 1982 flood, an additional 70 feet of concrete surface was added (part on both ends) to protect the entire wetted perimeter of the crossing. Five-foot deep downstream cutoff walls were also added in 1982. This structure has a low vent area ratio, as can be seen in figure A68. Currently the structure is outlet controlled due to a downstream beaver dam.

Bank stabilization and approaches: After the 1982 event, one set of gabion baskets was placed below the outlet of the culvert pipes for scour protection and energy dissipation. Additional scour protection includes the 5-foot-deep concrete cutoff walls along both sides of the ford (as shown on the site sketch) that are tied into the concrete slab roadway. Grouted riprap was placed outside of the cutoff walls along the upstream and downstream edges of the structure. The ford slopes gently into the drainage at 3 to 5 percent on both approaches.

Figure A68. Site plan view and road cross-section sketch. Note the 5-foot deep concrete cutoff wall (dotted lines).

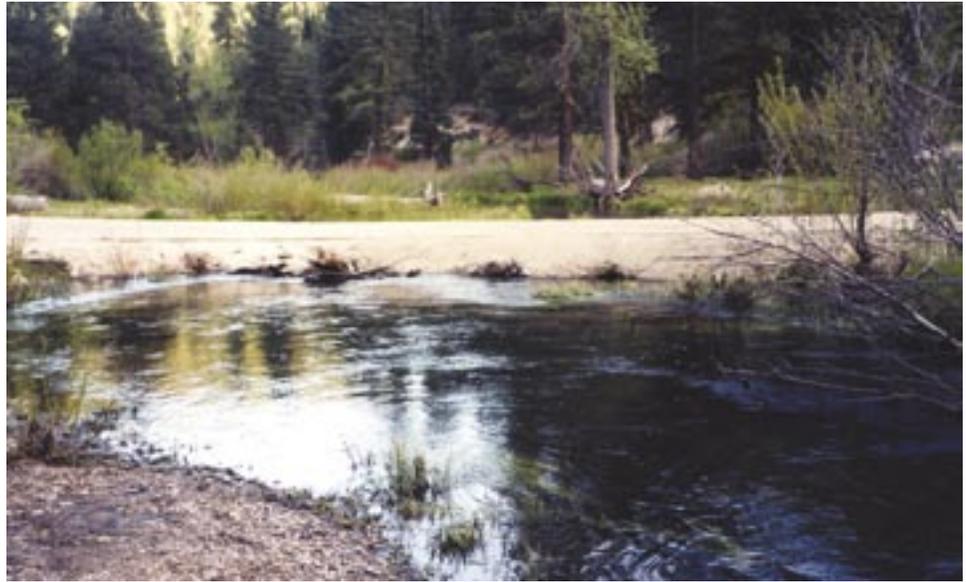
Figure A69. Small debris partially plugs the pipes.

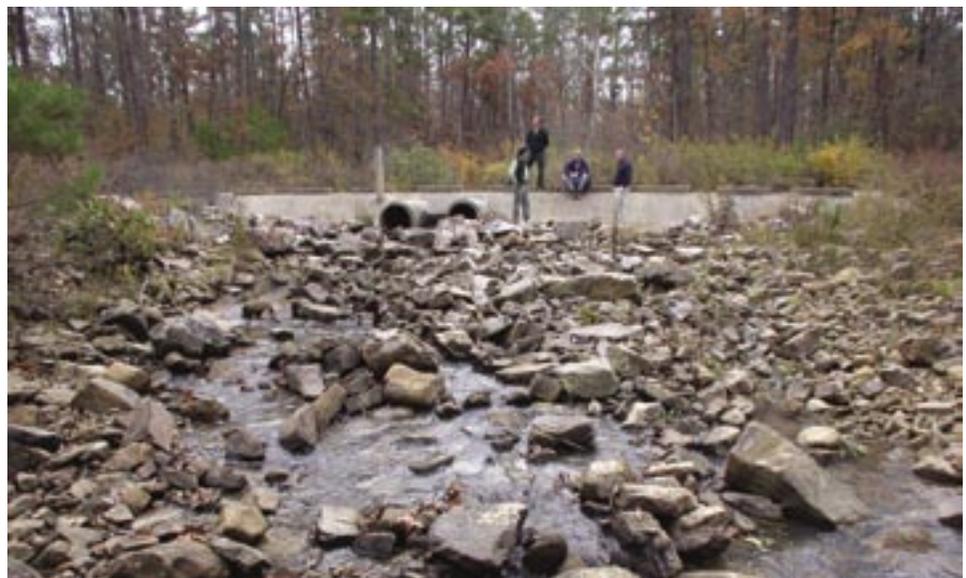
The Ouachita National Forest in west central Arkansas has traditionally made frequent use of concrete vented fords with round concrete culverts on second- and third-order streams. The crossing on lower Harris Creek on the Ogden Ranger District is a good example (figure A70).

Figure A70. Lower Harris Creek concrete vented ford.

The forest plans to replace this structure with a high vent-area ratio concrete box culvert that provides darter passage during low flows, like the crossings in case study 14.

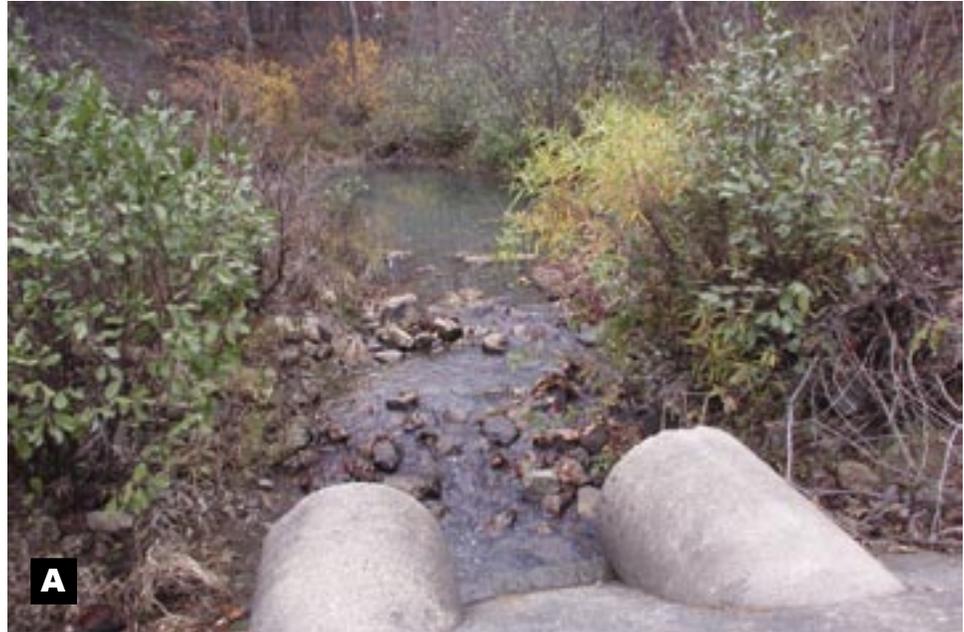
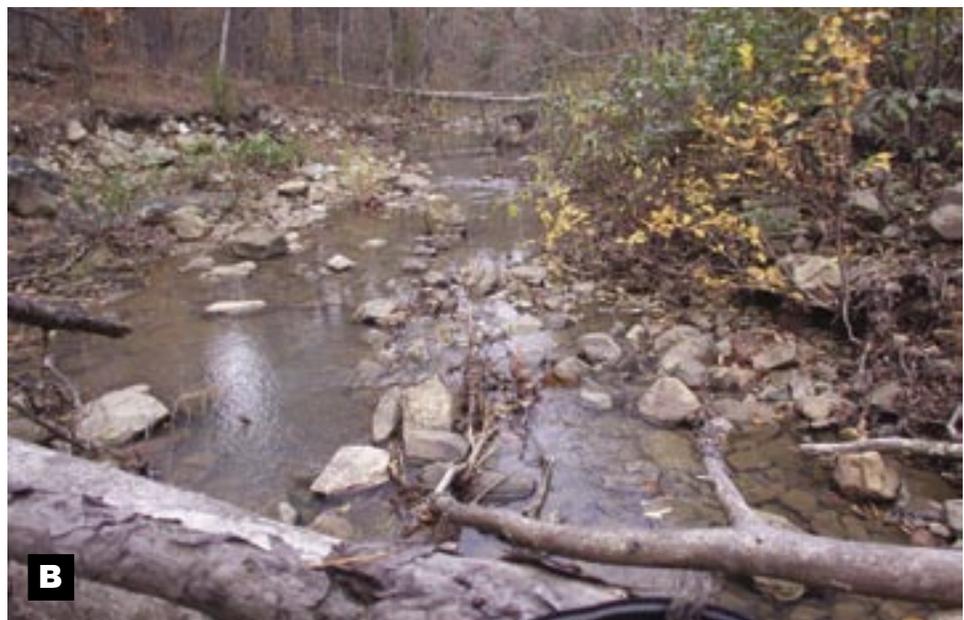
Figures A71a and A71b. Figure A71a. Harris Creek upstream of ford. Figure A71b. Downstream of ford.

Note the bank erosion and widened channel downstream of the structure (figure A71b). As figure A70 shows, the ford is nearly flat across the stream, and when it overtops flow can go around the ends of the structure, eroding the banks. The same type of turbulence shown in figure A66 at the Babcock crossing undoubtedly happens here during overflow, with similar results. Scour protection at this ford consists of a concrete splash apron (figure A72) and riprap. The riprap is placed in a trench just downstream of the apron.

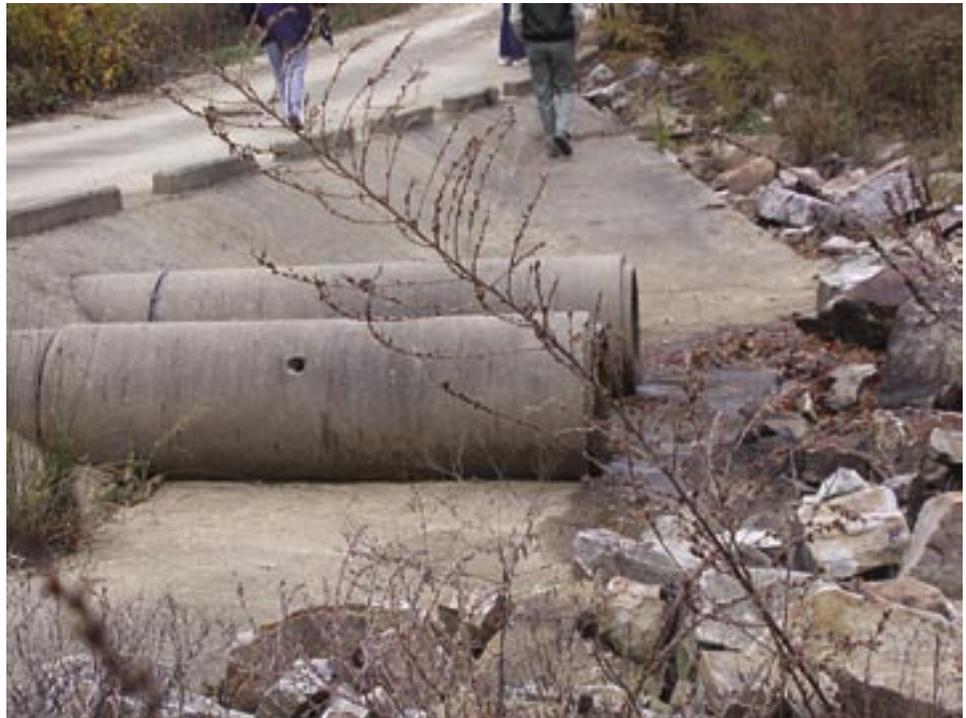
Figure A72. Concrete pipes outlet on splash apron with riprap downstream. Fillslope is also protected by concrete. Note erosion to side of fillslope concrete armor.
