## Case Study 12. Grubbs Concrete Slab Vented Ford

North central California. Plumas National Forest. Mount Hough Ranger District. Grizzly Creek. 3 miles west of Bucks Lake, CA. Forest Road 23N92Y, just off the Oroville-Quincy Highway (FH119).

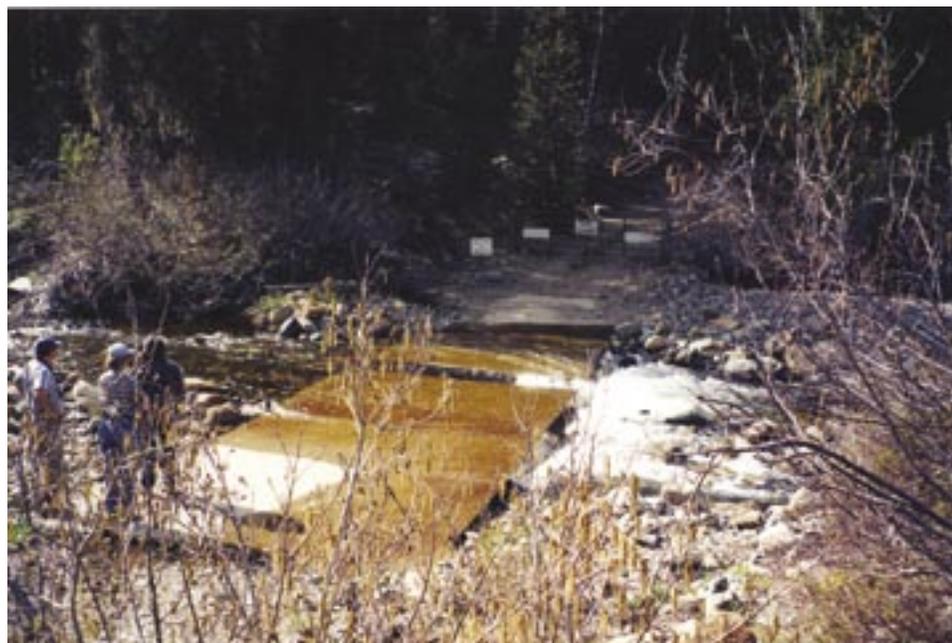
Figure A73. Grubbs crossing on Grizzly Creek, May 2002.

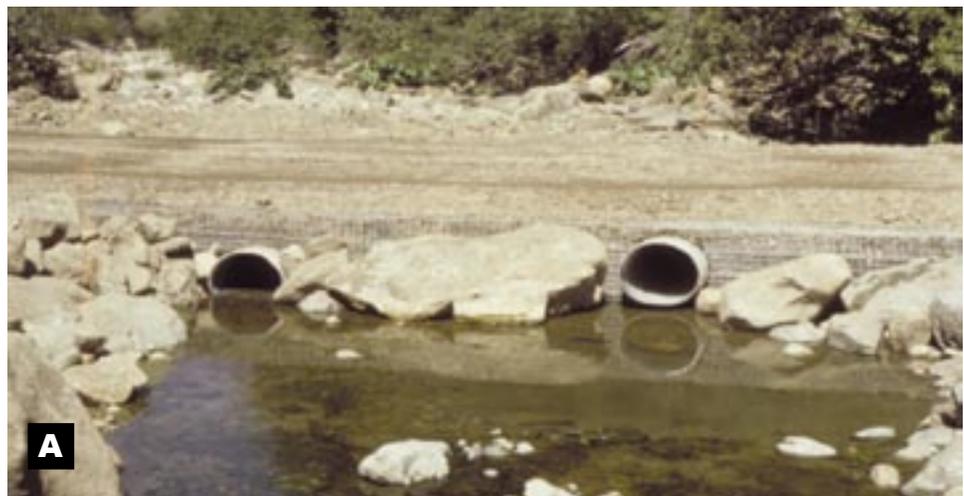
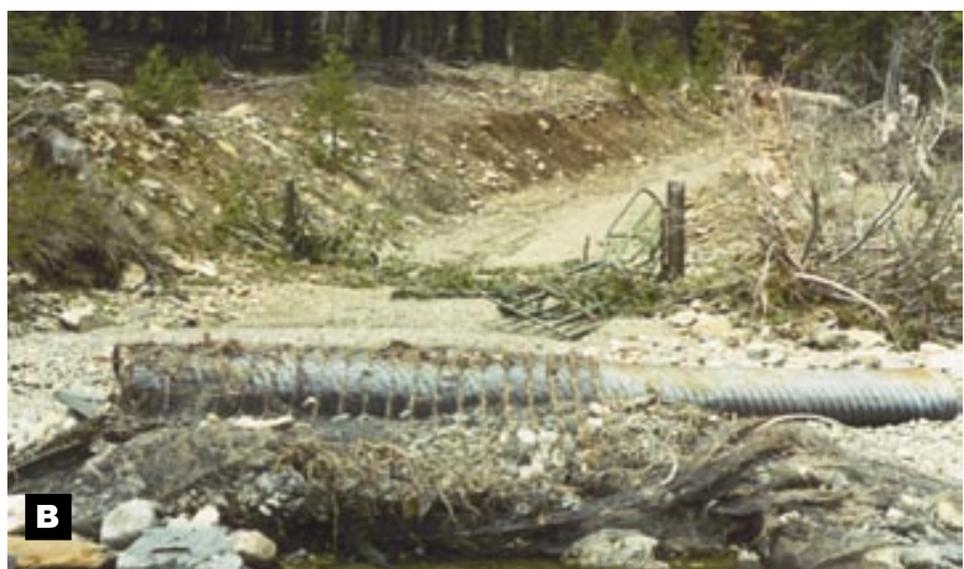
The previous crossing structure was a vented ford constructed in 1984 to provide access across the stream during a timber sale. It was a gabion-type structure fabricated from surplus pieces of welded wire from a retaining wall, and had two corrugated metal pipes as vents. It was too weak for the dynamic forces of the stream at this site, and was destroyed in 1986 (figure A74).

Figures A74a and b. The original gabion vented ford. (a) as built and (b) after the 1986 storm.

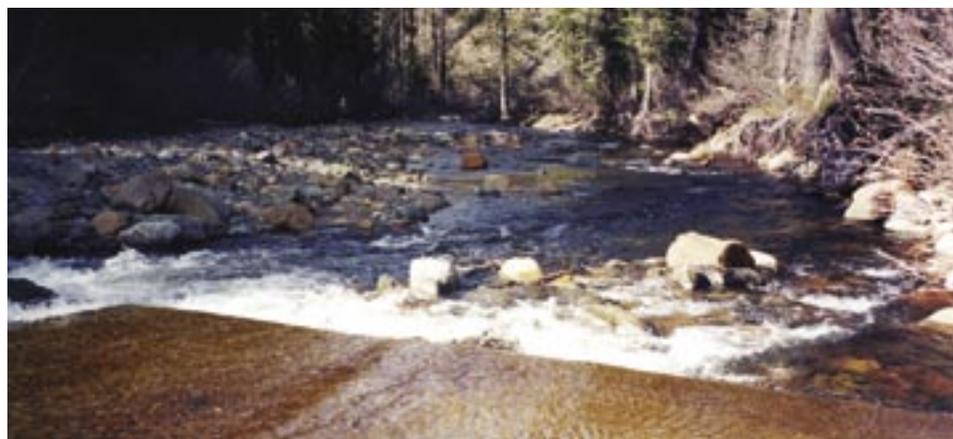
**Channel Description:** At the site, channel slope is 2 to 2½ percent, and the substrate is a well-graded mixture of gravels, cobbles, and boulders to a maximum size of about 18 inches. The bankfull channel is about 55 feet wide, and is slightly entrenched (figure A75). Streambanks are fairly stable, and riparian vegetation includes willow, alder, fir, and cottonwood.

Figure A75. Grizzly Creek downstream of the ford, May 2002.

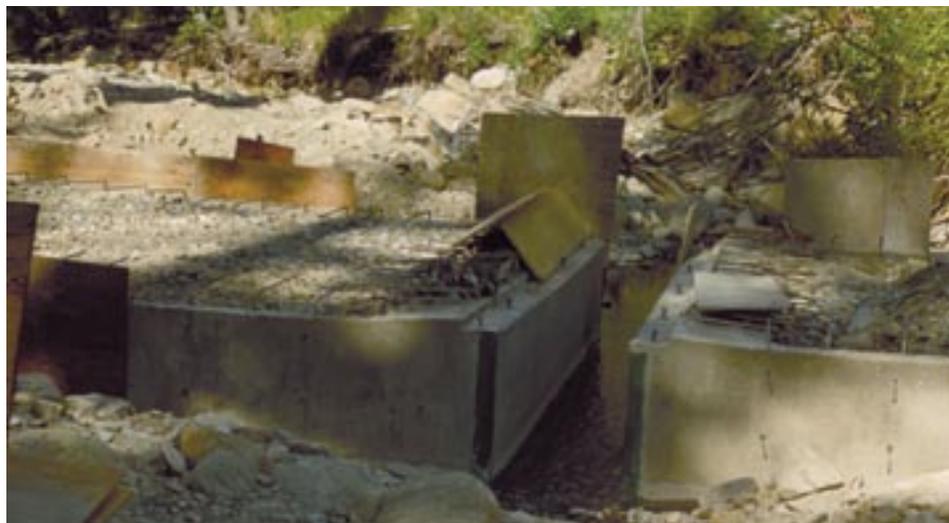
Figure A76. A 3-foot wide gap left between the two sides of the ford forms a narrow concrete-floored vent.

the channel bottom elevation. Also, the embedded box intended for fish passage is too narrow given the size of the bed load moving in the channel; it plugs frequently, and requires maintenance to clean the vent. After 20 years, the gabions are worn and need repair.

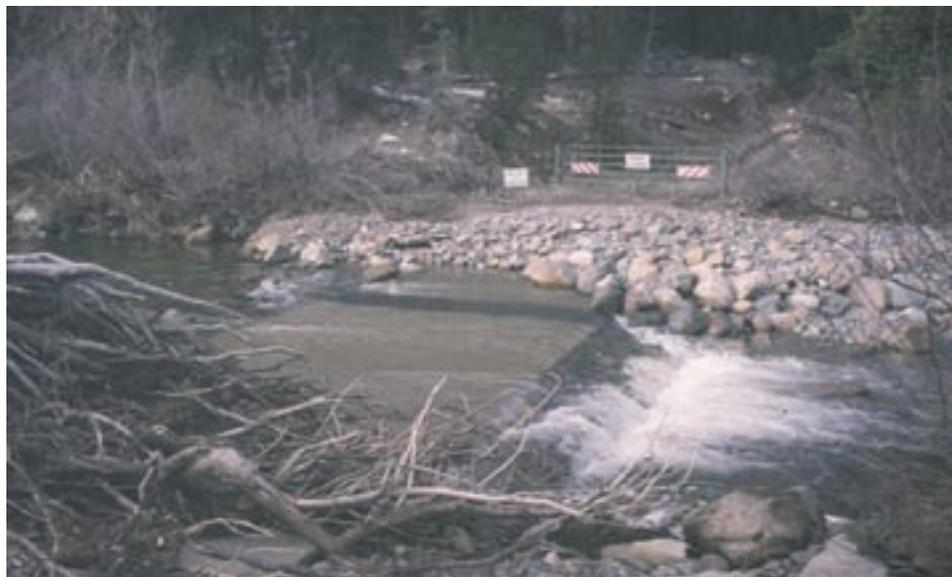
This massive reinforced concrete structure survived the major 1997 flood event with no damage (figure A78). Minor maintenance is frequently required to remove rocks and boulders off the slab and from the concrete box. Boulders moving in the channel during high flows are not much smaller than the box width, and in conjunction with small debris they tend to keep the box plugged most of the time. Some of the downstream gabions will need replacement soon due to damage and abrasion of the wire.

Figure A78. After a major storm, medium and large boulders and large root wads cover the ford, but the structure is undamaged.

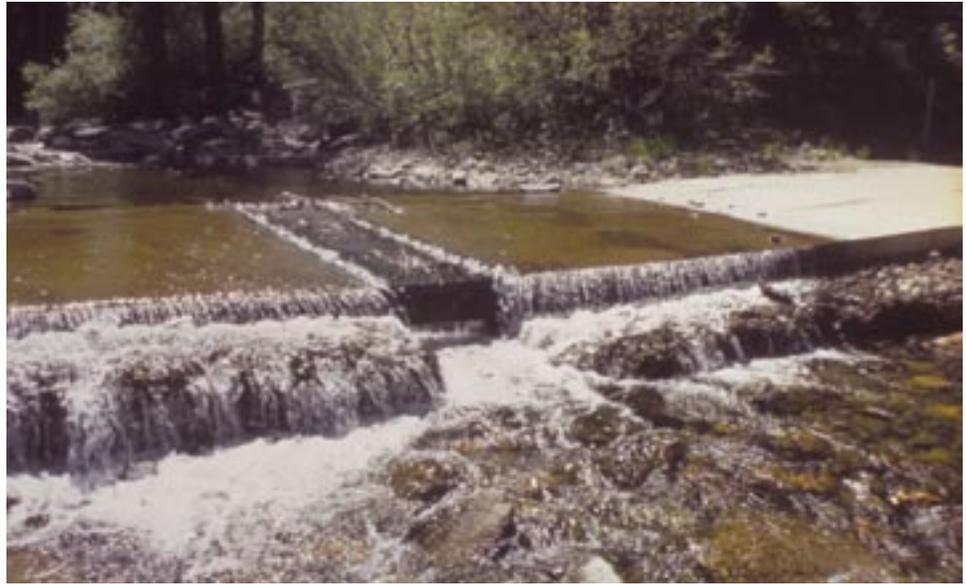
The Grubbs low-water crossing is a relatively massive concrete structure capable of withstanding major storm flows and major bedload movement (figure A79). This type of structure is necessary for a ford in a very dynamic stream environment. There has been little downstream scour, probably due to coarse streambed material. However, the entire structure should be lowered approximately 1 foot to conform more closely to

Figure A79. Grubbs ford immediately after construction in 1986. The vent appears to be a velocity barrier when it is not plugged.

This high stream power, high-value fishery site is a very difficult location for a low-water crossing. Any structure here will have to sustain high floods transporting large boulders, and it should pass fish and other aquatic organisms most of the year. Both objectives could be accomplished using a high-VAR ford with embedded concrete boxes approximating the bankfull channel width.
