Case Study 13. North Fork Consumnes River Tributaries Box Culvert Vented Fords

Central California. Eldorado National Forest, Placerville Ranger District. About 18 miles ESE of Placerville. North Fork Consumnes River basin. Meiss Cabin Road, Forest Road 52 upstream of Capps Crossing.

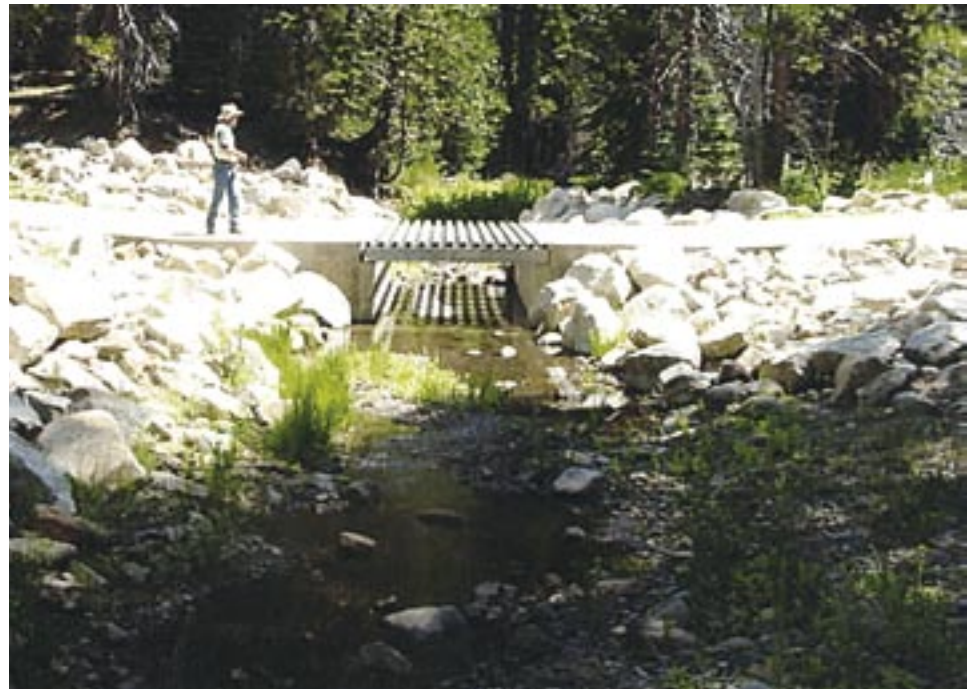
Figure A80. One of several grating-top box culvert fords on tributaries of the North Fork Consumnes River.

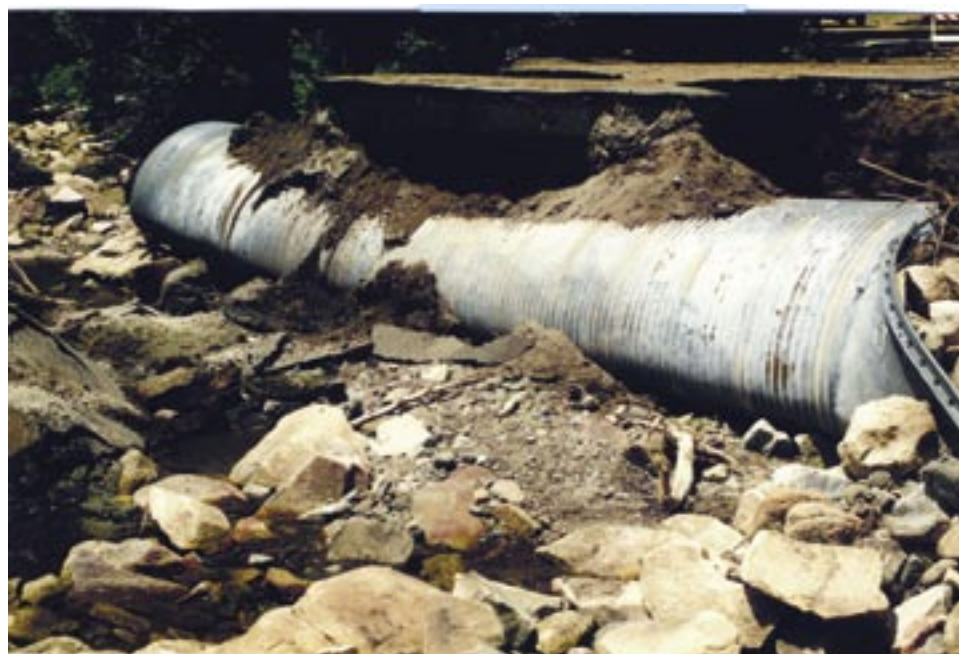
Previous structures at these sites were culverts, which had plugged and been replaced by progressively larger culverts over a period of years. All of the tributary crossings failed in the January 1997 storm event (figure A81). At one crossing, a Hilfiker welded wire headwall was so battered by boulders that it had to be removed. Refer to case study 21 for a review of watershed history and condition that explains why these tributaries are transporting so much rock and sediment.

Figure A81. Typical flood damage at edge of North Fork Consumnes River valley after 1997 rain-on-snow flood.

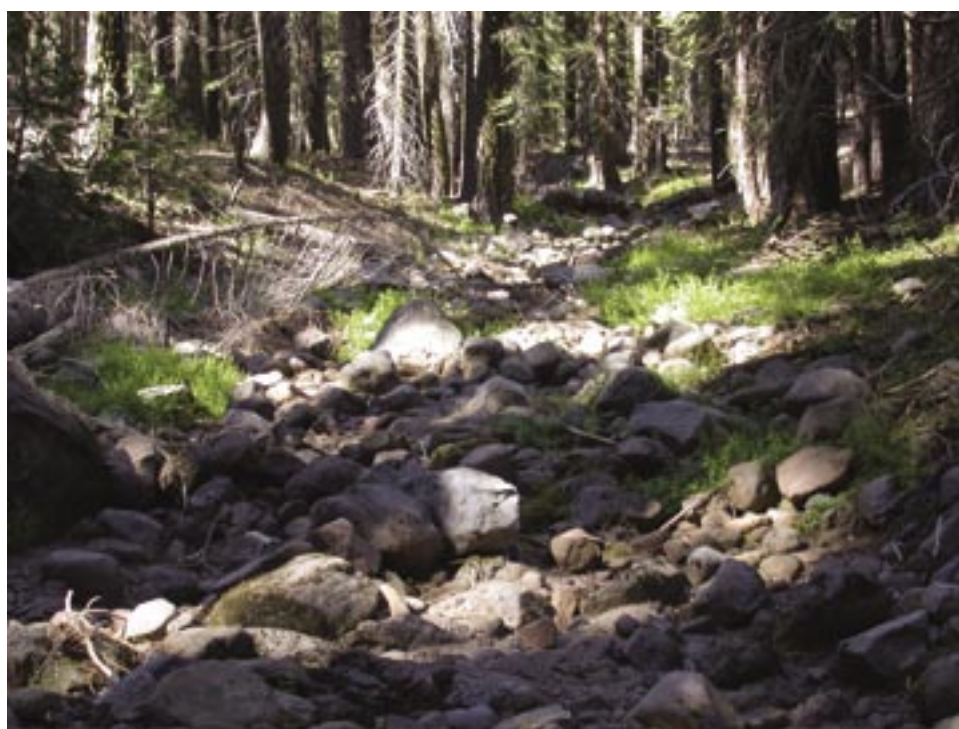
Channel Description: In gold rush days, roads ran right up the channels to get to mining or timber harvest areas. Coarse sediment is in ample supply in the streambeds (figure A82). These tributaries may naturally be B3 channels, but they are so disturbed in the vicinity of the crossings that they are difficult to classify. Channel slopes are at least 3 percent. Valleys are narrow and the streams are moderately entrenched.

Figure A82. Aggraded boulder-bed intermittent tributary of the North Fork Consumnes River, July 2002.

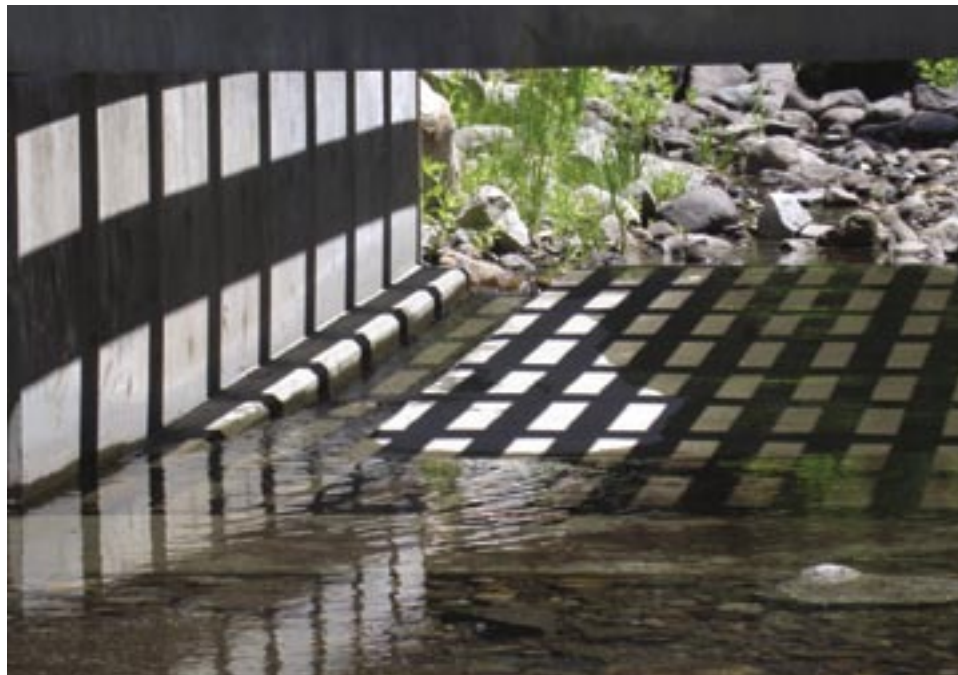
flow. Three-inch fish downstream of one culvert in July 2002 were unable to swim past the backwatered section (figure A83). There may be flows where some fish can move upstream. The structures are no more than 12 feet long, so larger fish may be able to negotiate them at higher flows.

Fish were attempting to move upstream in July 2002, but flow in the trench was too shallow and too fast.

Where fish passage is required, a similar grate-top box with an open bottom and natural streambed would better fit the need.

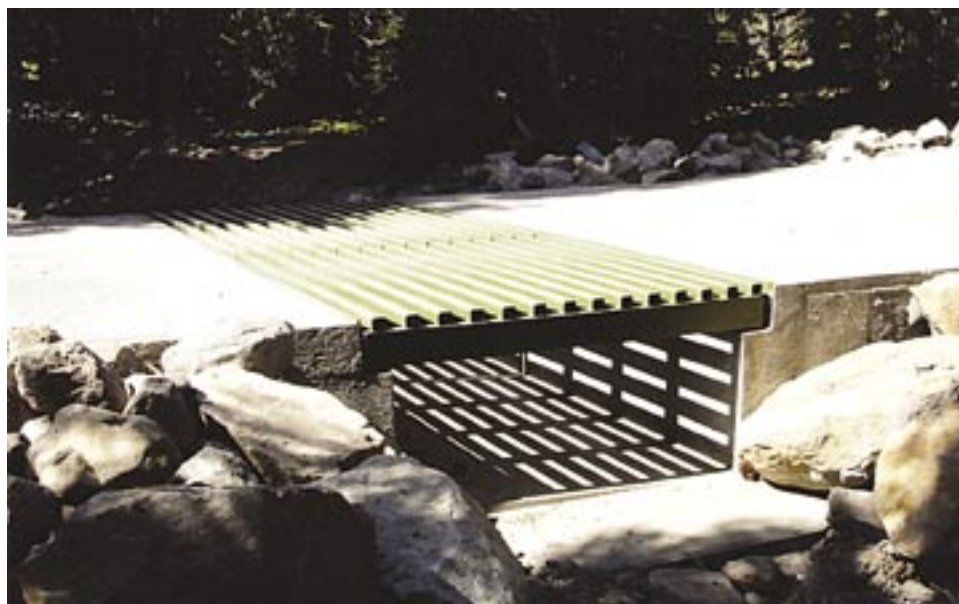
Structure: The structure is a small box culvert with an open top and cattleguard driving surface that can be removed for cleaning (figure A84). Concrete approaches dip into the ford, which has a total length of 75 feet (figure A85). The concrete box is 8 feet wide and 4 feet deep. The box floor slopes slightly perpendicular to the direction of flow to force low flow to concentrate in the trench at one side of the box. An upstream cutoff wall 9 inches deep runs the full length of the ford and is heavily riprapped.

Figure A84. Close up of grate-top vented ford.
