Case Study 14. Rocky Creek Vented Box Culvert Ford

West Central Arkansas. Ouachita National Forest; Oden Ranger District. Rocky Creek crossing on Forest Road 887 (Muddy Gibbs Road).

This is a concrete vented ford on a perennial stream that provides habitat for several fish and mussel species. The structure consists of three 6- by 3-foot concrete box culverts, with a splash apron extending downstream of the roadway (figure A86). Six-inch curbs focus water into the center culvert for low-flow passage for weak-swimming fish, and boulders embedded in the concrete provide resting areas for them .

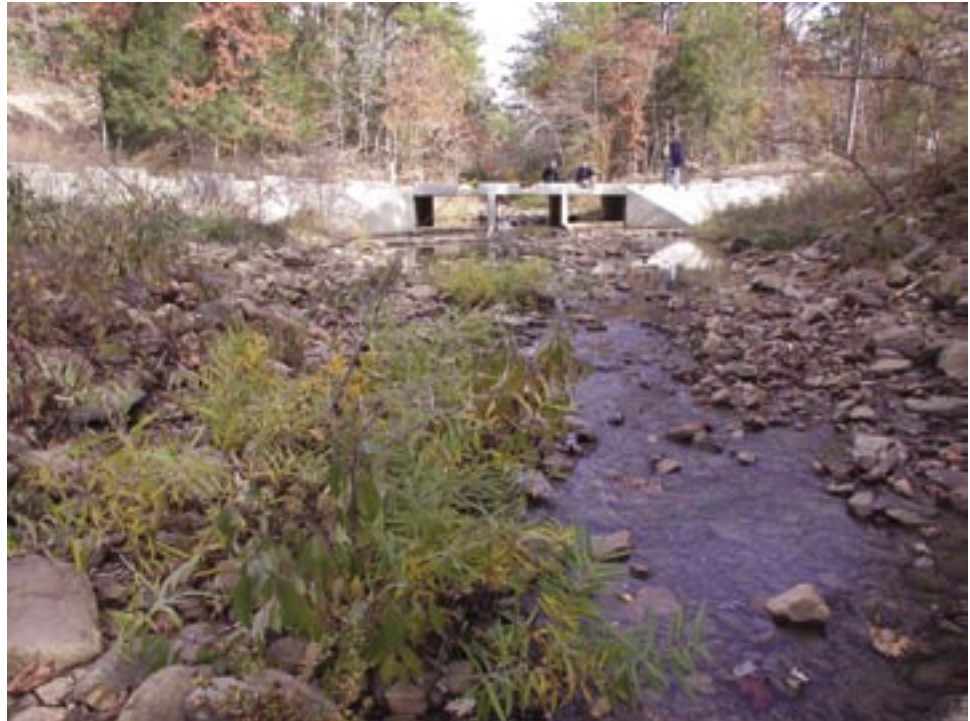
Figure A86. Looking upstream at the concrete vented ford and splash apron.

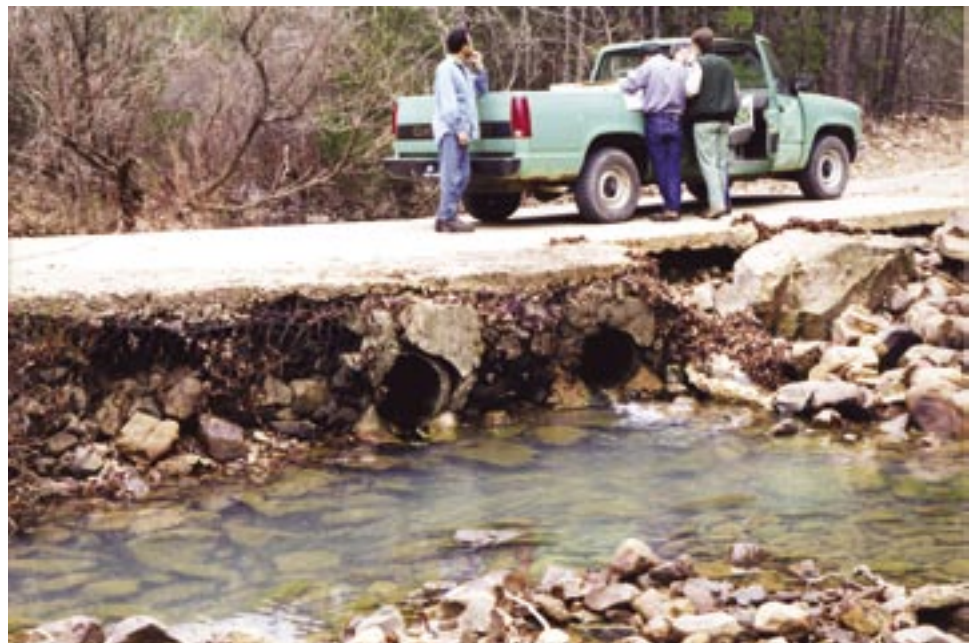
In 1964, an unvented ford was installed at this site with 39-inch gabions supporting the downstream edge of a gravel roadbed. The gabion structure was frequently damaged when high flows outflanked the approaches. By 1979, two 24-inch pipes had been placed under the roadbed, and the road was surfaced with concrete (figure A87). The pipes plugged frequently, and many repairs were needed. In 2000, when the existing structure was built, there were several generations of concrete to be removed along with the gabions and pipes.

Figure A87. The previous crossing on road 887 at Rocky Creek was a gabion-culvert structure that was frequently damaged during high flows.

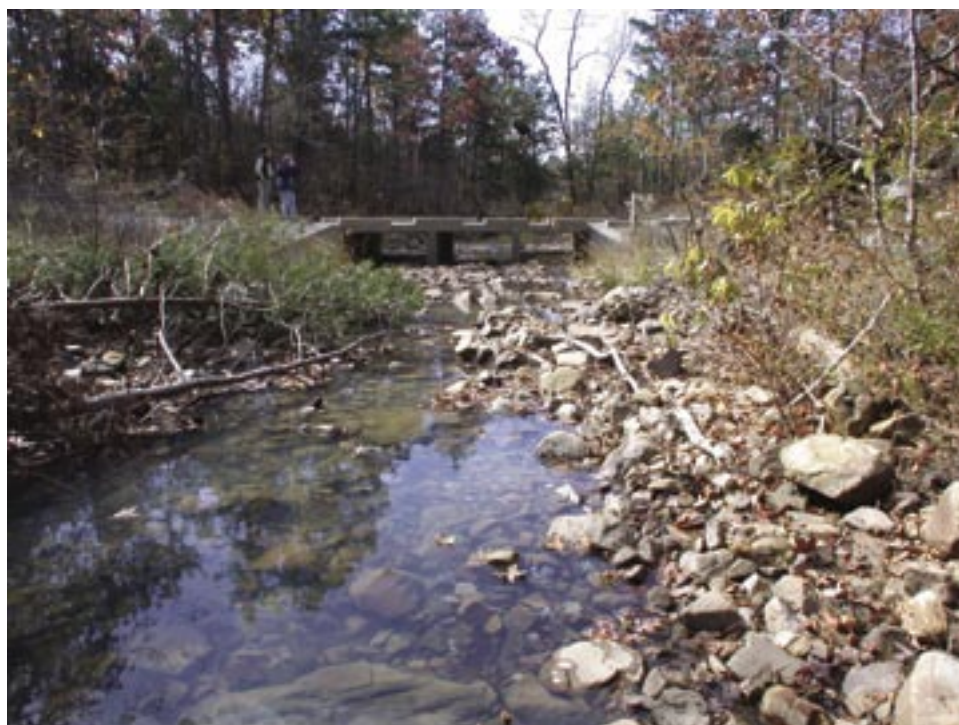
Figure A88. Looking downstream at the crossing on Rocky Creek.

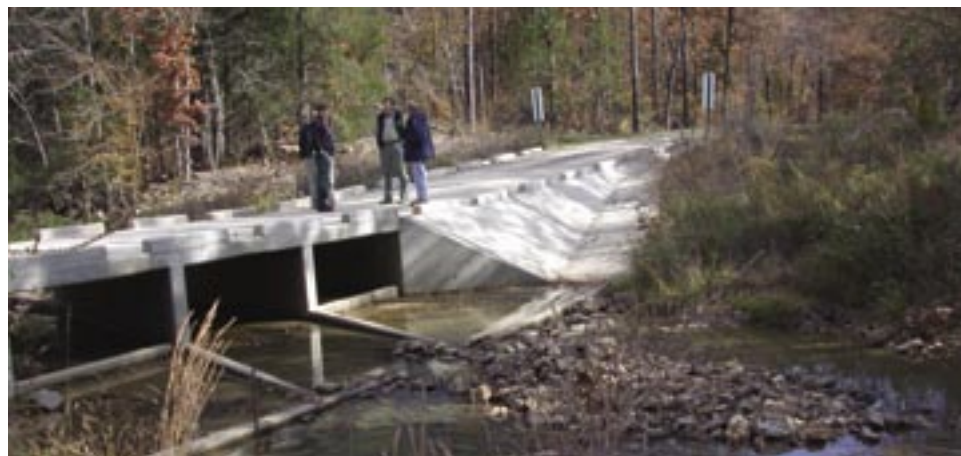
Figure A90. Looking upstream at the splash apron and backwater curbs.

Bank Stabilization and approaches: The driving surface and approaches are concrete. The structure is protected during overflow by concrete armored wings with ditches both above and below the crossing (figure A90). The approaches slope at 8 percent into the ford and the ditches on the downstream side empty onto the concrete apron below the structure, protecting the streambed from scour by high velocity ditch flows.

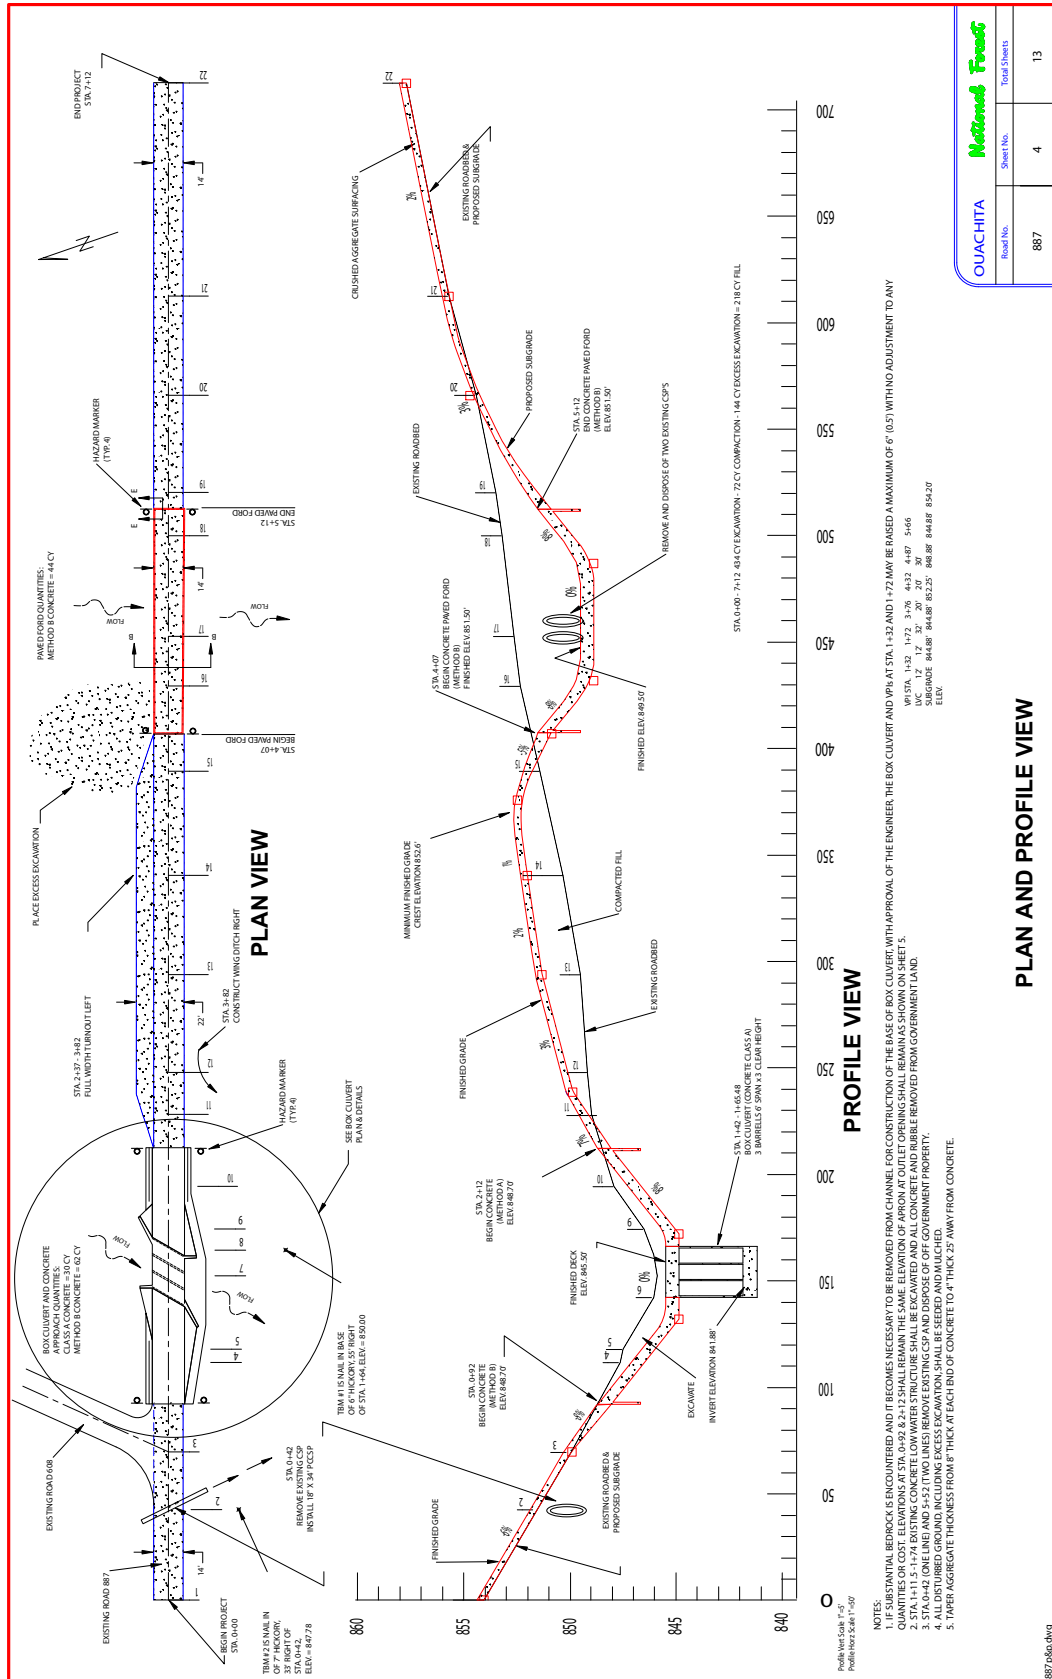
Structure: The structure consists of three 6- by 3-foot concrete box culverts set at streambed elevation (figure A89). A 10-foot long splash apron protects the structure against scour during overtopping flows, and a 6-inch curb at the apron's downstream edge is intended to prevent formation of a plunge there by creating a reverse eddy. Curbs under the roadway backwater flows in the side culverts and concentrate water toward the center box (figure A90) for low flow fish passage. The curbs help to retain some bed material in the floor of the culverts, which is also expected to help aquatic species passage through the culvert. Four- to 6-inch boulders embedded in the concrete floor further assist fish passage by providing resting areas.

Figure A89a—Plan and profile drawings of the concrete box culvert vented ford at Rocky Creek. A full size drawing may be found on the CD included in the back of this publication.

There is an overflow channel about 300 feet from the main channel that receives flow during most floods and takes some of the stress off the main structure. Before the replacement, water from the overflow channel would run down the road to the ford. Figure A89 (profile view) shows how the road alignment was modified to prevent diversion and protect both the road and water quality. The two pipes in the overflow channel were replaced by a concrete slab ford at stream grade that cannot plug and that greatly increases the volume of flow the overflow channel can accommodate.

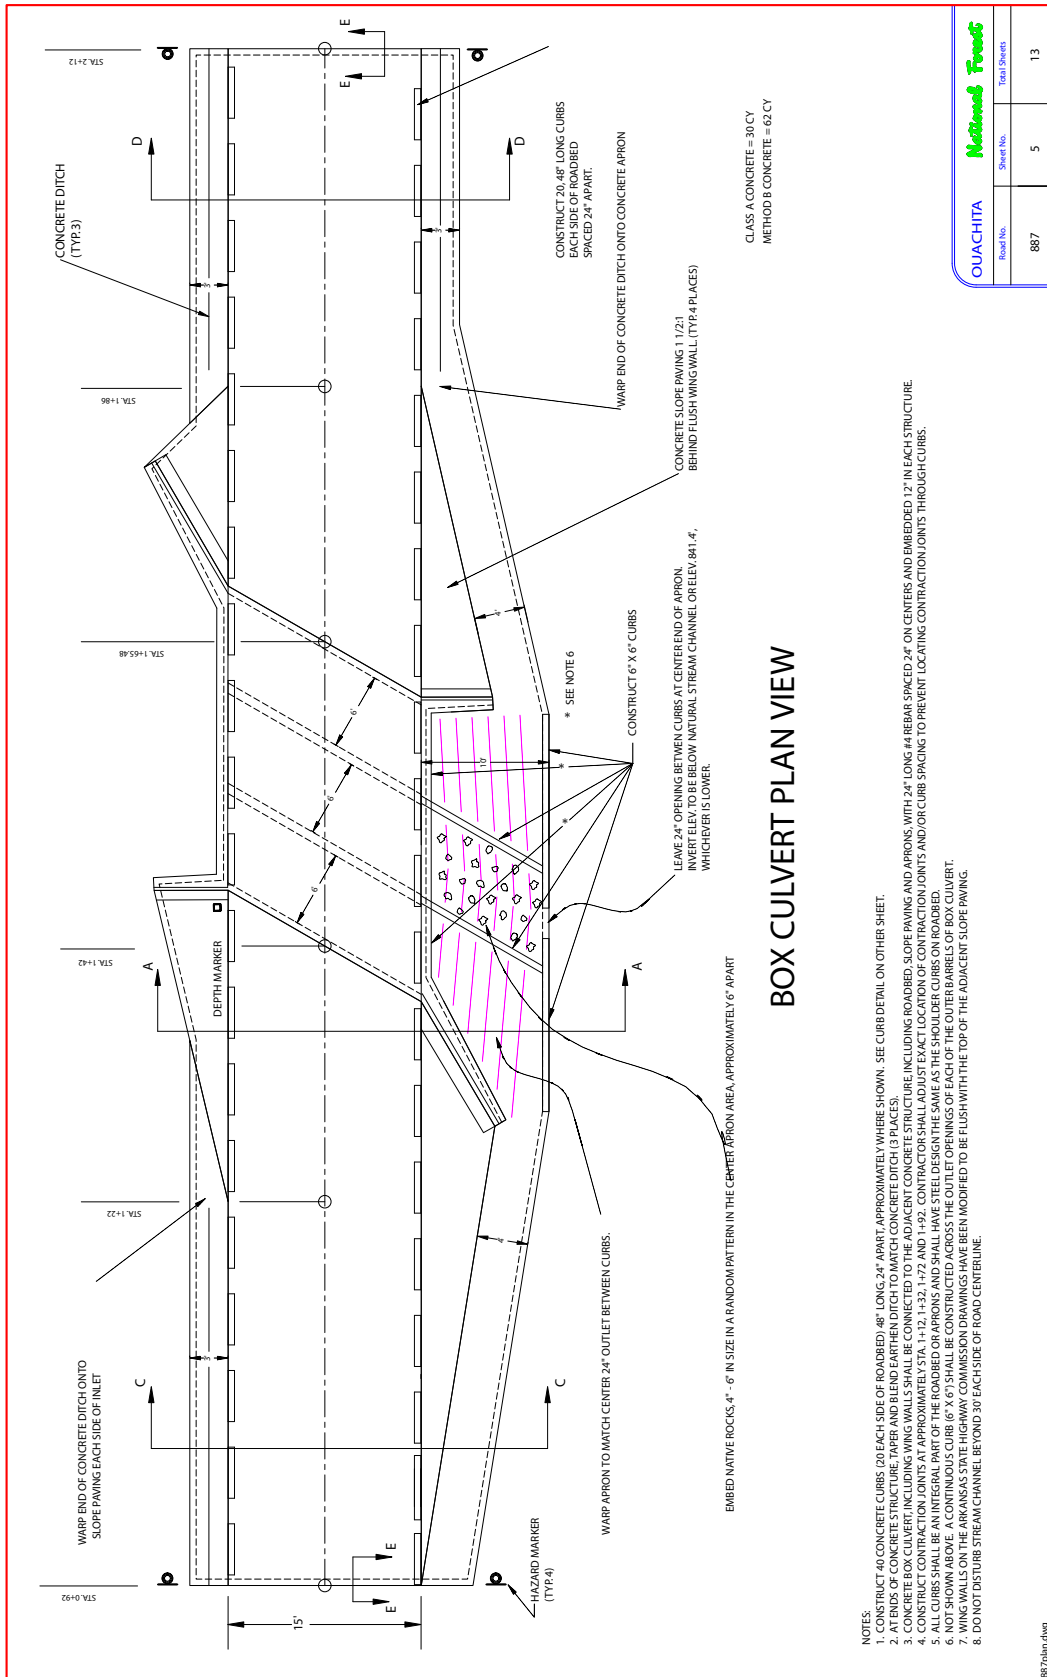
OUACHITA		Wildland Forest	
Road No.	887	Sheet No.	5
		Total Sheets	
		13

Figure A89b—Plan drawing of the concrete box culvert vented ford at Rocky Creek. A full size drawing may be found on the CD included in the back of this publication.

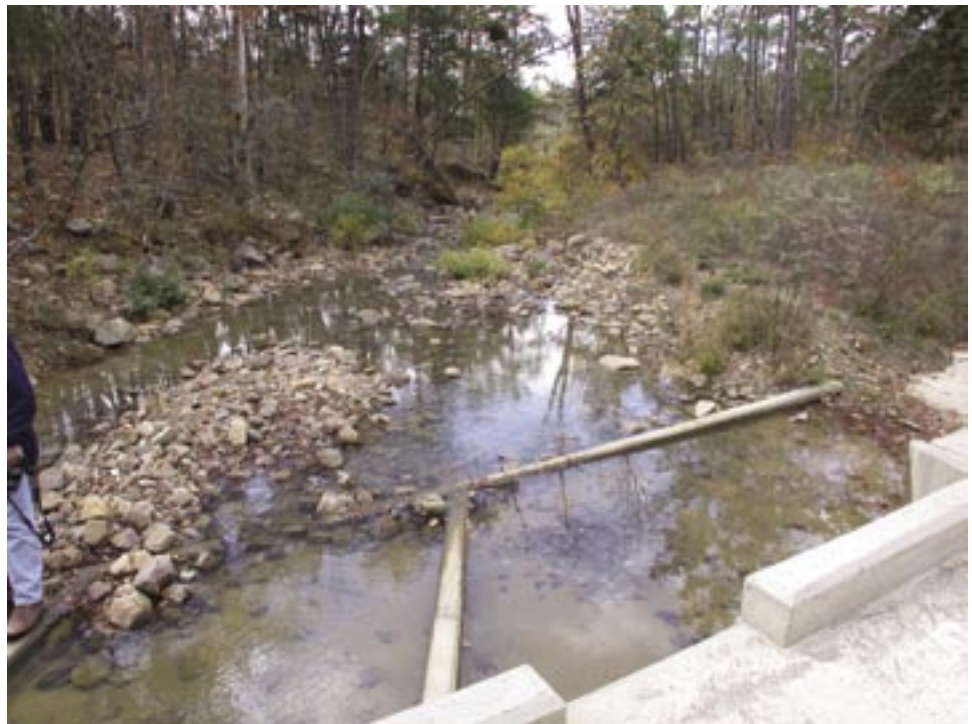
Figure A91. Looking downstream from ford. Note local channel widening.

Figure A91 looks downstream of the main crossing showing the locally widened channel. Although the channel is rocky and quite stable, flows that overtopped and spread out over and around the previous structure likely caused the bank erosion there. The road's skew relative to the channel may have contributed too.

The splash apron, curbs, concrete fillslope armoring, and ditches are working well to keep this structure and the roadway stable. There is no channel bed scour, and the bank scour visible in figure A91 appears to be very limited. The boxes are high enough to prevent plugging so far (5 years after construction). Traffic interruptions are brief enough to be tolerable even on this school bus route.

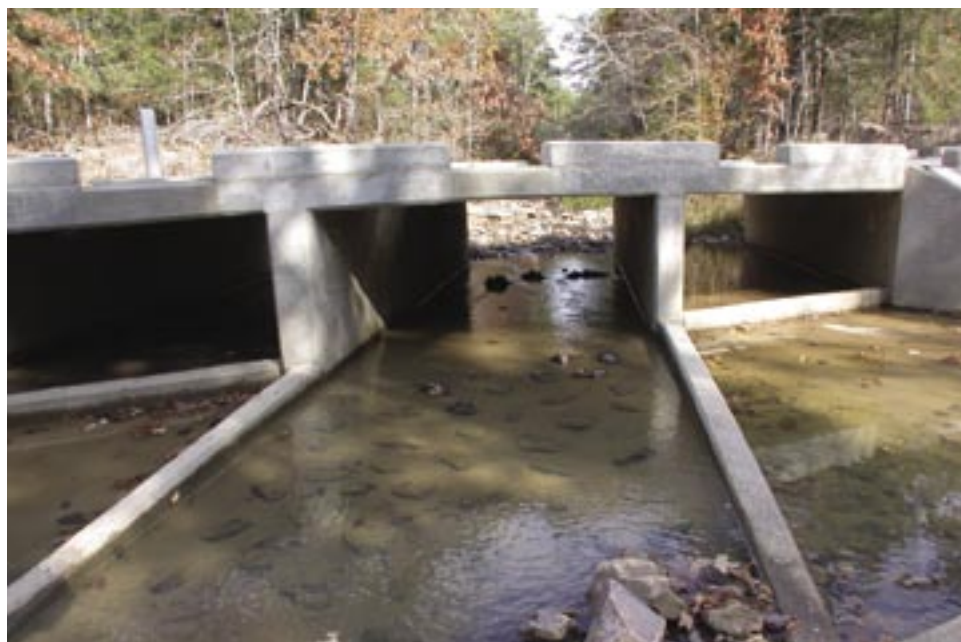
Fish are often observed in the crossing when it is wet. This particular crossing has been the subject of two fish passage studies but the stream is susceptible to drying and is quite remote so that fish passage detection has been difficult. Nonetheless, 4 of the 8 to 13 species found above and below the crossing have been documented as passing the structure: grass pickerel, central stoneroller, orangebelly darter, and green sunfish. There is a thin veneer of fines on the floor of the box and many embedded boulders (figure A92), but the bed lacks areas with different water velocities and depths, and may not provide passage for the non-fish species present in the stream.

Figure A92. The floor of the central box has a thin veneer of sediment at low flow.

Recognizing that a natural streambed is preferable where aquatic species passage is a goal, the forest is moving to embed more recent box culverts below streambed elevation (see Long Creek vented ford, below). Current practice is to embed the floor below the best estimate of final channel grade, keep the deck as low as possible so that overflows are not much wider than in the natural channel, and provide openings equivalent to the full channel width.

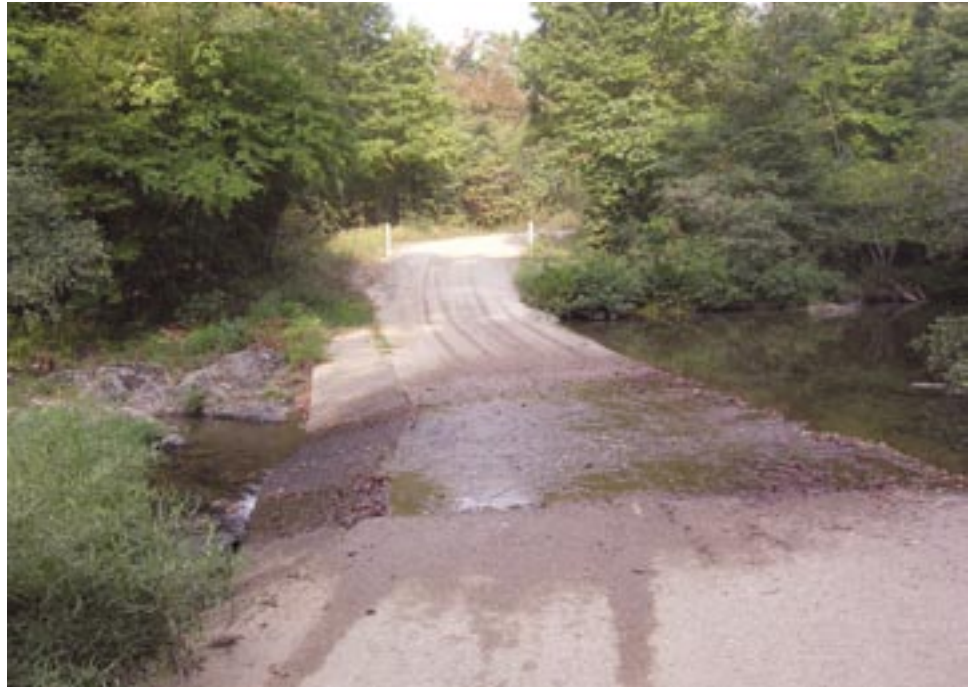
Forest Road 512 crosses Long Creek about 30 miles southwest of the Rocky Creek crossing described above. The stream types and road issues and constraints are similar. Figure A93 shows a ford similar to the old unvented ford at the Long Creek crossing. The new 2004 replacement has five 4-foot-high box culverts that were allowed to self-embed to a planned depth of 1 to 2 feet (figures A94 and A95). The crossing's total open width is now just under bankfull width.

Figure A93. Unvented ford similar to the one replaced at FR 512 crossing on Long Creek, Ouachita National Forest.

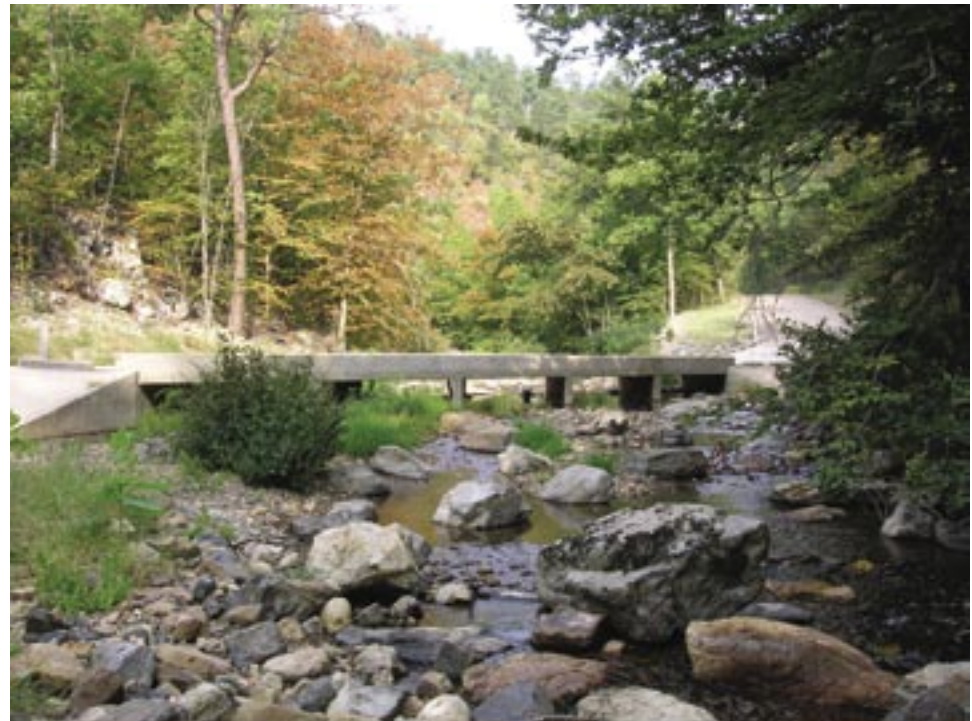
Figure A94. Looking upstream at the embedded box culverts that replaced the unvented ford in 2004.

The cost of the replacement in 2004 was \$110,000. Note that the curbs on this ford are continuous. Since the ford is the low spot on the road, it retains water on its surface and the curbs do not allow it to drain. In future, the forest plans to add drainholes in the road surface.

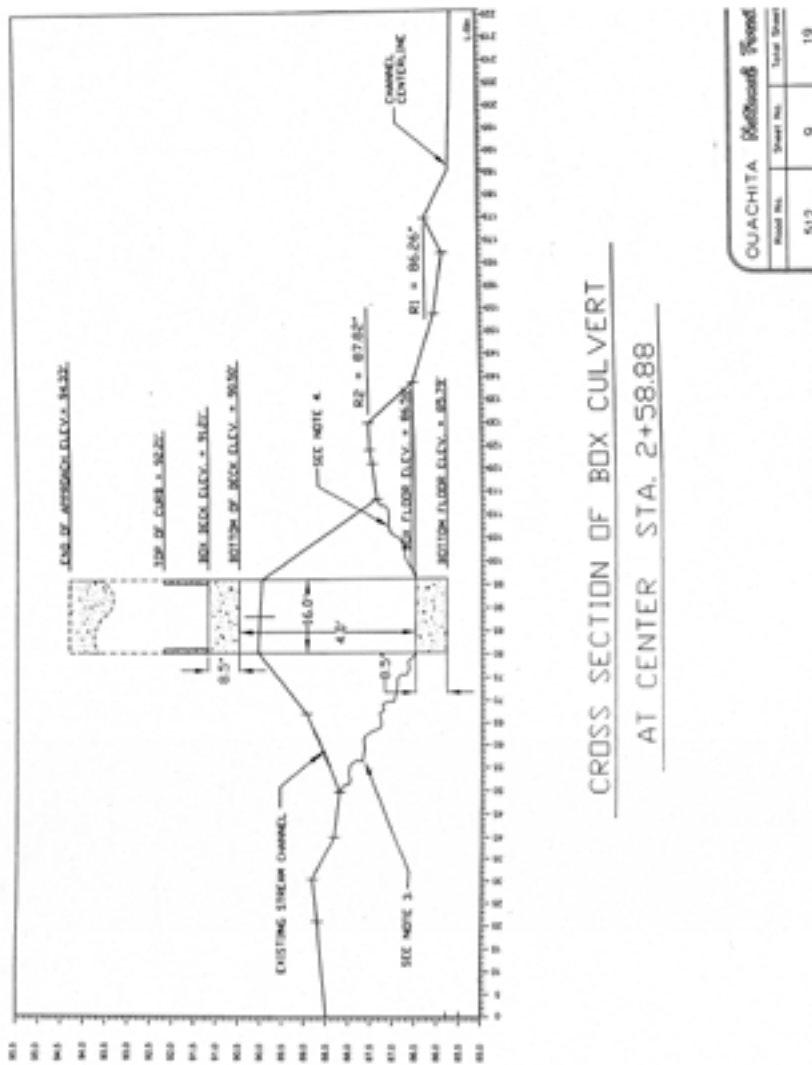
Figure A95 □
 tinuous across the channel. A full size drawing may be found on the CD included in the back of this publication.

Figure A95a is a contract drawing showing the longitudinal profile of the stream. The plan was to allow the embedded boxes to fill in with streambed material naturally over time. However, a large storm during construction overtopped the structure and completely plugged the boxes with construction-generated material and natural bedload. The structure was partially cleaned out, leaving substrate at grade and the streambed has maintained itself. In gravel-bed streams, not filling the embedded culverts during construction could produce a headcut. However, in this case there was no headcutting risk because bedrock is intermittently exposed along and across the channel above and below the crossing.

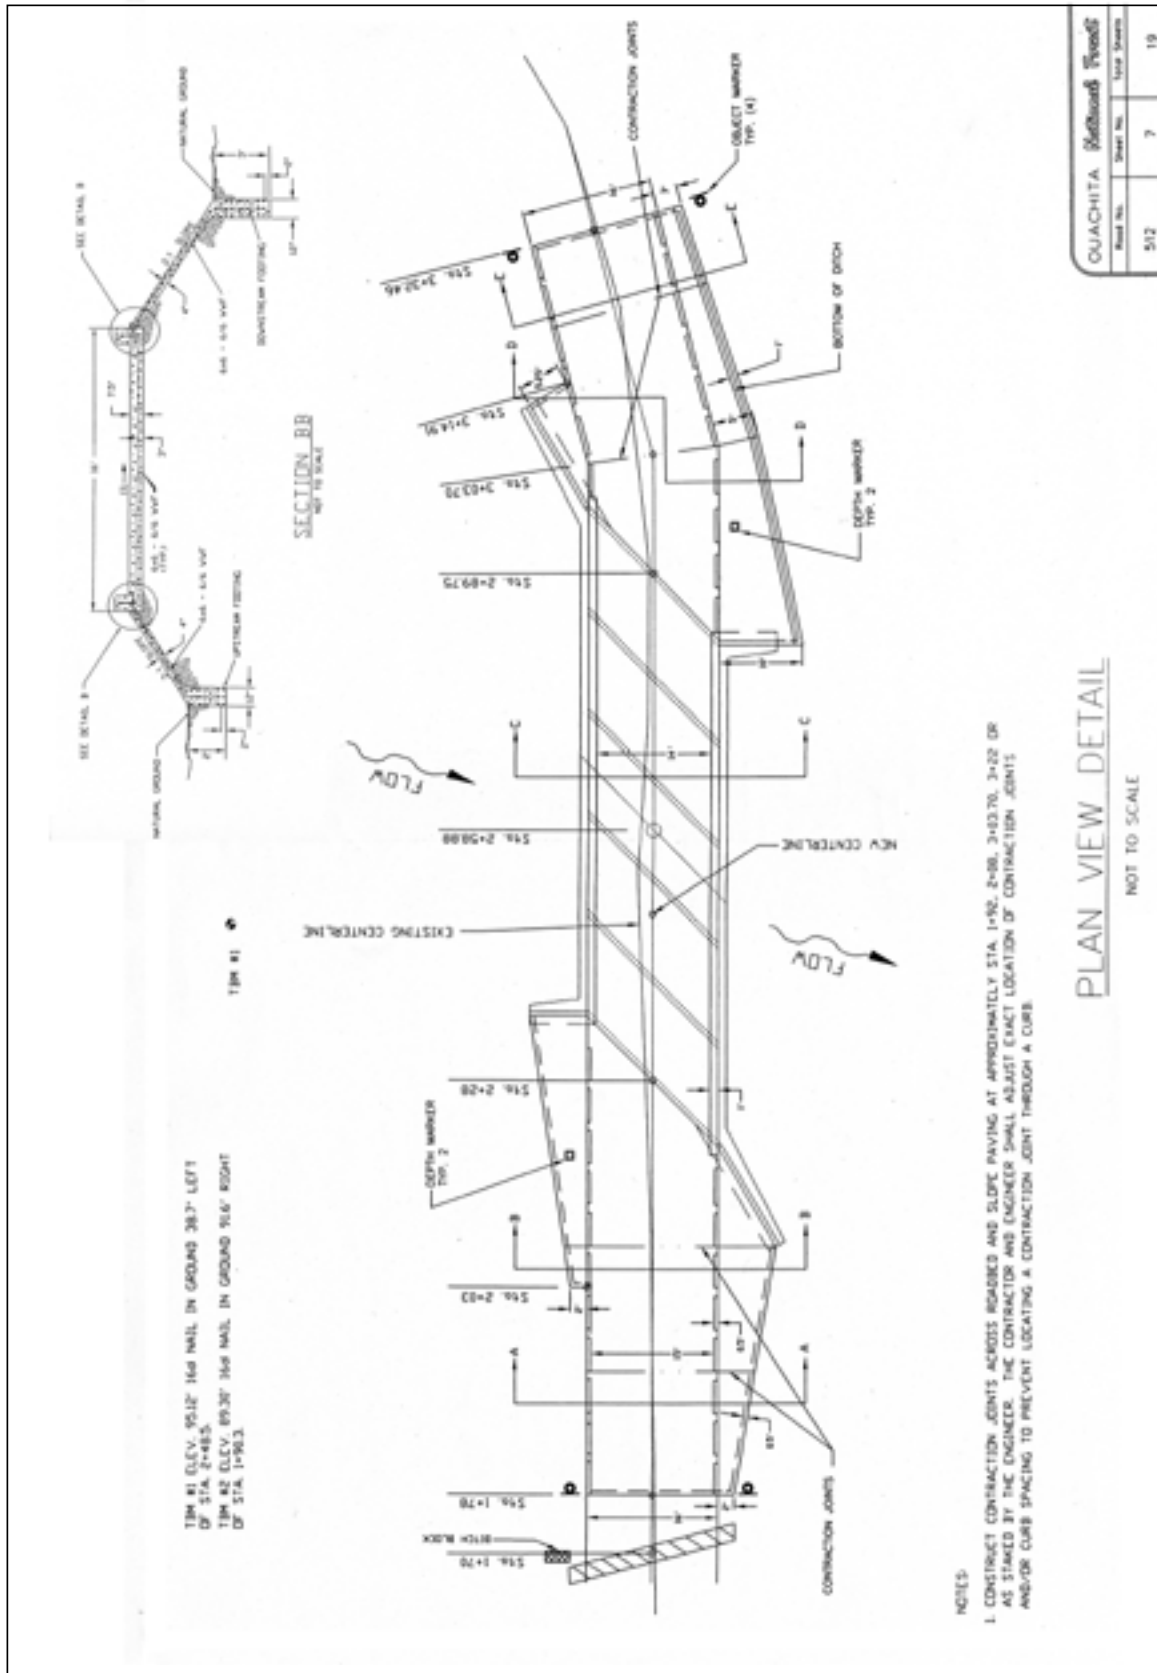
Figure A96—Plan view contract drawing and cross section detail of structure near the channel centerline. A full size drawing may be found on the CD included in the back of this publication.
