Case Study 15. Moonlight Crossing Concrete Box Vented Ford

Crossing Description

This large concrete box vented ford, reconstructed in 2000, is located on Lights Creek, a perennial fisheries stream. Previous crossing structures had caused upstream aggradation and downstream degradation, and there was an 8-foot elevation drop at the site. The vented ford is designed to prevent lowcutting from progressing upstream. The structure is a trapezoidal shape over four reinforced-concrete box culverts, one containing a fish ladder (figure A97). The roadway surface across the ford, including the steel cattleguard and the 6-inch-thick reinforced concrete approach slab, is 15 feet wide and 109 feet long. The driving surface over the boxes (across the active channel) is 32 feet long.

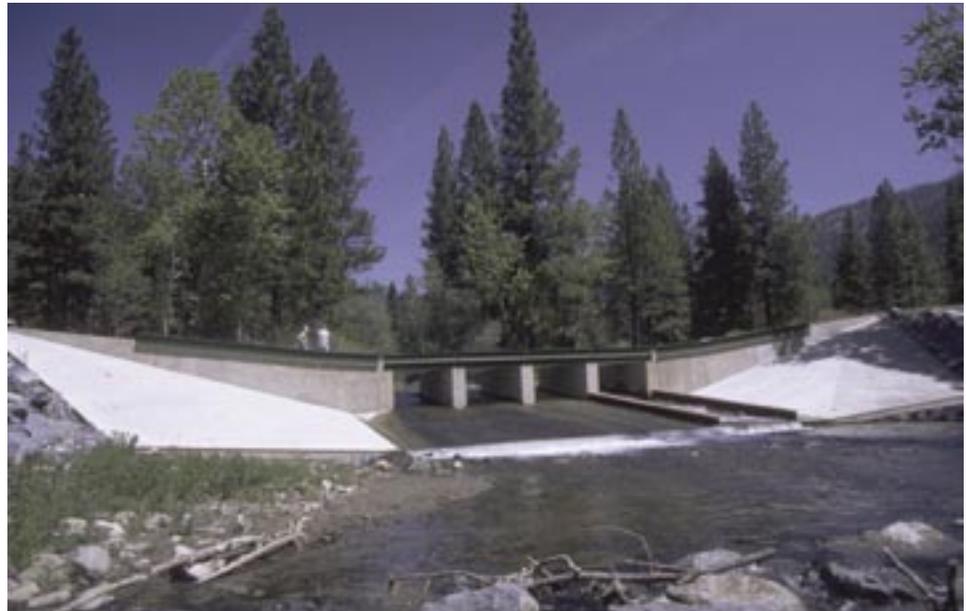
Figure A97. Moonlight crossing with fish ladder 2001.

Water flowing over the smooth concrete surface of the apron, drops into a large plunge pool, approximately 50 feet across, which is lined with large stone riprap.

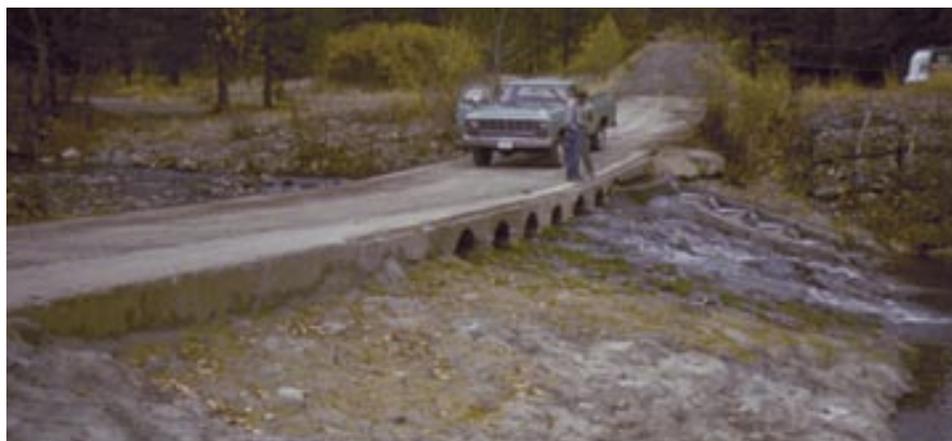
The previous, possibly original structure was a lightly constructed concrete slab over seven 24-inch culverts. The culverts exited onto a grouted rock apron that sloped down to the much lower streambed. During the major 1986 storm event part of the downstream apron was undermined and new large boulders and concrete grout (figure A98) were placed at that time. Also a small fish ladder was built on the east side of the structure below one culvert pipe. This structure again washed out in 1997, undermining the concrete slab (figure A99). Most likely the downstream depth of riprap was inadequate and the toe of the apron was undermined by scour, leading to progressive failure of the entire apron (figure A100). Also during the low-flow years the pipes tended to plug up because of their small size and the high sediment load in Lights Creek.

Figure A98. Moonlight Crossing prior to the 1997 flood. Note the weakly grouted small riprap armoring the downstream apron. There was no cutoff wall.

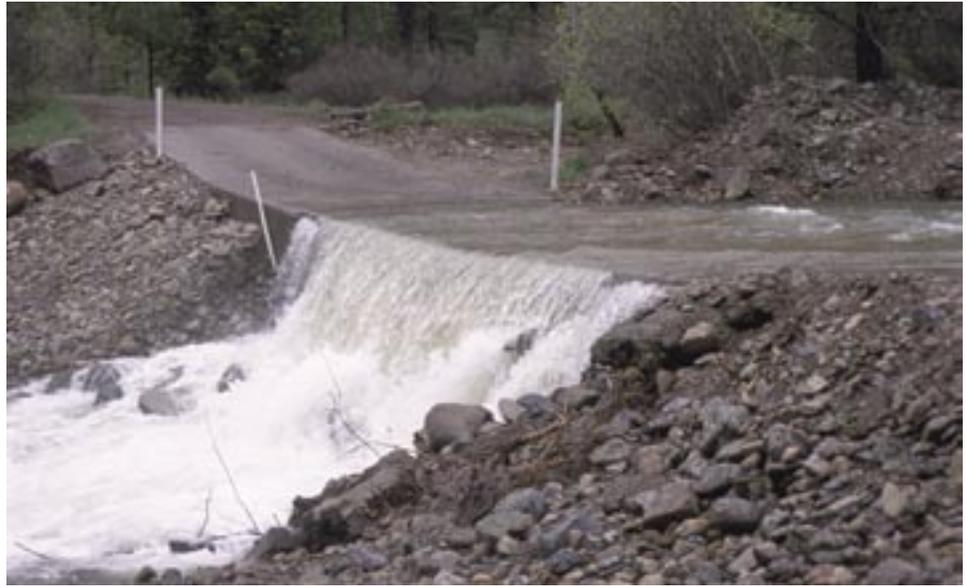
Figure A99. Damage to the Moonlight low-water crossing after the 1997 flood. The downstream rock armoring was undermined and washed away, partially undermining the concrete slab driving surface.

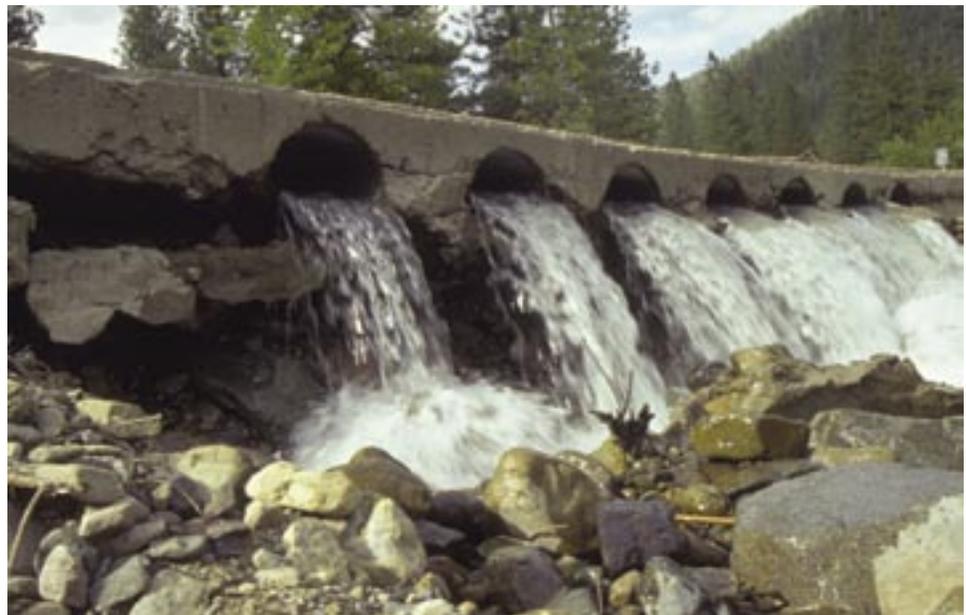
Figure A100. Moonlight crossing in 1999 prior to construction of new structure.

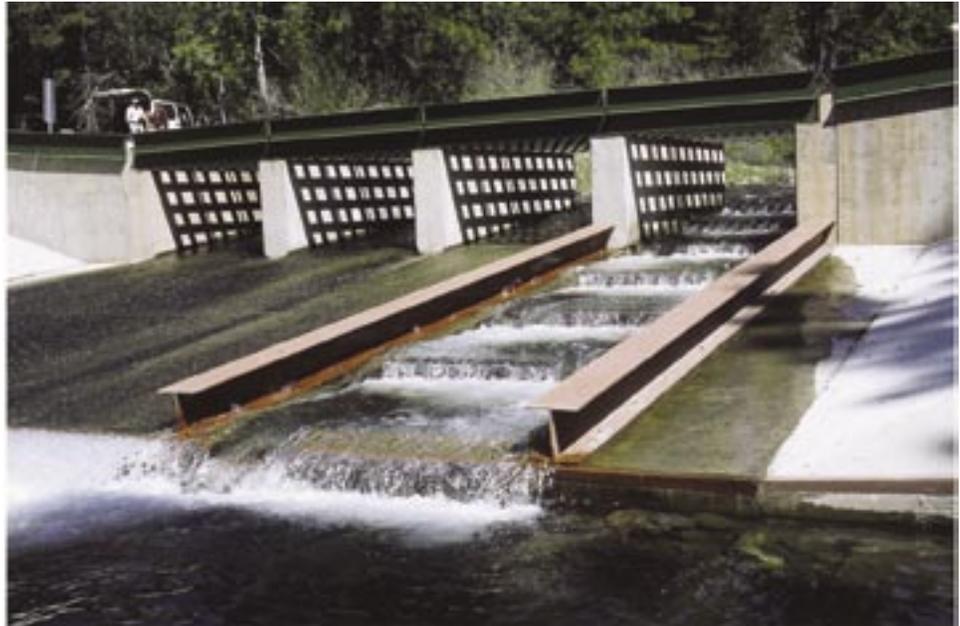
Figure A102. Detail of the fish ladder built into the Moonlight Crossing.

The project took approximately 5 months to construct and required a total of 150 cubic yards of concrete. Because of the complexity of the site there was a 1-foot error in the elevations at the bottom of the structure, such that the downstream lip of the apron is 1-foot higher than designed. This causes a 6-inch drop to the downstream pool level. If this pool level drops, it may be a problem for access to the fish ladder and may require additional downstream work.

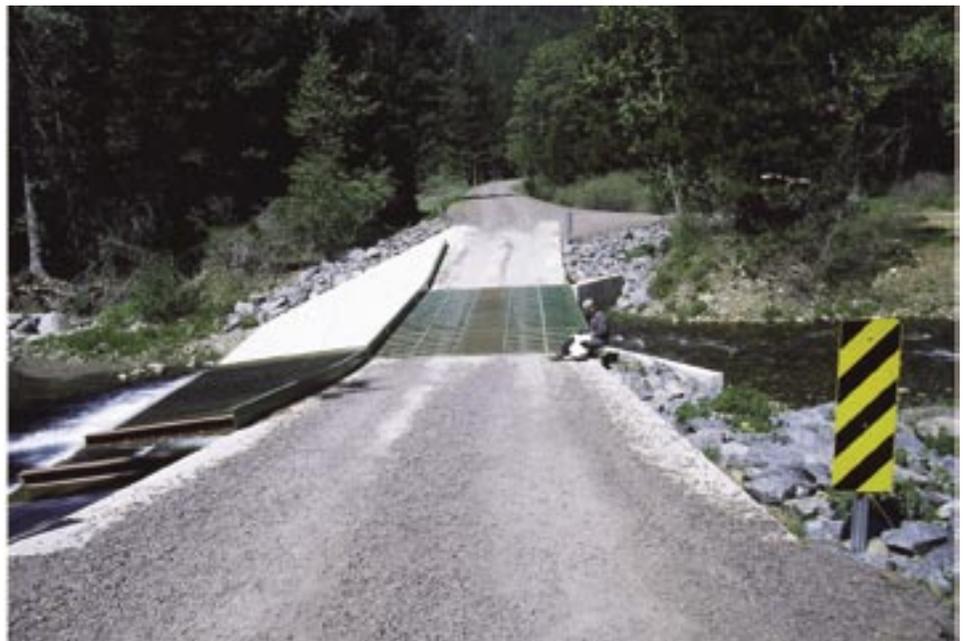
Figure A103. Roadway across the Moonlight ford.

Safety: The structure has a low (8-inch high) steel curb along both sides of the road, with a low enough profile to prevent major accumulation of debris. The crossing is marked with object markers at each approach, and it is located on a tangent section of road, so safety appears adequate for its use. There are no safety warning signs or depth markers. The metal grating is reported to be “slippery when wet.”

More communication and a more careful review of the design during construction might have prevented the 1-foot elevation error. Approaches leading to the structure should be paved as the gravel roadway surface constantly ravel onto the concrete approach slabs.

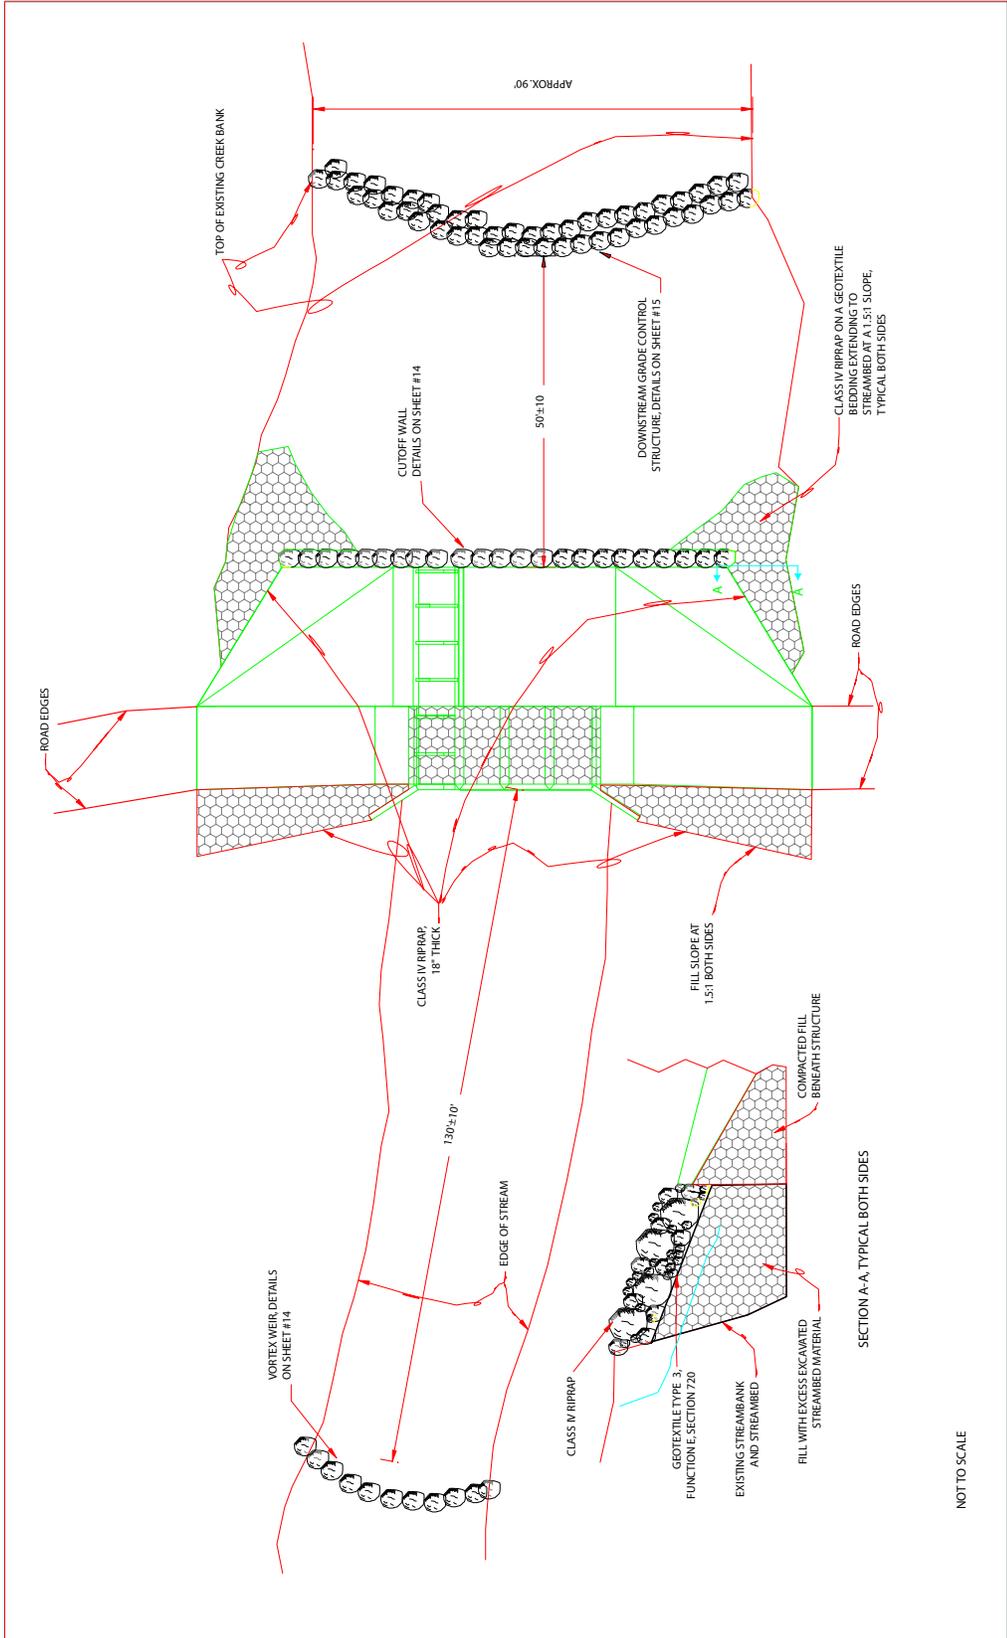
Figure A104c—Contract drawings; (c) rock placement. A full size drawing may be found on the CD included in the back of this publication.

Bank and bed stabilization, and approaches: The immediate approaches are concrete and slope steeply into the drainage at 14 percent (figure A104a). Considerable Class VIII and Class XII riprap (4-foot-plus-diameter boulders) was placed along the approaches, along the downstream 6-foot-deep cutoff wall at the downstream edge of the concrete spillway, and at the downstream edge of the plunge pool to form a grade control structure (figure A104c).
