**Case Study 18. French Creek Embedded Concrete Box Vented Ford****Location**

North central California, Plumas National Forest, on French Creek. Three miles northwest of Brush Creek and 15 miles northeast of Oroville, CA. Forest Road 22N34.

**Crossing Description**

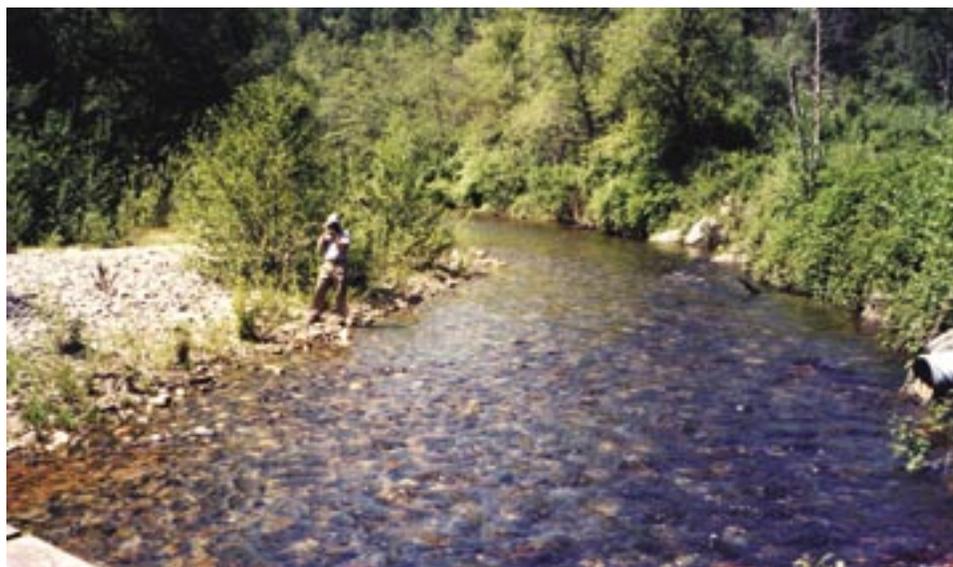
**Channel Description:** French Creek is an unentrenched C4 channel; bankfull width and depth are about 55 feet and 2 feet respectively (figure A115). The substrate is a well-graded mixture of sands, gravels, and cobbles, and there is considerable bed movement during storms. Channel slope is less than 1 percent. The crossing is located on a broad bend, and the ford crosses French Creek from a low terrace on the east side across a point bar-flood plain sequence on the west side. Heavy riparian vegetation, including willow, alder, and blackberry vines stabilizes the high outside bank. The five boxes match the stream bed width so that low flows pass the structure freely. However, to keep vehicles out of the water during normal high flows and maintain a level driving surface across the point bar, the slab is raised 2 to 3 feet above the point bar. This induces some scour immediately downstream of the structure as water pours over the raised slab.

Figure A115. Looking upstream from the ford at French Creek.

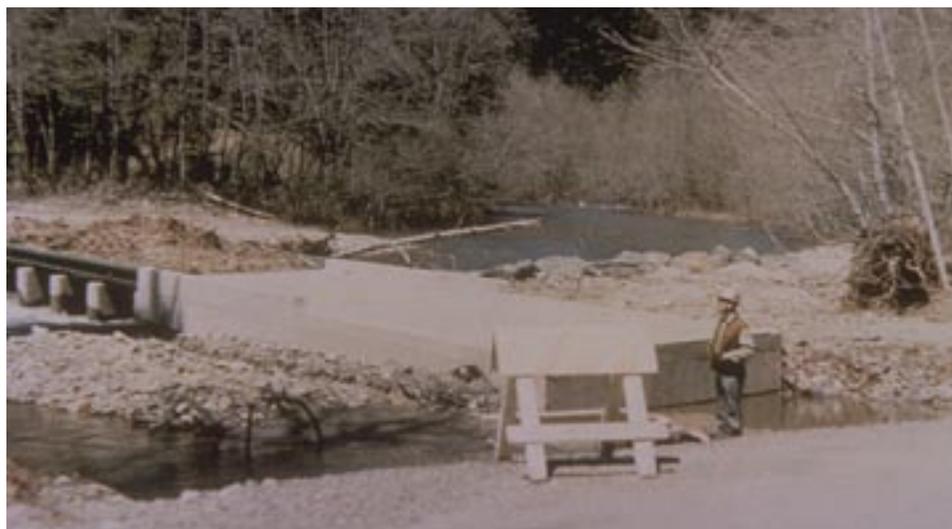
The vented ford was slightly damaged by scour in 1982, the year after it was constructed, and again during a flood in 1986. In 1986, the structure was overtopped and a scour hole formed in the roadway where the original concrete armoring ended (figure A117). The concrete roadway surface with 3-foot deep cutoff walls was extended 50 feet on the east side, covering the area of scour. Also some energy dissipation measures were added along the downstream edge of the structure where the water flows over the concrete slab roadway. Large articulated concrete blocks were used, as well as some additional large riprap (figure A118b).

Figure A117. Scour around the east end of the structure after the 1986 flood. The concrete driving surface was then extended 50 feet.

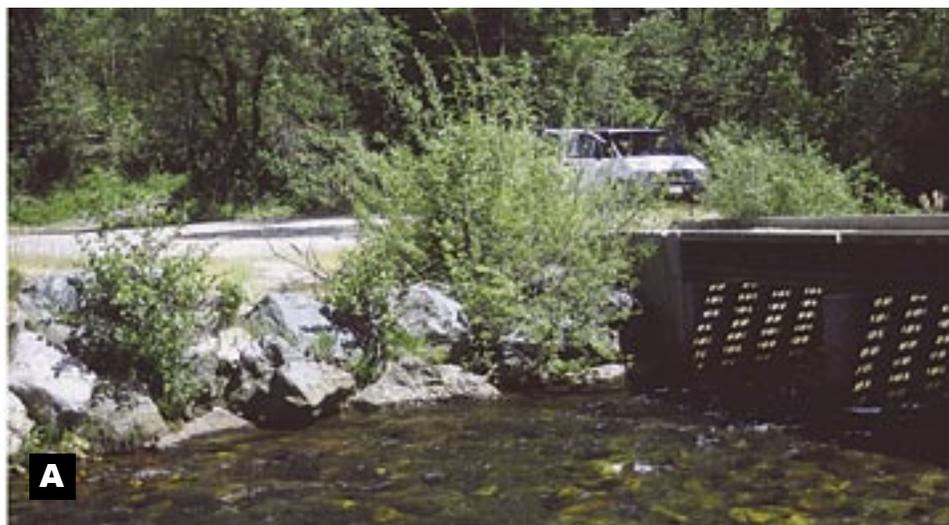
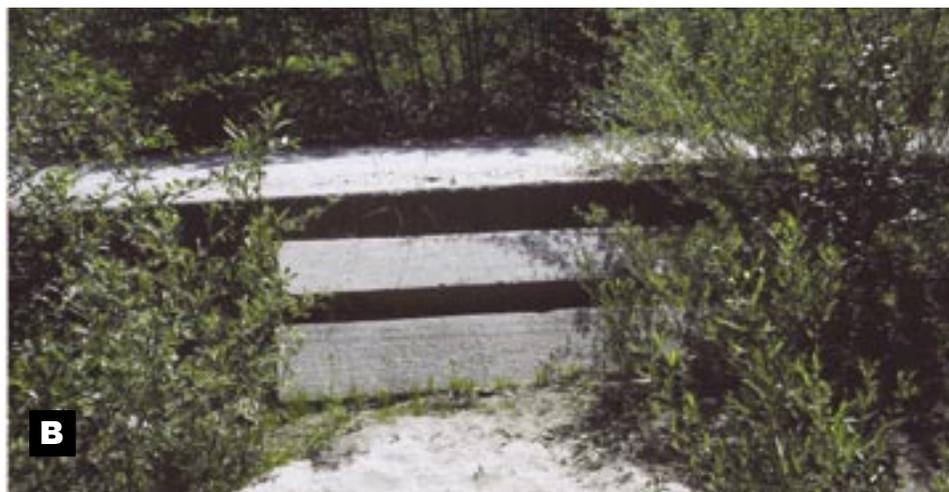
**Bank stabilization and approaches:** The ford slopes gently into the drainage at 5 percent on the west side and is nearly flat to the east across a broad flood plain. The approaches are not surfaced. Bank stabilization includes riprap of large boulders and willows (figure A118a). Both gabions and concrete blocks were placed along the downstream edge of the elevated driving surface across the flood plain areas (figure A118b).

Figures A118a and A118b. Scour protection measures a) using riprap with vegetation along the channel (left) and b) concrete blocks and gabions along the elevated roadway (right).

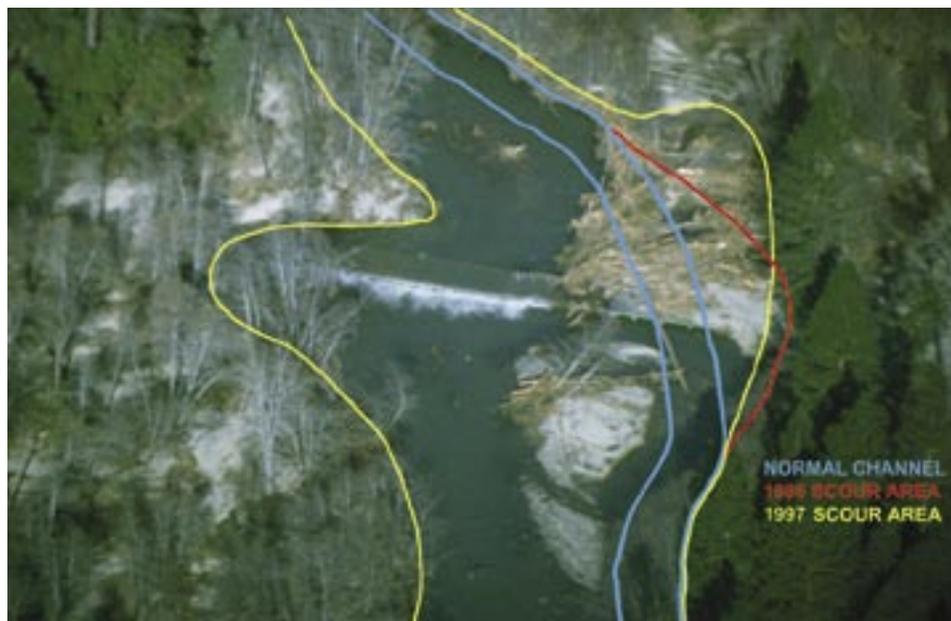
In the 100-year event of 1997 the entire structure was plugged with debris, as seen in figure A119, causing the channel to move to the west side of the structure, in the flood plain area. The original channel was cleared and flow returned to the main channel. The structure itself was not damaged.

Figure A119. Debris dammed the structure during the 1997 flood event. The main thread of flow shifted to the west and is spilling over the elevated roadway. The white sand deposited everywhere except the higher forested ground in the upper left and lower right of the photo shows that almost the entire area was flooded in 1997. The area that was scoured east of the ford in 1986 is also delineated.

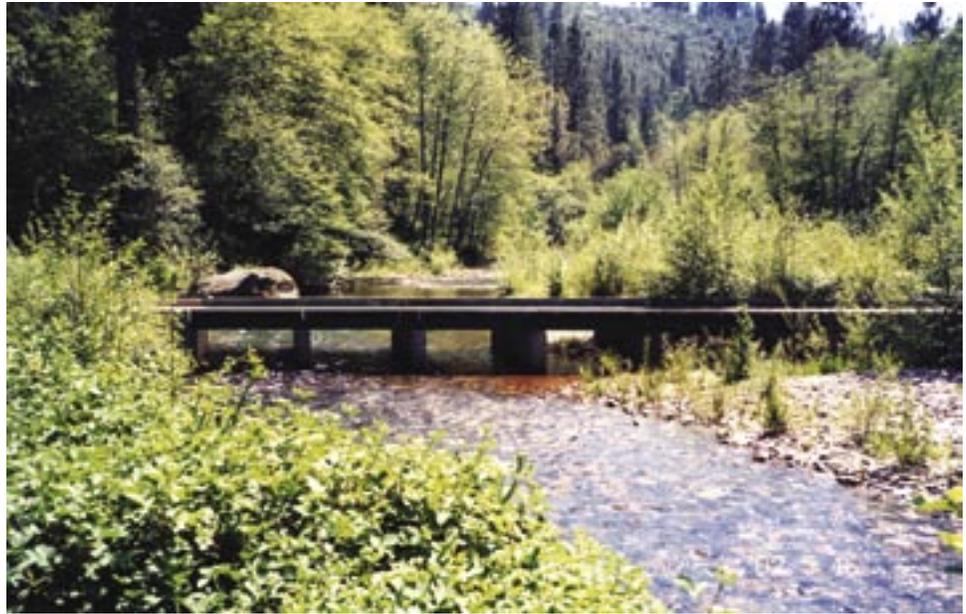
The French Creek crossing is a relatively massive integral concrete box structure with a steel grating driving surface (figure A120). It is designed to withstand major storm flows and major sediment movement, and to resist significant scour. The site is poor because it has a broad flood plain where channel processes can be disrupted by a blockage such as the raised slab. In addition, the stream can shift its location during floods when the structure plugs with debris. A narrower, more entrenched channel location would have been a better site for a crossing. A few hundred feet above the crossing site is a straight and more confined reach of French Creek. Both banks at that location are 8-foot high, and there is no flood plain. A bridge at this site would have had less site problems, but would have been a much more expensive structure. Also other site constraints prevented relocating the road.

Figure A120. Looking downstream at the vented ford with point bar on right.

longer to protect the entire wetted perimeter, and the boxes should have been set slightly deeper to ensure full coverage of the box floors with natural streambed material. However, the floors are already approximately 90-percent covered and subsequent repairs have added the necessary downstream scour protection. Also the roadway elevation should have been set a couple feet lower across the flood plain to prevent the water drop over the roadway and subsequent scour in this area.
