Case Study 19. Mill Creek Embedded Box Culvert Vented Ford**Location**

Southeast Missouri. Mark Twain National Forest; Houston-Rolla Ranger District. Southeast of Rolla, south of Interstate 44, off of State Road P: Forest Road 1576. Mill Creek, tributary of Little Piney Cr, Gasconade River basin.

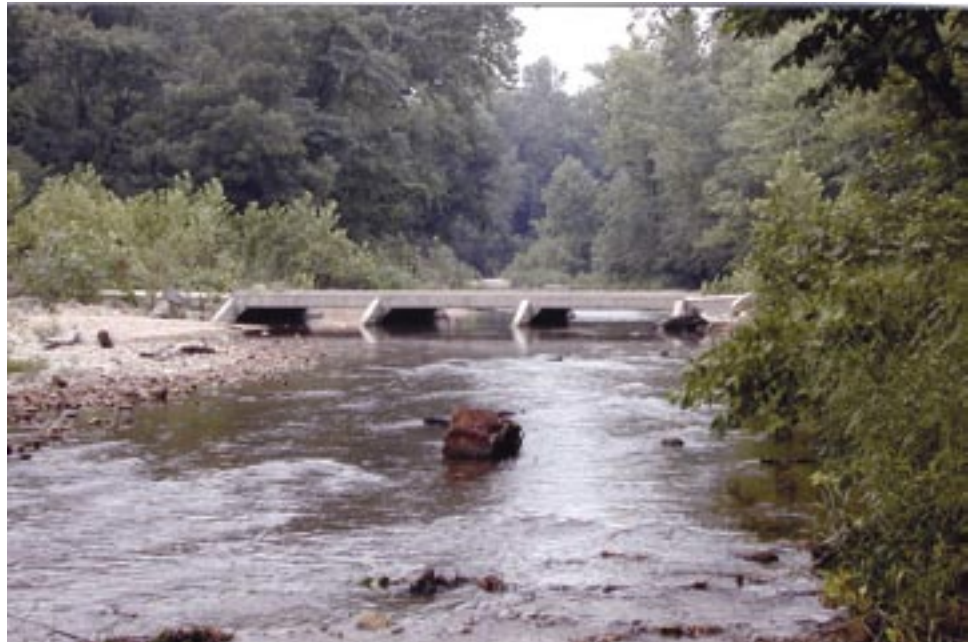
Figure A121. Looking upstream at Mill Creek box culvert vented ford, 2002.

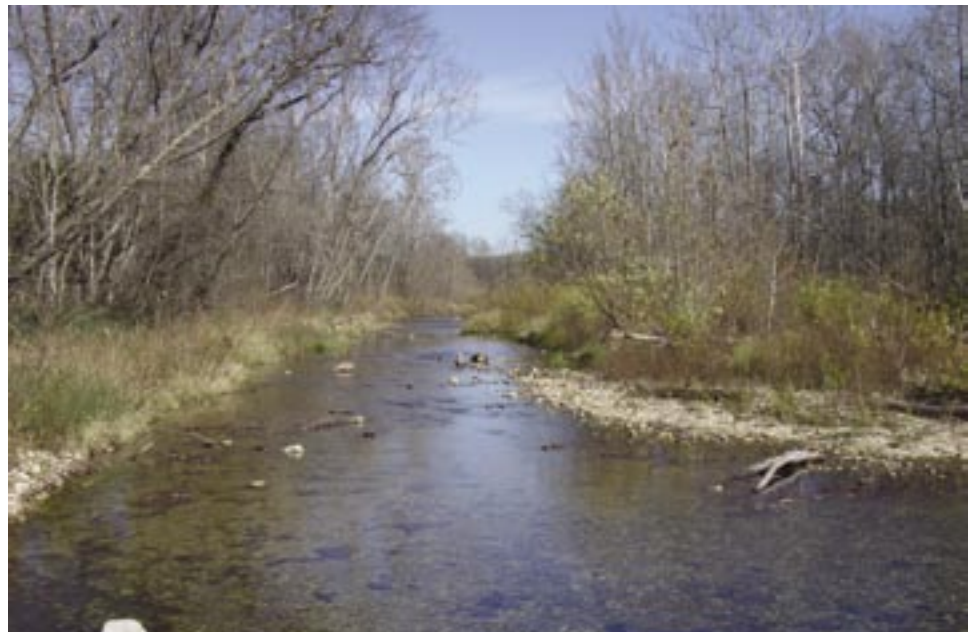
Figure A123. Looking downstream on Mill Creek from the box culvert ford.

Channel Description: This reach of Mill Creek is a pool/riffle, gravel bed stream with an estimated gradient of 2 percent. It is about 40 feet wide away from the widened section at the crossing, and banks are 2 to 3 feet high (figure A123). The well-vegetated flood plain is about 3 feet below the wooded terrace that forms the broader valley floor. The channel appears to be vertically stable, but has at least moderate potential to migrate laterally. The crossing is on a slight bend, and crosses a gravel bar on the right bank (bar is on left side of figure A121). Historical land use in this area of the Ozarks, especially riparian grazing and stream channelization, affected streams by removing riparian vegetation and inducing bank erosion. This mobilized large volumes of gravel, and streams responded by widening and shallowing (Jacobson and Primm, 1997). Bank erosion is prevalent on some reaches of Mill Creek.

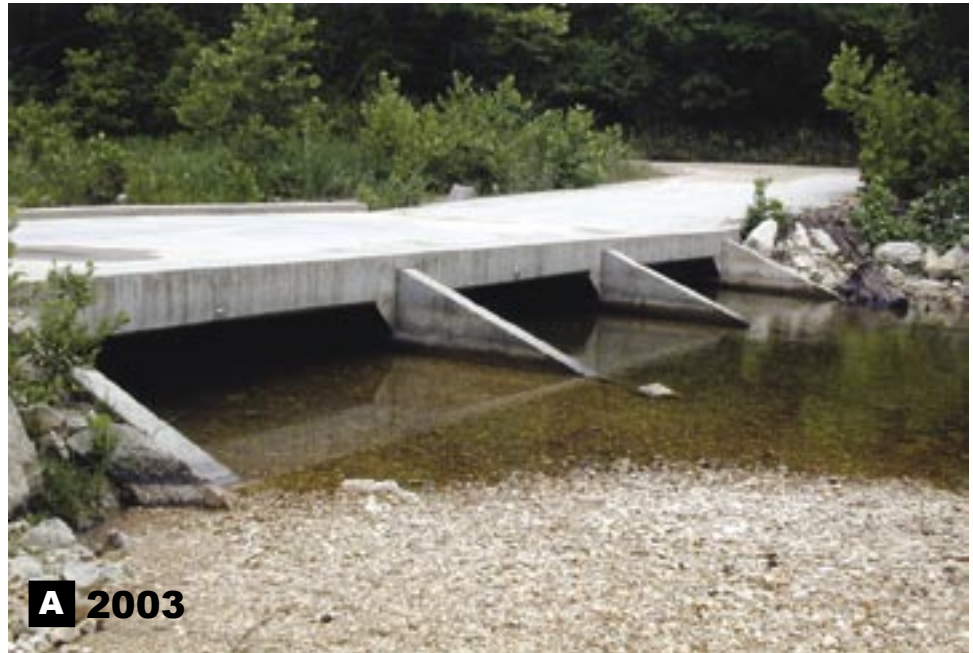
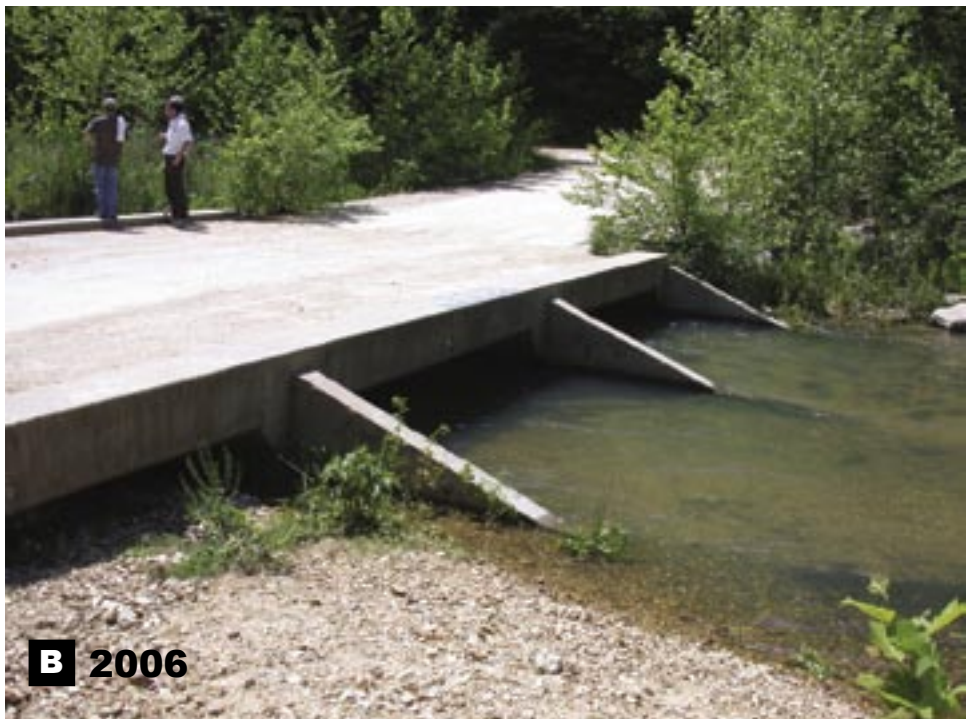
Structure: This current structure has three boxes, with sloping wings designed to sweep debris up and over the deck. Open area under the deck approaches bankfull cross section area, but is being reduced by gravel accumulation on the right bank (foreground, figure A124). The interior openings of the boxes are 14 feet wide and 5 feet high, and they are embedded 1 foot into the streambed so that the natural streambed is continuous throughout. The design is a standard Missouri Department of Transportation design that is available on the Internet. See Concrete Triple Box Structure drawing 703.81F for sample plans (http://www.modot.org/business/standards_and_specs/currentsec700.htm).

because gravel loading is so high in the stream. Some riprap is used to stabilize the banks immediately adjacent to the structure (figure A124a).

Figures A124a and A124b. Downstream side of the box culvert crossing. Between 2003 and 2006, gravel bar enlarged to block one box.

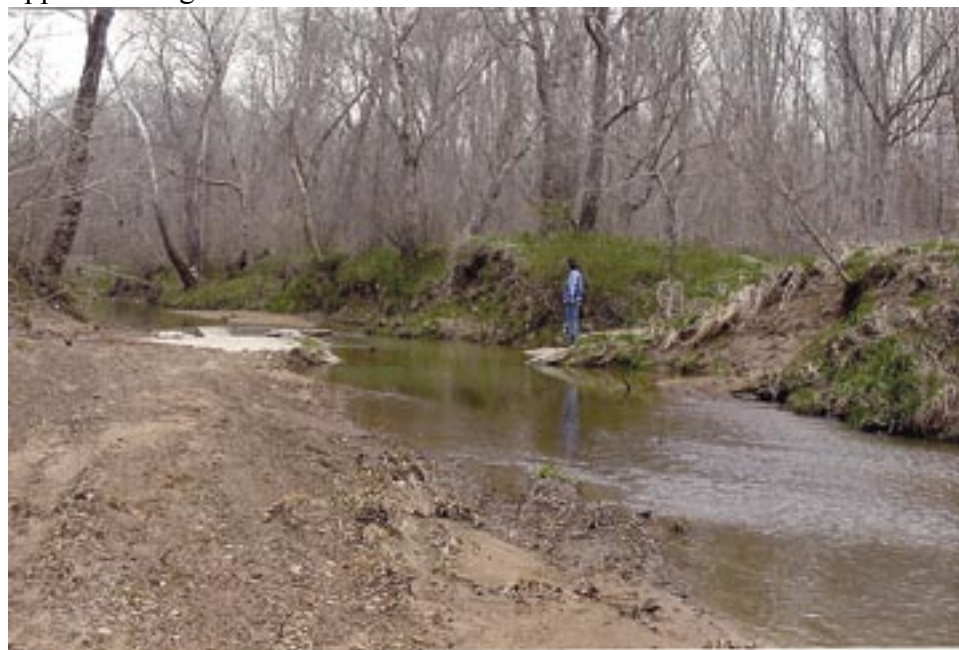
The previous crossing structure was a concrete slab ford (figure A125). Silty sediment and woody debris routinely accumulated on it during high water, frequently making it impassable. The slab collapsed when the stream undercut it on one side. The soil at the site has difficult engineering properties. It is a poorly-drained silt loam characterized by a seasonally high water table, frequent winter flooding, and stream bank erosion. Severe erosion of the 4-foot to 5-foot high banks around the ford is apparent in figure A125.

Figure A125. Looking upstream at failed Kinkaid Creek crossing, 2000. Stream slope is 0.3 percent.

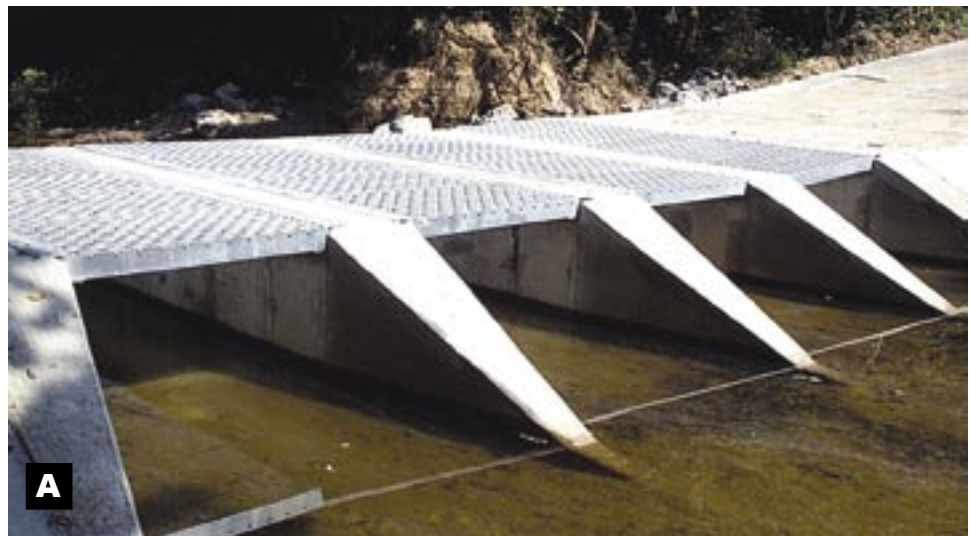
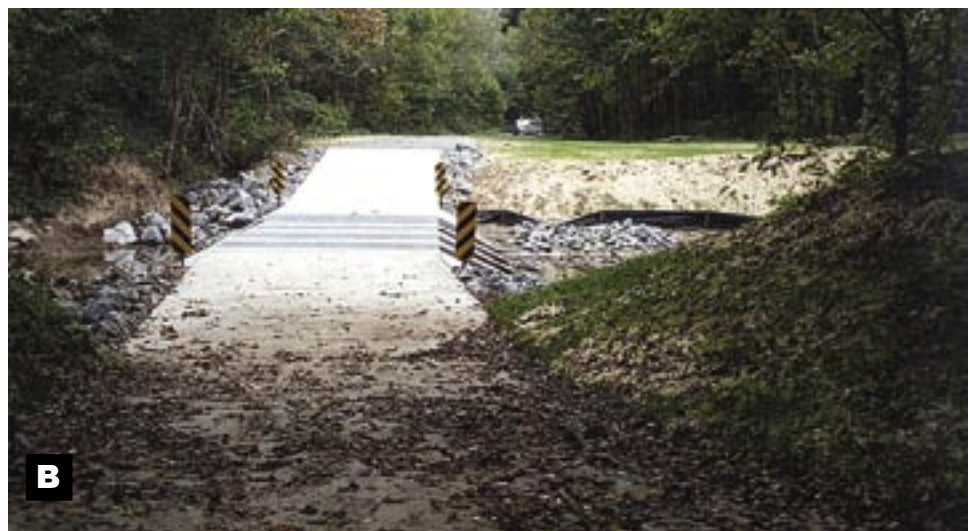
Figures A126a and A126b. Kinkaid crossing just after construction in 2001. A126a. Close up of embedded boxes; A126b. View along vented ford showing riprap.

The 3-foot-high boxes are embedded about 1 foot into the streambed for fish passage (figure A126a). The boxes were allowed to fill naturally with streambed material, and in this case the streambed was mobile enough (medium to coarse gravel) and the sediment supply high enough that no headcut resulted. The streambed in the boxes has maintained itself successfully through two approximately normal rainfall years.

The new structure was designed to pass the mean annual flow underneath the deck at a depth of 6 to 8 inches, and it is submerged at frequent high flows (3 to 4 times per year). Approach slopes are steep at 10 to 12 percent but at a site where the natural banks are nearly vertical, the structure had to be somewhat wider than the channel. Riprap provides erosion protection upstream and downstream of the cutoff walls (figure A126b). The structure cost \$23,000 to install in 2003.
