Case Study 20. Deep Creek Low-Water Bridge

North Central Florida. Osceola National Forest. Road 237-1 at Deep Creek, 1/4 mile north of Forest Road 262-2 and about 11 miles NE of Lake City, Florida.

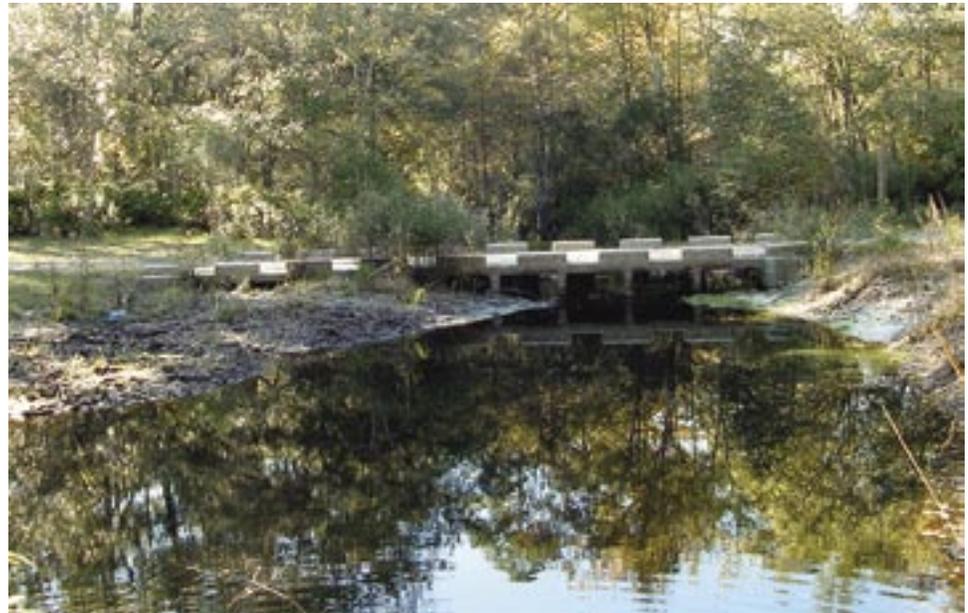
This low-water bridge was constructed in 1991 (figure A128). It is built of preformed concrete T-sections set parallel to the direction of streamflow. The T-sections are supported by two concrete mud sills placed on the sand and clay streambed. The channel and surrounding area are quite flat and the flood plain is several hundred feet wide. The bridge approximates the channel dimensions, and it does not alter flow velocities and sediment transport enough to cause significant channel changes. When water overtops the bridge, there is virtually no plunging flow (the site is backwatered) and velocities remain moderate. Periods of submergence typically last for 1 to 2 weeks.

Figure A128. Looking downstream at the low-water bridge, November 2003.

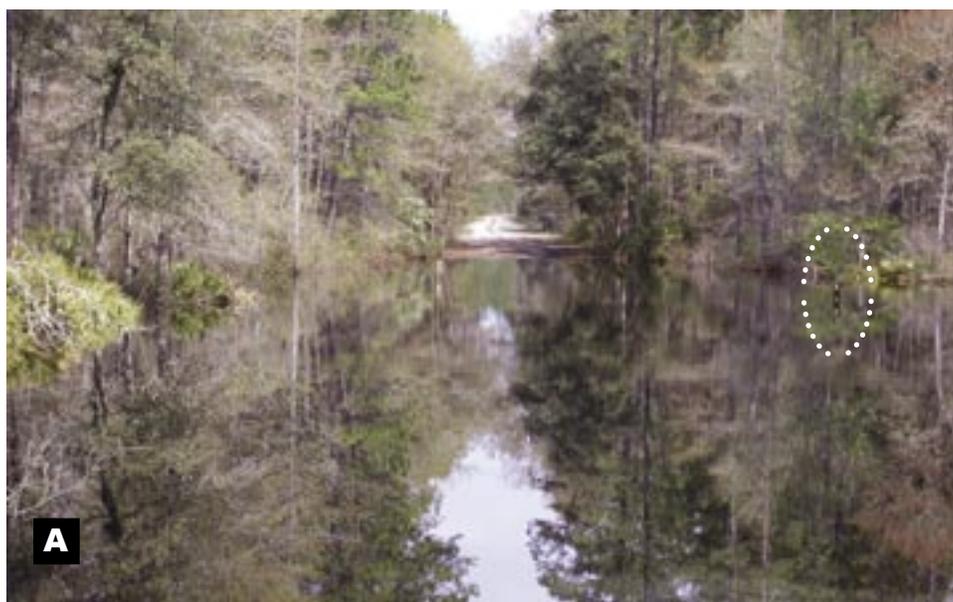
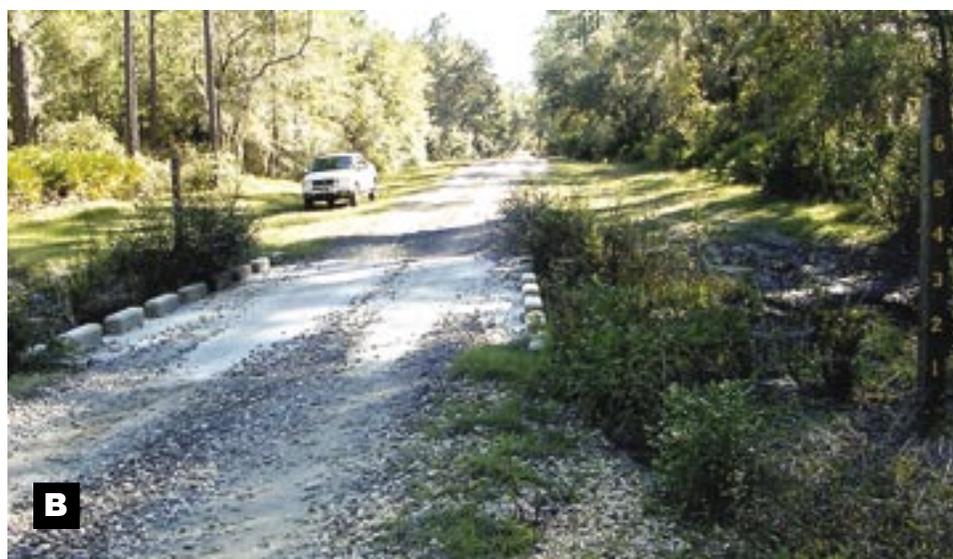
to utilize the entire width of the flood plain and to flow freely down the valley. The stream is about 10 feet wide where it flows through undisturbed forest, with nearly vertical 2-foot-high banks stabilized by an intertwined mass of roots. At the crossing site, the stream is about 40 feet wide, and the bridge matches this width. Soils in the area, including the streambed and banks, are mixed sand and clay. Because of long periods of very low surface flows, vegetation overgrows much of the streambed and tends to stabilize sediment deposits. During overbank flow in March 2003, water velocity in the thread of fastest flow was estimated at between 1 and 2 feet per second (figure A129).

Figures A129a and A129b. A129a. March 13, 2003. Bridge is under approximately 6 feet of water. Note depth marker on right. A129b. Looking opposite direction along bridge, November 2003.

Safety: On each edge of the bridge large, bright-yellow numbers painted on 7-foot-high wood posts indicate water depth over the structure (figure A129). Flooding and fords are both common in the very low relief Flatwoods area, and residents are used to submerged roads, so no other warning signs are considered necessary here. Discontinuous curbs also provide security.

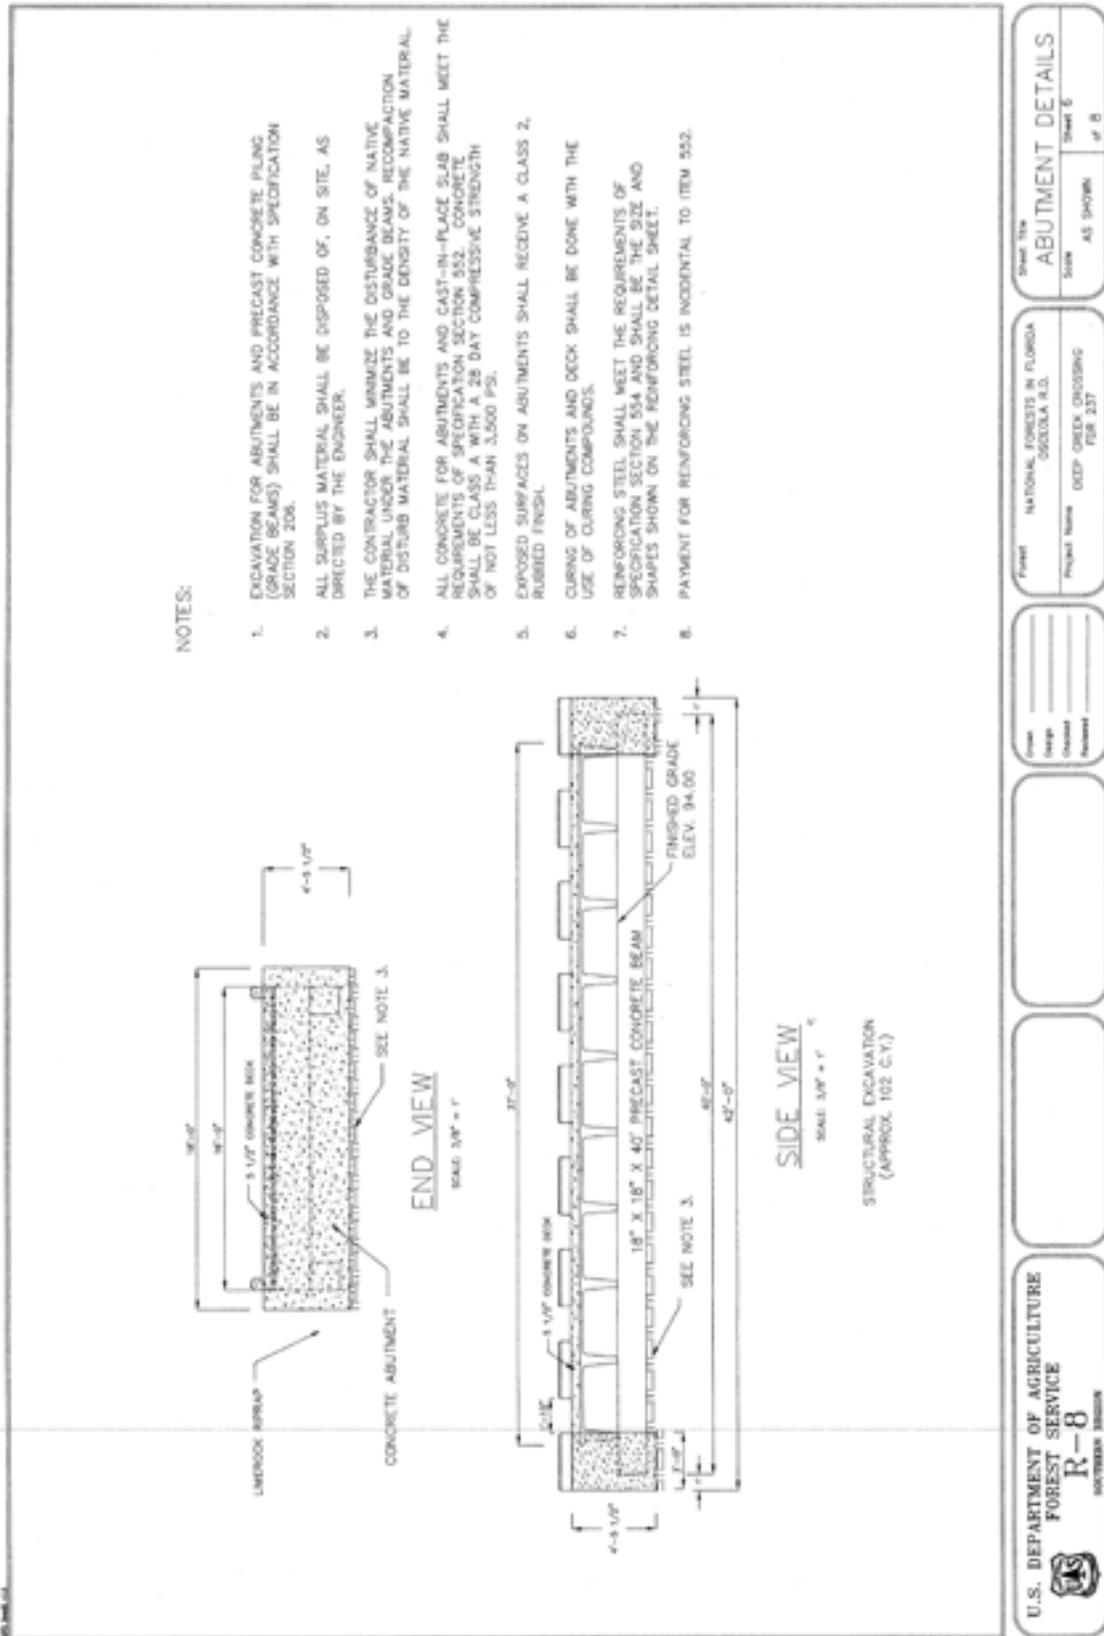
Figure A130a—1990 contract drawing, side view. A full size drawing may be found on the CD included in the back of this publication.

Structure: Two 18- by 18- by 40-inch prestressed concrete beams were set across the channel with the top of the beam at channel bed elevation (figure A130a). Eight-foot wide by 2-foot high by 18-foot long double-T sections, precast to HS 20-44 bridge specifications, were placed parallel to streamflow on the concrete beams. Normally in this kind of construction, the foundations are placed on the streambanks supporting the T-sections which span the channel. Here, the supports cross the channel and the T-sections are parallel to the direction of flow. Three-foot deep by 4½-foot high abutments on each end hold the structure in place. A concrete deck 5½-inches thick, and curbs create a safe running surface on the T-sections.

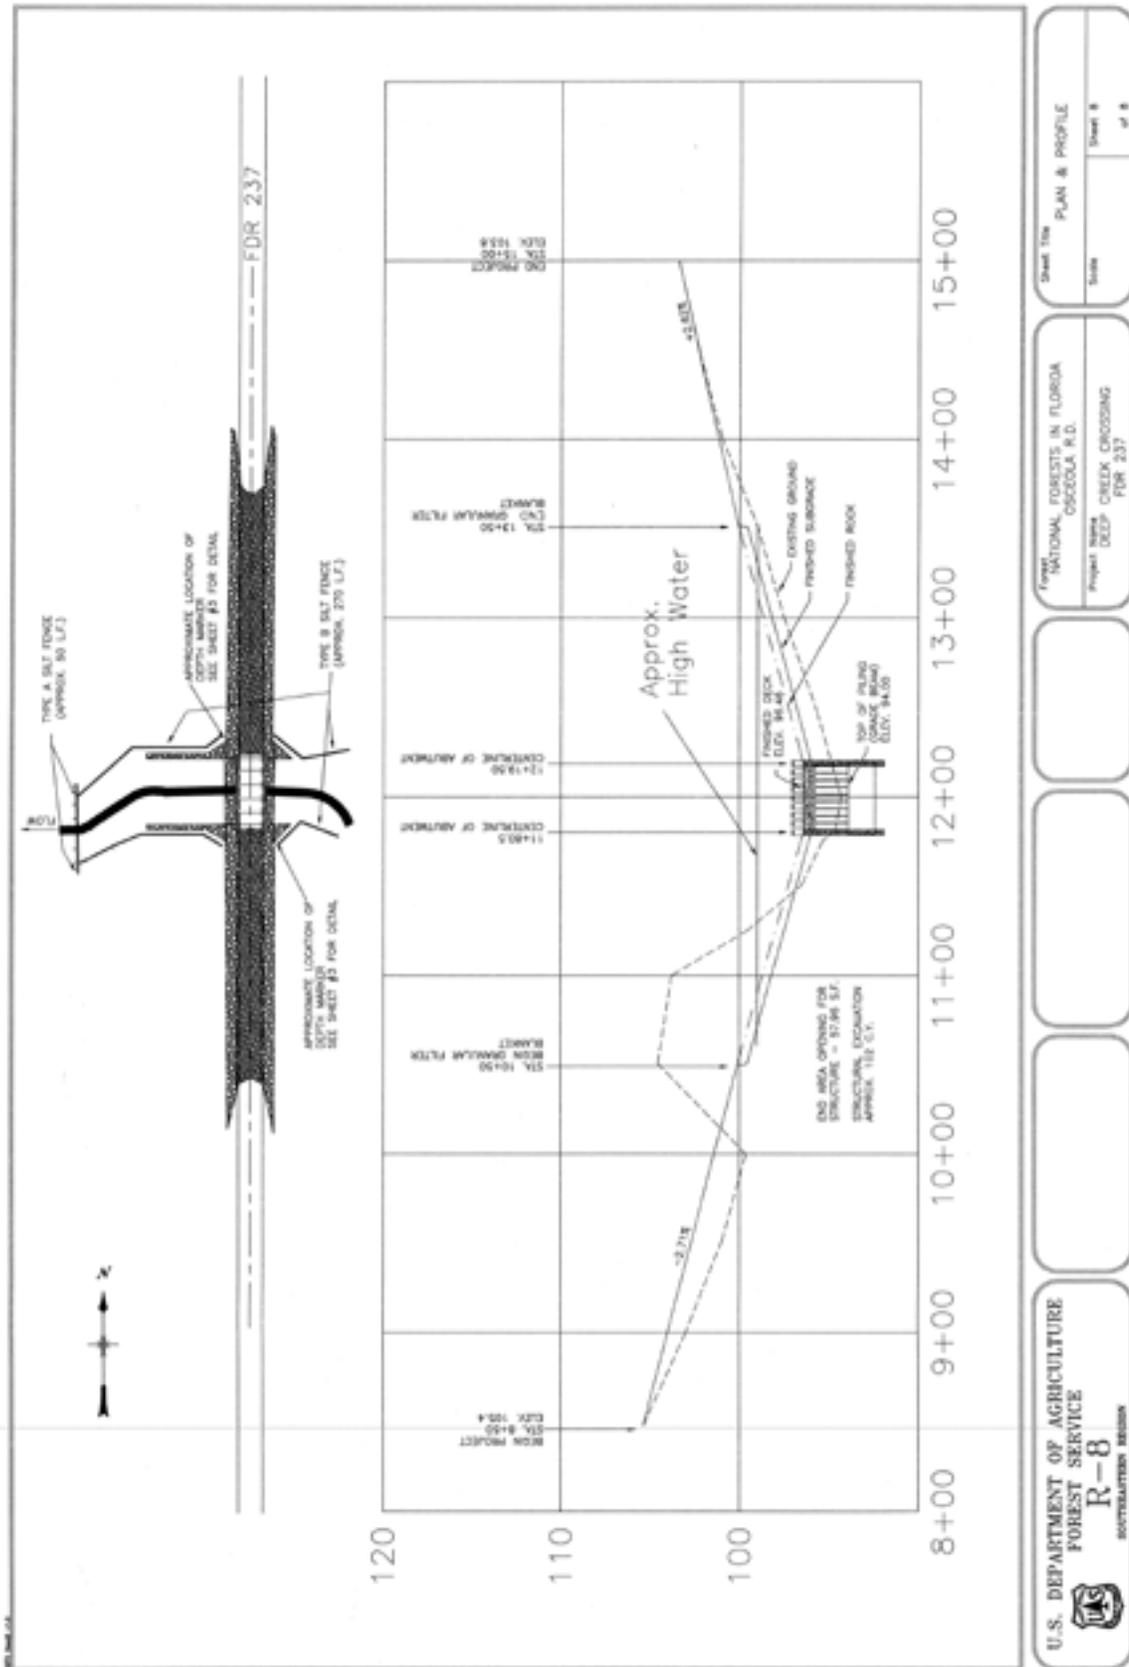
Figure A130b—1990 contract drawing, plan and profile. A full size drawing may be found on the CD included in the back of this publication.

Bank stabilization and approaches: The approach road is crowned and slopes at about 2.6 percent into the crossing (figure A130b). A 1-foot thick layer of class II riprap over geotextile fabric extends 130 feet on each side, armoring the excavated slopes, road shoulders, and downstream banks from erosion. A riprap blanket 1½-foot thick was also placed between the bearing beams, as well as 4 feet upstream and 6 feet downstream from the foundations (figure A130c).

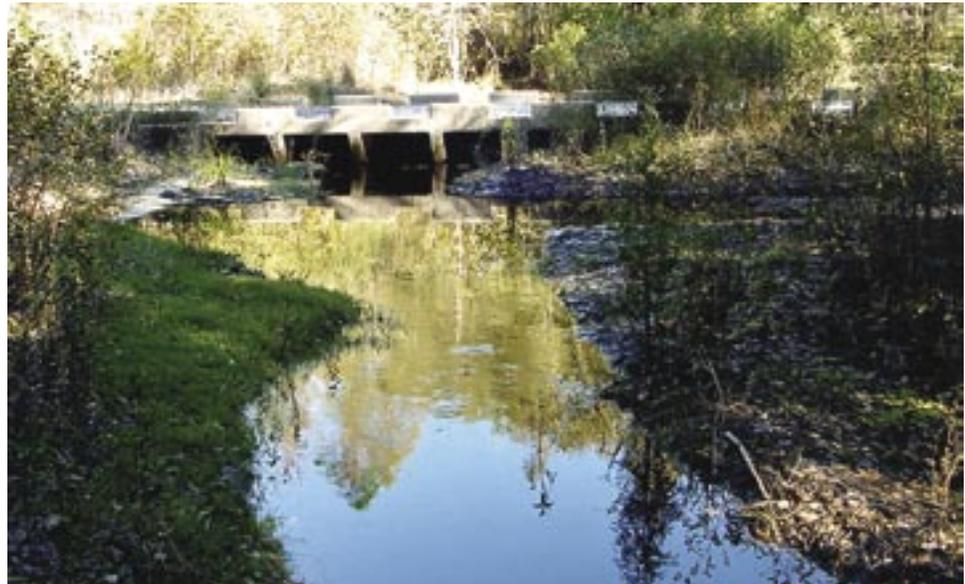
Figure A131. Sand and silt deposit downstream of the bridge (2003).

The current low-water bridge was constructed to match existing site channel dimensions. Site width was significantly wider than the natural channel due to the impacts of the previous bridge and subsequent all-terrain vehicle crossing. Sediment deposition is occurring both upstream and downstream as the stream adjusts to regain its normal width (figures A128 and A131). Given the availability of alternative access, it may be acceptable to allow this process to progress until sediment transport

capacities are equalized with those in the adjacent channel. Channel narrowing can be expected to cause a few more days of traffic interruption per year.
