Case Study 21. Capps Low-Water Bridge

North central California. El Dorado National Forest, Placerville Ranger District. North Fork Cosumnes River. Meiss Cabin Road, Primary Forest Route 52.

This low-water bridge was constructed in 1998 as an Emergency Relief for Federally Owned Roads (ERFO) project (figure A132). It replaced a vented concrete slab ford that plugged and caused substantial channel and flood plain damage during the 1997 flood. Because the old ford blocked sediment transport during high flows, it had caused dramatic channel aggradation and flood plain erosion. To reestablish channel stability at the site, the designers decided to bridge the entire flood plain, and to provide for overflow in case of debris jamming. The bridge has 13 concrete piers set on bedrock and the deck is square steel tubing with two smooth steel plate runways.

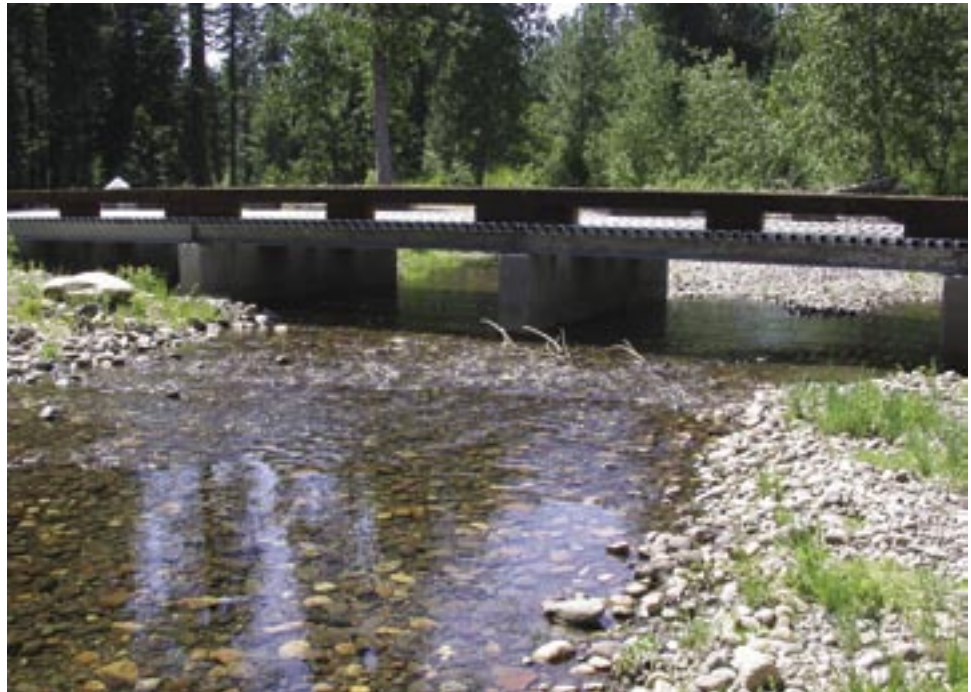
Figure A132. Looking downstream at the Capps low-water bridge. July 2002.

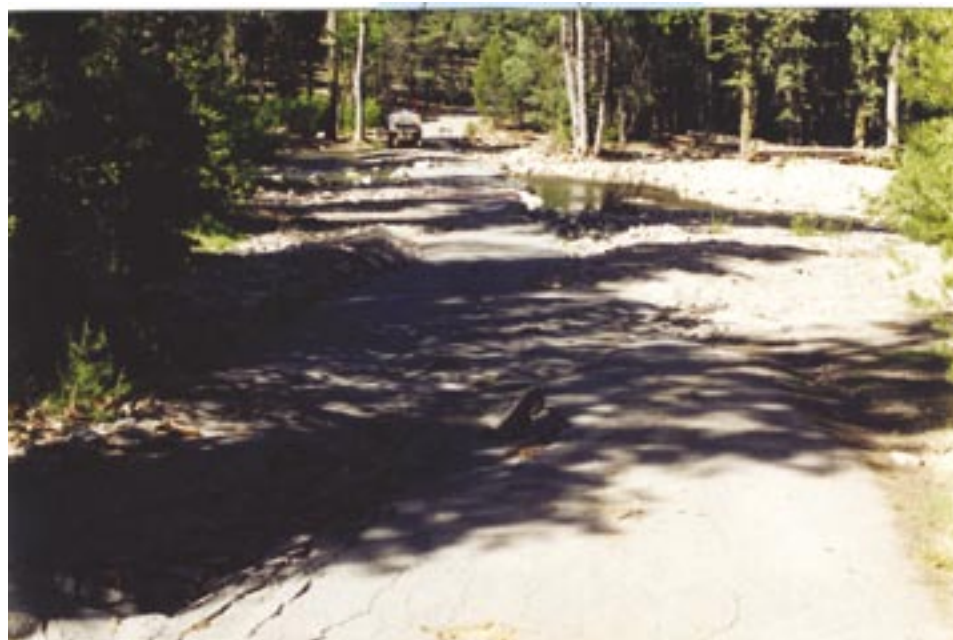
Subsequent ford improvements did not solve the problem. The structure that existed prior to the 1997 flood of record was a concrete slab with an 8-foot-wide concrete box culvert, which filled with bed material and needed annual cleaning even during normal years. During floods, the ford plugged and flow spread over the flood plain, eroding and changing channel location, and washing out the road approaches. To reopen the road after floods, onsite stream-deposited material was routinely heaped up into a turnpike across the eroded flood plain, topped with an aggregate base, and either paved or oiled. This practice, combined with erosion during floods, explains why the flood-plain surface at the crossing site is several feet lower than in adjacent sections upstream and downstream of the site. Because of the widened section, sediment deposition was a serious problem, and the channel became so embedded it seemed to be paved. The vented ford washed out in 1997, during the flood of record (figure A133).

Figure A133. Capps ford after the 1997 flood. Flood flows spread out across the entire valley and road is washed out on far side.

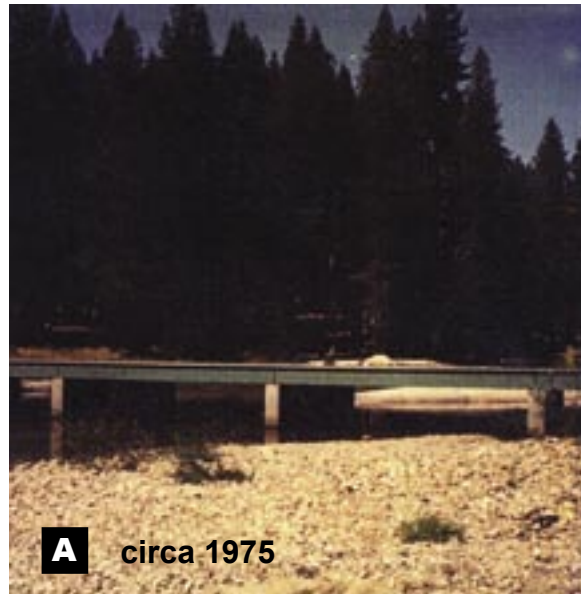
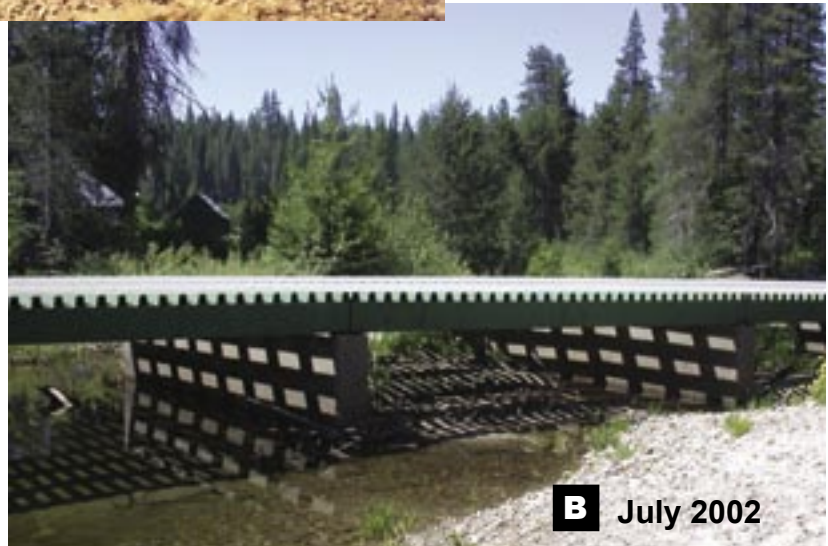
This reach is flatter than Capps, bed material is finer (coarse gravels about 1 to 1½ inch), and the channel appears to be more stable. The bridge is located just upstream of a right-angle bend in the river and crosses the point bar leaving enough space for natural adjustments in sediment storage. Woody debris trapped under the bridge on the point bar side has not been removed, and has contributed to sediment accumulation (figure A137). Both upstream and downstream bars have enlarged since the 1970s (figures A138a, A138b). Nonetheless, comparing current channel conditions to Brink's 1974 description, the channel does not seem to have changed much, indicating that the stream is functioning naturally and is stable. None of the pier footings are exposed.

Figures A138a and A138b. Looking downstream at the Jones Wreckum Bridge. A138a. Bridge inspection photo.
