**Case Study 5. Willow Creek Concrete Plank Ford**

**Crossing Description**

### Flood and Maintenance History

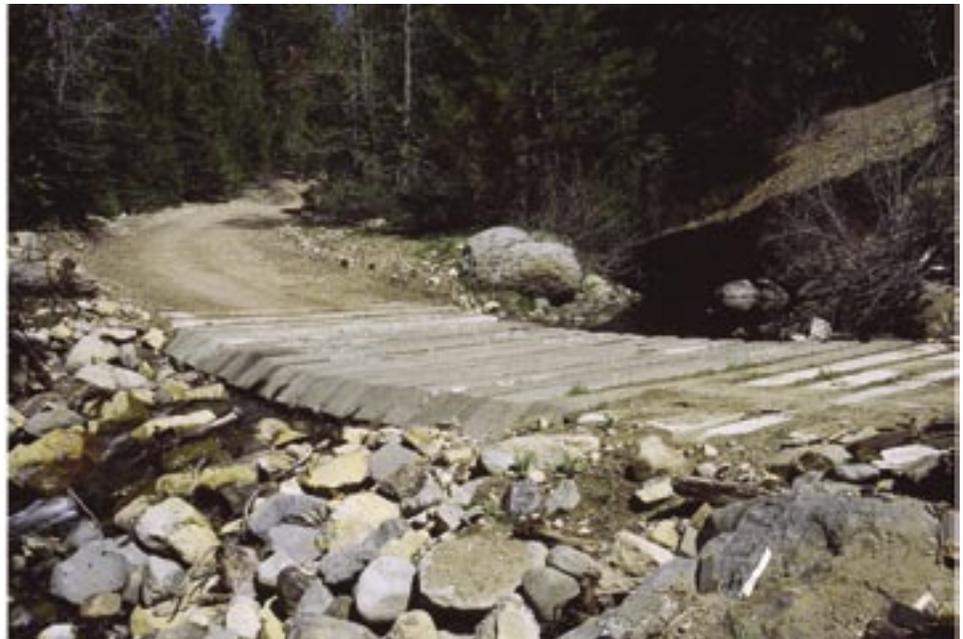
Figure A22. Willow Creek concrete plank ford.

**Bank stabilization and approaches:** Large riprap was added to stabilize the downstream area from the effects of the drop downstream (figure A22). Road approaches dip down into the crossing at 7- to 9-percent slope (see site sketch, figure A25).

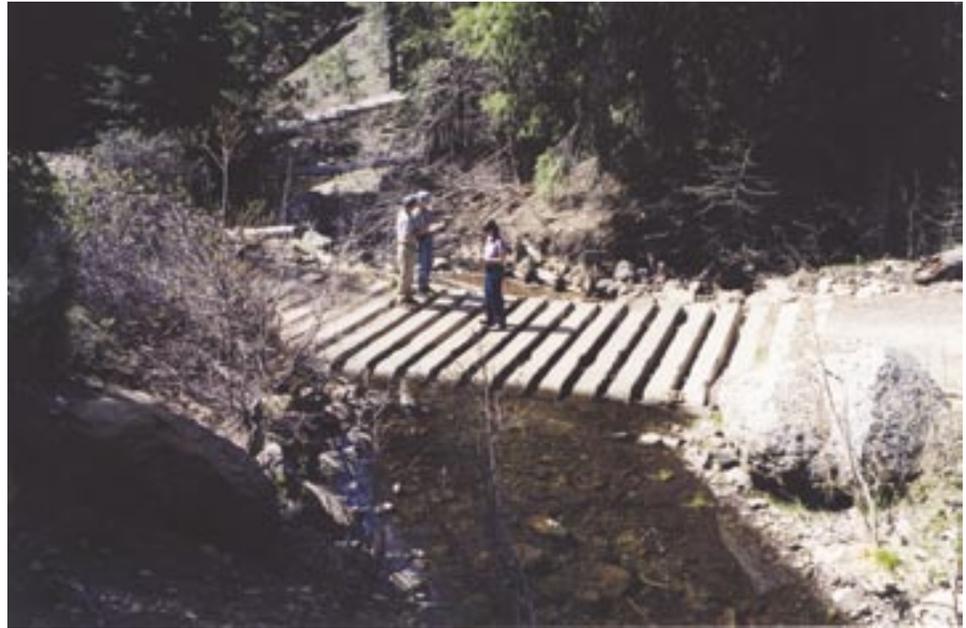
**Channel Description:** Channel slope is about 3 to 5 percent at the crossing. There is a drop in the channel bottom elevation of 3.5 feet just downstream of the crossing. This is partially due to scour, but also to an old wooden diversion structure that failed and caused channel cutting. A tributary also enters the stream immediately downstream of the road-crossing (figure A23—upper right). Sloping streambanks are 1 to 2 feet high and quite stable with boulders and riparian vegetation including willow and fir trees. Bankfull width is approximately 15 feet, with a bankfull depth of 2.5 feet. The substrate is a mixture of cobbles, some gravels, and large boulders.

Figure A23. Looking downstream: ford is just above a tributary junction where an old diversion structure blew out and caused streambed to degrade.

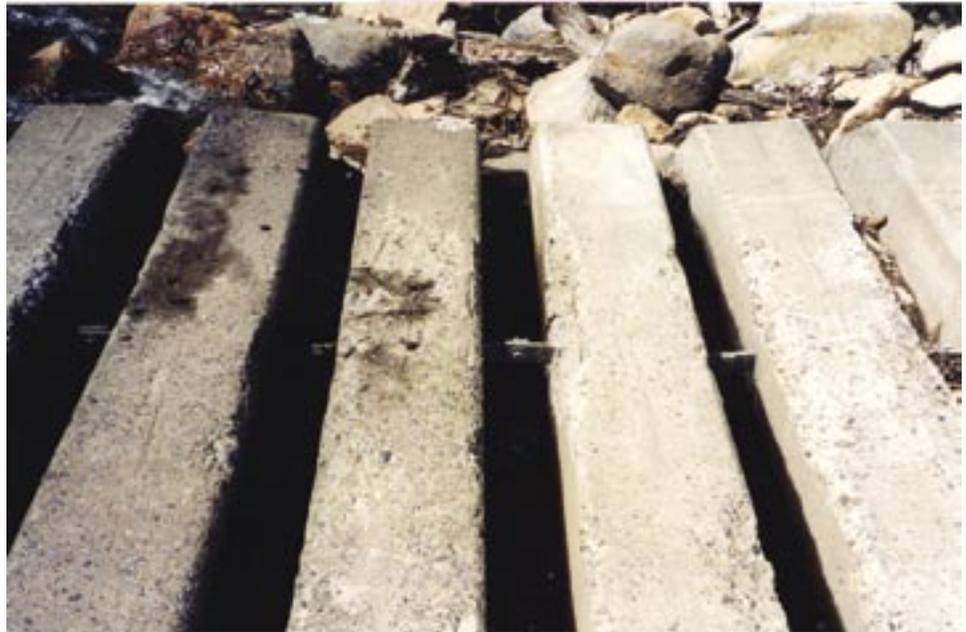
Figure A24. Detail of planks and metal brackets.

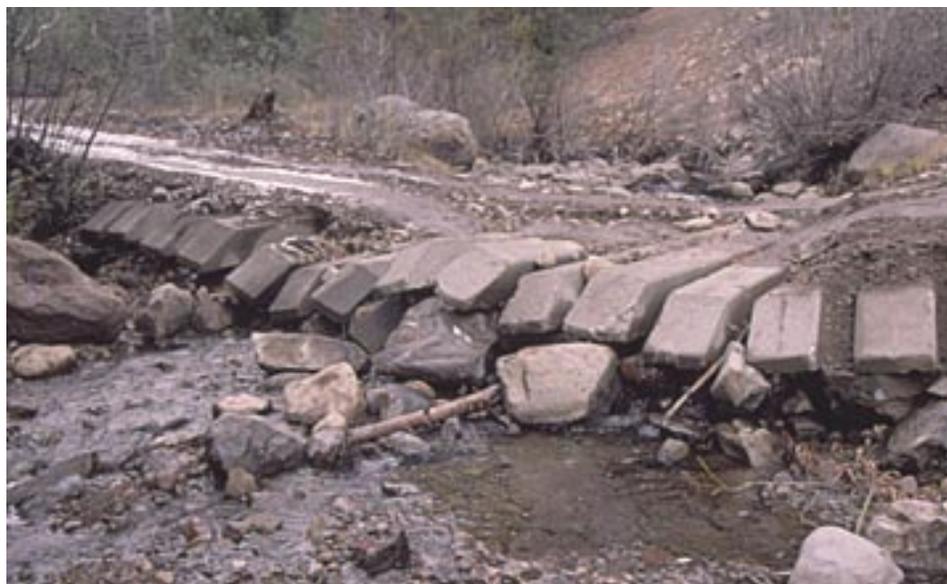
The structure received only minor damage in the large storms of 1986 and 1995. However, during the major 1997 flood (local storm of record), some of the concrete planks were undermined, cracked, and steel was exposed (figure A26). Repairs included replacing some concrete planks, rebedding most of those in the middle of the channel, and adding riprap scour protection at the downstream outlet of the structure.

Figure A26. The crossing was damaged in the 1997 flood by scour of fine bedding materials under the planks. The planks had to be reset into coarser materials and the downstream edge protected with riprap.
