**Case Study 8. Agua Fria River Concrete Slab Ford**

**Location**

**Crossing Description**

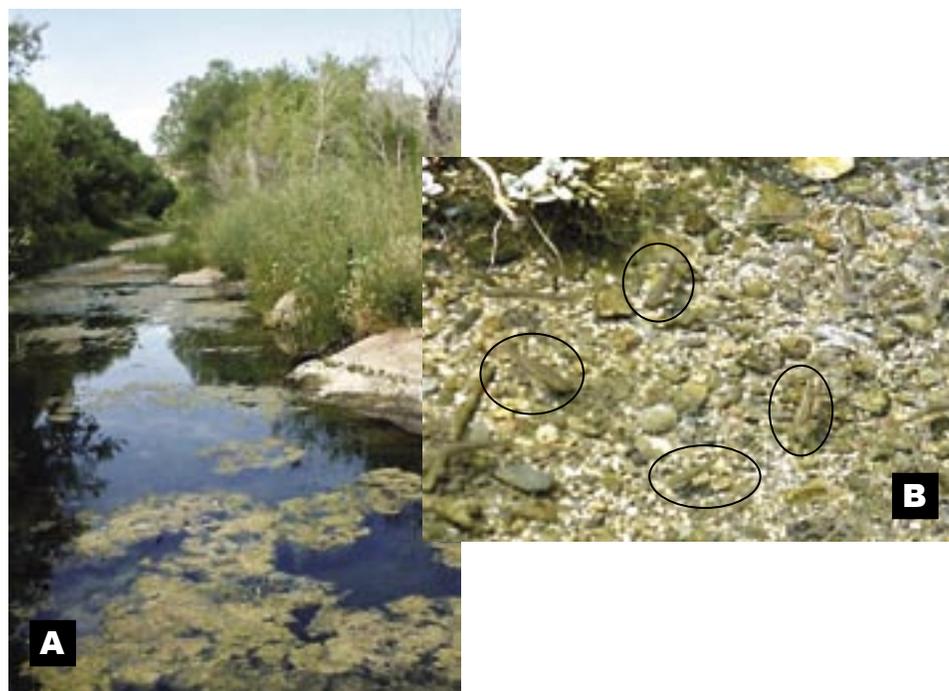
**Aquatic Organisms:** Fish biologists have recently identified fish passage as an issue of concern at this type of site (Calamusso, personal communication). As flow decreases, fish need to be able to follow the water to springs, deep pools, or other refuges. At this site, fish were observed moving downstream over the ford in less than an inch of water after a thunderstorm runoff event in May 2003. Later, in August, they were isolated in pools both upstream and downstream from the ford (figure A43). Needs for passage for other aquatic species in this area are unknown.

Figure A43a and A43b. Agua Fria River A43a. Pool several hundred feet upstream of ford in August 2003. A43b. Fish are in isolated pools both upstream and downstream of the dry ford.

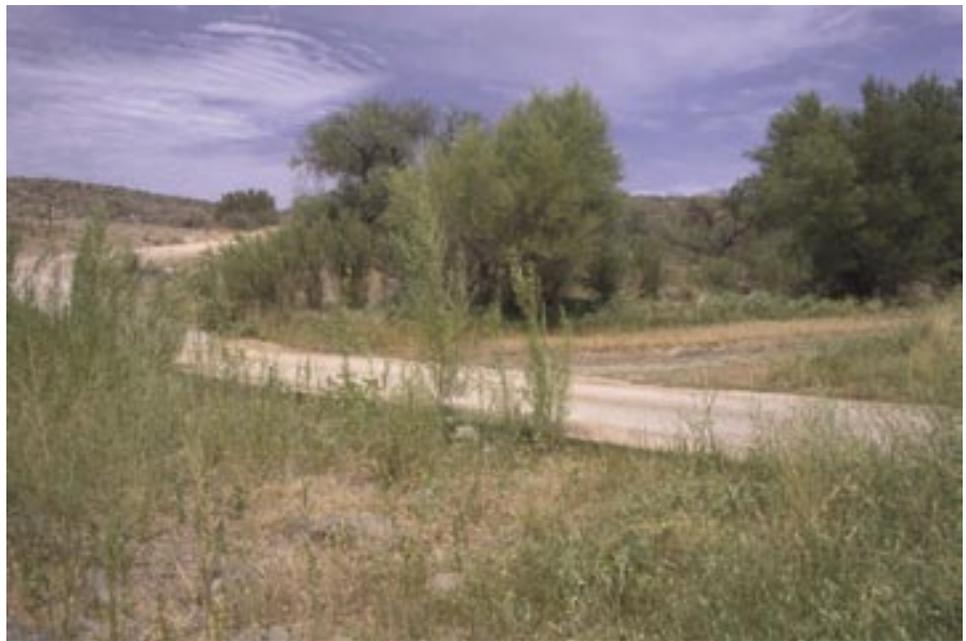
**Channel Description:** The crossing reach is moderately confined between valley and terrace walls and is controlled by bedrock outcrops in the channel and along one bank a few hundred yards above the ford. Banks are stable and vegetated with trees, shrubs, and grasses. Channel width is about 30 feet, depth about 1 to 2 feet, and slope was estimated at 1 percent (figure A45). Just upstream of the ford, three terraces are distinguishable adjacent to the channel, each one rising about 2 to 4 feet above the previous one, and each bordered by 1- to 2-foot-high vegetated levees. Bed material in transport is primarily sand and gravel, and woody debris trapped on trees shows that debris loads during floods are high. The slightly elevated ford surface has caused the active channel to aggrade somewhat upstream of the crossing.

Figure A44. Oblique view of ford and aggraded upstream channel.

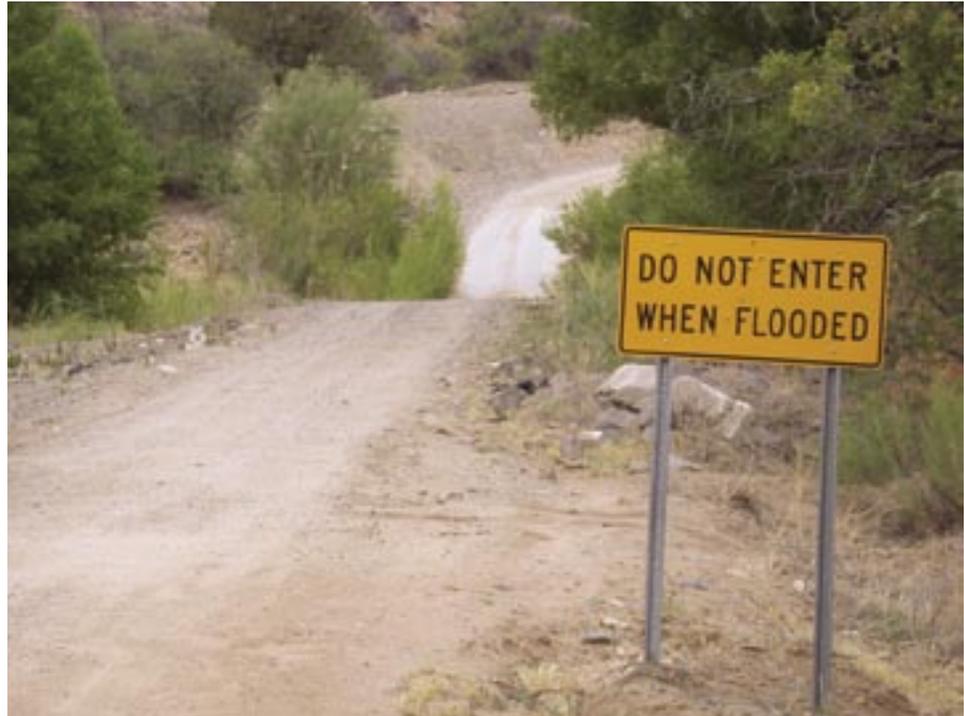
**Safety:** The crossing is signed before both approaches with “Dip - 5 MPH” and “DO NOT ENTER WHEN FLOODED” signs (figure A46). The road itself is signed as being maintained for high-clearance vehicles only at the junction with the freeway. When water flows over the ford for long times, slippery algae can sometimes be a road hazard.

Figure A46. Warning sign at Agua Fria River ford.

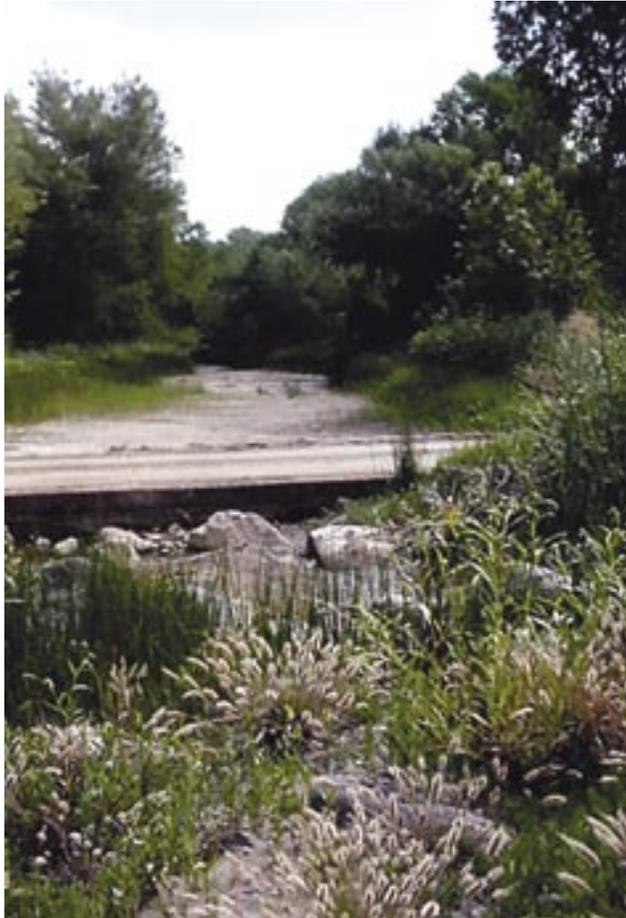
The structure fits the site, with its infrequent floods and moderate road use. It also fits the stream fairly well, except for the fact that it obstructs aquatic organism movement as flow decreases to zero after a runoff event. Since the approach roadfill slightly constricts the flood channel, some gullying and scour are expected along the edge of the road fill.

The downstream edge of the flat slab is about 1-foot above the streambed. Riprap has been placed there to control scour but minor undermining has already occurred in the fine, easily erodible streambed materials. A several-foot-deep downstream cutoff wall would be recommended here.

Figure A47. Looking upstream at ford and Agua Fria channel. Fish can move across the ford only when it is submerged.

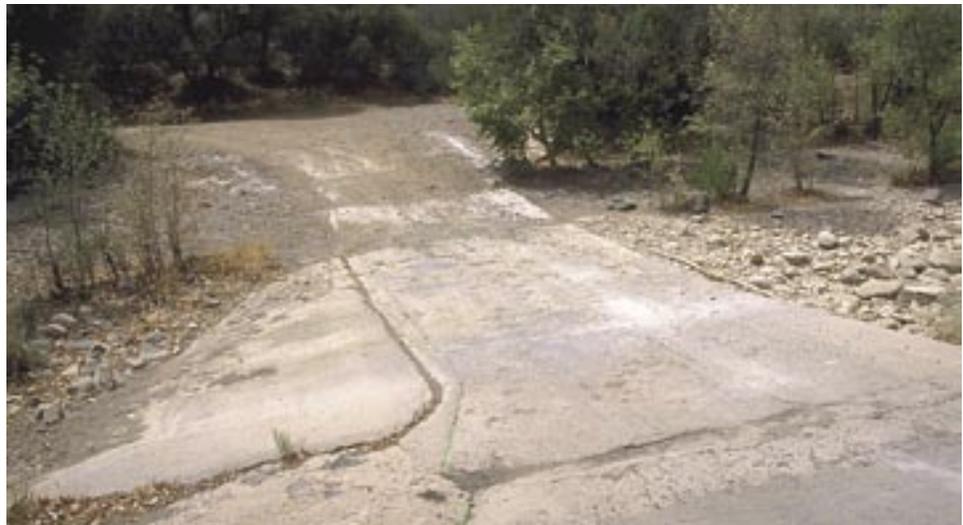
Figure A48. Ashdale concrete slab ford (downstream is to left).

The ford is 50-years old. It has been through many desert floods, including the major 100-year-flood event of 1993. Its concrete surface is battered and has been repaired or extended on both ends. Flows have partially outflanked it at some times in the past, so grouted riprap and pieces of concrete and rock have been placed along the approaches to control scour (figure A51). Downstream scour occurred at some point in its history, leading to the construction of the concrete apron, which currently provides adequate protection against scour. The ford has not received any maintenance since the late 1980s. The structure is appropriate to this high-energy site since it provides for free passage of debris and rock during high flows and there are no aquatic animal issues.

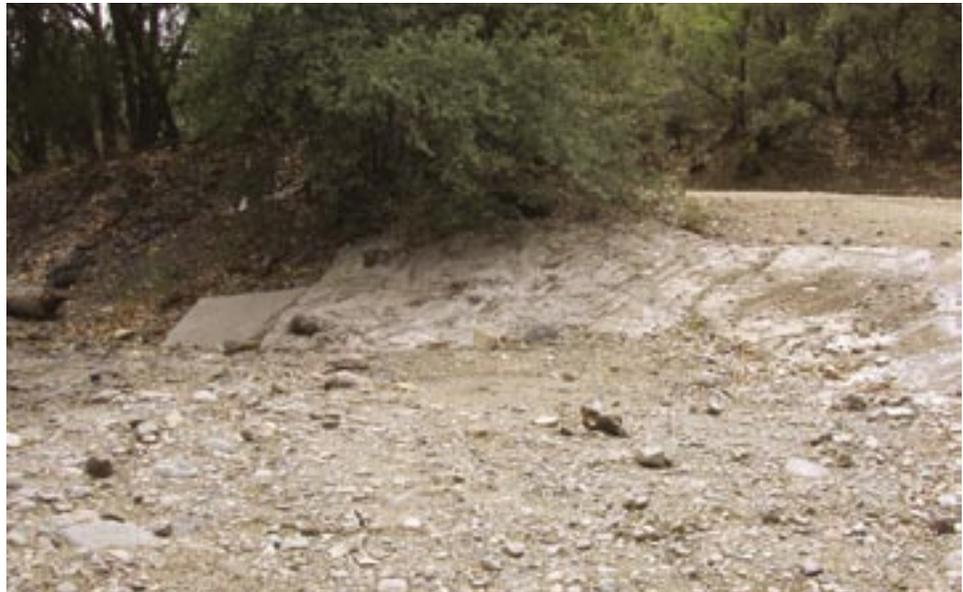
Figure A51. Concrete apron and grouted riprap prevent downstream scour and scour around edges of the ford.
