Cispus River Engineered Logjam Restoration Project

Developing Monitoring Plans— Chapter 3

Project Methods, Design, and Monitoring

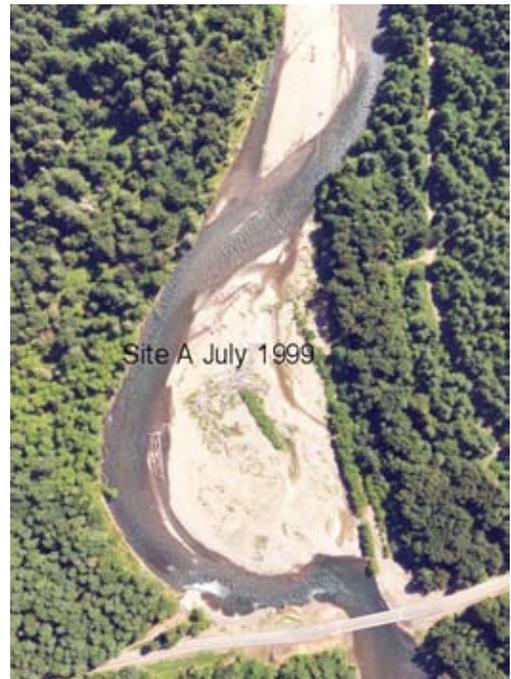
Figure 2. Site A in 1999, no structures installed in 1999.

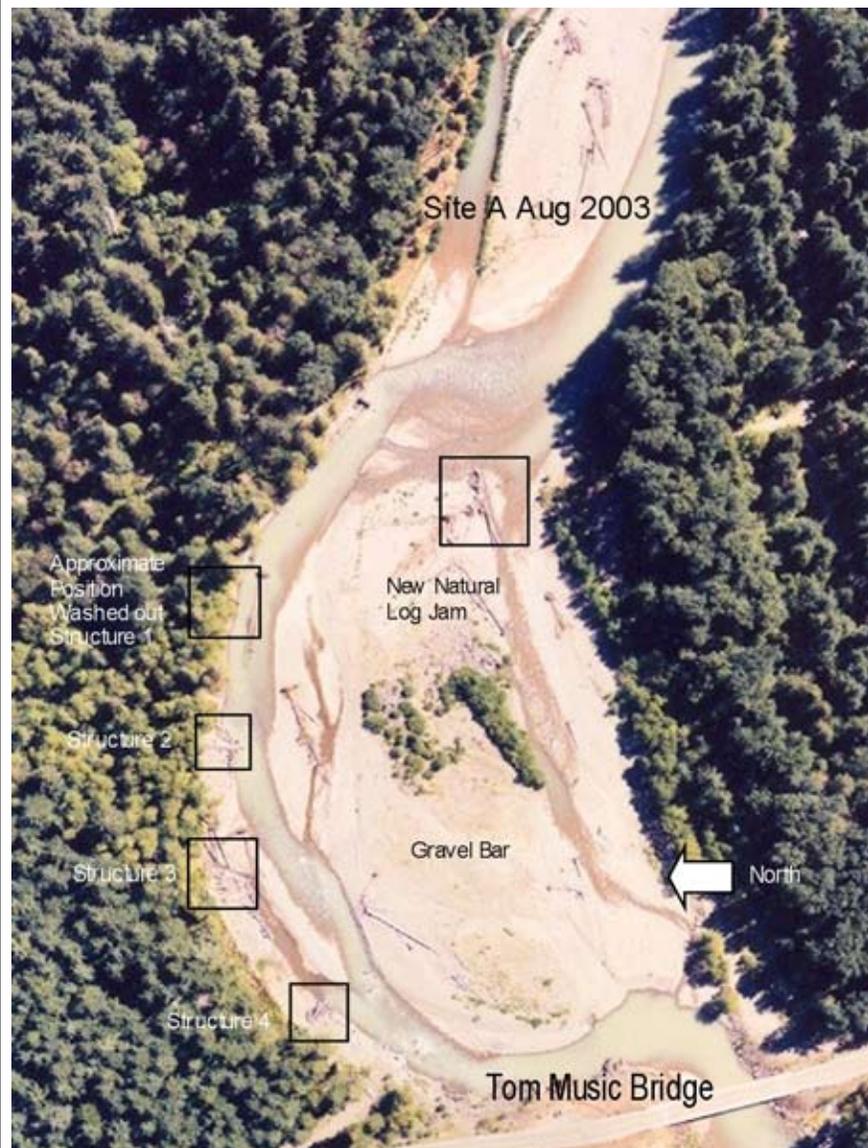
Figure 3 - Site A in 2003, with labels that show the locations of the structures; logjam formed in the flood of 2003.

The important points from these photographs are that (1) a greater portion of the river is flowing down the side channel in 2003 than in 1999, (2) new streambanks are building between the existing structures, and (3) the new streambanks provide greater protection for the approach to the bridge and the archeological sites behind the structures.

The shift of the channel was unrelated to the structures installed in 2001. During the flood of 2003, a 60-inch-diameter log was recruited and lodged on the upstream portion of the point bar. This log has formed a small natural logjam that deflects the flow of water across the gravel bar and directly under the bridge. This logjam reduces the overall risk to the bridge and archeological sites.

The furthest upstream engineered logjam (one of four, installed in 2001) washed out during the 2003 flood. Therefore, the risk for bank erosion at this logjam location is now the same as that of the preproject condition. The three remaining logjams are structurally sound and functioning as expected. The backwater areas downstream of structures two and three allowed sediment to deposit in these areas. As a result, new banks are building and protecting the area between the structures. In addition, a log

was recruited in the area between structures two and three and caused the formation of a gravel bar that deflects flows away from structures three and four. This gravel bar reduces the risk to the bridge approach and archeological sites.

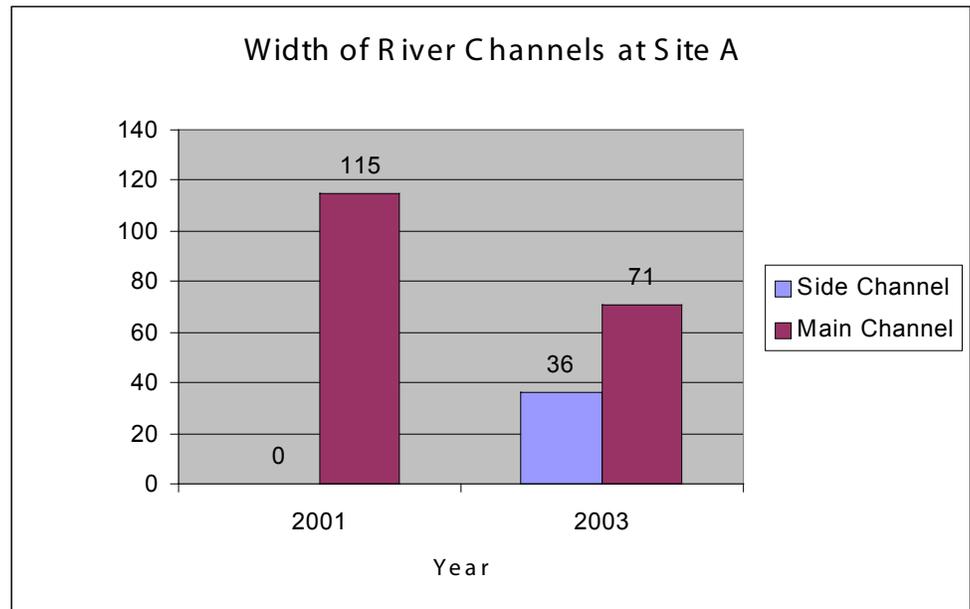
Figure 4. A comparison of the width of the main channel and side channel between years.

An overflow channel is now perennial, carrying approximately 10 percent of streamflow during low flow. This channel goes directly under the bridge, reducing the amount of water flowing in the main channel and reducing erosive forces on the archeological site and bridge approach.

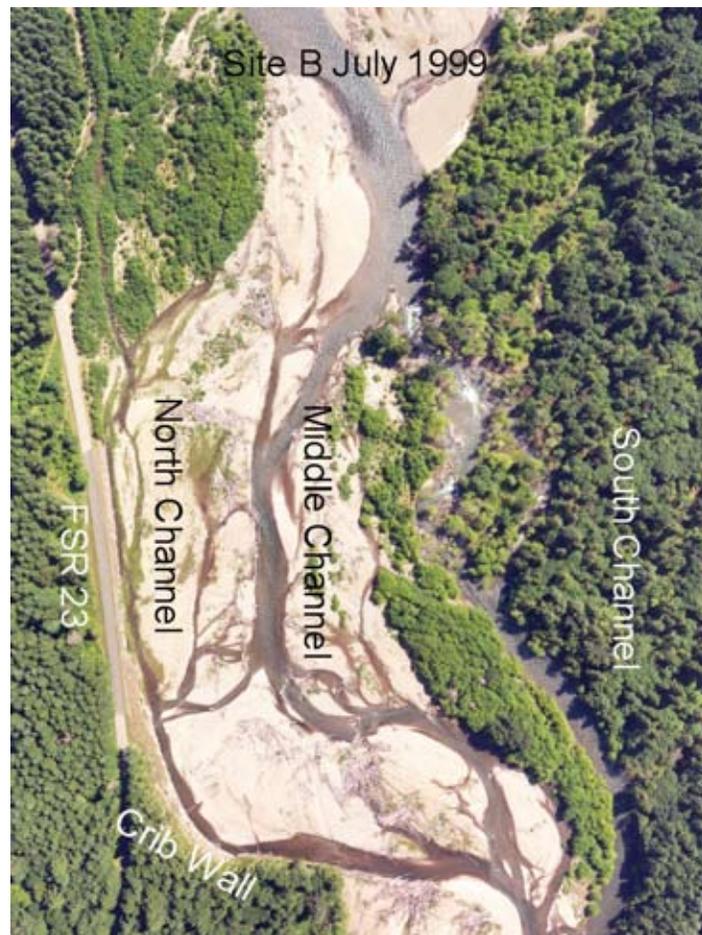
Figure 5 - Site B in 1999, before the construction of the logjams.

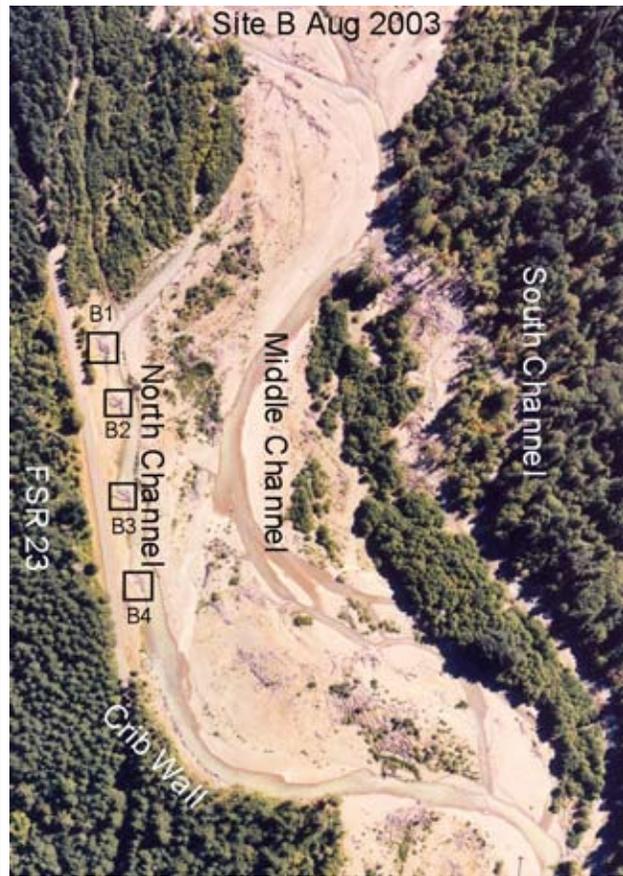
Figure 6 – The position of the river channels and the structures.

The large channel has switched sides of the valley, so that the largest channel is now on the north side of the valley next to FSR 23. The key points are these: (1) the North Channel is carrying a greater proportion of the rivers flow, and (2) the construction of the structures pushed the North Channel away from FSR 23, and (3) the North Channel increased in width while the South Channel is much smaller.

The threats to FSR 23 increased at site B: Channel migration upstream of site B increased the amount of water flowing by site B.

The low-flow wetted channel width was 15 feet (50 percent) wider in 2003 than in 1999, meaning that more water is now flowing next to FSR23. This increase in water volume increases the erosive forces close to the FSR 23. Therefore, the potential for the river to damage this road has increased.

- At site B, only 3 of the 12 horizontal pins remain functional after the January 2003 flood.
- At the 9 lost pin locations, at least 3 feet of bank was washed away.
- The three remaining pins are associated with the logjams either just upstream of or within the structure. All of the bank erosion pins associated with the cribwall structure have washed out.
- Two of the three remaining bank erosion pins showed a loss of bank material.
- Although the erosion at site B is not threatening FSR 23, the erosion is threatening the integrity of the structures, particularly the cribwall.

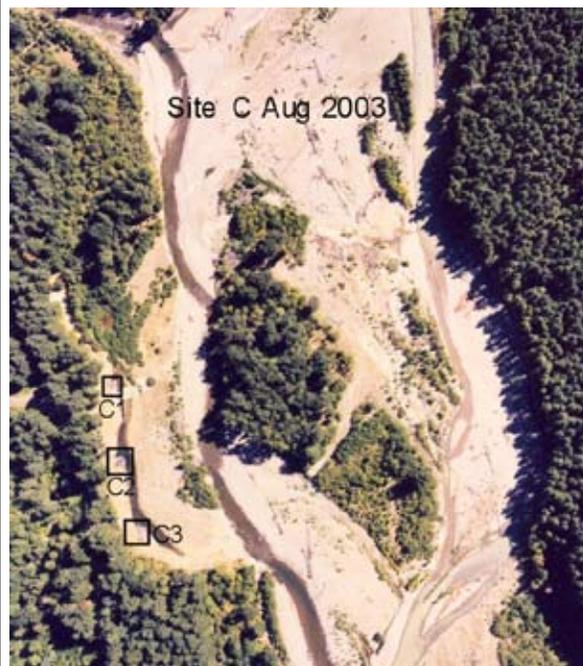
Figure 8 – Site C, 2003, with position of the structures.

The key points are as follows: (1) the channel next to the structures is wider and deeper in 2003 than in 1999, despite a decrease in streamflow, and (2) the main channel has shifted away from the channel across the intervening bar.

The amount of bank at site C has increased slightly. Nearly all of the changes at the bank erosion pins are positive, indicating the building of new banks. However, visits to site C have not revealed deposited stream sediments like those observed at site A. What we observed instead is that the upper banks at site C are sloughing material on top of the bank erosion pins. However, we have not determined the exact mechanism of the sloughing.
