Transportation Management Tech Tips

March 2009

GlasGrid Fights Pavement Reflective Cracking at Diamond Lake

Gordon L. Hanek, Geotechnical Engineer, Umpqua National Forest

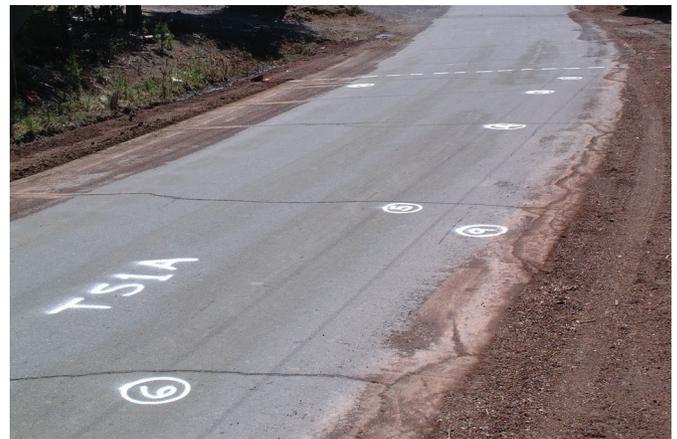
In the summer of 2001, two segments of the paved loop road around the Diamond Lake Recreation complex on the Umpqua National Forest were treated using a hot-mix asphalt overlay. The first road segment accesses a winter-sports area with a sledding hill and snowmobile rental shop near the lake. The pavement in this road segment suffered from severe regularly spaced thermal cracks, many that were 1/2- to 1-inch wide (figure 1).

Figure 1—Test section 1, exhibiting large, regularly spaced thermal cracks.

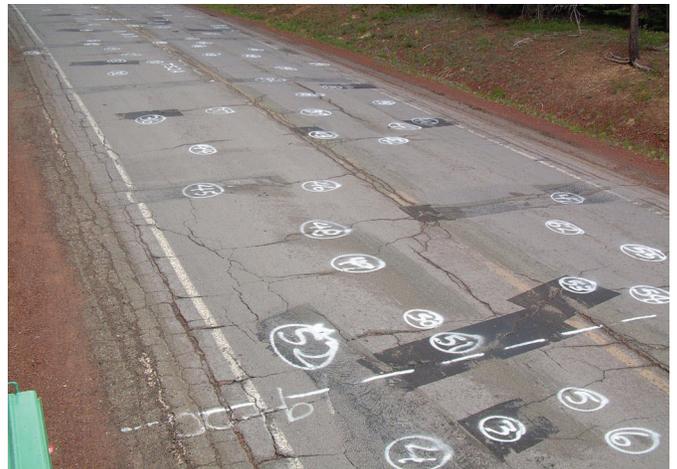
The second segment was a portion of the old State highway (figure 2) that originally served the area and was over 40 years old. The surface was severely cracked due to heat, age, and load distress (exhibiting block, longitudinal, thermal, and alligator-type cracking).

Figure 2—Test section 2, exhibiting a variety of pavement-cracking distress types.

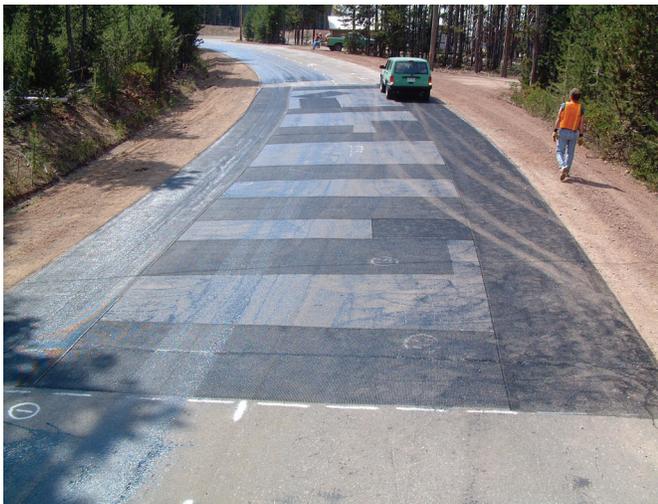
The 8502 product is twice as strong in one direction as the other and is intended for use over individual cracks. It was used in test section 1 where the individual-crack treatment was applied (figure 4).

Figure 4—GlasGrid Type 8502 was used to treat the individual thermal cracks in test section 1. The darker areas are those covered by the GlasGrid.

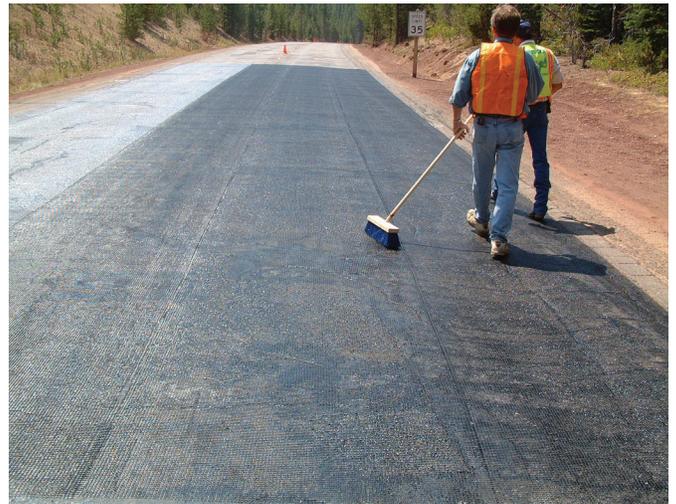
The 8501 product is intended for use where cracking is widespread. It was used to cover 100 percent of the cell in test section 2 (figure 5).

Figure 5—GlasGrid Type 8501 was applied with 100-percent coverage in test section 2. A 2-inch overlap was used at all seams.

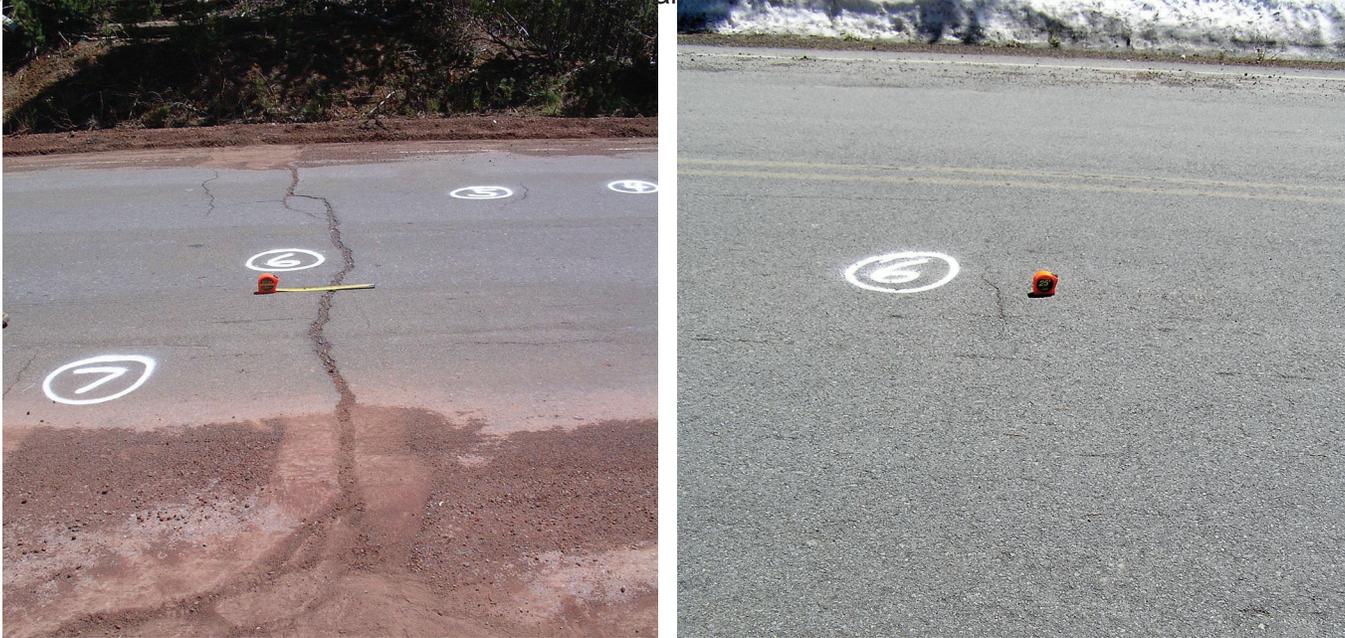
The GlasGrid-treated cell in test section 1 (where large, regularly spaced, thermal cracks were the primary distress) has performed significantly better than either the control cell or the cell with only a crack-sealing pretreatment (figures 13 and 14). After 6 years, less than 2 percent of the crack length has reflected through in the GlasGrid section versus almost 45 percent in the control section. Originally, crack severity in test section 1 was generally medium (mean-crack width greater than 1/4 inch) to high (mean-crack width greater than 3/4 inch), whereas all cells after 6 years still have generally low-severity (mean-crack width less than 1/4 inch) cracks though a few medium-severity cracks have developed in the cells without GlasGrid. Reflective cracks are occurring over original cracks that were of medium and high severity.

Figure 13—Comparison of reflected crack in GlasGrid-treated cell of test section 1 after 6 years.

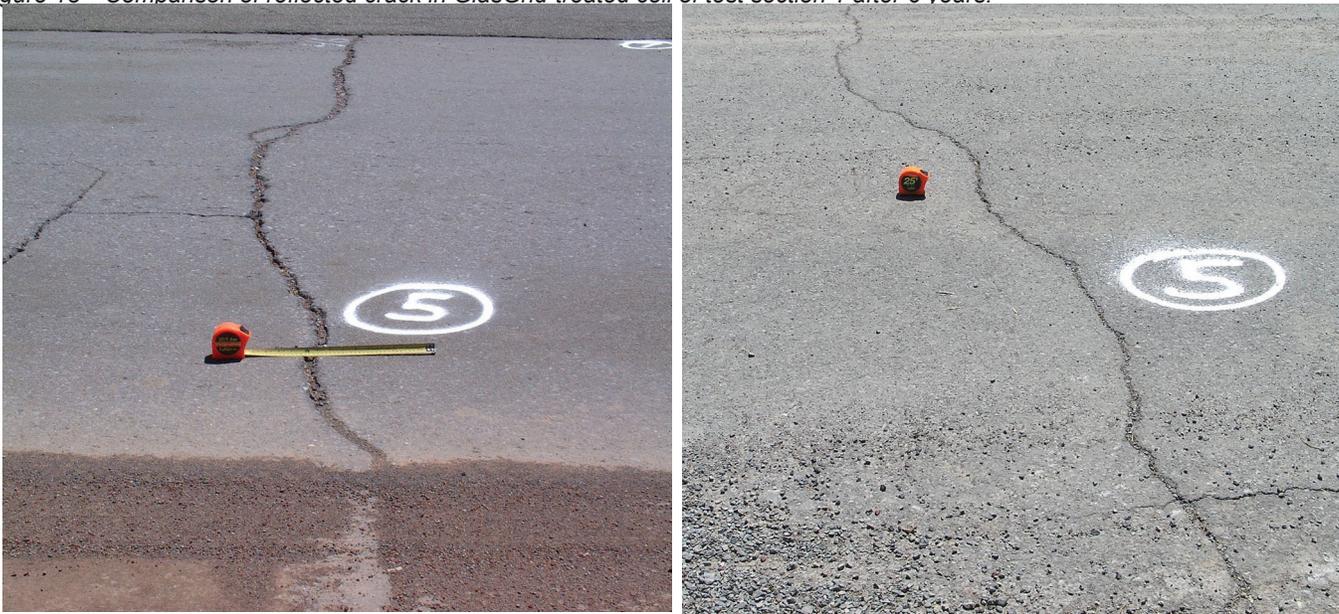
Figure 14—Comparison of reflected crack in control cell of test section 1 after 6 years.

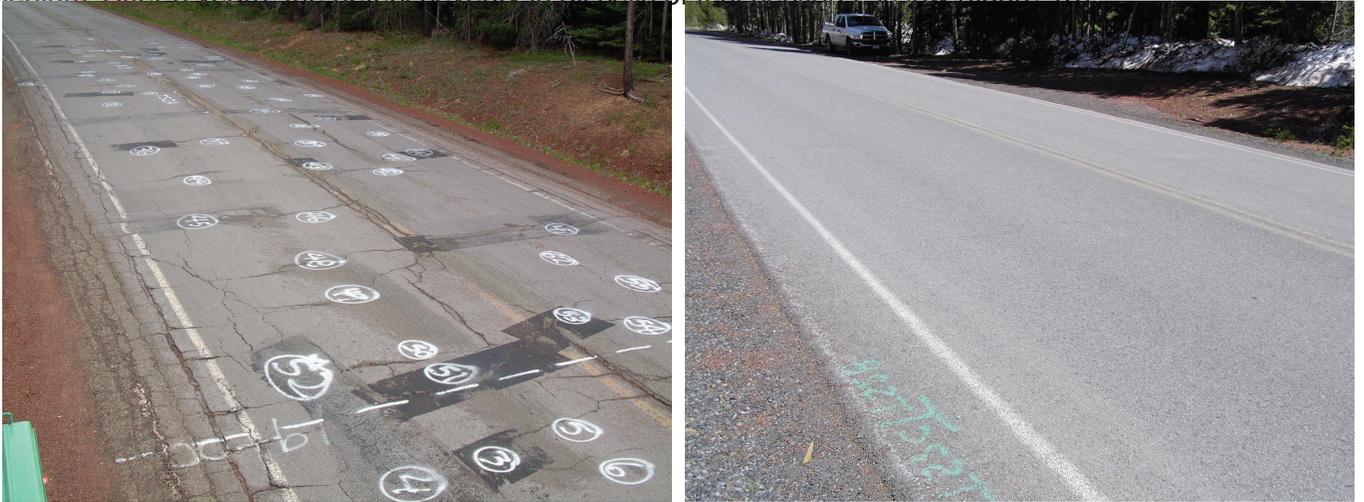
In test section 2, where a variety of crack-distress types including block, alligator, longitudinal, and thermal occurred, the GlasGrid-treated cell experienced less reflective cracking than the control cell but more than the cell with only crack sealing as a treatment. It appears that the GlasGrid was not as successful in retarding the more generally distributed and greater variety of cracking-distress types present in this test section. However, given the relatively small amount of overall reflective cracking that has occurred in test section 2, it may be premature to draw conclusions until additional future observations can be made. As was the case with test section 1, the pretreatment defect-severity in test section 2 was also generally medium. After 6 years, the defect severity in all cells of test section 2 is low (figure 15).

Figure 15—Comparison of test-section 2 surface after 6 years.
