Water/Road Interaction: Examples from Three Flood Assessment Sites in Western Oregon

Ronald L. Copstead, P.E.

David Kim Johansen, P.E.

September 1998

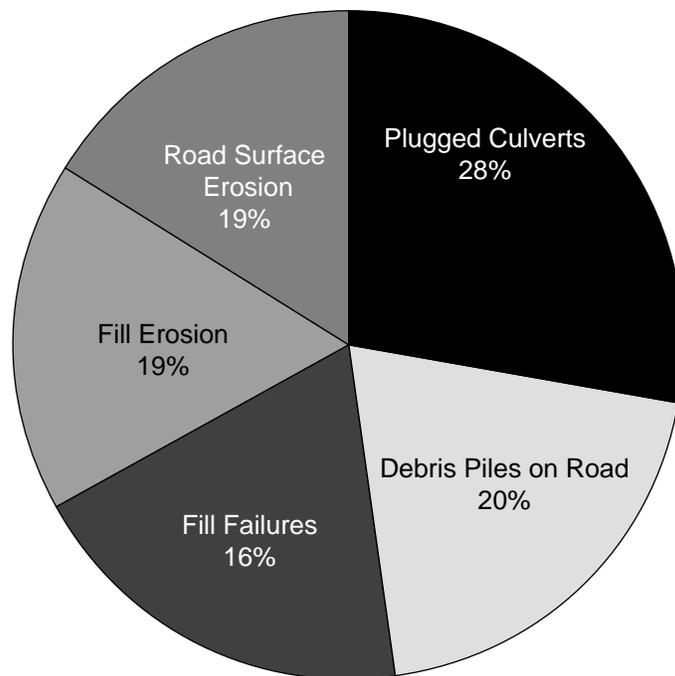
R9800132

Surveys of damage to roads and to local areas surrounding roads on the Detroit Ranger District showed that plugged culverts and road-surface and road-fill erosion accounted for most of the damage to roads and road-stream crossings (Figure 1).

Culvert plugging by stream bedload and woody debris was the most common type of failure overall (28 percent). Often a small branch caught in the culvert inlet and resulted in stream bedload accumulation and eventual burying of the inlet. Culverts that were 600 mm (24 inches) diameter or less accounted for 81 percent of the plugged culverts.

The cause of flood damage to roads from erosion of road surfaces and stream channels adjacent to roads, fill failures, and forest slides contributed about equally to road damage, each comprising 14 to 18 percent of the number of sites that were damaged. Cutslope failures contributed only 6 percent of sites that were damaged.

Figure 1—Road related storm damage by type (352 Sites on Detroit RD 1996).

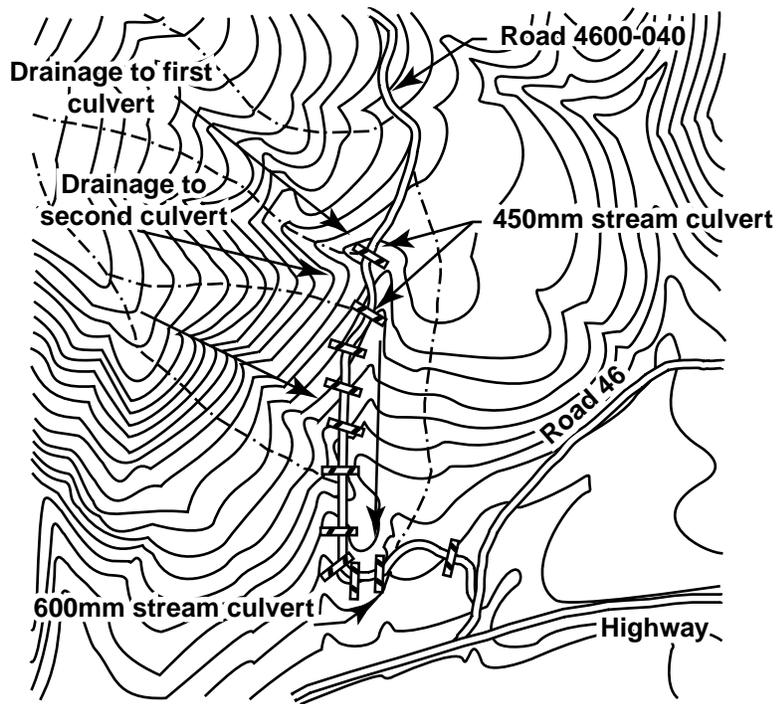
R9800156

The damage on this site began where two adjacent small streams carrying high flows and sand- to cobble-sized bedload plugged road culverts (Figure 2). Both of these 1.0 to 1.5 m-wide stream channels crossed the road with 450-mm (18-inch) diameter corrugated metal pipes lying on a 5 percent

Figure 2—Breitenbush site map.

(stream) gradient. The upstream end of the culverts projected into widened inlet basins. Roadside ditches were open uphill and downhill to these inlet basins. Stream bedload accumulated at both of the culvert inlet basins, filling them until their inlets were buried. Storm flow was then diverted to the road ditch. The flow and stream sediment from the first culvert flowed down to the second culvert, where they combined and continued down the road ditch. The flow from the slope above the road and road surface drainage also accumulated in the ditch. The high volume and high-velocity flow—the road and ditch grade ranged from 8 to 11 percent—began eroding the road ditch to a depth limited only by bedrock lying from 0.5 to 3 meters below the originally constructed ditch bottom (Figure 3). At the entrances to ditch-relief culverts, either inlet basins were severely eroded or the entrances were plugged by sediment so that none of the culverts were transporting water across the road. The accumulated flow could not escape the ditch and continued down the road for 1.2 km (.75 mile).

Storm flow eventually eroded through softer road-fill material, forming a 1.3-m-deep gully. Debris was carried into a small, intermittent drainage where some of it was deposited. The remainder was carried further downhill into a larger stream drainage. This larger drainage crossed the road near the junction via the forest highway with a 900 mm (36 in.) culvert. The entrance basin to this crossing was filled by debris and the pipe entrance was buried. The stream flow overtopped the road and eroded through the

fill approximately one meter down to bedrock, carrying the material 100 meters to the forest highway below. Debris deposited on the highway and the flow spread over the road surface and was dispersed into the forest below.

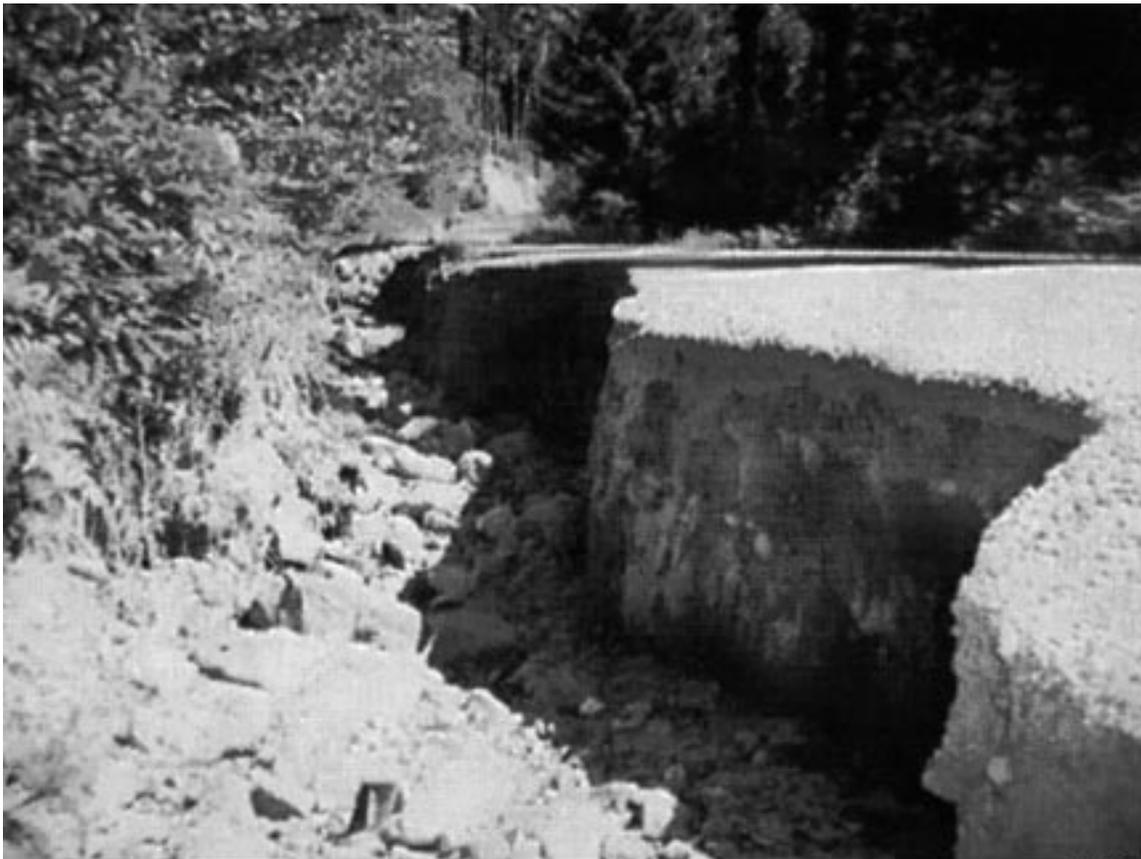
R9800157

Figure 3—Severe gullying at Breitenbush flood-assessment site.

The dense, well-graded gravel road surface received little damage from surface runoff during the storm. Sediment and rock debris were scattered onto the road surface at some locations. A summary of drainage features and observations of what happened during and after storm events is shown in Table 2. Virtually all of the material that eroded and moved off site came from the unlined ditches and resulting gullying that occurred during the storm (Figure 3).

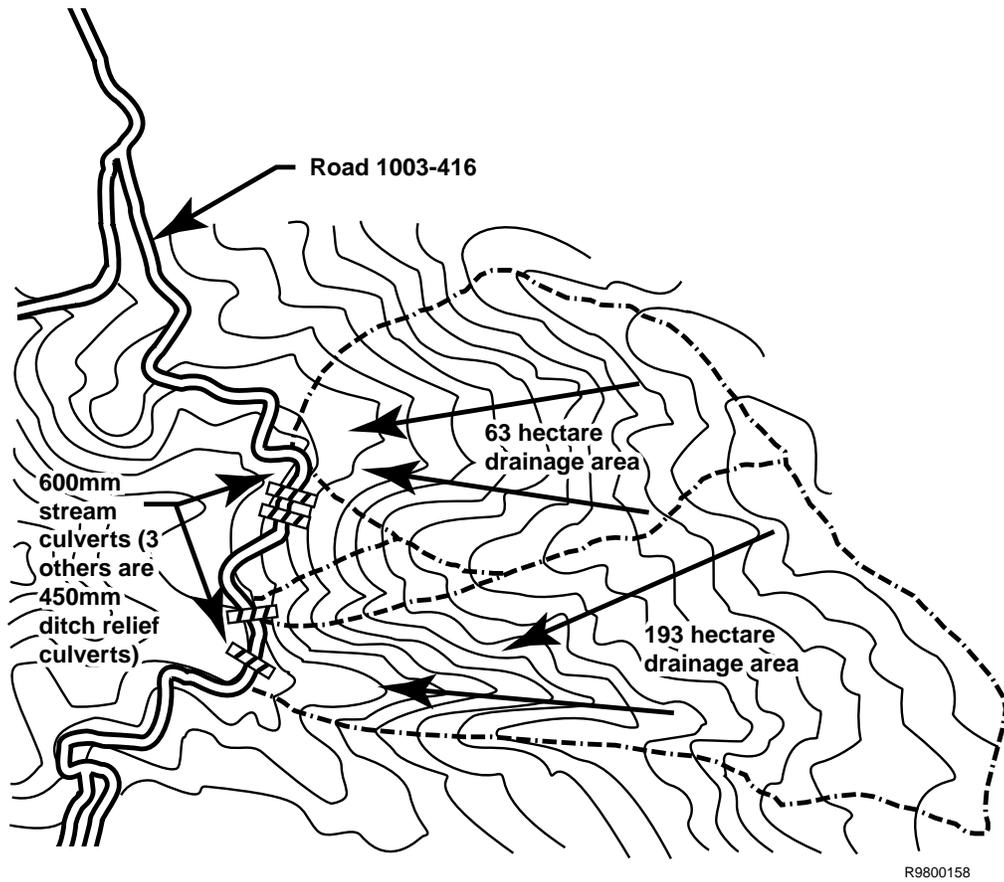
Damage at this site began at the 2.7-km stream crossing, where debris filled a stream crossing culvert inlet basin, plugging the 600-mm (24-in.) corrugated metal pipe and diverting the stream into the road ditch (Figure 4). As the road ditch was eroded, debris was scattered on the road surface in numerous places. Ditch relief culverts were plugged by coarse-grained sediment. A portion of the water was deflected off the road by this debris while the remainder flowed down the road ditch and traveled on the surface causing additional damage. Eventually the stream eroded through the road template creating a gully up to 3 m (9.8 ft) deep by 3 m (9.8 ft) wide (Figure 5). This gully followed the

Figure 4—K-Creek site map.

Debris generated from the diverted stream 0.5 km away was deposited in the inlet basin for a 600-mm (24-in.) diameter culvert near the bottom of the site (at location 3.2 km), plugging the inlet. The stream flow pooled and overtopped the road, eroding the fill and exposing the culverts. A summary of drainage features and observations of what happened during and after storm events at this site is shown in Table 3.

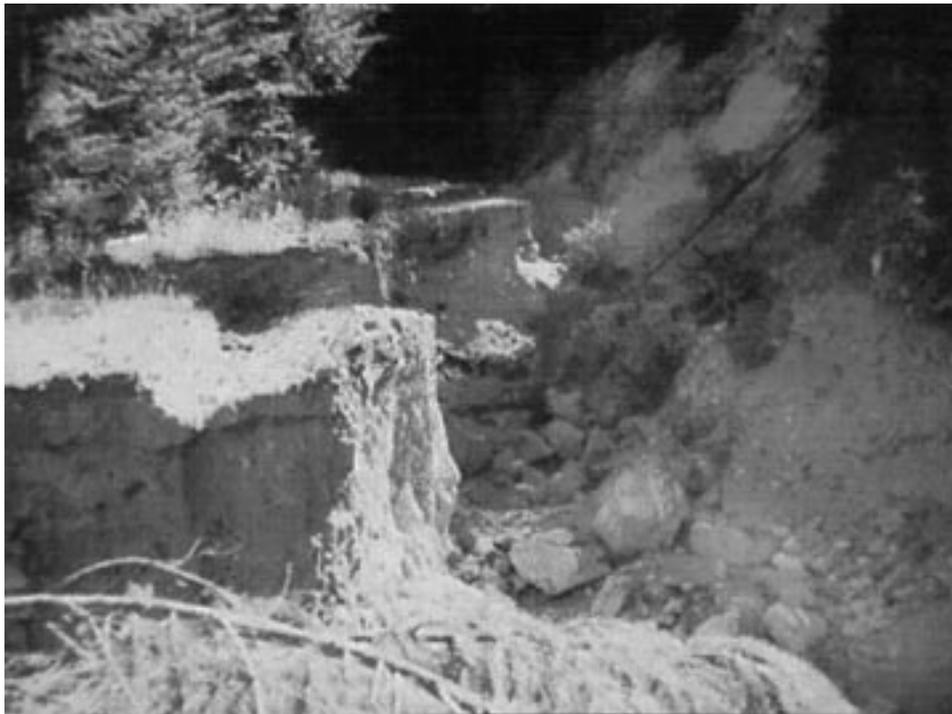
Figure 5—Severe gullying at K-Creek flood-assessment site.

road until it eroded through the fill, diverting the stream and depositing sediment in a broad, shallow basin adjacent to the road. The forest vegetation served as a buffer strip to help capture sediment before it reached stream channels. The basin allowed water to pool and drop suspended sediment. Location of cross drains and stream crossing culverts are shown in Table 3.

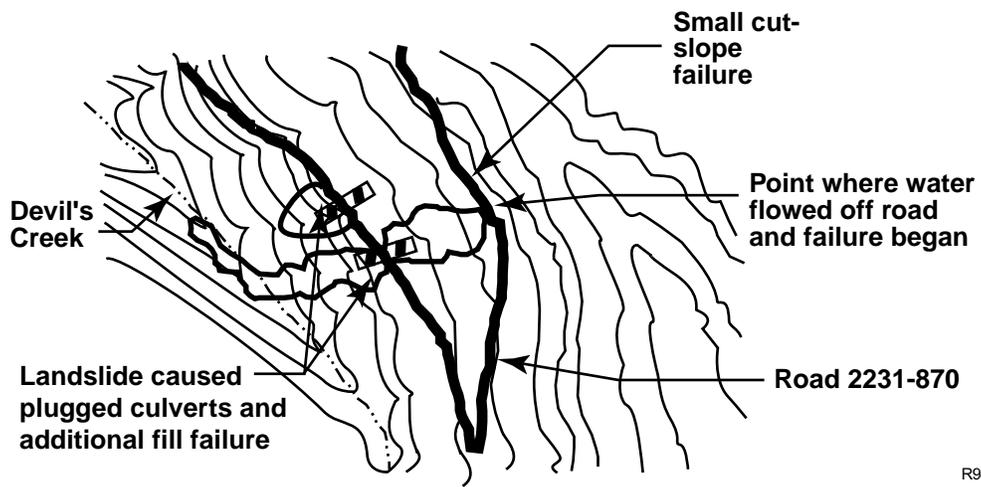
R9800160

This site involved the failure of a thin side cast road fill that scoured the soil off a drainage headwall on the hillside and deposited it on a lower segment of the road, within the lower segment of the drainage and within Devil's Creek (Figure 6). The failure was caused by water being diverted by a small cutslope slide (estimated volume was 5 cubic meters) that dammed a ditch, causing ditch water to run out onto the road surface, down wheel tracks and eventually over the fill slope edge of the road (Figure 7). The fill slope apparently failed as a result of saturation caused by rainfall combined with the overtopping ditch water eroding the toe of the fill. The failed fill slope became a fast-moving earth flow that

combined with wet 1- to 5-meter-thick surface soil in the drainage headwall, gathering volume as it moved and not stopping until it encountered the road below. The debris then filled the inlet basin of the road culvert, covered the road with about 800 cubic meters of debris, and sent the bulk of the debris into the drainage channel below the road and into Devils Creek. The channel debris swept up a forest slope, knocking down trees and burying the channel. The drainage eventually eroded through the channel debris to reconnect with Devil's Creek. It was estimated that, of the approximately 4200 cubic meters that were eroded and subsequently slid from the site, about 25 percent was stopped by the road, with the remaining volume ending up within the stream bed below. The road fill was partially eroded, damaging the outlet end of two 750-mm (30-inch) diameter stream culverts located at the site. Apparently, one of the culverts had been damaged in the past by a debris slide, left in place, and replaced with a new culvert of the same size.

Subsequent maintenance at the site removed debris from the road surface, but did not re-establish flow into the cross drain. Instead, water flowed into the road ditch and continued about 70 meters down to the next culvert. The sediment carried by the diverted drainage eventually plugged the next culvert, then diverted over the road surface, eroding approximately 3,000 cubic meters of road fill. The fill material was deposited in a flattened area below the road and within a forested buffer strip area below. Very little road fill reached Devil's Creek drainage below. The road culvert was severely damaged and the road subgrade was destroyed.

Figure 6—Devil's Creek site map.

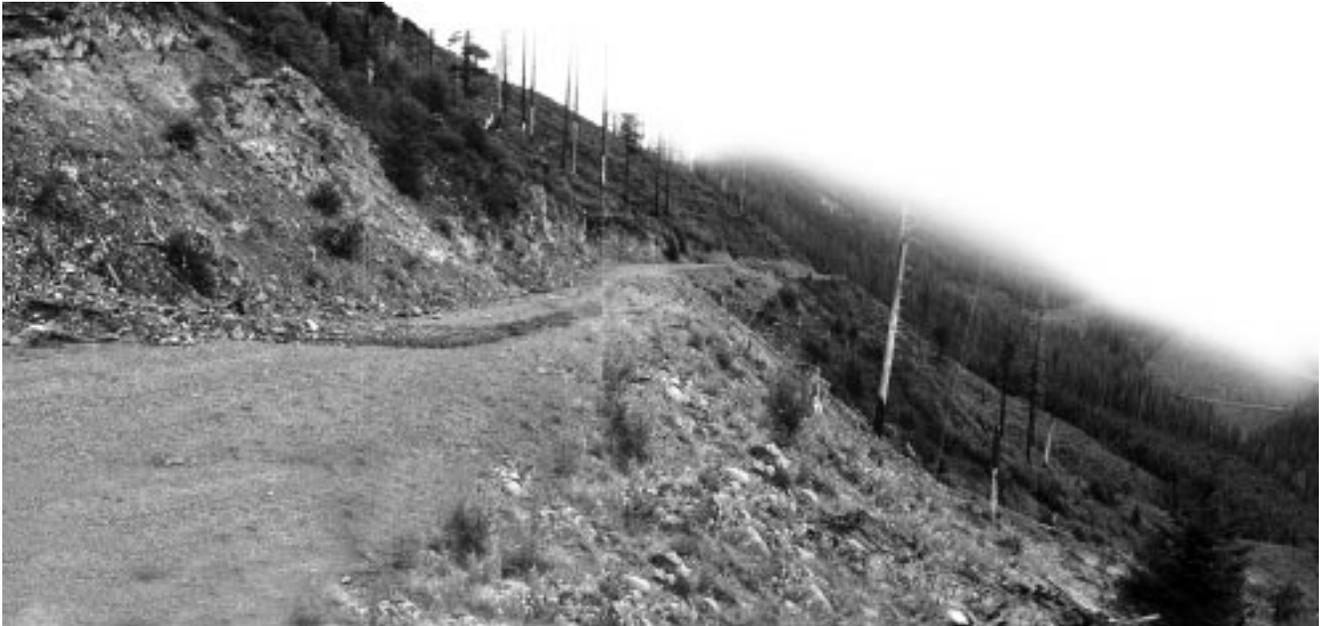
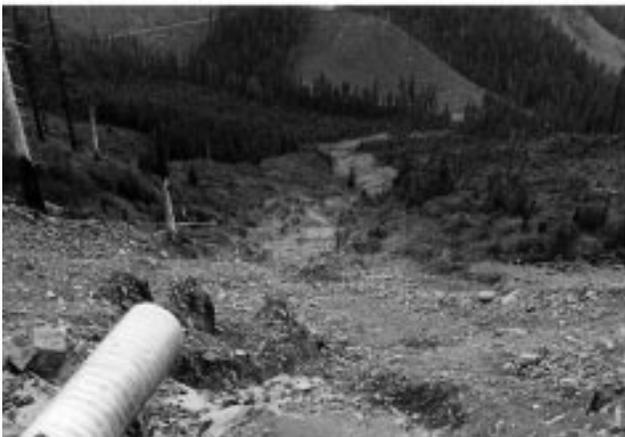
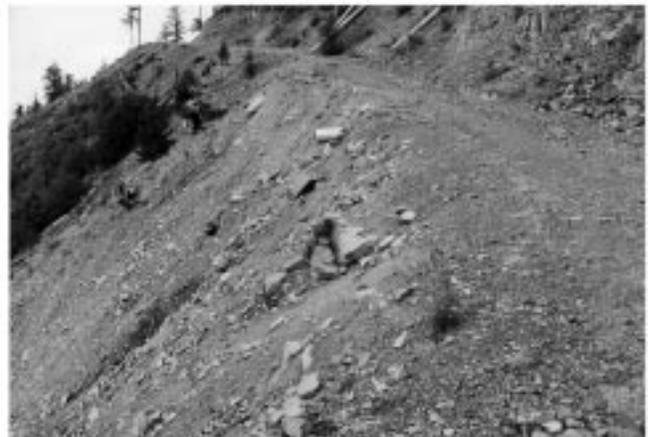
R9800181

Figure 7—Initiation of debris slide at Devil's Creek flood-assessment site.

Damage to the Devil's Creek site resulted from a failed cut bank plugging a ditch. Wheel tracks carried the diverted water down the road until a surface depression was reached. The effect was to saturate a fill, which then initiated a slide at the toe of a slope. This small slide developed into a debris chute. The road is a full bench design that had a shallow layer of soil sidecast as waste during construction (a "sliver fill"). The sidecast soil lies on a thin mat of soil and organic matter (partially decomposed by now) such as stumps and brush. This created a zone of weakness that failed more readily than other soil in the area.

The topography and management regime below the road probably contributed to the failure. The area below the road was a 55 to 70 percent, ten-year-old, clear-cut unit. Typically, tree roots remaining in the soil in this type of area have significantly rotted, losing shear strength that helps hold soil on the slope. The

absence of large trees also meant there was little to stop a slide once it became mobile. The underlying bedrock mostly parallel to the slope, acted as a slip zone for the soil. This situation suggests that maintenance personnel should carefully monitor roads in similar areas with steep, wet, relatively shallow soils with thin fills. Unstable fills should be pulled back before they can fail. Also, during full bench construction, efforts to pull back fill spilled over the side may eliminate potential failures.

The \$5,000 to fix the upper road (clean ditch and ditch relief culvert) was small compared to the value of other resources that may could be damaged. In contrast to the other two sites, the role of the culvert/drainage design for this road was incidental to the initiation of the failure. The relatively small cut-slope failure that initiated this damage is an example of how seemingly isolated and innocuous events can trigger much more catastrophic results when "fail-safe" drainage designs are not used.
